Re: Bowie Resources, LLC, Bowie No. 2 Mine
Coal Mine Waste Banks & Instrumentation Monitoring
Pond Quarterly Inspections
Permit C-1996-083

Coal Mine Waste Bank Nos. 1, 2, & 3 Inspections –2nd Quarter 2018

Subject: Summary of Instrumentation Monitoring
2nd Quarter 2018
Bowie Coal Waste Disposal Area No. 2
Paonia, Colorado

Subject: Summary of Instrumentation Monitoring
2nd Quarter 2018
Bowie Coal Waste Disposal Area No. 3
Paonia, Colorado

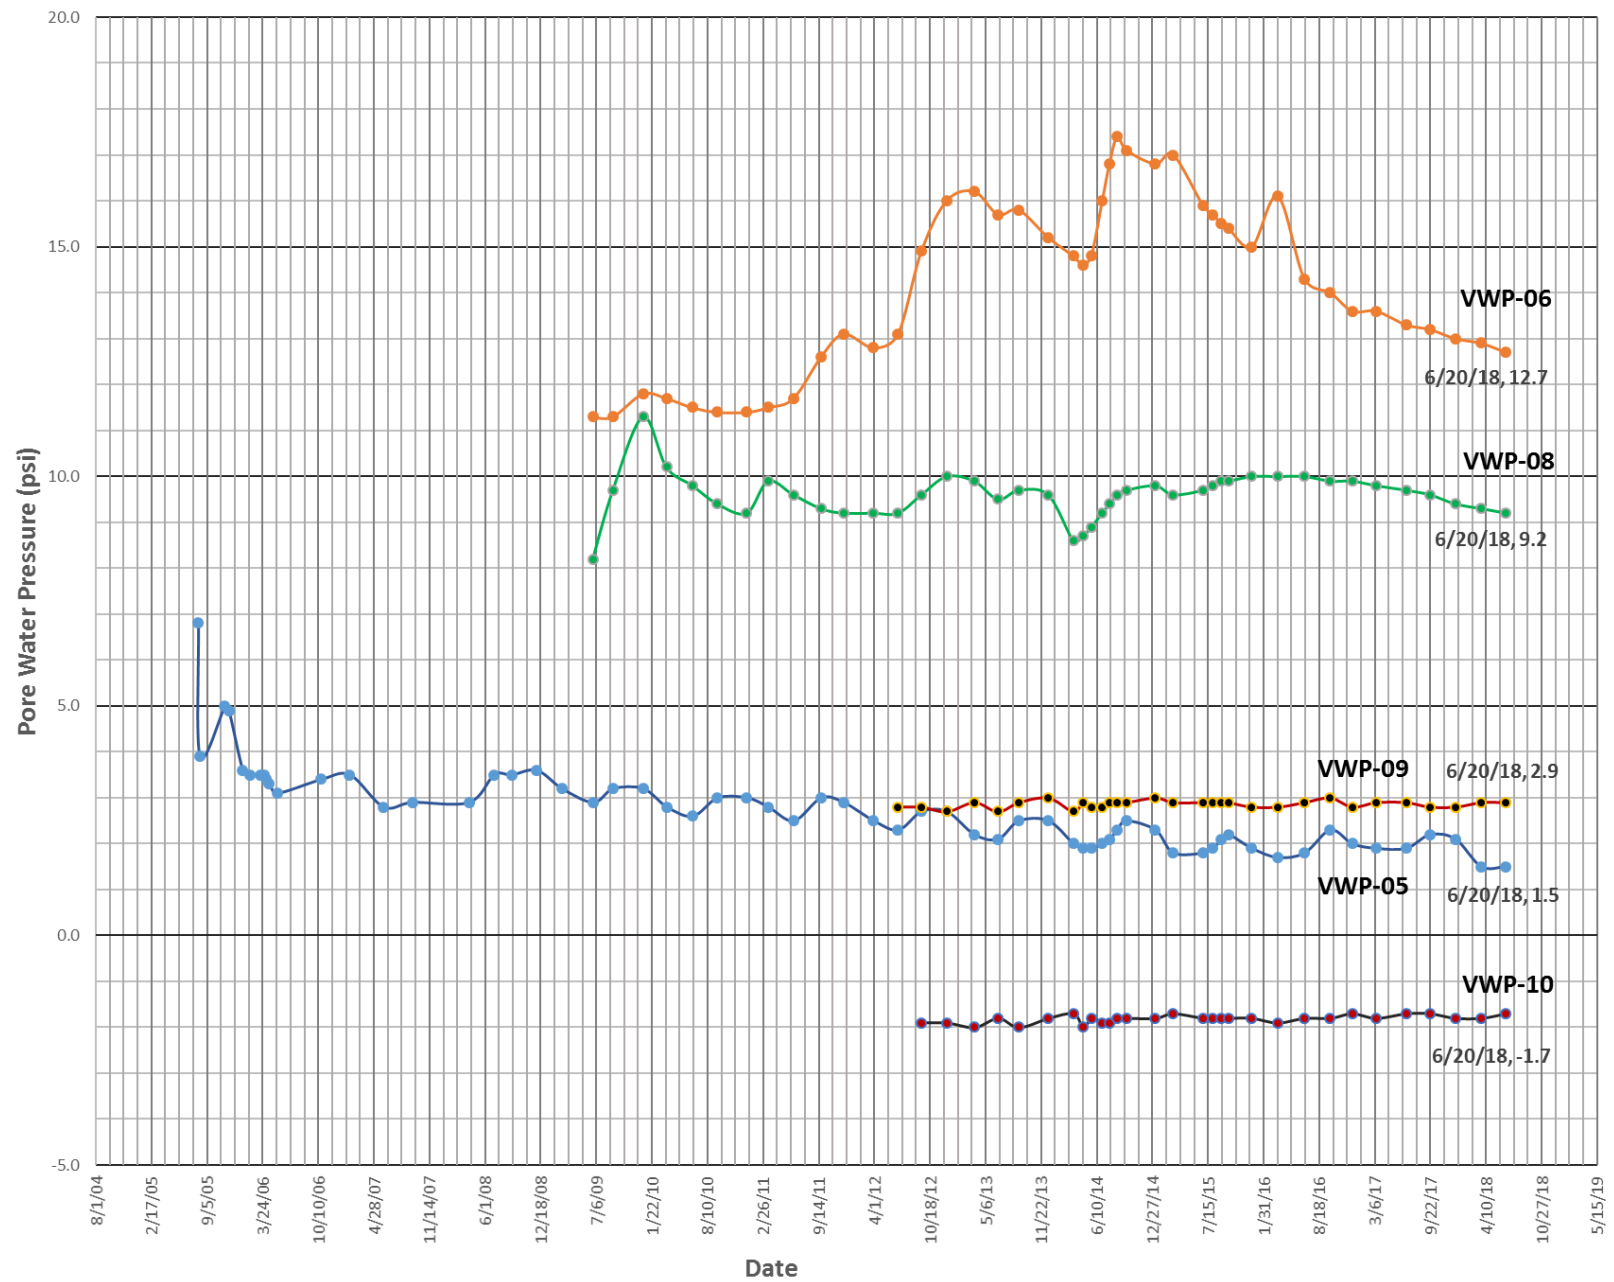
Figure 2 - Bowie Mine #2 - CWDA #2
Active Vibrating Wire Piezometer Data

As indicated in the referenced *Stability Evaluation* report, the stability of CWDA No. 2 is sensitive to increases in pore pressures in VWP-08. An increase in the pore pressure of 7 psi in VWP-08 would result in a reduction of the Factor of Safety to below 1.5.

The current pore pressure reflects a piezometric surface elevation of approximately 6097 feet which is much less than the critical elevation of 6113 feet. As a result, HBET does not believe that the measured pore pressures in VWP-08 are any indication of instability in CWDA No. 2.

VWP ID #	Installation Pore Pressure (psi)	03/22/18 (Q1) Pore Pressure (psi)	06/20/18 (Q2) Pore Pressure (psi)	Difference Since Installation (psi)	Difference Since Last Quarter (psi)
VWP-05	6.8	1.5	1.5	-5.3	0.0
VWP-06	11.3	12.9	12.7	1.4	-0.2
VWP-08	8.2	9.3	9.2	1.0	-0.1
VWP-09	2.8	2.9	2.9	0.1	0.0
VWP-10	-1.9	-1.7	-1.7	0.2	0.0

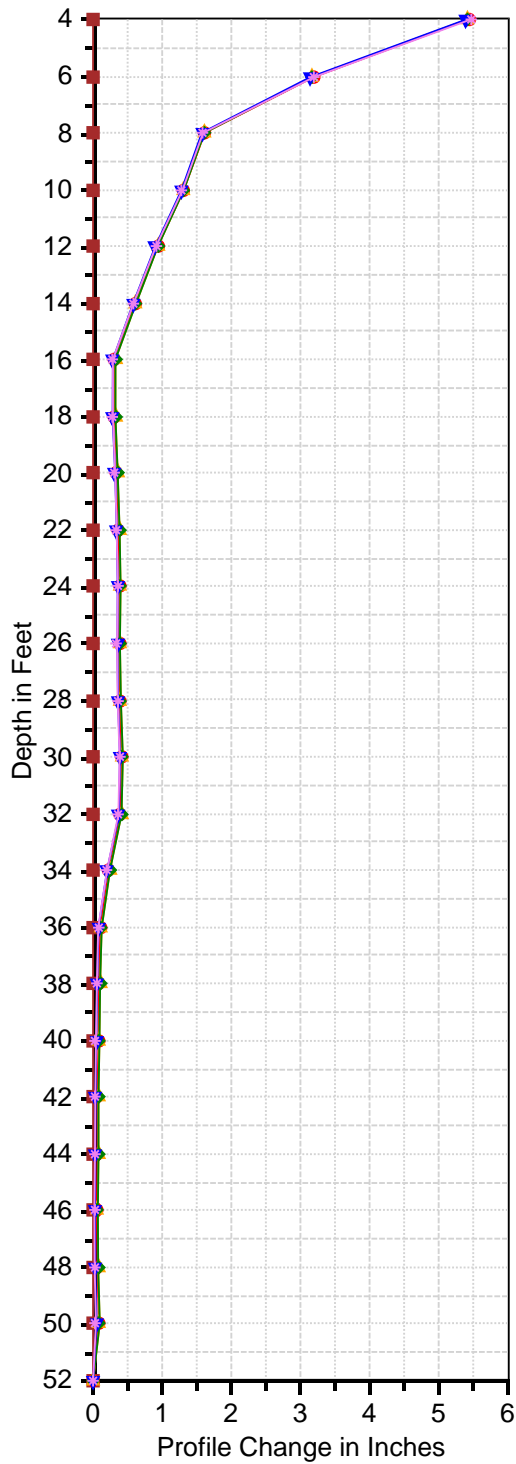
BOWIE BG05_4 A

As described in previous reports, we believe historic displacements indicated on the plots for the approximate upper ten feet of the inclinometers are likely due to placement of cover soil on the face of the waste bank during normal operations for maintenance and revegetation.

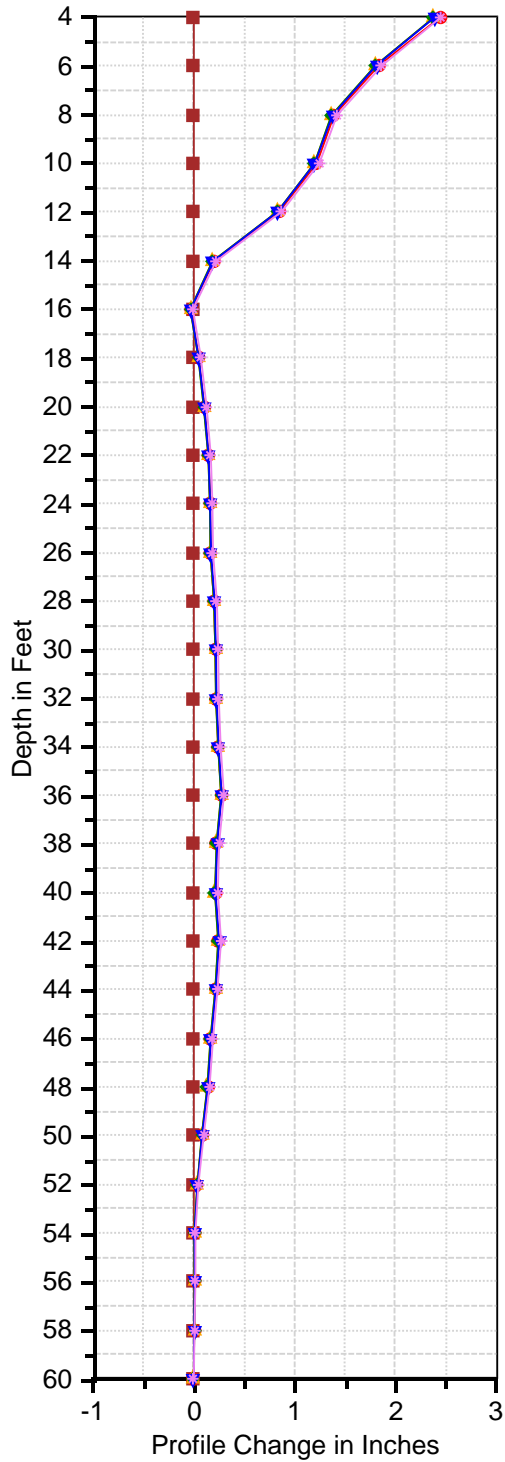
BOWIE BG05_5 A

Inclinometer BG05-5 Axis B shows a small offset in the orthogonal direction. This inclinometer reading was re-measured in July due to a large systematic offset. Because this is an orthogonal reading, not downslope, the offset is not likely to be slope movement and may be a systematic error. We will re-evaluate this small offset for the 3rd and 4th quarter readings.

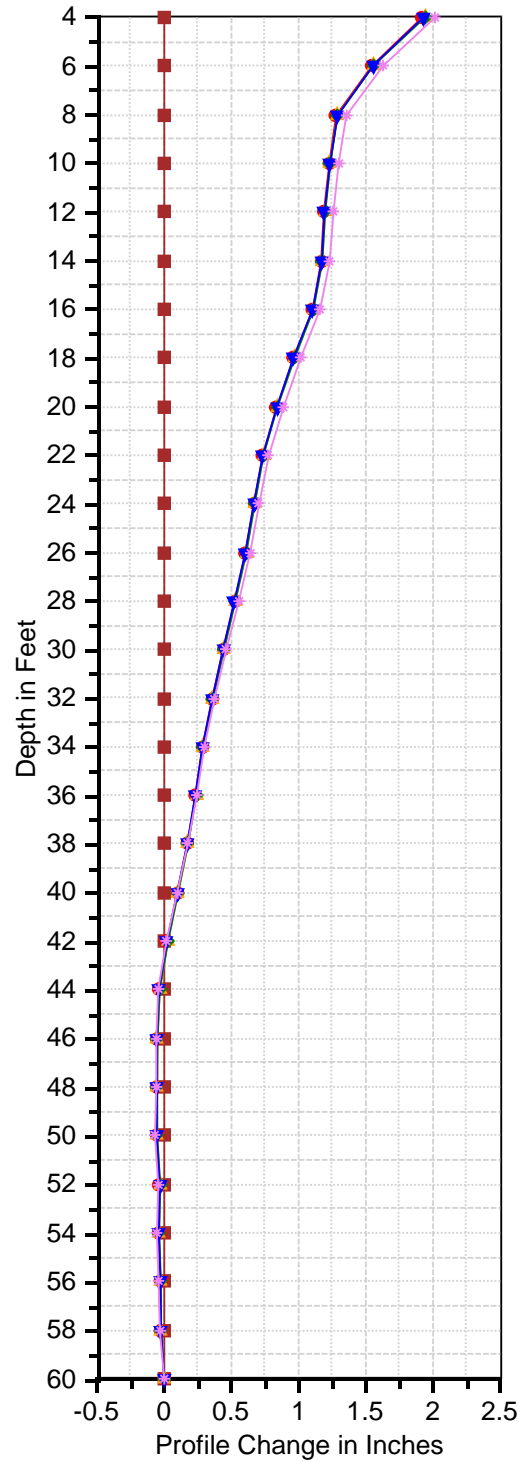
BOWIE BG05_5 B

The latest inclinometer readings indicate no major movements since the last quarterly reading. Slight deflection was indicated in the data for BG05-5 along the B-axis; however, the noted deflection is minimal. In addition, the overall profile of the data is the same as prior readings. This suggests an error in the deeper data which created an offset in the shallow data. However, additional evaluation will be conducted upon completion of the 3rd Quarter readings. In general, the 2nd Quarter 2018 monitoring data does not provide any indication of instability in CWDA No. 2.

Recent readings are generally consistent with previous readings, except for BG05-7A which has had anomalous readings in previous quarters near the surface and BG05-5B which is likely a small systematic instrument error to be confirmed with future readings.
