**COLORADO**Division of Reclamation,  
Mining and Safety

**MINERALS PROGRAM INSPECTION REPORT****PHONE: (303) 866-3567**

<b>MINE NAME:</b> Henderson Mine	<b>MINE/PROSPECTING ID#:</b> M-1977-342	<b>MINERAL:</b> Molybdenum	<b>COUNTY:</b> Clear Creek, Grand
<b>INSPECTION TYPE:</b> Monitoring	<b>INSPECTOR(S):</b> Peter S. Hays	<b>INSP. DATE:</b> October 25, 2018	<b>INSP. TIME:</b> 09:30
<b>OPERATOR:</b> Climax Molybdenum Company	<b>OPERATOR REPRESENTATIVE:</b> Miguel Hamarat, Aaron Hilshorst, Ron Hickman	<b>TYPE OF OPERATION:</b> 112d-3 - Designated Mining Operation	
<b>REASON FOR INSPECTION:</b> Normal I&E Program	<b>BOND CALCULATION TYPE:</b> None	<b>BOND AMOUNT:</b> \$37,993,785.00	
<b>DATE OF COMPLAINT:</b> NA	<b>POST INSP. CONTACTS:</b> None	<b>JOINT INSP. AGENCY:</b> None	
<b>WEATHER:</b> Clear	<b>INSPECTOR'S SIGNATURE:</b>

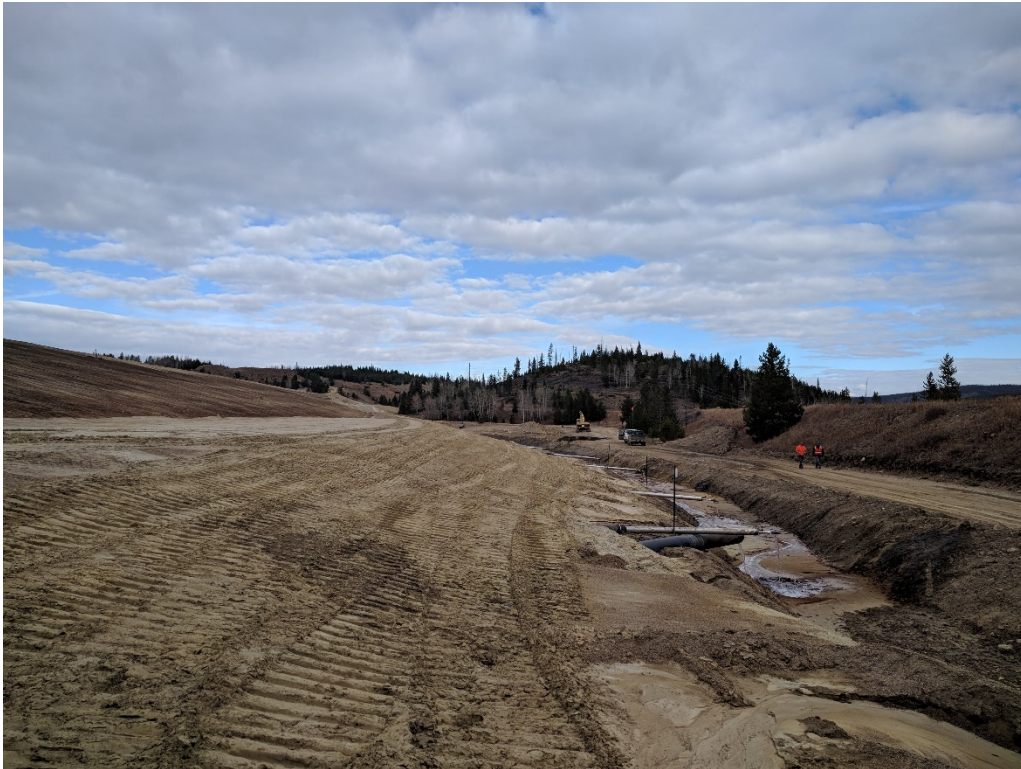
View of final graded lower south 3-dam buttress looking north from south end

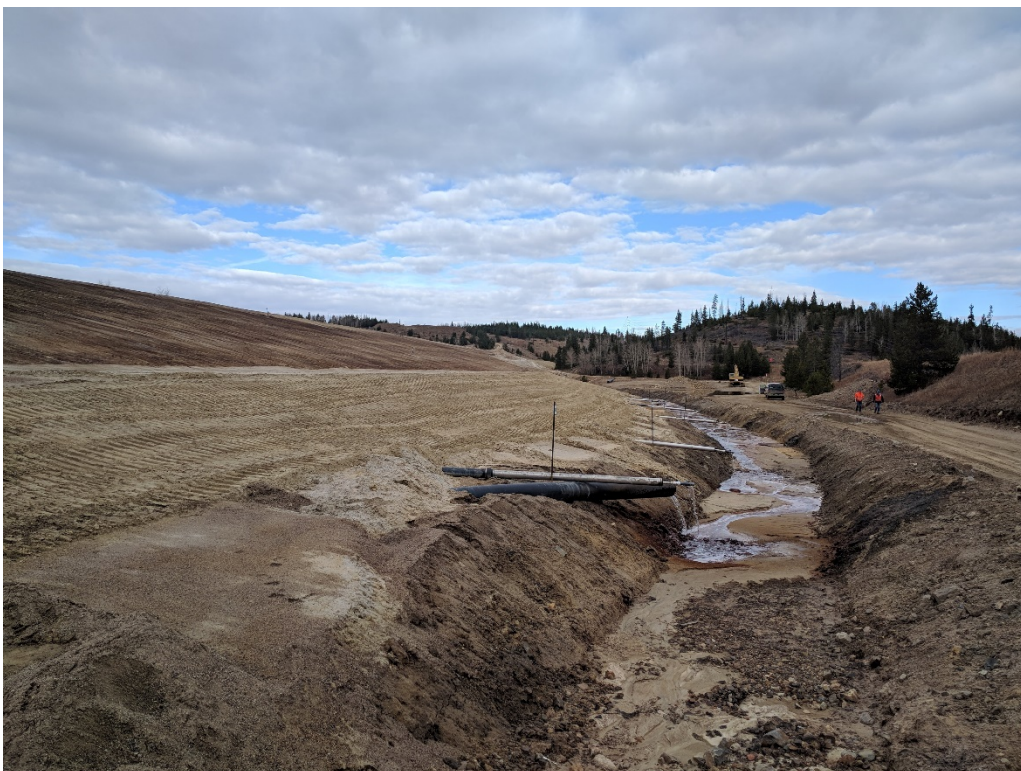
View of final graded lower south 3-dam buttress looking north from south end

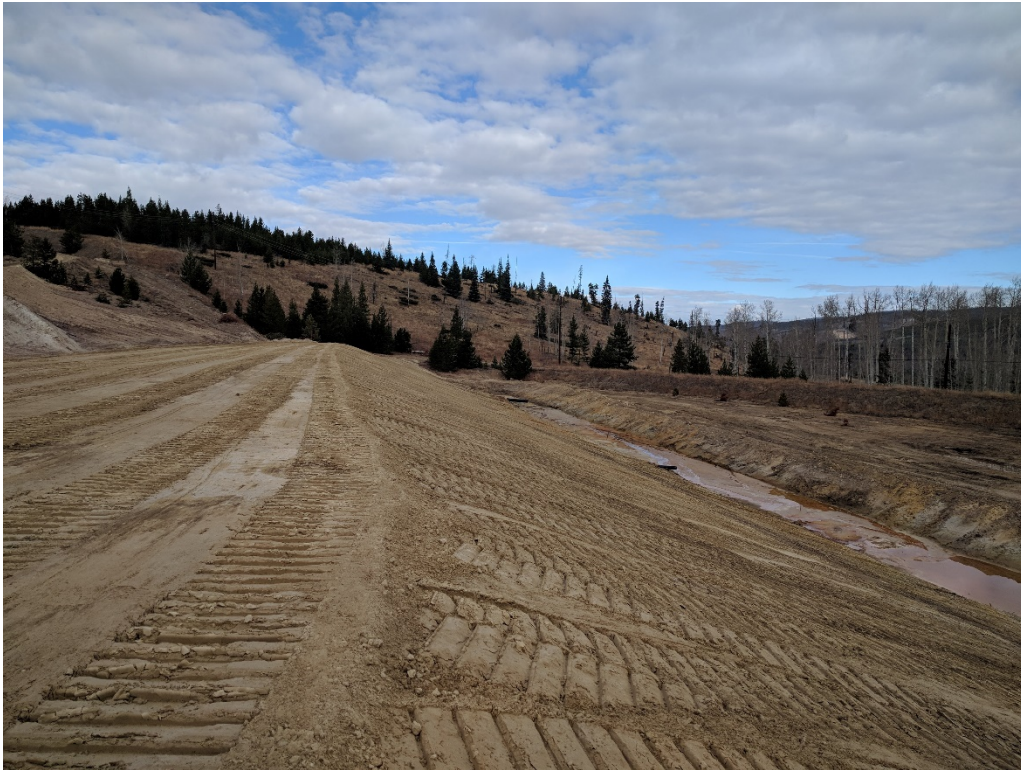
View of final graded lower north 3-dam buttress looking north from south end

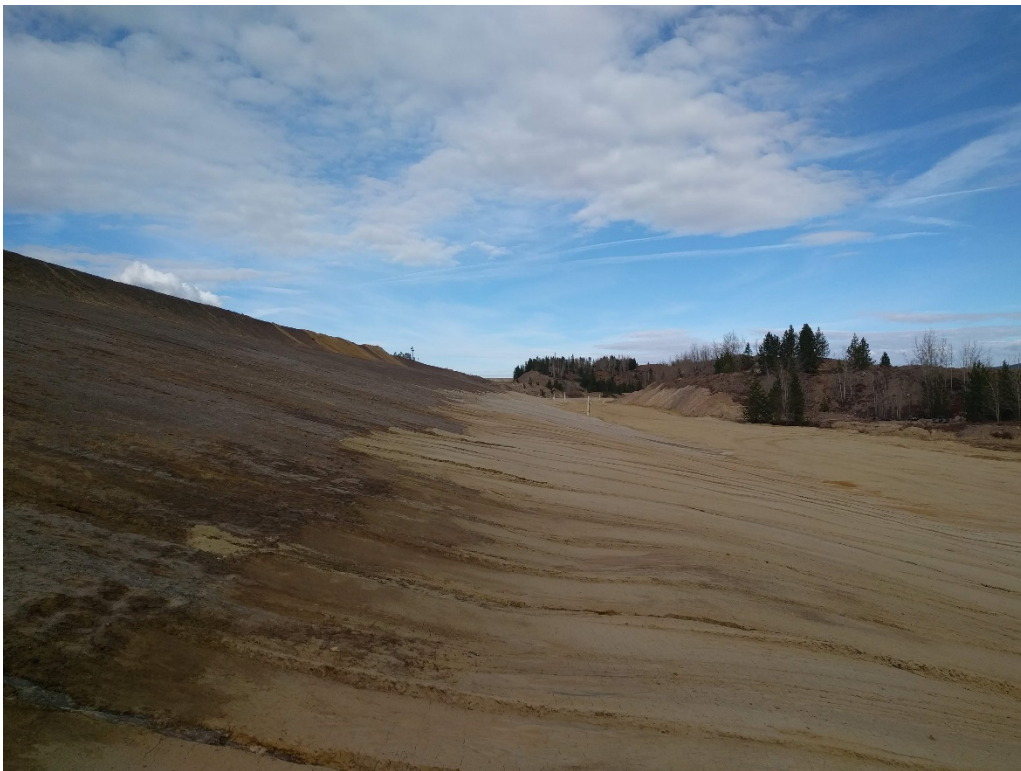
View of the south portion of the upper 3-Dam buttress looking north from the south end

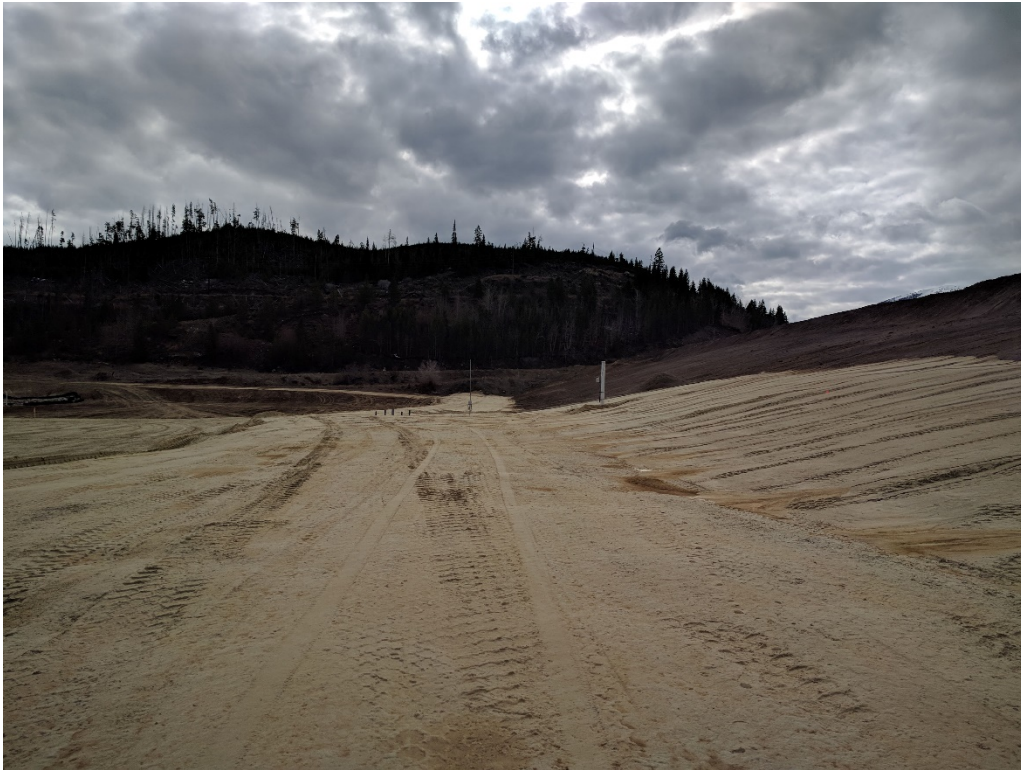
View of the south portion of the upper 3-Dam buttress looking south

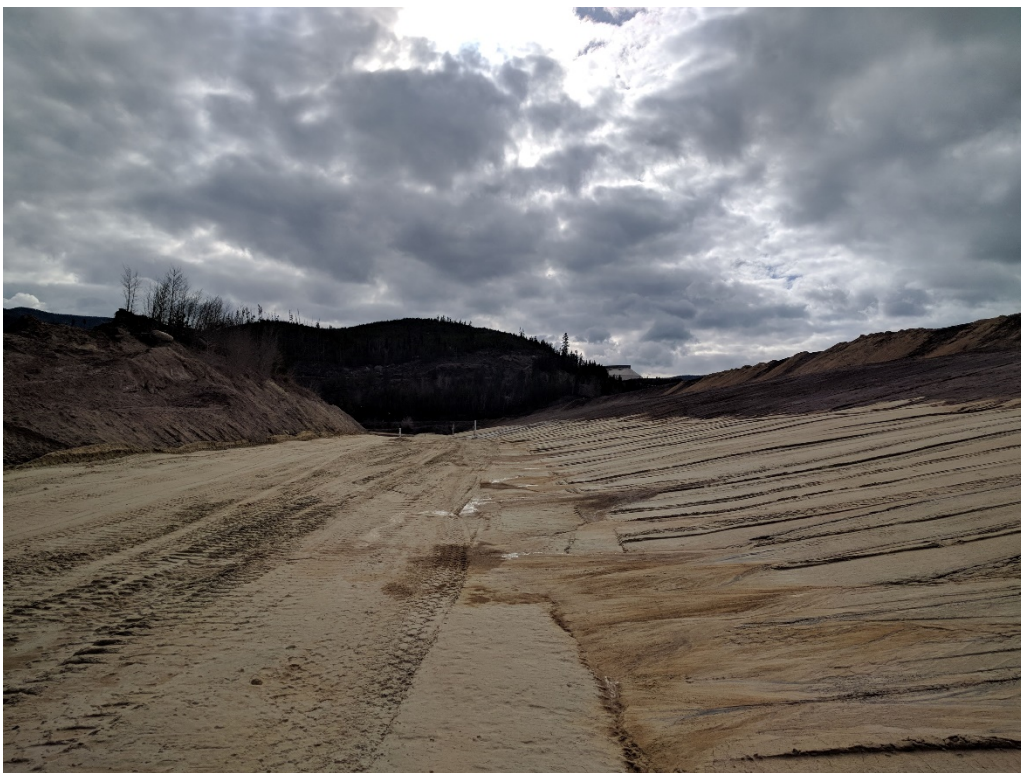
View of the middle portion of the upper 3-Dam buttress looking south

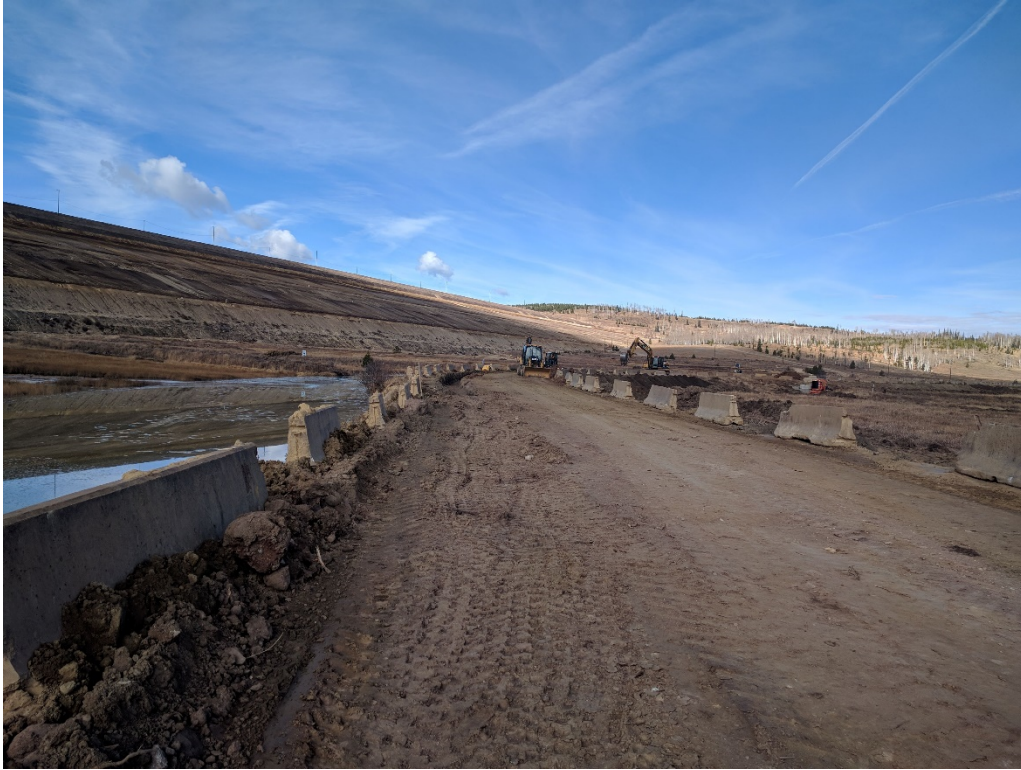
View of the backfill portion of the cutoff trench looking north from the south end

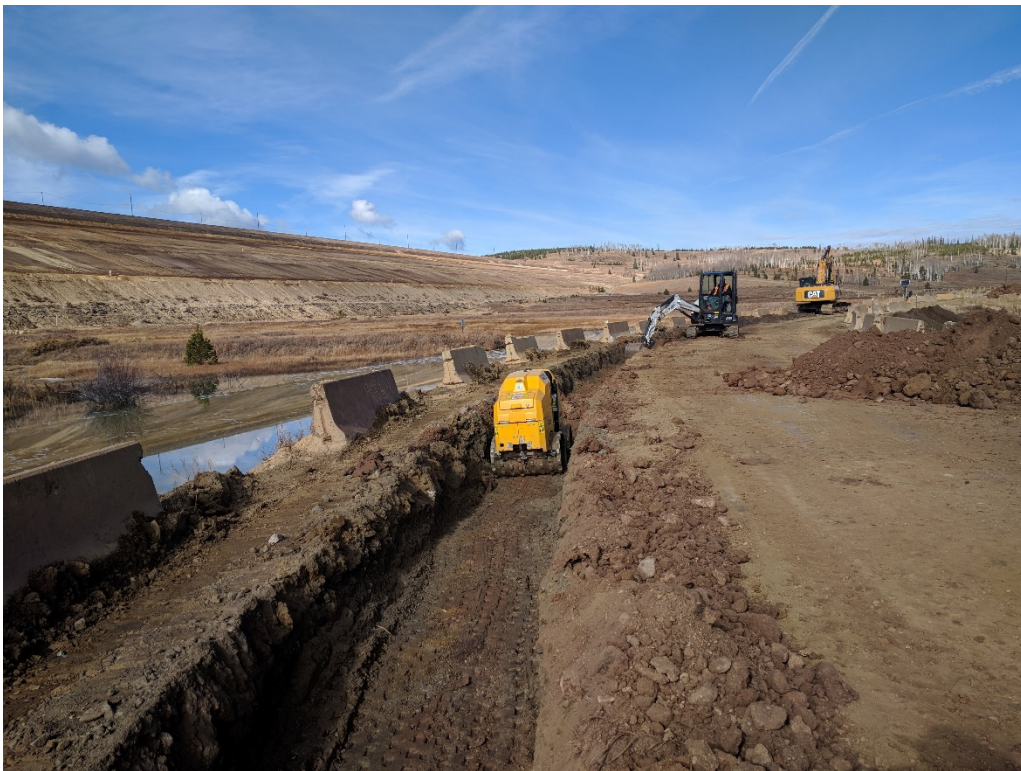
View of the backfill operation for the cutoff trench

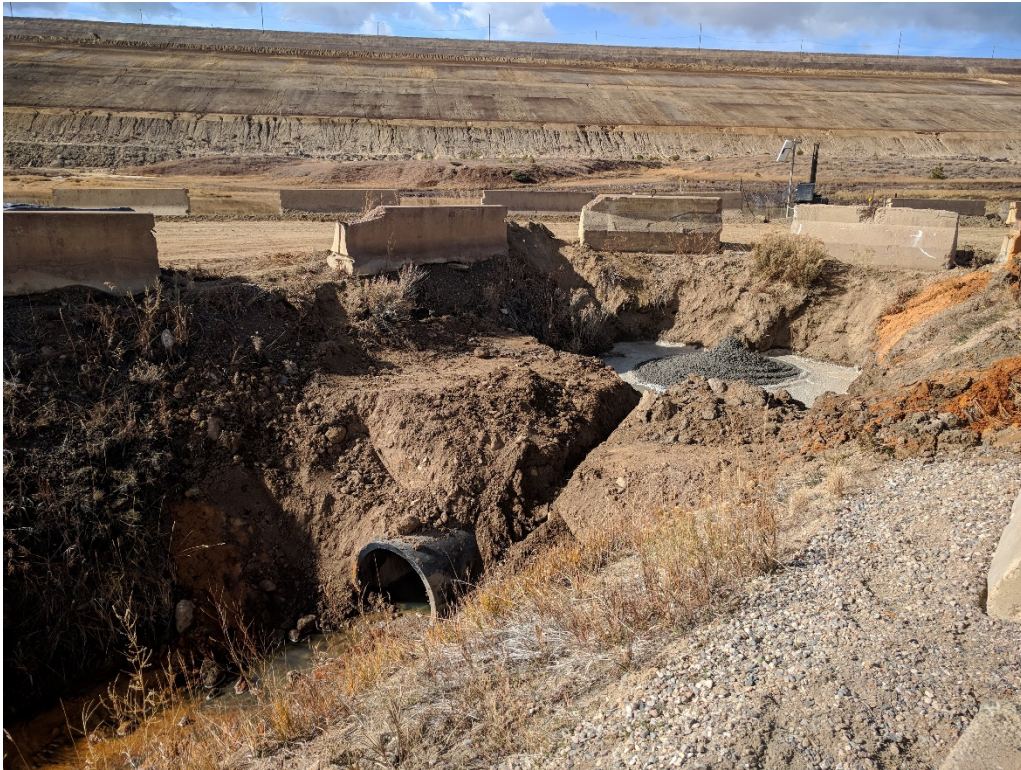
View of the extended north feeder channel culvert and concrete block

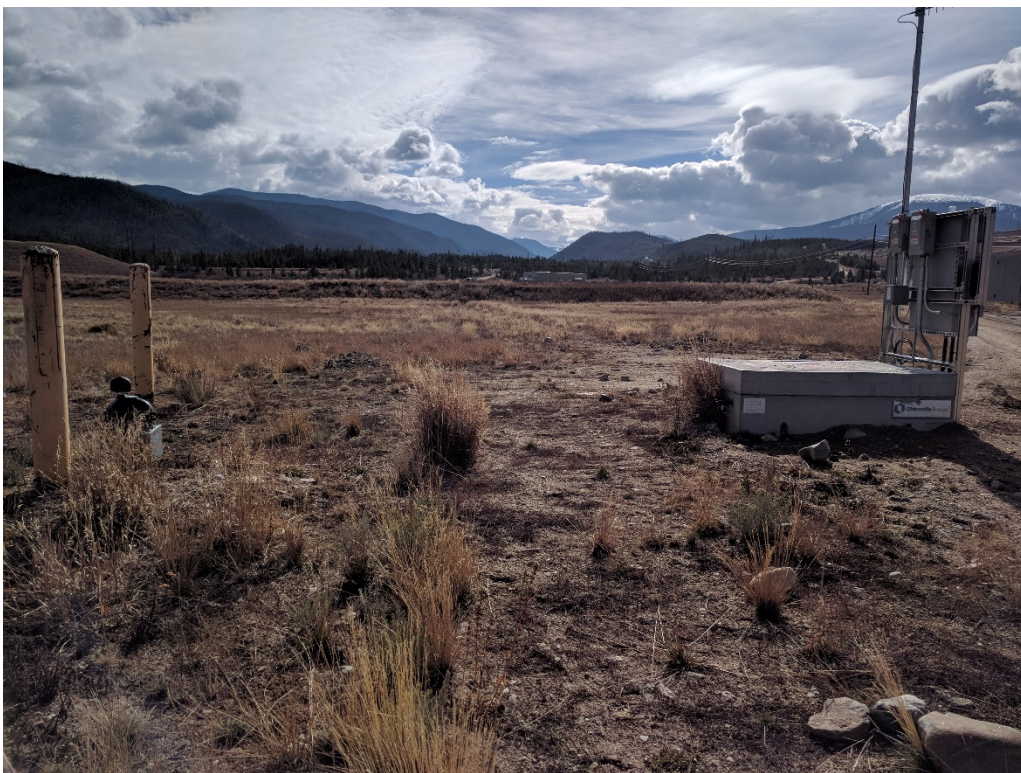
The above ground components of the Ute Park extraction wells; MLEX-1, MLEX-2, MLEX-3, MLEX-4, MLEX-5 were observed and appeared to be in compliance with the approved as-built drawings for the wells and associated infrastructure.

View of MLEX-1
