**MINERALS PROGRAM INSPECTION REPORT****PHONE: (303) 866-3567**

<b>MINE NAME:</b> Ellison Mine	<b>MINE/PROSPECTING ID#:</b> M-1978-342	<b>MINERAL:</b> Uranium and vanadium	<b>COUNTY:</b> San Miguel
<b>INSPECTION TYPE:</b> Multi Person Inspection	<b>INSPECTOR(S):</b> Lucas J. West	<b>INSP. DATE:</b> October 16, 2018	<b>INSP. TIME:</b> 10:36
<b>OPERATOR:</b> Gold Eagle Mining, Inc.	<b>OPERATOR REPRESENTATIVE:</b> Kyle Turley, Mary Young	<b>TYPE OF OPERATION:</b> 110d - Designated Limited Impact	
<b>REASON FOR INSPECTION:</b> Normal I&E Program	<b>BOND CALCULATION TYPE:</b> None	<b>BOND AMOUNT:</b> \$100.00	
<b>DATE OF COMPLAINT:</b> NA	<b>POST INSP. CONTACTS:</b> None	<b>JOINT INSP. AGENCY:</b> None	
<b>WEATHER:</b> Clear	<b>INSPECTOR'S SIGNATURE:</b>

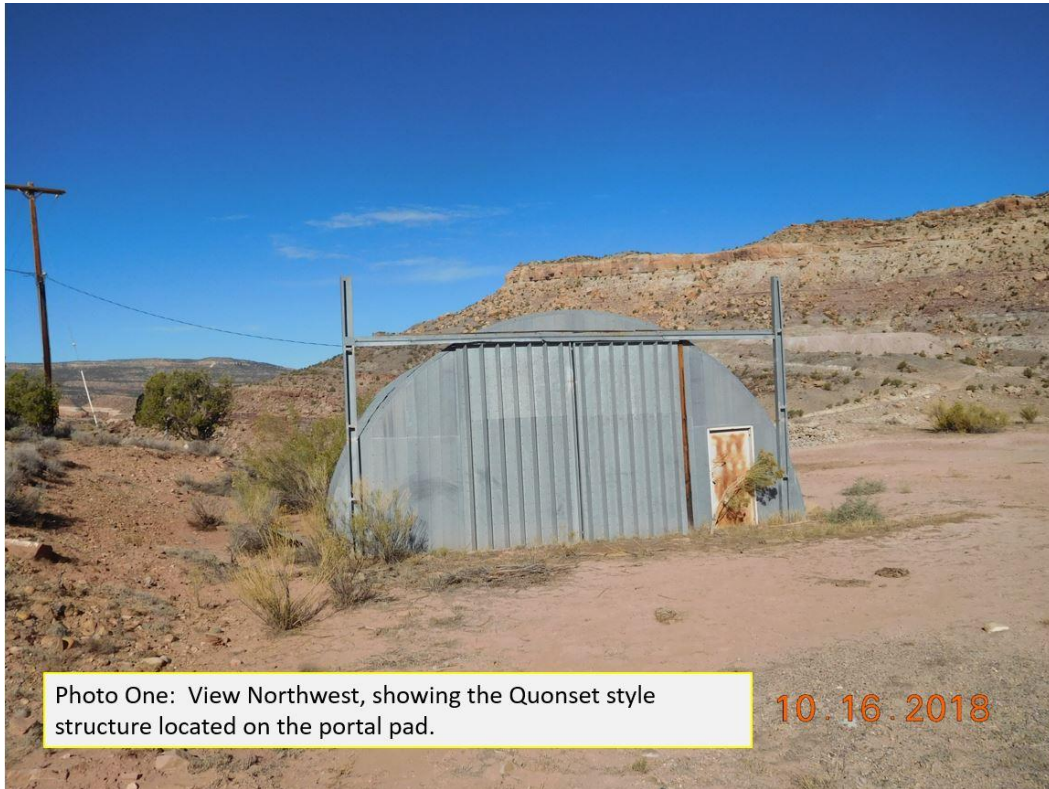
Photo One shows the Quonset hut style structure located on site. The structure was secure and in good condition at the time of this inspection. The door to the structure was vandalized in the past and remains in the same condition as it was during the previous inspection. Also located on is a shipping container used for storage that was also secured and in good condition. The main pad and work area that the structure, container and portal are located on was in good condition and well vegetated with native grasses and shrubs. The pad and work area can be seen in Photo Two. The portal, shown in Photo Three, is enforced with a Quonset style structure leading underground, and secured with a locked, welded steel grate. All components associated with the portal are in good condition and show no signs of attempted unauthorized entry.

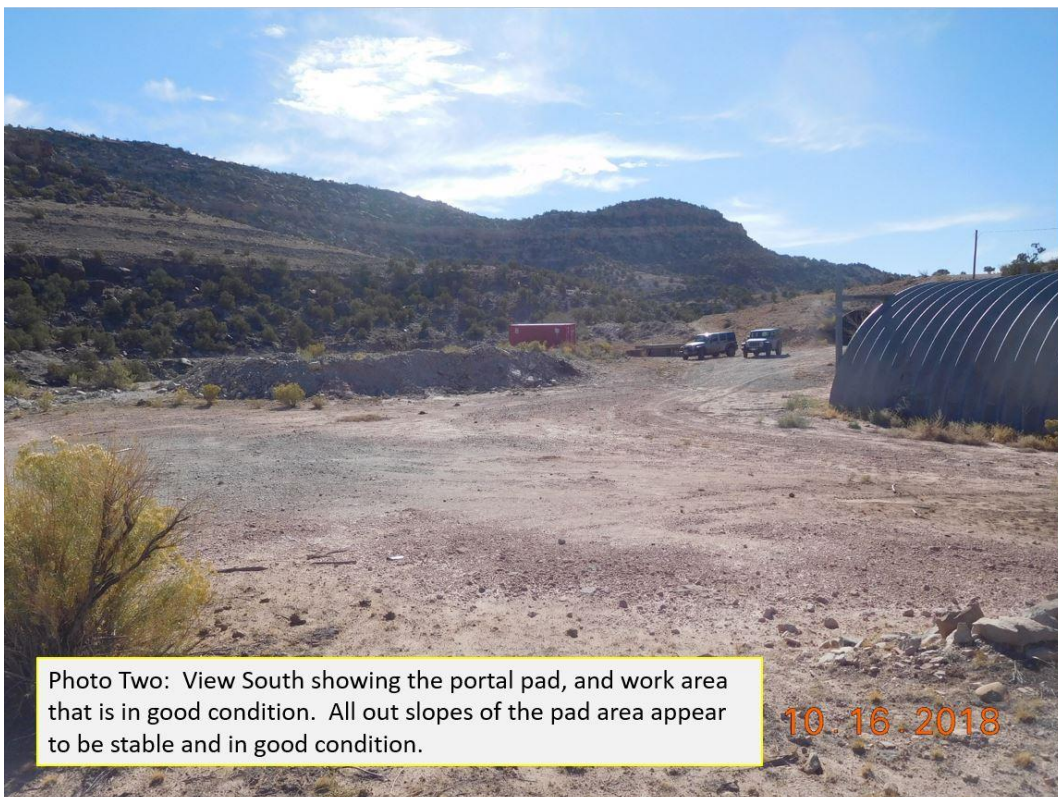
Permit boundary markers were observed, and all disturbance was inside the permitted area. The storm water controls were also observed and appeared to be functioning as designed. Evidence of storm water control device maintenance was observed. The maintenance work was approved and supervised by the DOE. No erosional issues were observed during this inspection. The slopes of the main pad and work area were all well vegetated and appear to be stable.

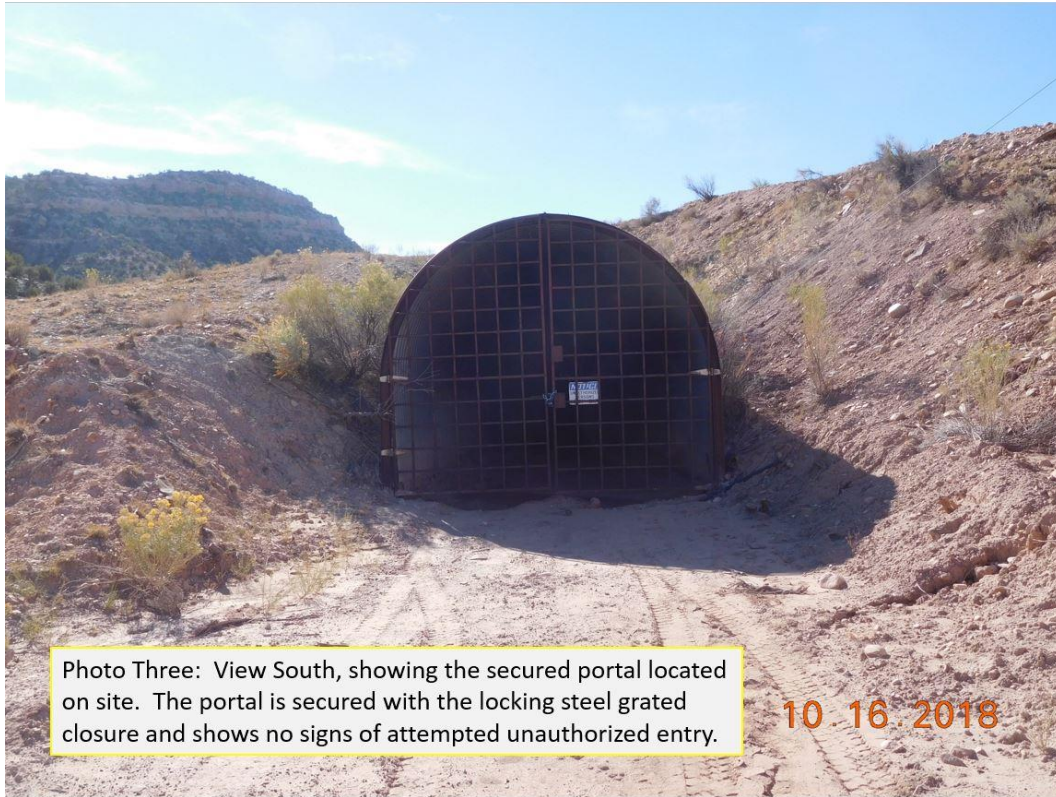
Photo Three: View South, showing the secured portal located on site. The portal is secured with the locking steel grated closure and shows no signs of attempted unauthorized entry.
