MINERALS PROGRAM INSPECTION REPORT
PHONE: (303) 866-3567

MINE NAME: Howard Creek Pit #1 & #2	MINE/PROSPECTING ID#: M-1999-033	MINERAL: Gravel	COUNTY: Fremont
INSPECTION TYPE: Monitoring	INSPECTOR(S): Timothy A. Cazier	INSP. DATE: August 7, 2018	INSP. TIME: 12:35
OPERATOR: Fremont County	OPERATOR REPRESENTATIVE: Sterling Rife & Paul Garrett	TYPE OF OPERATION: 110c - Construction Limited Impact	
REASON FOR INSPECTION: Normal I&E Program	BOND CALCULATION TYPE: None	BOND AMOUNT: \$0.00	
DATE OF COMPLAINT: NA	POST INSP. CONTACTS: None	JOINT INSP. AGENCY: None	
WEATHER: Cloudy	INSPECTOR'S SIGNATURE:

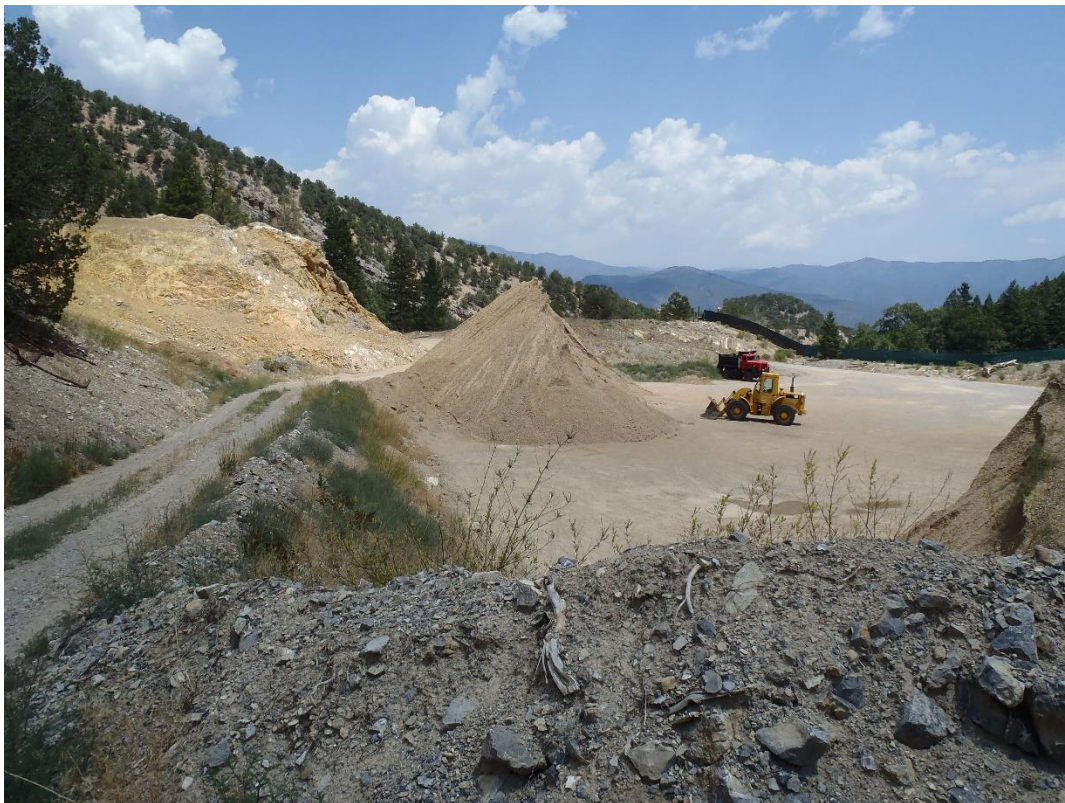
Gen. Compliance with Mine Plan: The operation appeared to be in compliance with the approved mine plan. Mr. Rife indicated they were nearly done mining this site. Google Earth was used to measure the disturbed area, which was estimated to be approximately 5.2 acres, based on 2016 imagery. The maximum allowed disturbed area is 8.94 acres. Highwalls were estimated to vary between 10 and 15 feet in height and appeared stable (see **Photo 1**). Mr. Rife indicted the County may take more material from the east pit floor.

Support Facilities On-site: A loader owned by a contractor and a haul truck owned by the subdivision were observed on site (see **Photo 1**).

Photo 1. Highwall and product stockpile on west side of east pit (looking NE).

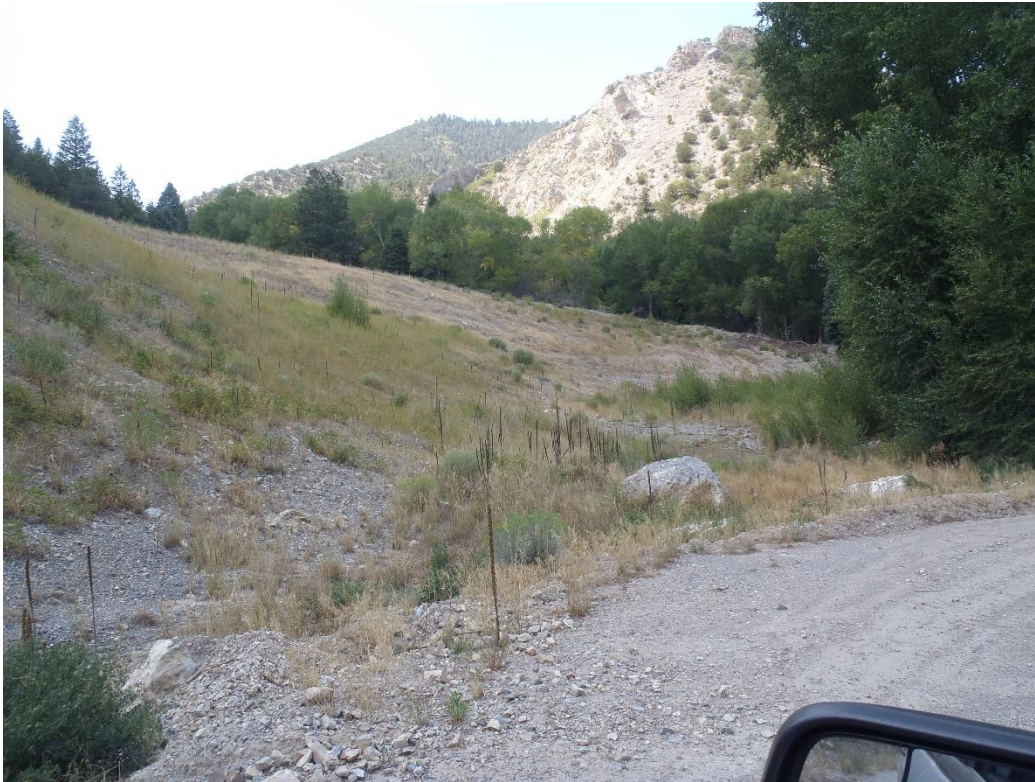
Revegetation: A large portion of the west pit has been revegetation (see **Photo 2**). No noxious weeds were observed.

Photo 2. Reclaimed portion of west pit.

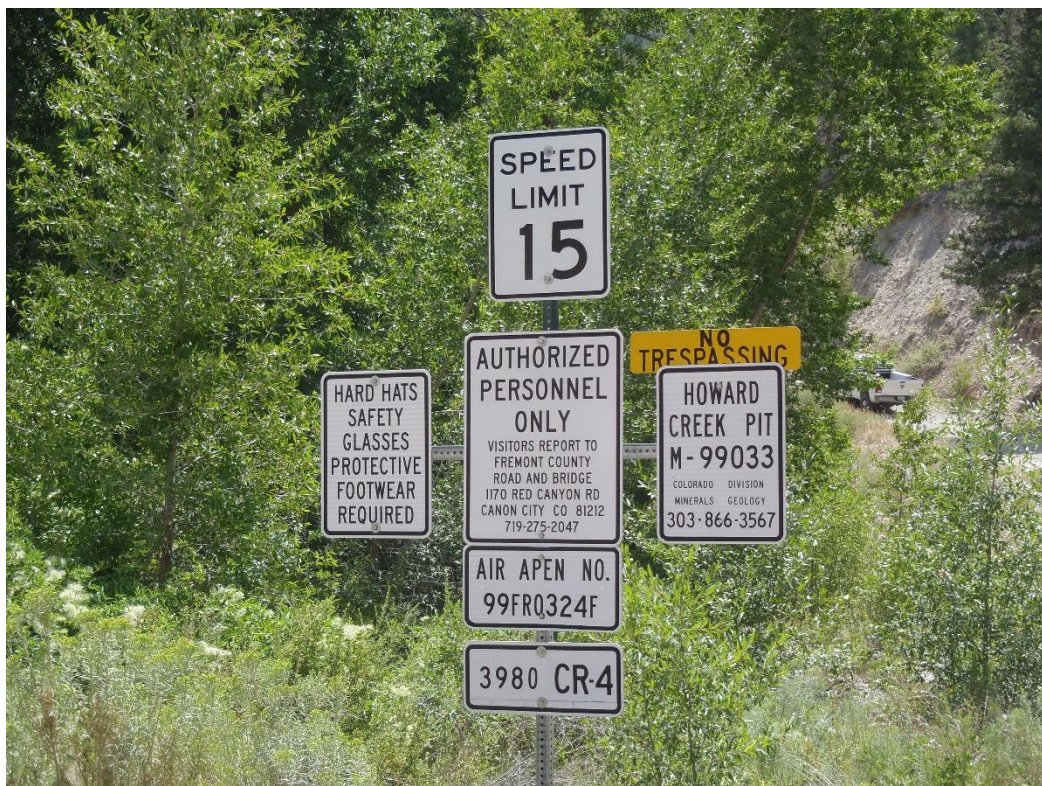
Signs and Markers: The permit sign was properly posted (see **Photo 3**) and boundary markers were observed

Photo 3. Permit sign (at entrance).

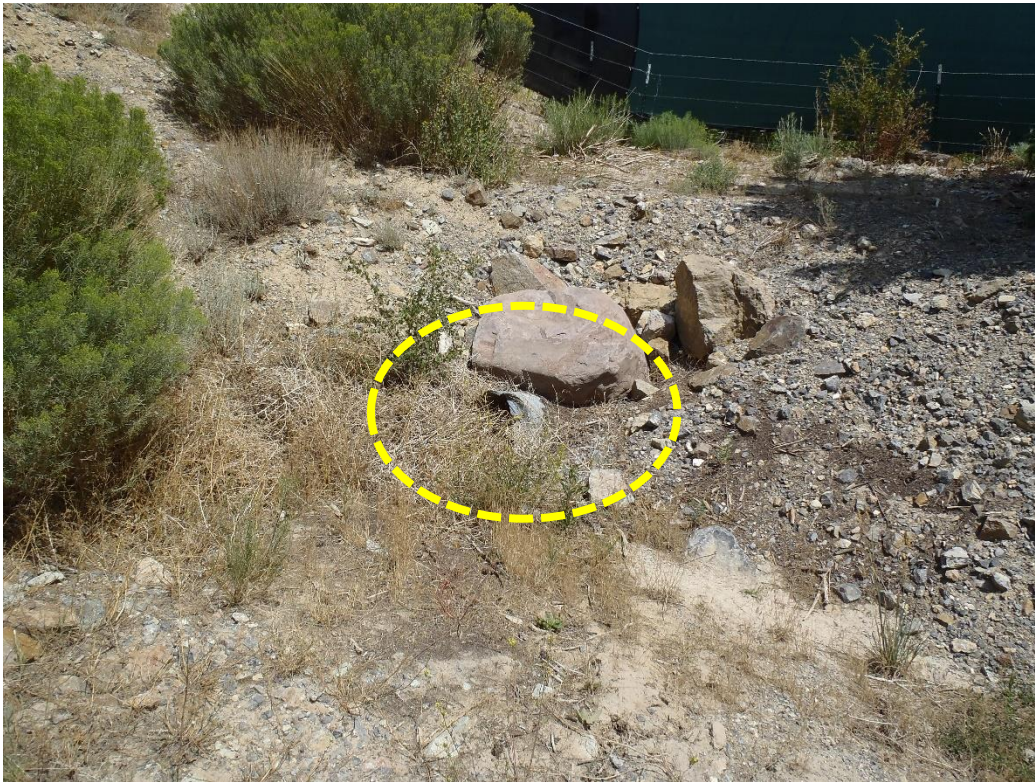
Storm Water MGT Plan: No oil or fuel spills observed. Representatives stated the stormwater management plan is kept in County office. Stormwater drains to the pit floor. A culvert overflow was observed on the north end of the east pit (see **Photo 4**).

Photo 4. Overflow culvert on north end of east pit (looking east).

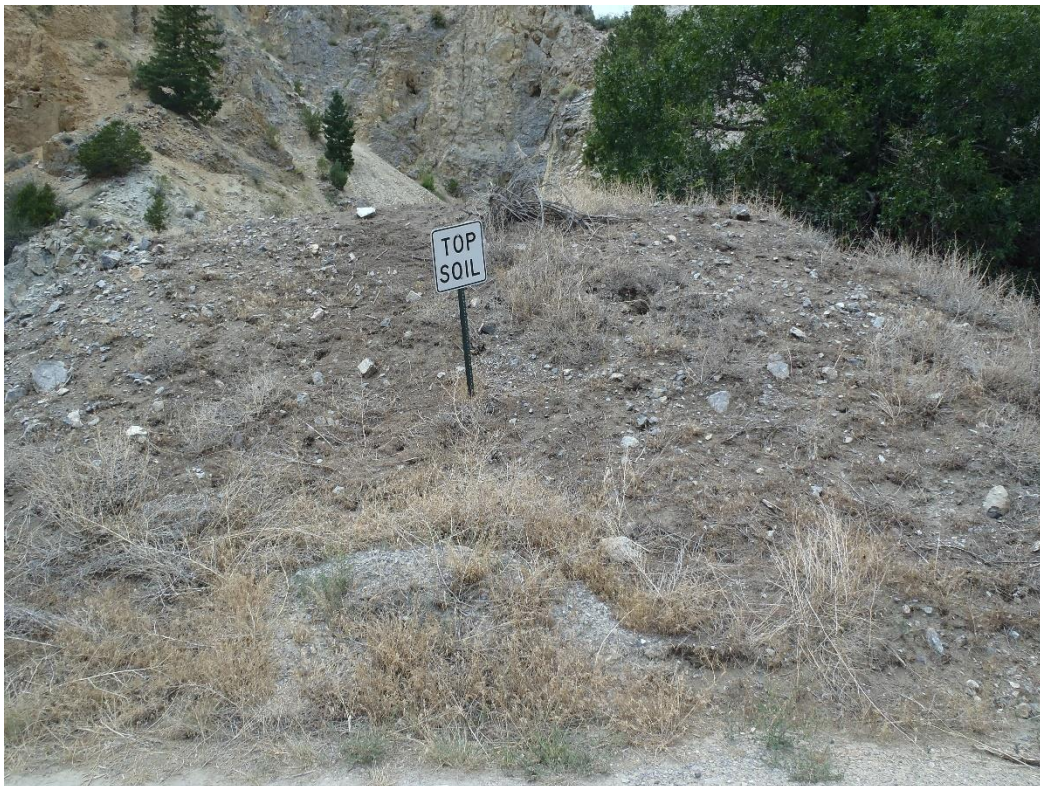
Topsoil: A topsoil stockpile is in the southwest corner of the east pit and labeled as such (see **Photo 5**).

Photo 5. Topsoil stockpile with sign (SW corner of east pit).

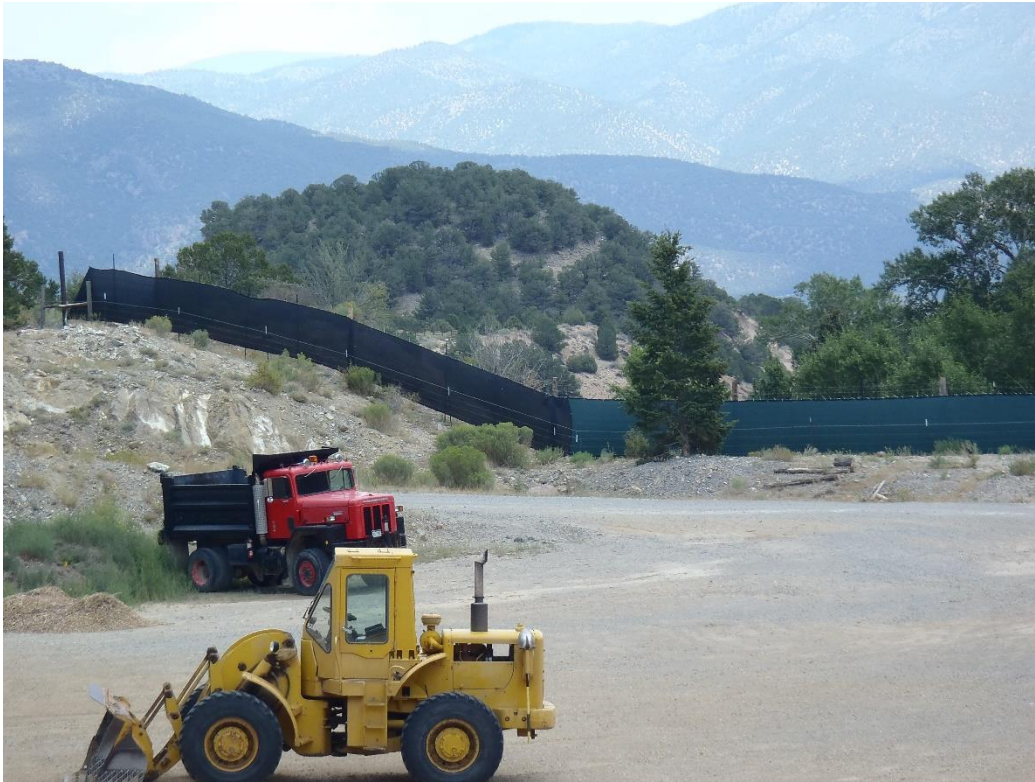
Structures: The only structures observed were fences on the south and northeast sides of the east pit (see **Photo 6**).

Photo 6. Fence marking AR-01 release boundary from east pit (looking NE).

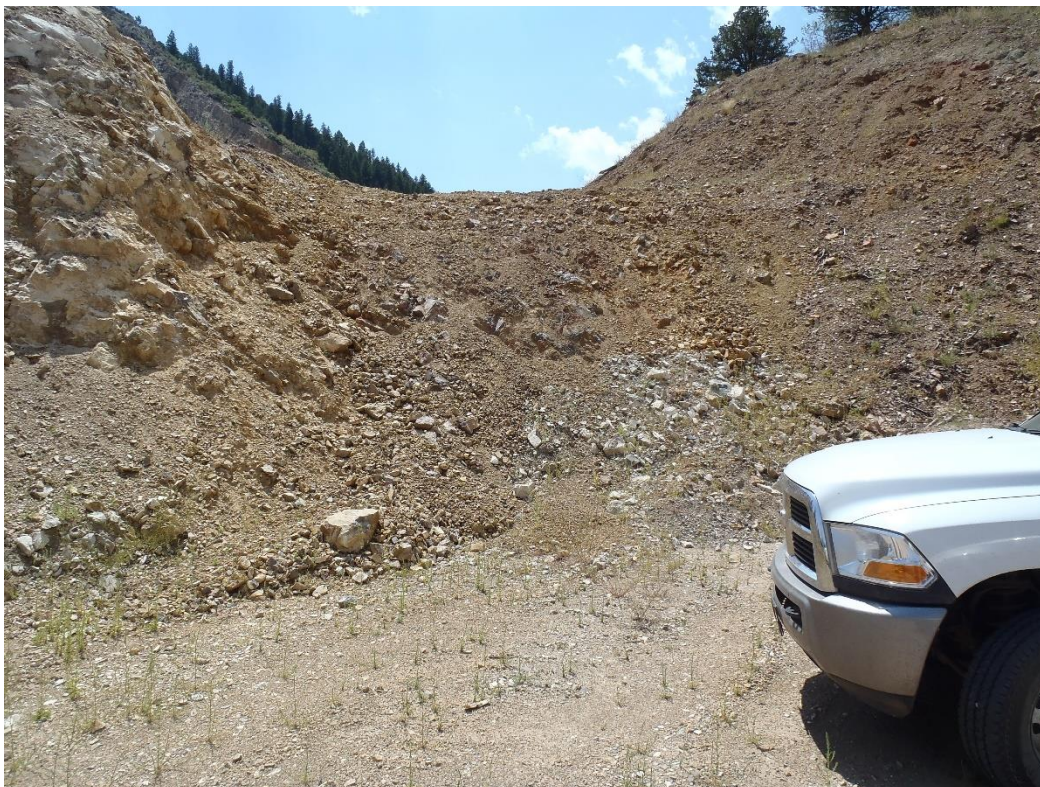
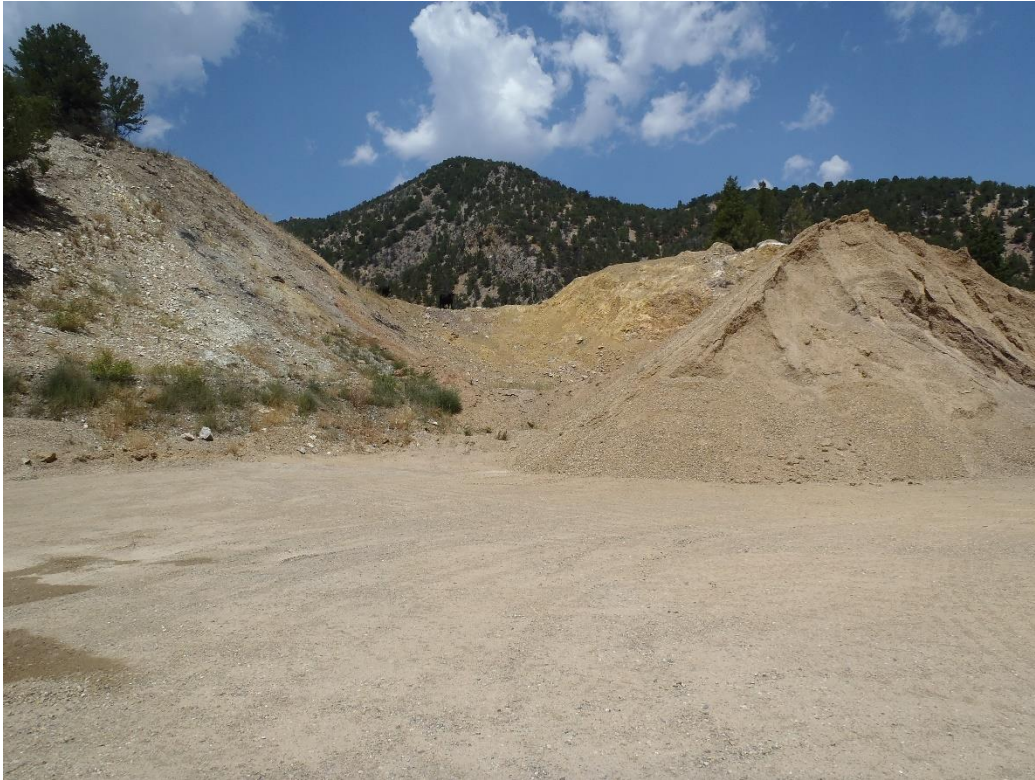
Roads: Haul and access roads could possibly be a source of sediment, but not a source of sediment that could be tracked offsite. Mr. Rife explained the County was cutting through the ridge between the west and east pits to provide an access road for the landowner (see **Photo 7** and **8**). This area was added in AM-01.

Photo 7. Access road cut from road between east & west pits (looking south).

Photo 8. Access road cut from east pit (looking north).
