MINERALS PROGRAM INSPECTION REPORT
PHONE: (303) 866-3567

MINE NAME: Cole Gravel Pit	MINE/PROSPECTING ID#: M-2004-020	MINERAL: Sand and gravel	COUNTY: Mesa
INSPECTION TYPE: Monitoring	INSPECTOR(S): Amy C. Yeldell	INSP. DATE: October 29, 2018	INSP. TIME: 11:20
OPERATOR: M.A. Concrete Construction, Inc.	OPERATOR REPRESENTATIVE: Frank Neely	TYPE OF OPERATION: 112c - Construction Regular Operation	
REASON FOR INSPECTION: Normal I&E Program	BOND CALCULATION TYPE: Complete Bond	BOND AMOUNT: \$335,500.00	
DATE OF COMPLAINT: NA	POST INSP. CONTACTS: None	JOINT INSP. AGENCY: None	
WEATHER: Clear	INSPECTOR'S SIGNATURE:

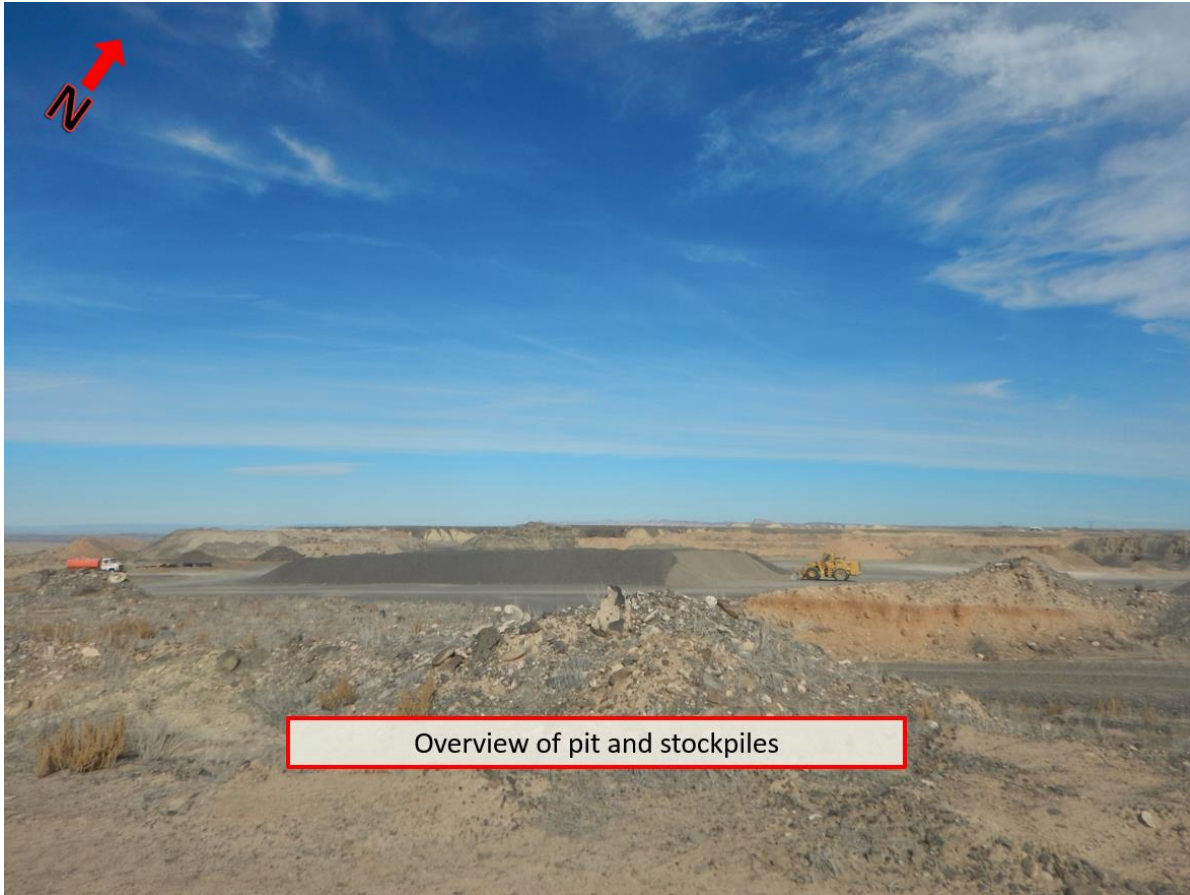
Overview of pit and stockpiles

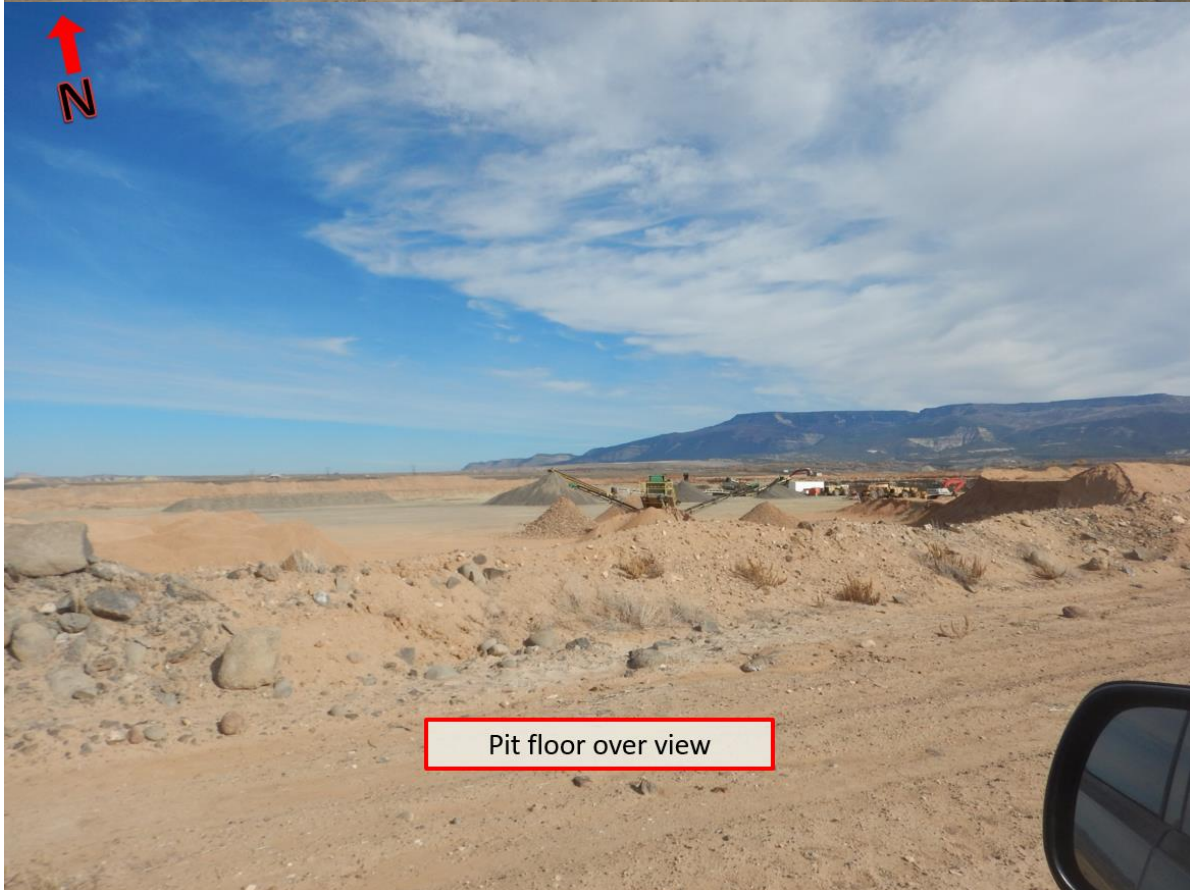
Pit floor over view

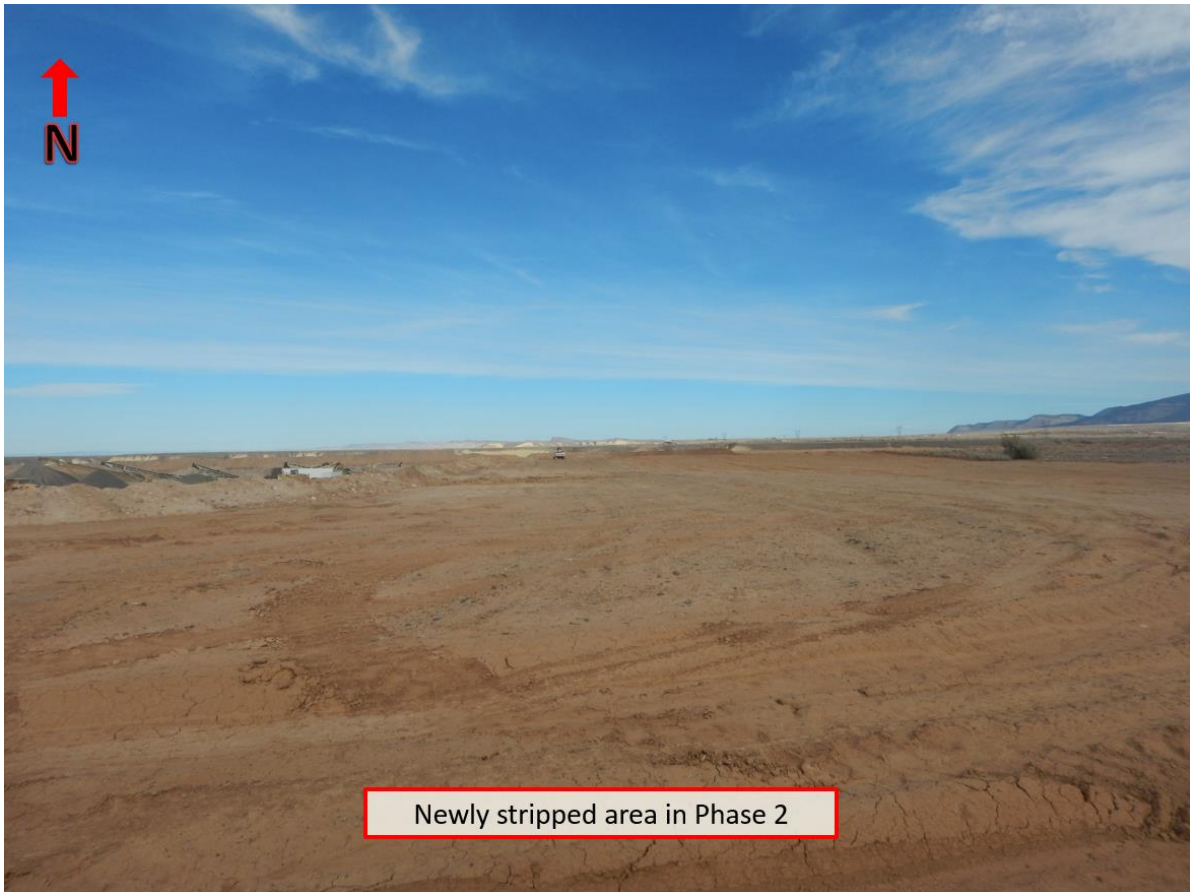
All new mining is occurring in Phase 2. Approximately half of phase 2 has been mined to date. In Phase 2, on the east side, a new area has been cleared and stripped of large surface rocks. This area is approximately 500 yards by 100 yards (approx. 10 ac) . The mined out western portion of phase 2 is also used for stockpile storage. There are also two crusher plants. No water is used to process the material. Water is only for dust suppression. Water is brought in and held in a tank on site adjacent to the crusher. A second fuel tank is also located near the crusher and is in a double walled tank.

Newly stripped area in Phase 2

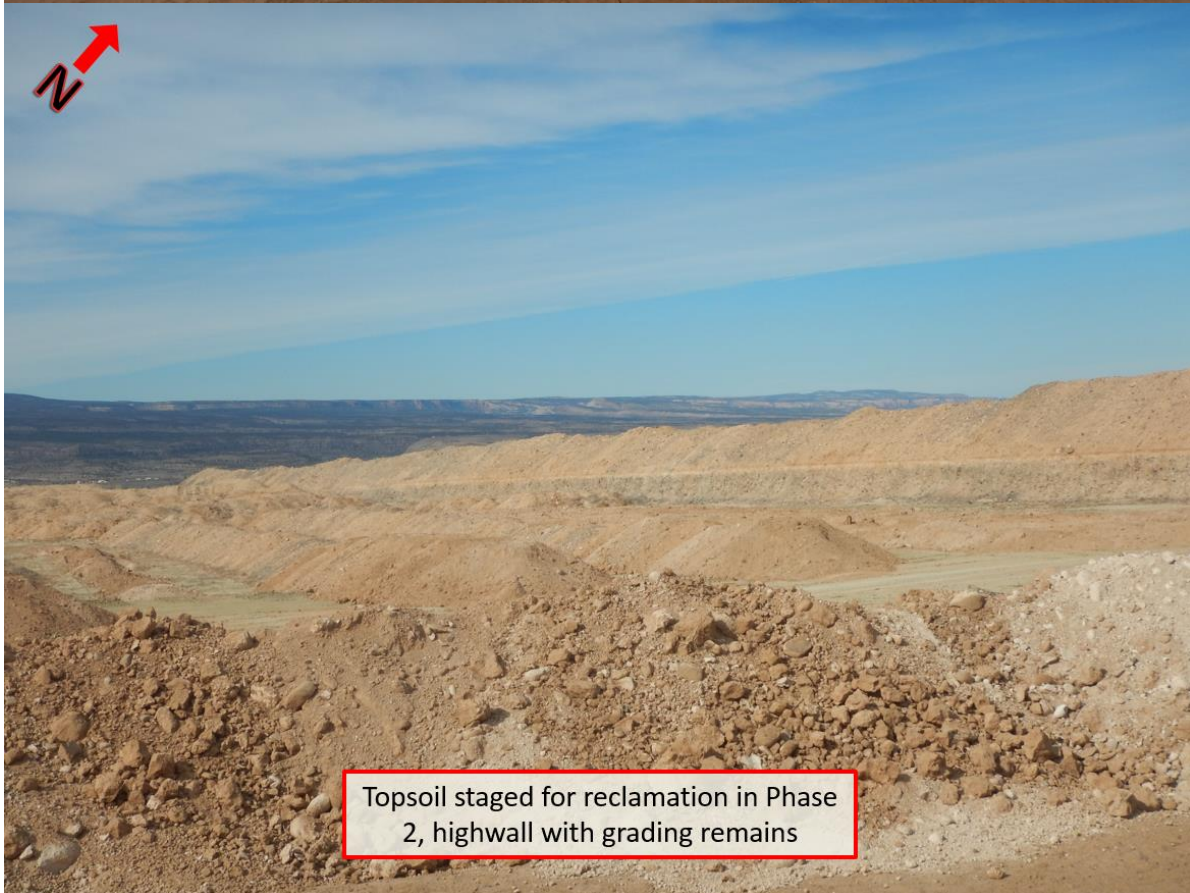
A topsoil berm has been staged along the north and east permit boundary. Topsoil has also been placed on the pit floor north of the crusher in phase 2. Topsoil is still heaped in rows and will require grading. Approximately 4 acres will be topsoiled once graded.

The north highwall adjacent to the placed topsoil still requires grading. This highwall is near vertical and approximately 10 feet tall by 2000 feet long. Approximately a 3000 linear foot highwall 10-15 feet tall near vertical highwall makes up the south and east sides of the pit floor. There is no true highwall on the western edge of Phase 1 as there are several stockpiles that will require removal prior to reclamation. This operation has reached the maximum disturbance limit. The operator is encouraged to begin interim reclamation where practical or increase the maximum disturbance limit.

Topsoil staged for reclamation in Phase 2, highwall with grading remains
