**MINERALS PROGRAM INSPECTION REPORT****PHONE: (303) 866-3567**

<b>MINE NAME:</b> Monument View Gravel Pit	<b>MINE/PROSPECTING ID#:</b> M-2000-032	<b>MINERAL:</b> Sand and gravel	<b>COUNTY:</b> Mesa
<b>INSPECTION TYPE:</b> Monitoring	<b>INSPECTOR(S):</b> Amy C. Yeldell	<b>INSP. DATE:</b> October 29, 2018	<b>INSP. TIME:</b> 12:30
<b>OPERATOR:</b> M.A. Concrete Construction, Inc.	<b>OPERATOR REPRESENTATIVE:</b> Martin Azcarraga	<b>TYPE OF OPERATION:</b> 112c - Construction Regular Operation	
<b>REASON FOR INSPECTION:</b> Normal I&E Program	<b>BOND CALCULATION TYPE:</b> Partial Bond	<b>BOND AMOUNT:</b> \$686,663.00	
<b>DATE OF COMPLAINT:</b> NA	<b>POST INSP. CONTACTS:</b> None	<b>JOINT INSP. AGENCY:</b> None	
<b>WEATHER:</b> Clear	<b>INSPECTOR'S SIGNATURE:</b>

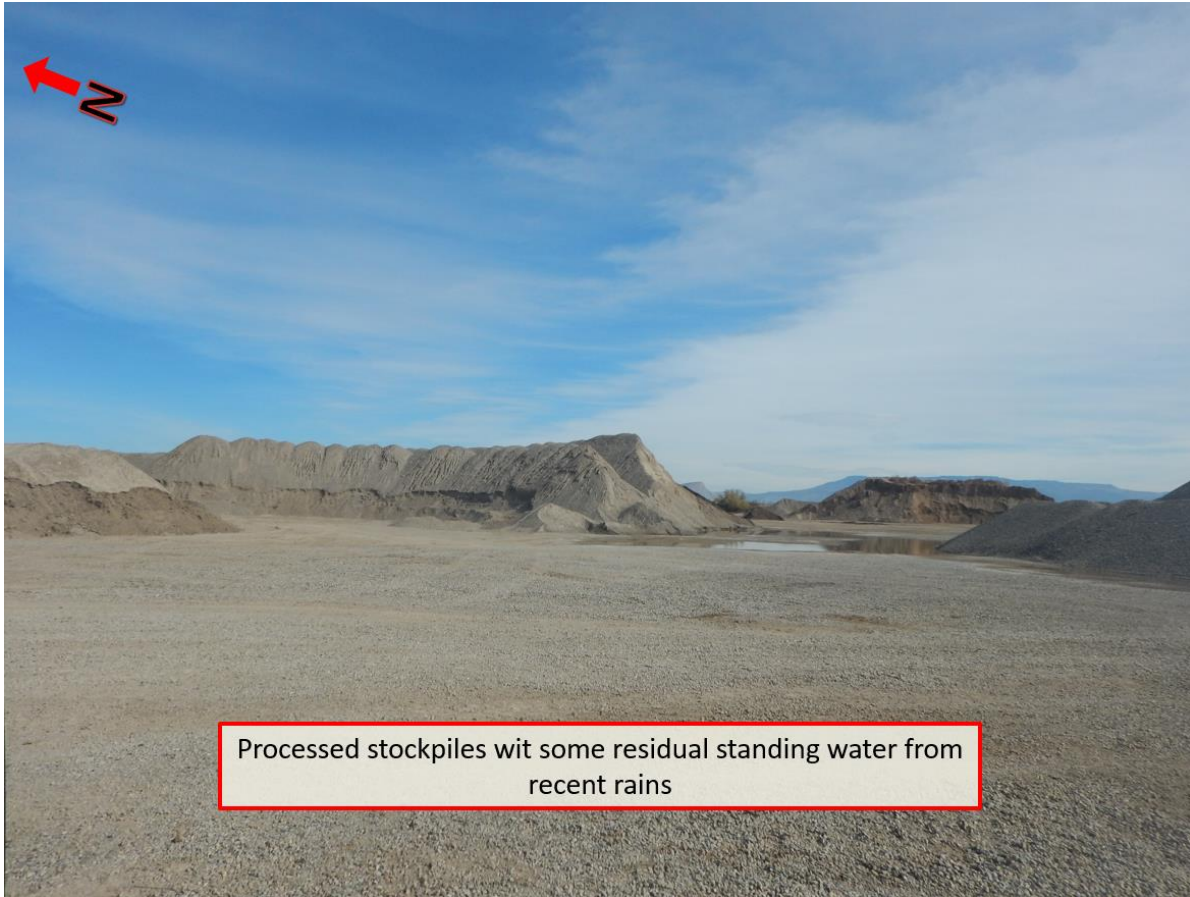
A small area still required backfill and is approximately 100 by 100 feet and 10 feet deep. This area is being pumped down and water is used to supply trucks for dust suppression. Due to the recent rains this area is still inundated with water. Throughout the pit in low lying areas there is also some standing water. Mr. Azcarraga indicated that at one point the entire pit had standing water but it has since drained and infiltrated.

Processed stockpiles wit some residual standing water from recent rains

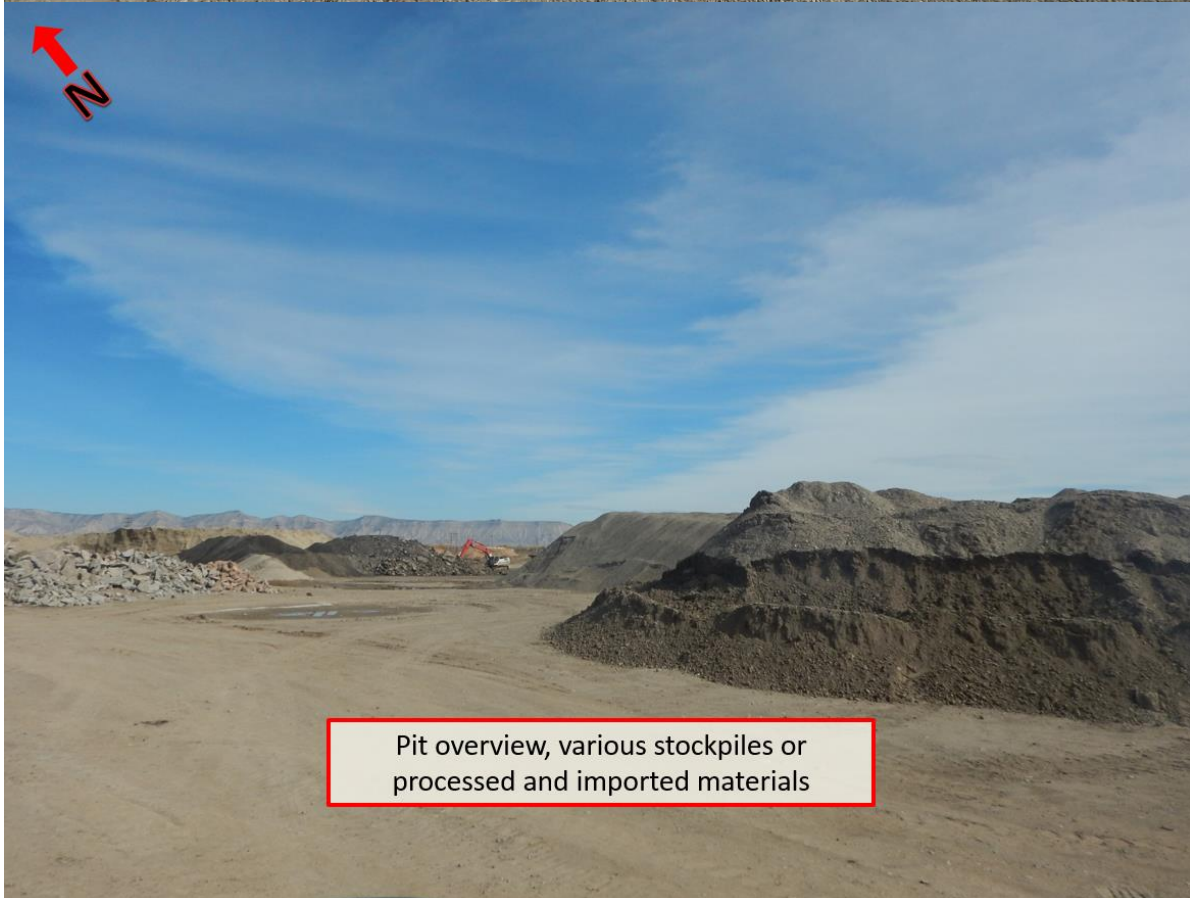
Several large stockpiles of processed material are stored on the backfilled pit floor. There are also several piles of imported material that has yet to be process or placed and are stored on the pit floor. In addition to imported fill material, piles of rebar, culverts and other excess metals are stored on site. The operator is reminded that these items are not considered inert and must be disposed of appropriately off-site. Mr. Azcarraga mentioned they accumulate a metal load before taking it to recycling.

Pit overview, various stockpiles or processed and imported materials
