**MINERALS PROGRAM INSPECTION REPORT**  
**PHONE: (303) 866-3567**

<b>MINE NAME:</b> Hukill Gulch Millsite	<b>MINE/PROSPECTING ID#:</b> M-2009-076	<b>MINERAL:</b> Silver and gold	<b>COUNTY:</b> Clear Creek
<b>INSPECTION TYPE:</b> Monitoring	<b>INSPECTOR(S):</b> Peter S. Hays	<b>INSP. DATE:</b> October 31, 2018	<b>INSP. TIME:</b> 09:30
<b>OPERATOR:</b> Venture Resources, Inc.	<b>OPERATOR REPRESENTATIVE:</b>	<b>TYPE OF OPERATION:</b> 110d - Designated Limited Impact	
<b>REASON FOR INSPECTION:</b> Normal I&E Program	<b>BOND CALCULATION TYPE:</b> Complete Bond	<b>BOND AMOUNT:</b> \$96,827.69	
<b>DATE OF COMPLAINT:</b> NA	<b>POST INSP. CONTACTS:</b> None	<b>JOINT INSP. AGENCY:</b> None	
<b>WEATHER:</b> Clear	<b>INSPECTOR'S SIGNATURE:</b>

### **Technical Revision No. 5**

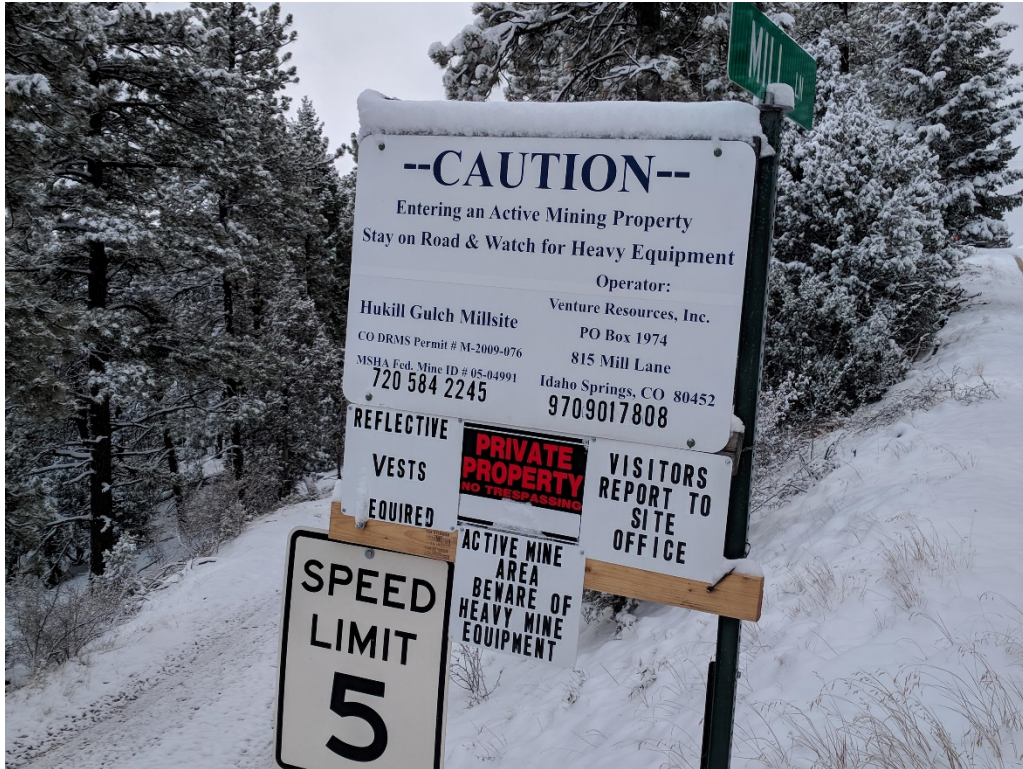
The mine sign was posted at the entrance gate as required by Rule 3.1.12.

Hukill Gulch Millsite sign

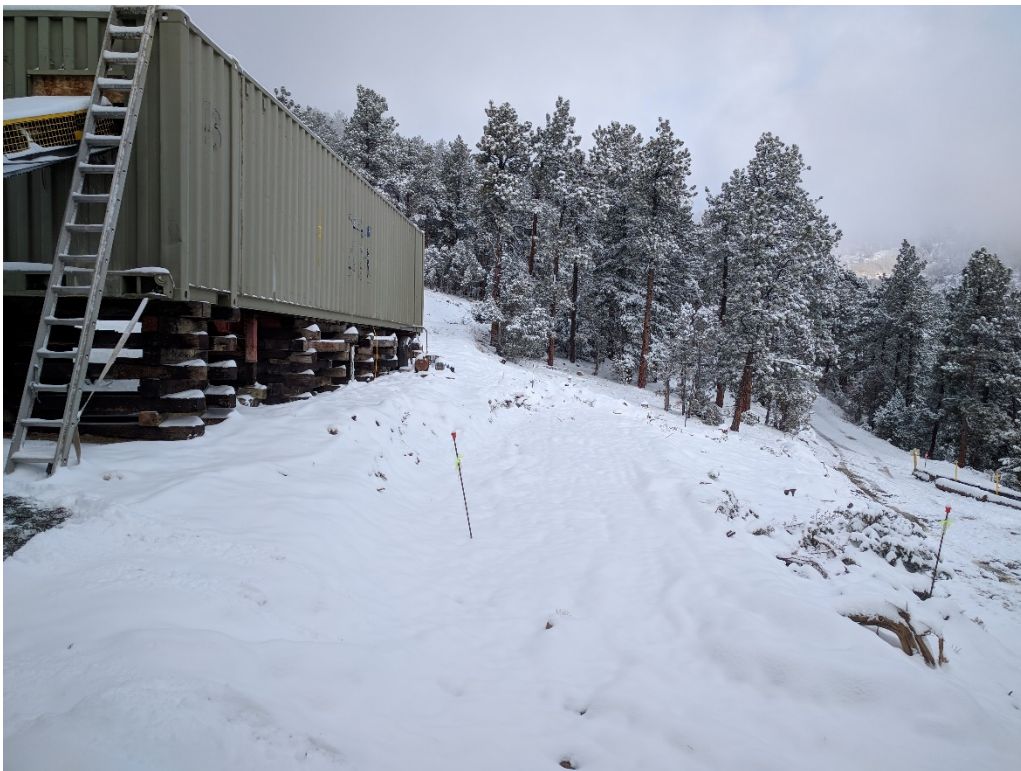
View of the staked corners of the new lower concrete foundation

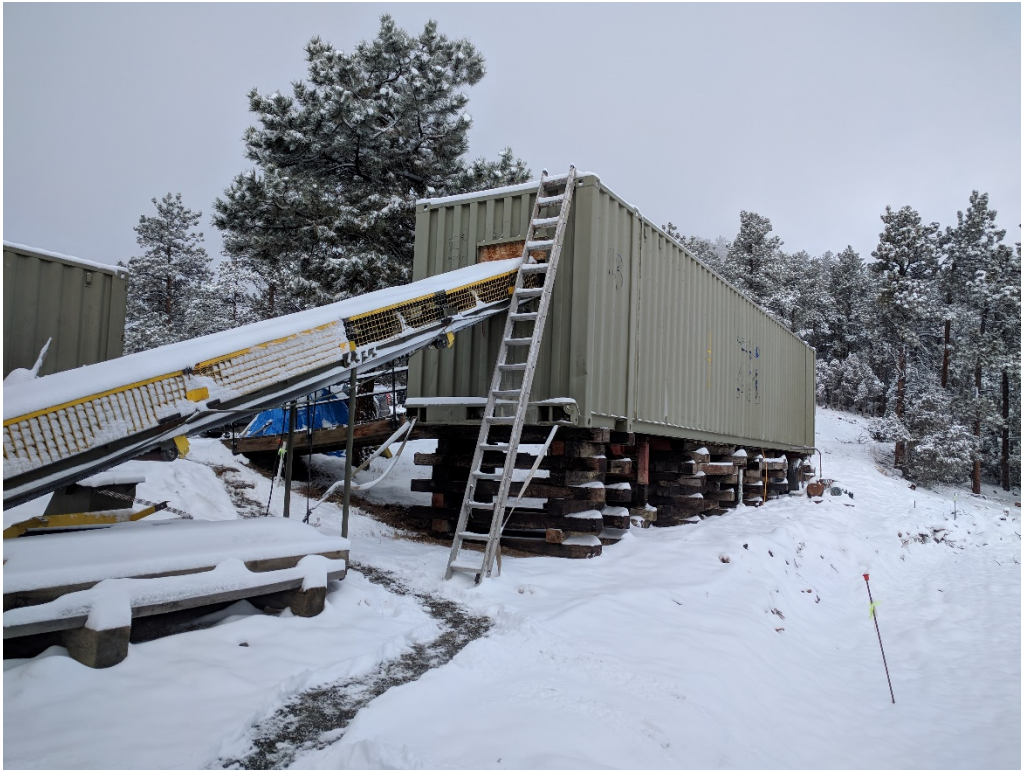
View of the ball mill trailer

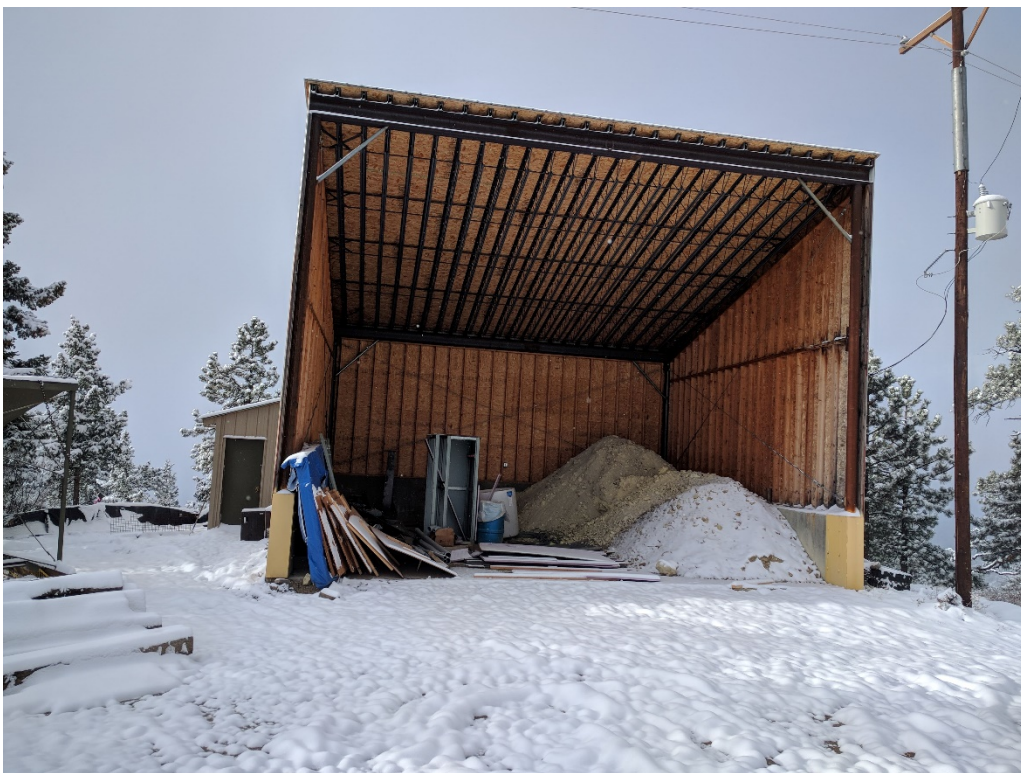
View of the ore bin and stockpile

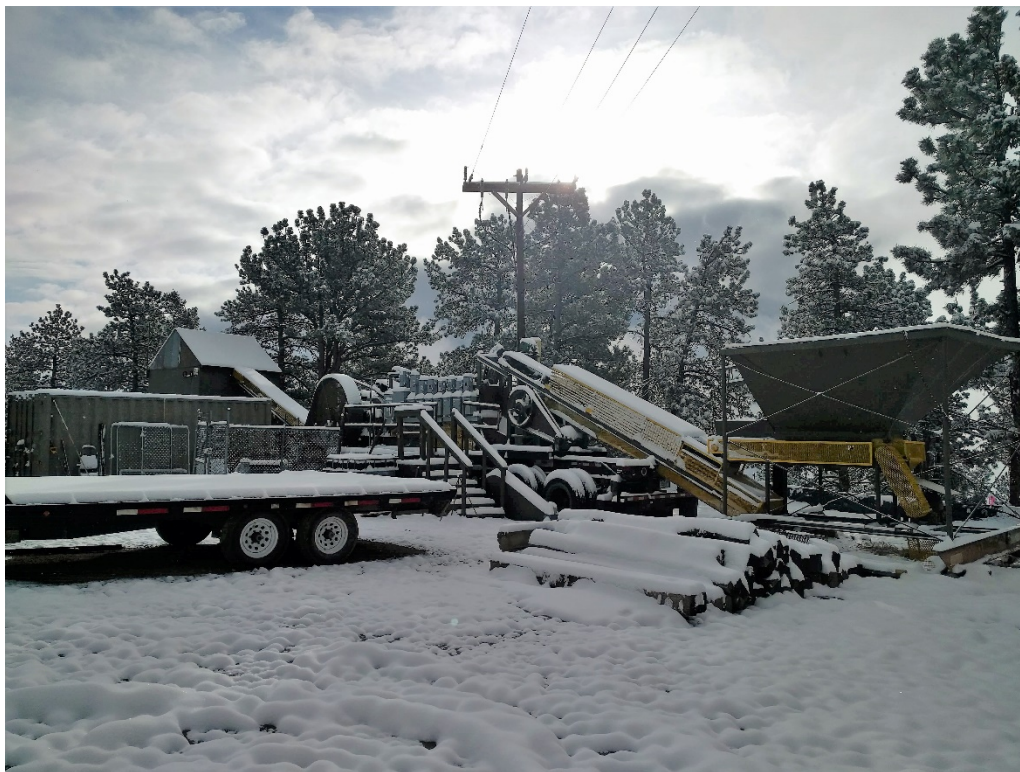
View of the crusher feed bin, crushing trailer and covered crushed ore bin

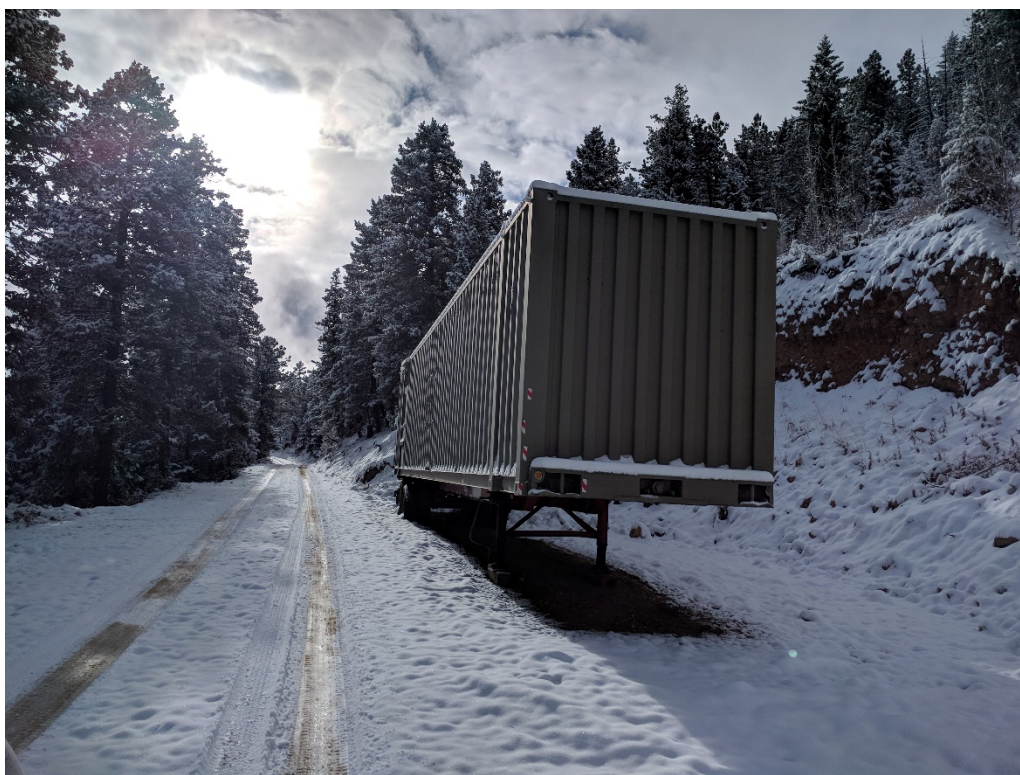
View of flotation trailer temporarily moved from the mill site
