**MINERALS PROGRAM INSPECTION REPORT**  
**PHONE: (303) 866-3567**

<b>MINE NAME:</b> Old Town Reclamation Project	<b>MINE/PROSPECTING ID#:</b> M-2018-057	<b>MINERAL:</b> Unknown commodity	<b>COUNTY:</b> Gilpin
<b>INSPECTION TYPE:</b> Preoperation Inspection	<b>INSPECTOR(S):</b> Peter S. Hays	<b>INSP. DATE:</b> October 31, 2018	<b>INSP. TIME:</b> 10:00
<b>OPERATOR:</b> Venture Resources, Inc.	<b>OPERATOR REPRESENTATIVE:</b> Patrick Maher	<b>TYPE OF OPERATION:</b> 110d - Designated Limited Impact	
<b>REASON FOR INSPECTION:</b> Pre-Operation Inspection	<b>BOND CALCULATION TYPE:</b> None	<b>BOND AMOUNT:</b> No Bond Held	
<b>DATE OF COMPLAINT:</b> NA	<b>POST INSP. CONTACTS:</b> None	<b>JOINT INSP. AGENCY:</b> None	
<b>WEATHER:</b> Snowing	<b>INSPECTOR'S SIGNATURE:</b>

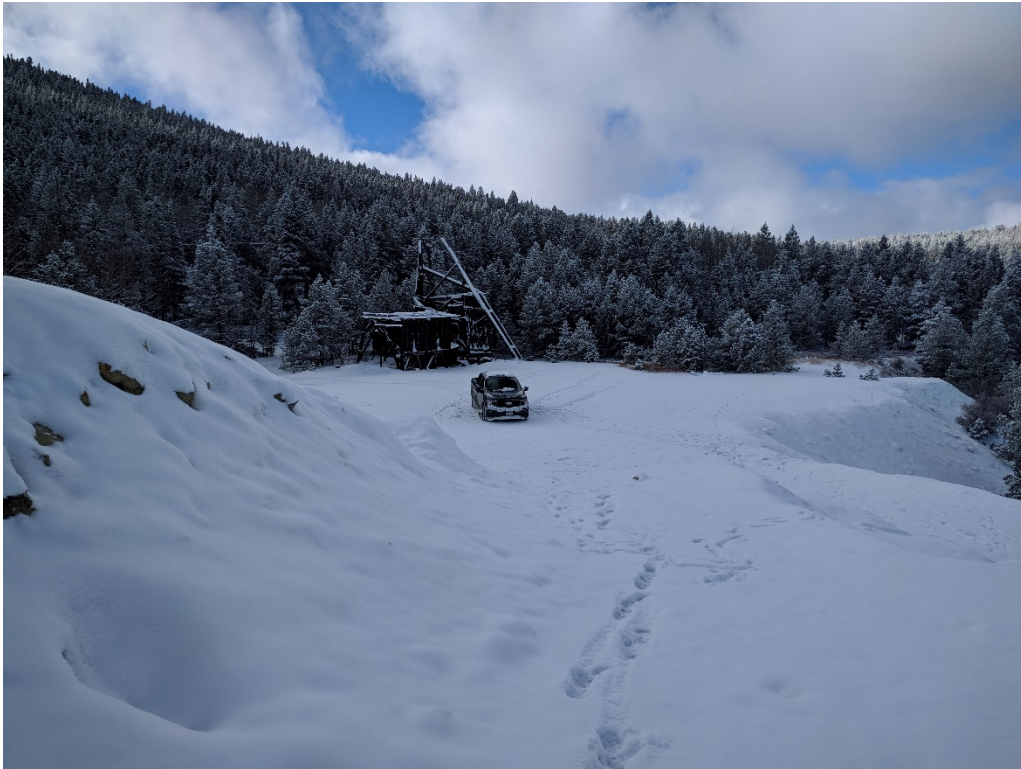
View of site from top of the mine dump looking south

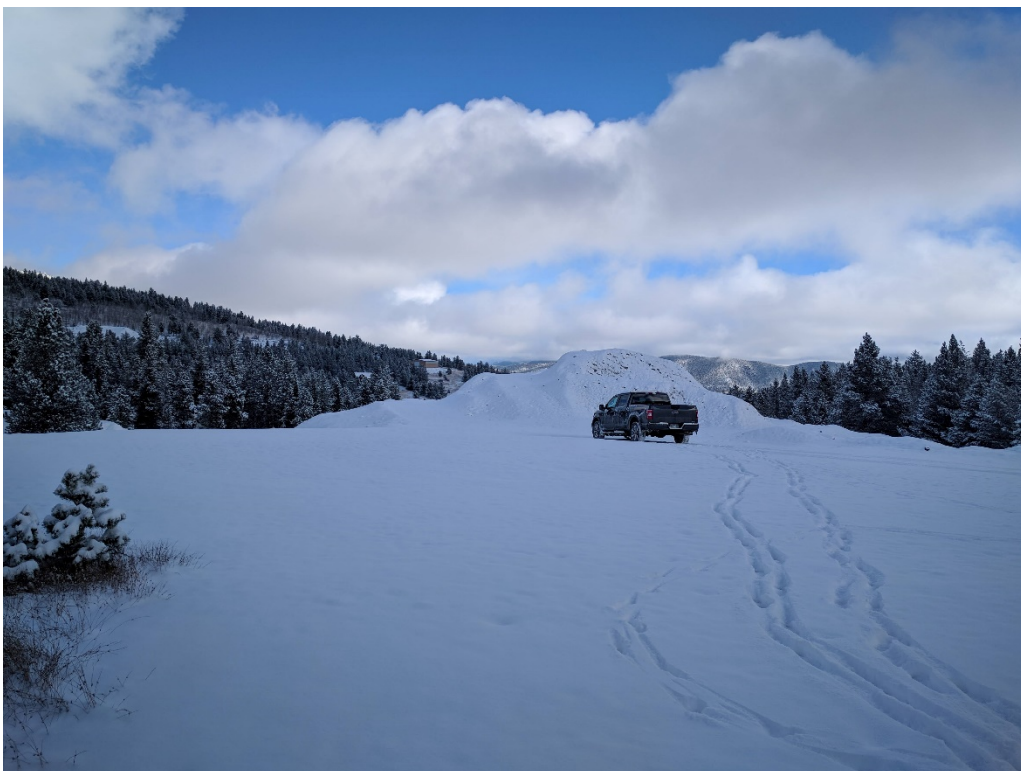
View of the site from the headframe structure looking north

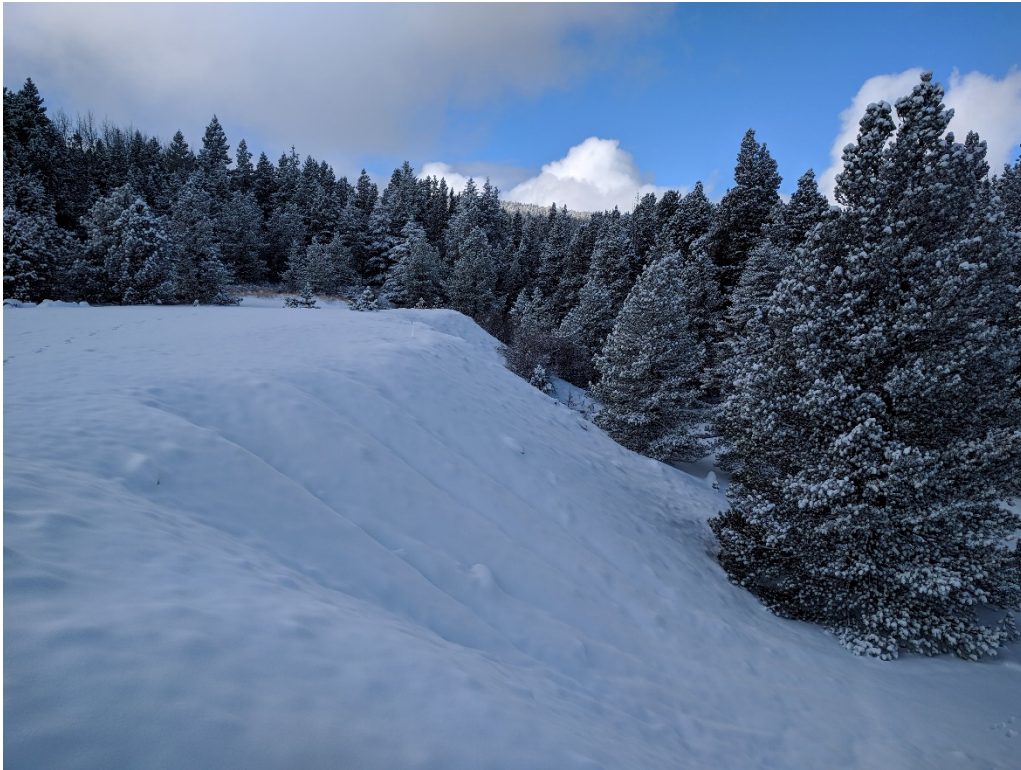
View of the east slope of the mine dump

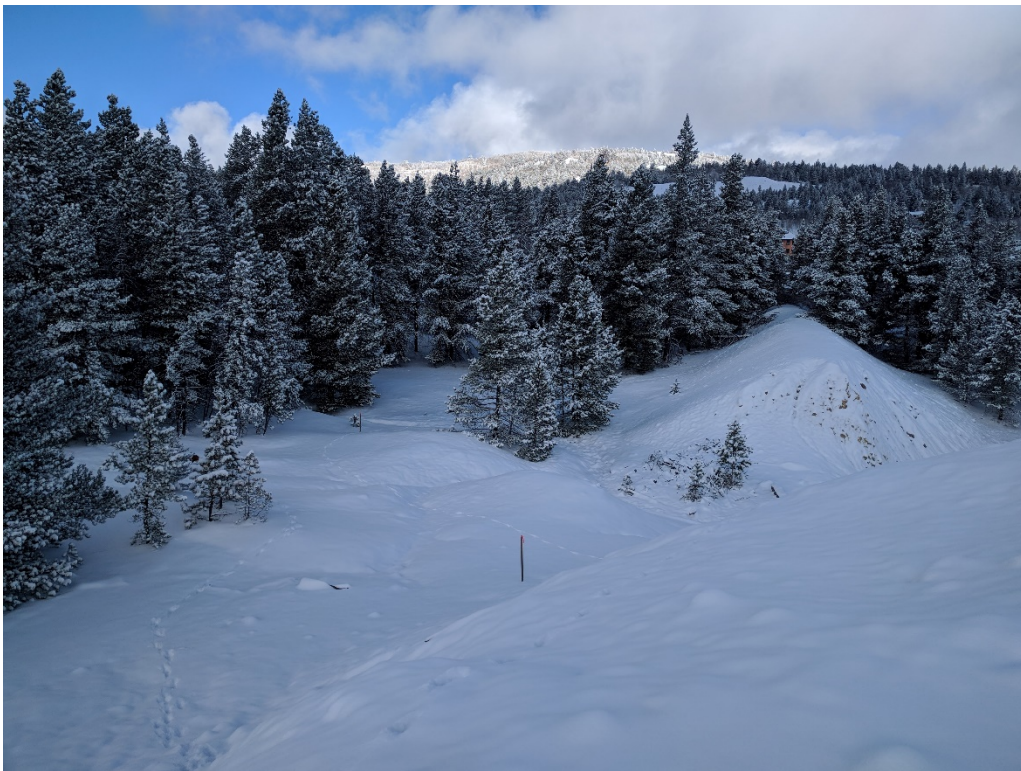
View of the western mine dump and boundary marker

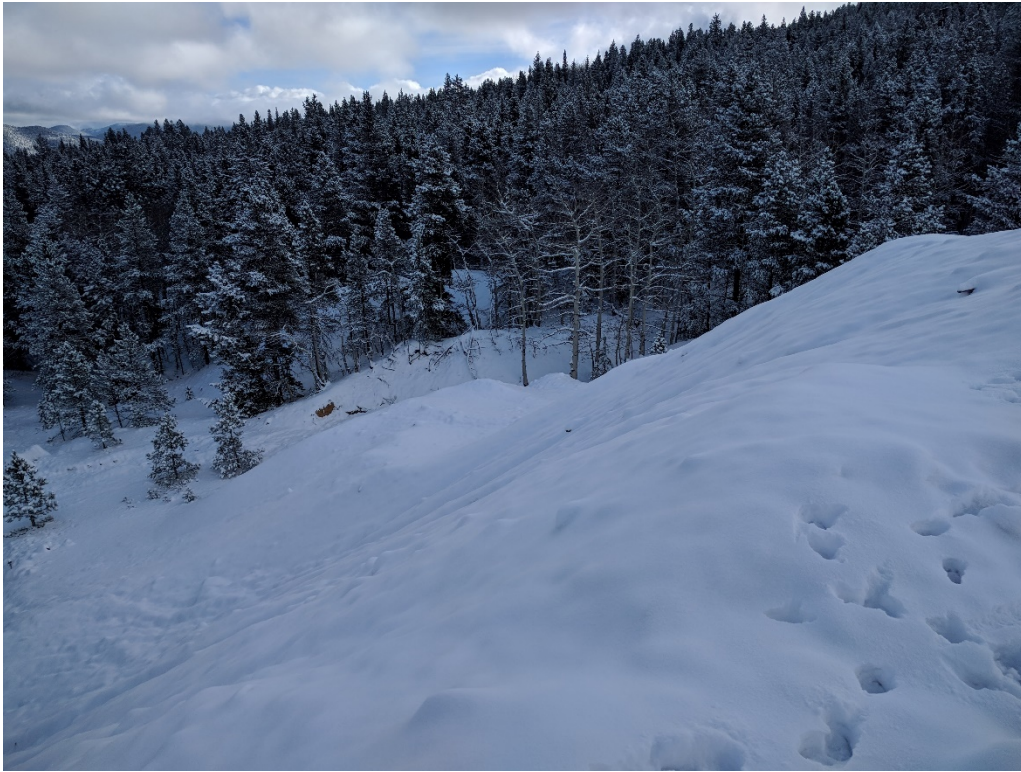
View of the north slope of the mine dump
