**MINERALS PROGRAM INSPECTION REPORT**  
**PHONE: (303) 866-3567**

<b>MINE NAME:</b> ARS Sand and Gravel	<b>MINE/PROSPECTING ID#:</b> M-1980-020	<b>MINERAL:</b> Sand and gravel	<b>COUNTY:</b> Douglas
<b>INSPECTION TYPE:</b> Monitoring	<b>INSPECTOR(S):</b> Peter S. Hays	<b>INSP. DATE:</b> October 31, 2018	<b>INSP. TIME:</b> 13:00
<b>OPERATOR:</b> ARS Sand & Gravel Co., LLC	<b>OPERATOR REPRESENTATIVE:</b> Derek Garben	<b>TYPE OF OPERATION:</b> 112c - Construction Regular Operation	
<b>REASON FOR INSPECTION:</b> Normal I&E Program	<b>BOND CALCULATION TYPE:</b> None	<b>BOND AMOUNT:</b> \$92,400.00	
<b>DATE OF COMPLAINT:</b> NA	<b>POST INSP. CONTACTS:</b> None	<b>JOINT INSP. AGENCY:</b> None	
<b>WEATHER:</b> Clear	<b>INSPECTOR'S SIGNATURE:</b>

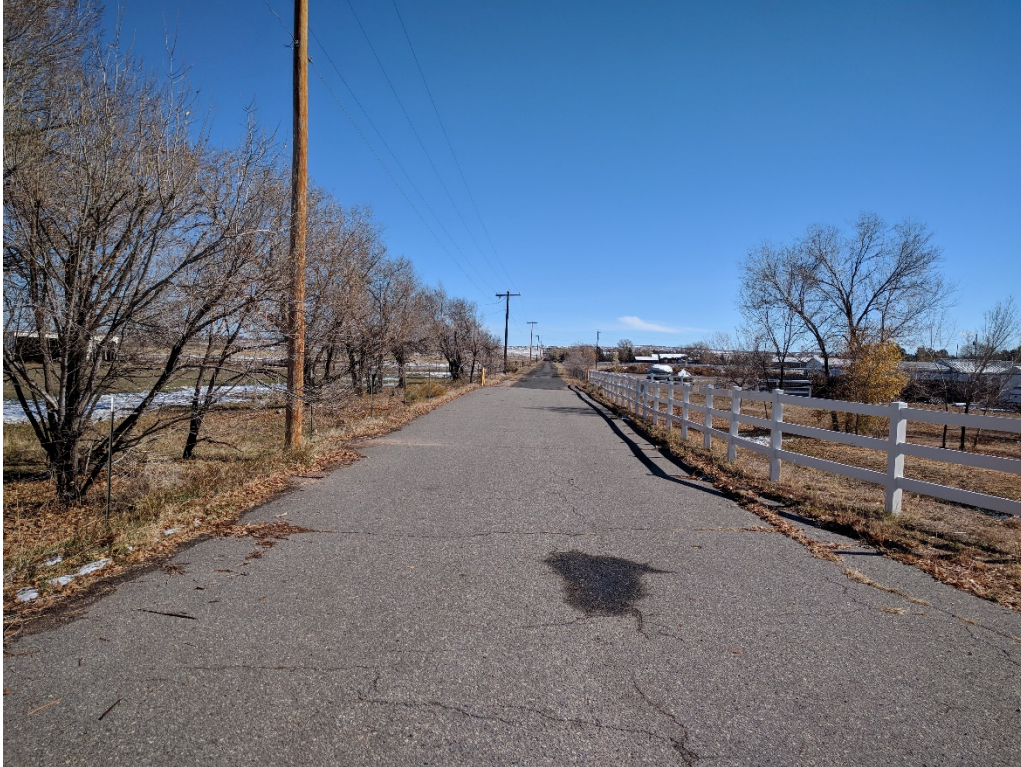
View of north access road from Roxborough Park Road looking east

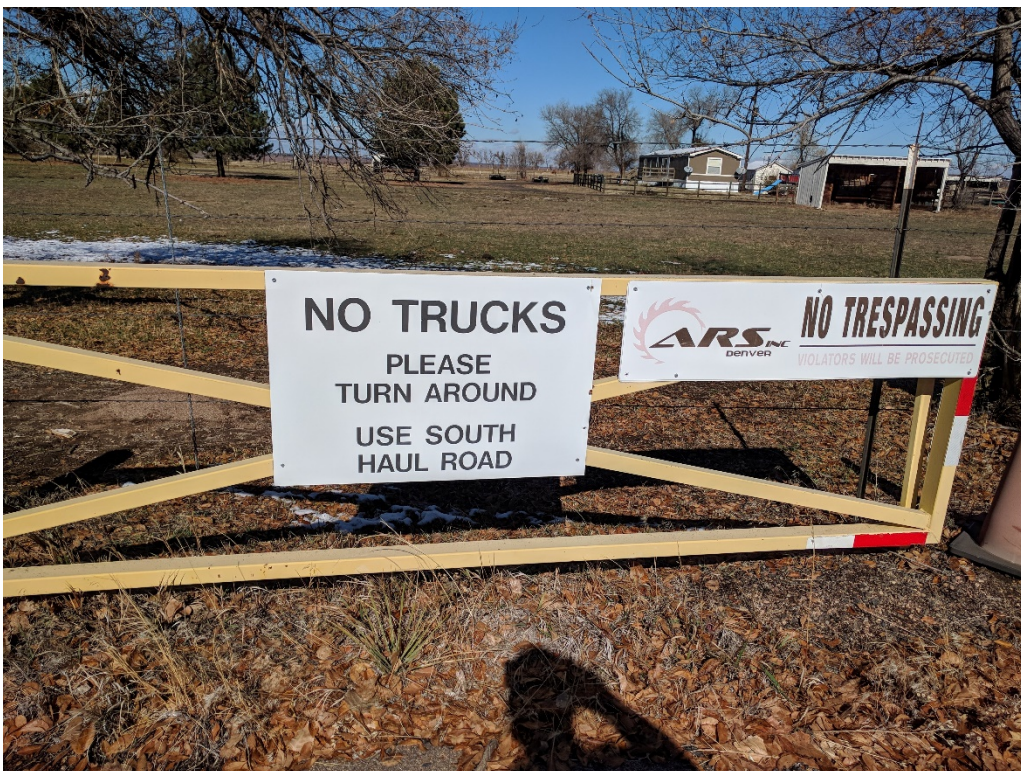
View of the instruction sign at the north access road gate
