## MINERALS PROGRAM INSPECTION REPORT

<b>MINE NAME:</b> Apache 9	<b>MINE/PROSPECTING ID#:</b> M-1978-009	<b>MINERAL:</b> Clay (general) and sand and gravel	<b>COUNTY:</b> El Paso
<b>INSPECTION TYPE:</b> Monitoring	<b>INSPECTOR(S):</b> Timothy A. Cazier	<b>INSP. DATE:</b> May 9, 2018	<b>INSP. TIME:</b> 10:30
<b>OPERATOR:</b> General Shale Brick, Inc.	<b>OPERATOR REPRESENTATIVE:</b> Jason McGraw	<b>TYPE OF OPERATION:</b> 112c - Construction Regular Operation

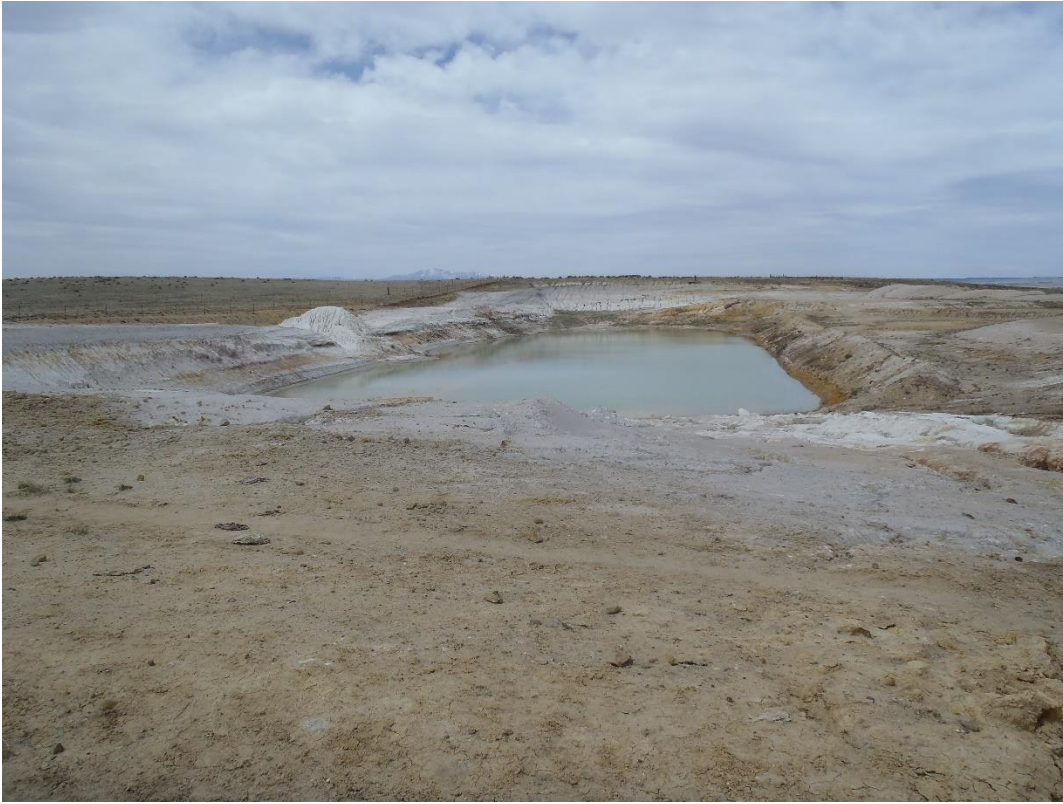
**PROBLEM/POSSIBLE VIOLATION:** Problem: The Division has no evidence that the operator has a valid well permit, substitute water supply plan, or approved water augmentation plan for the exposed groundwater at the site. This is a problem related to 34-32.5-116(4)(h) of the Colorado Revised Statutes and 3.1.6(1)(a) of the Construction Materials Rules and Regulations governing injury to existing water rights.

Hydrologic Balance: Water was observed in all the sediment ponds (Stage 1A, Stage 2A and Stage 3). What is believed to be exposed groundwater was observed in the south pit of Stage 1A (see **Photo 1** and **Figure 2**). Mr. McGraw indicated General Shale Brick contacted the Division of Water Resources (DWR) about 10 years ago to inform them of the exposed groundwater, but never heard back from them. The DRMS has contacted Mr. Chris Grimes (DWR) with respect to the potential exposed groundwater. DWR has no record of an approval of a replacement plan to offset those evaporative losses, nor could they find a letter from General Shale Brick. **This exposed groundwater is cited as a problem on page 1 of this report.**

Photo 1. Probable exposed groundwater observed in the south pit of Stage 1A (looking west).

**CORRECTIVE ACTIONS:** The operator shall demonstrate that the operation is in compliance with the Office of the State Engineer, show evidence that the operator is taking measures to bring the site into compliance with the SEO, or backfill the pits to at least two feet above the groundwater surface by the corrective action date specified.

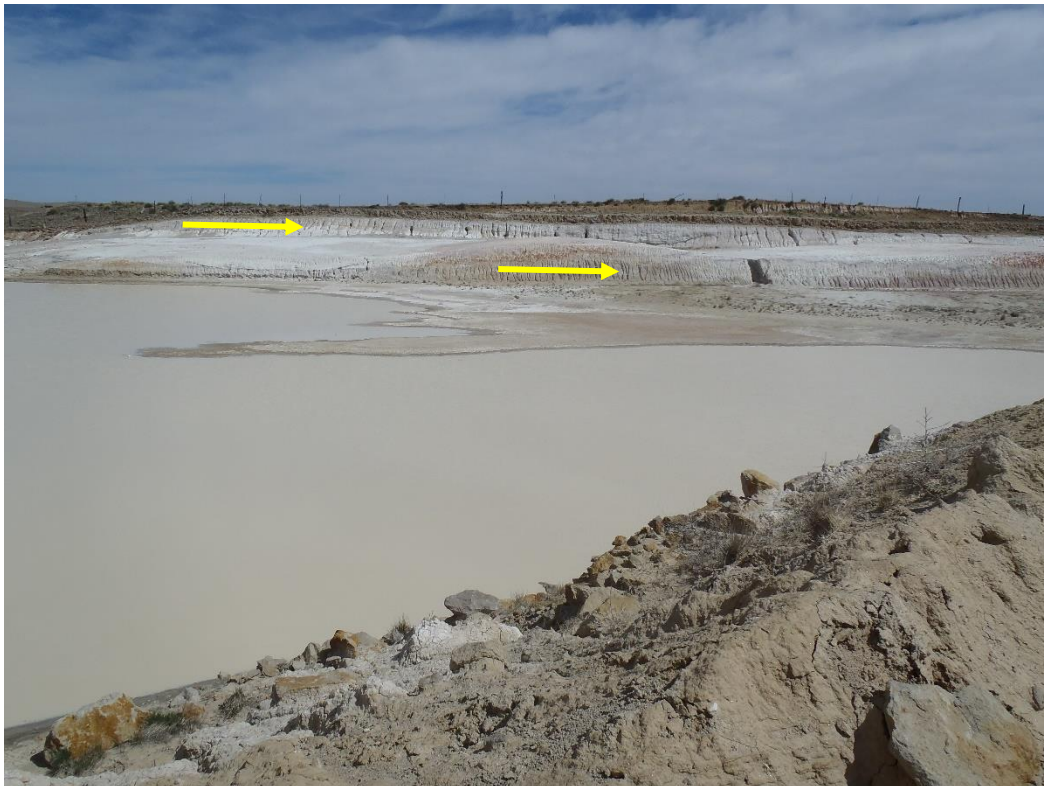
The two highwalls in the Stage 3 active area were estimated to be a consistent six (6) feet in height and appeared stable (see **Photo 2**). Two material stockpiles were observed in the Stage 3 area (see **Photo 3**). In the Stage 1A area the west highwall appeared to be close to 3H:1V and near 20 feet in height (see **Photo 4**) and the south highwall was near 1H:1V, varying between 10 and 20 feet in height (see **Photo 5**).

Photo 2. Stage 3 six-foot highwalls (sediment pond in foreground, looking north).

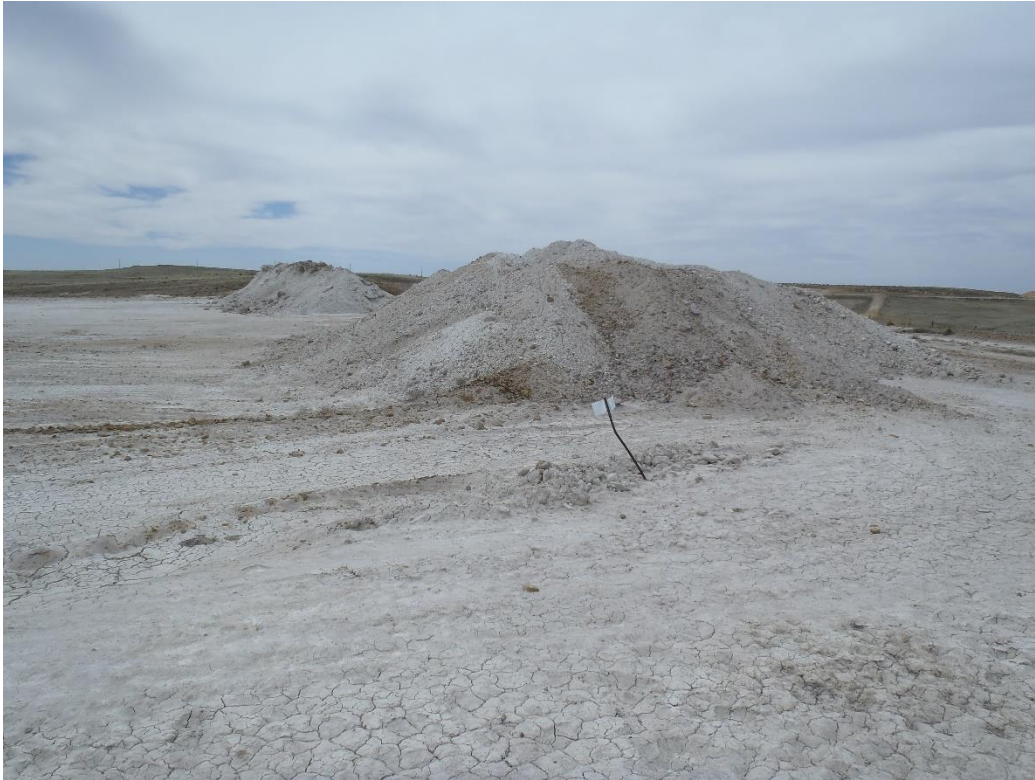
Photo 3. Stage 3 material stockpiles (looking east).

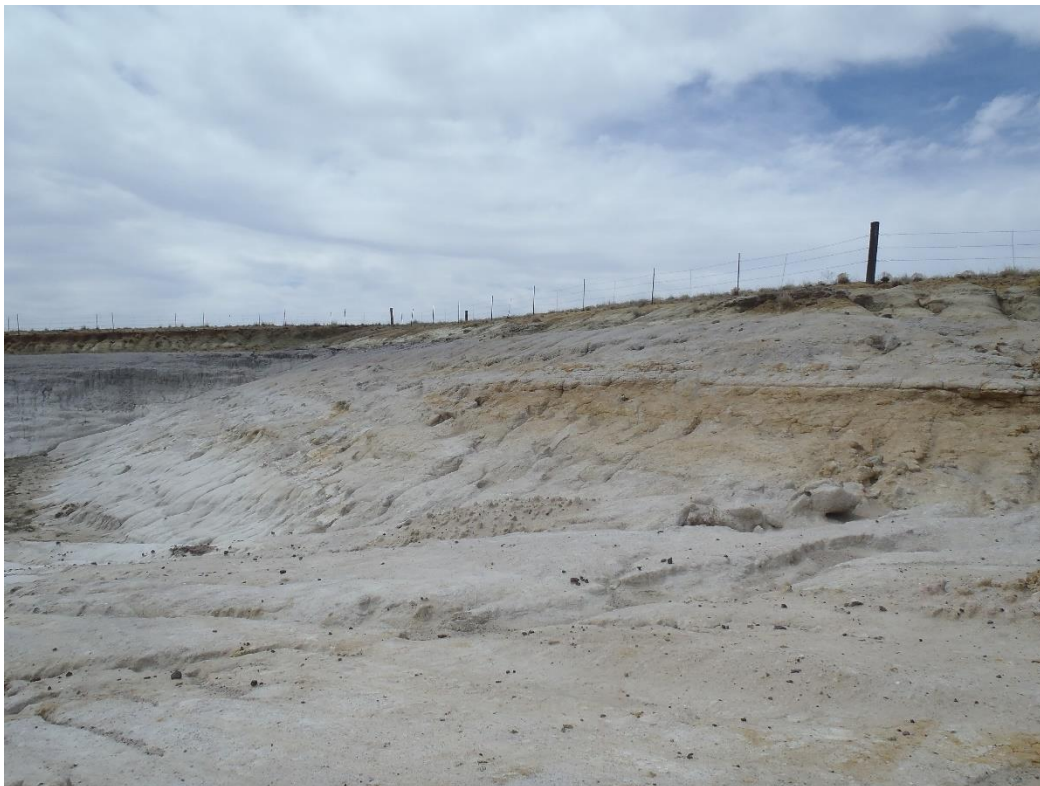
Photo 4. Stage 1A area west highwall (looking SW from NW corner of pit).

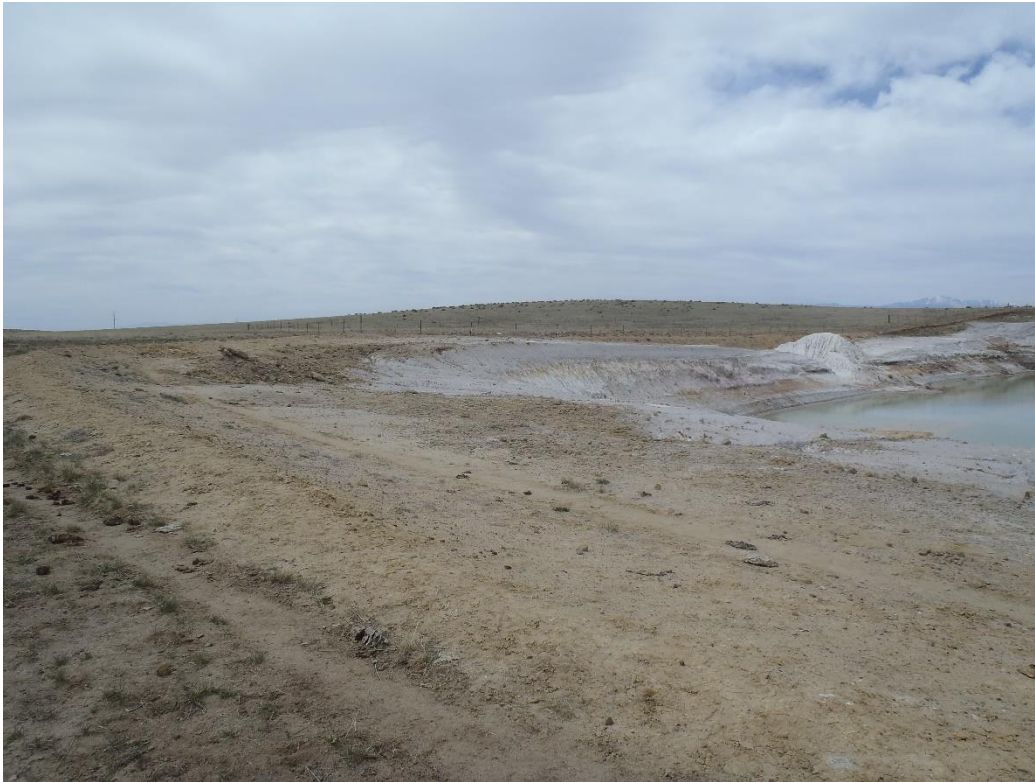
Photo 5. Stage 1A area south highwall (looking SW from east end).

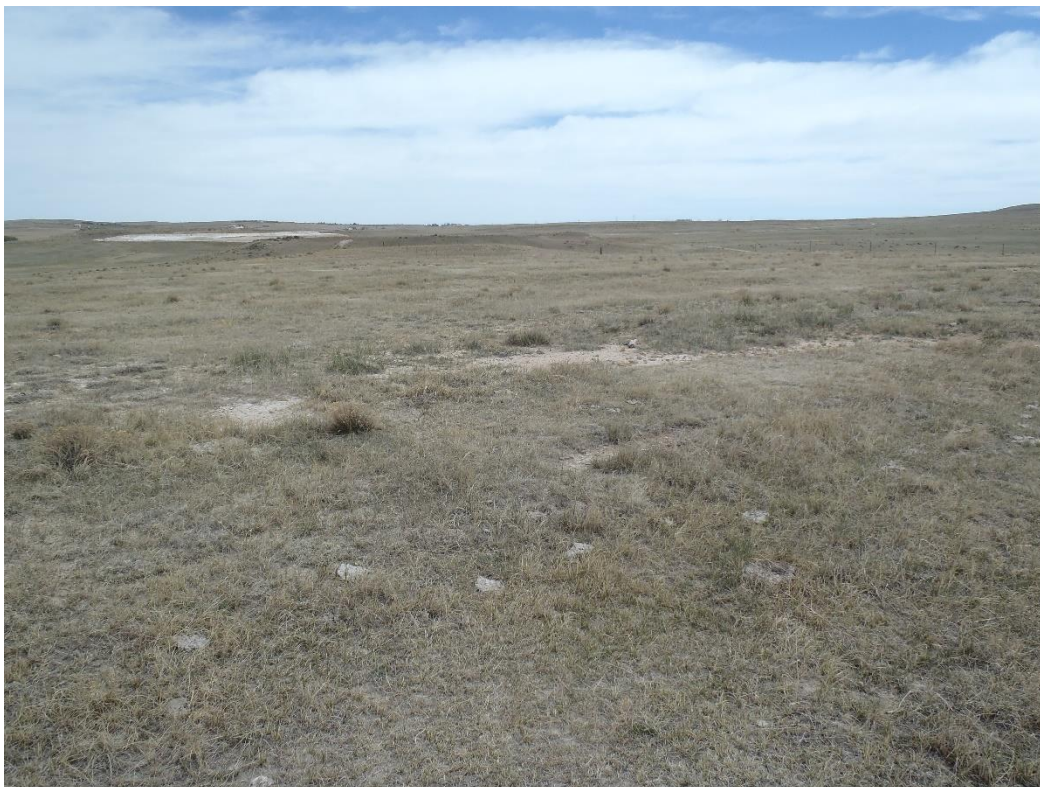
Reclamation Success: As discussed above in "Gen. Compliance with Mine Plan", an estimated 39 acres have achieved satisfactory reclamation (see **Photo 6**).

Photo 6. Typical reclaimed area (SW corner of Stage 3, looking north).

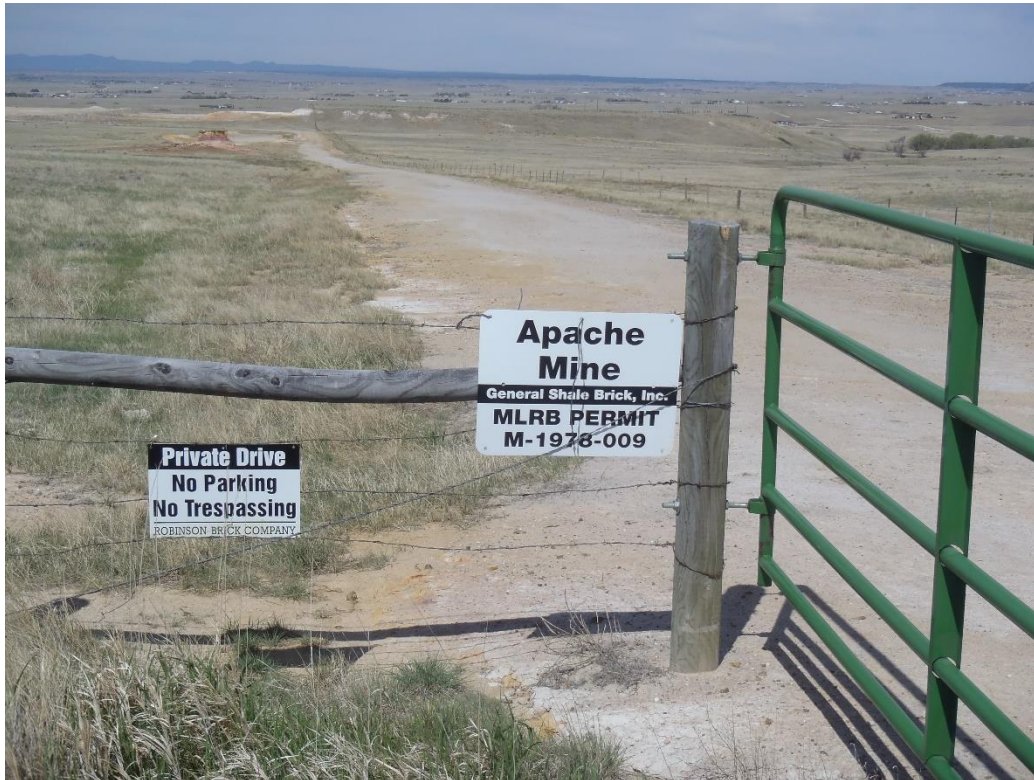
Signs and Markers: The permit sign was properly posted (see **Photo 7**) and boundary markers consisting mostly of fences were observed to delineate the permit boundary.

Photo 7. Permit sign (at entrance).

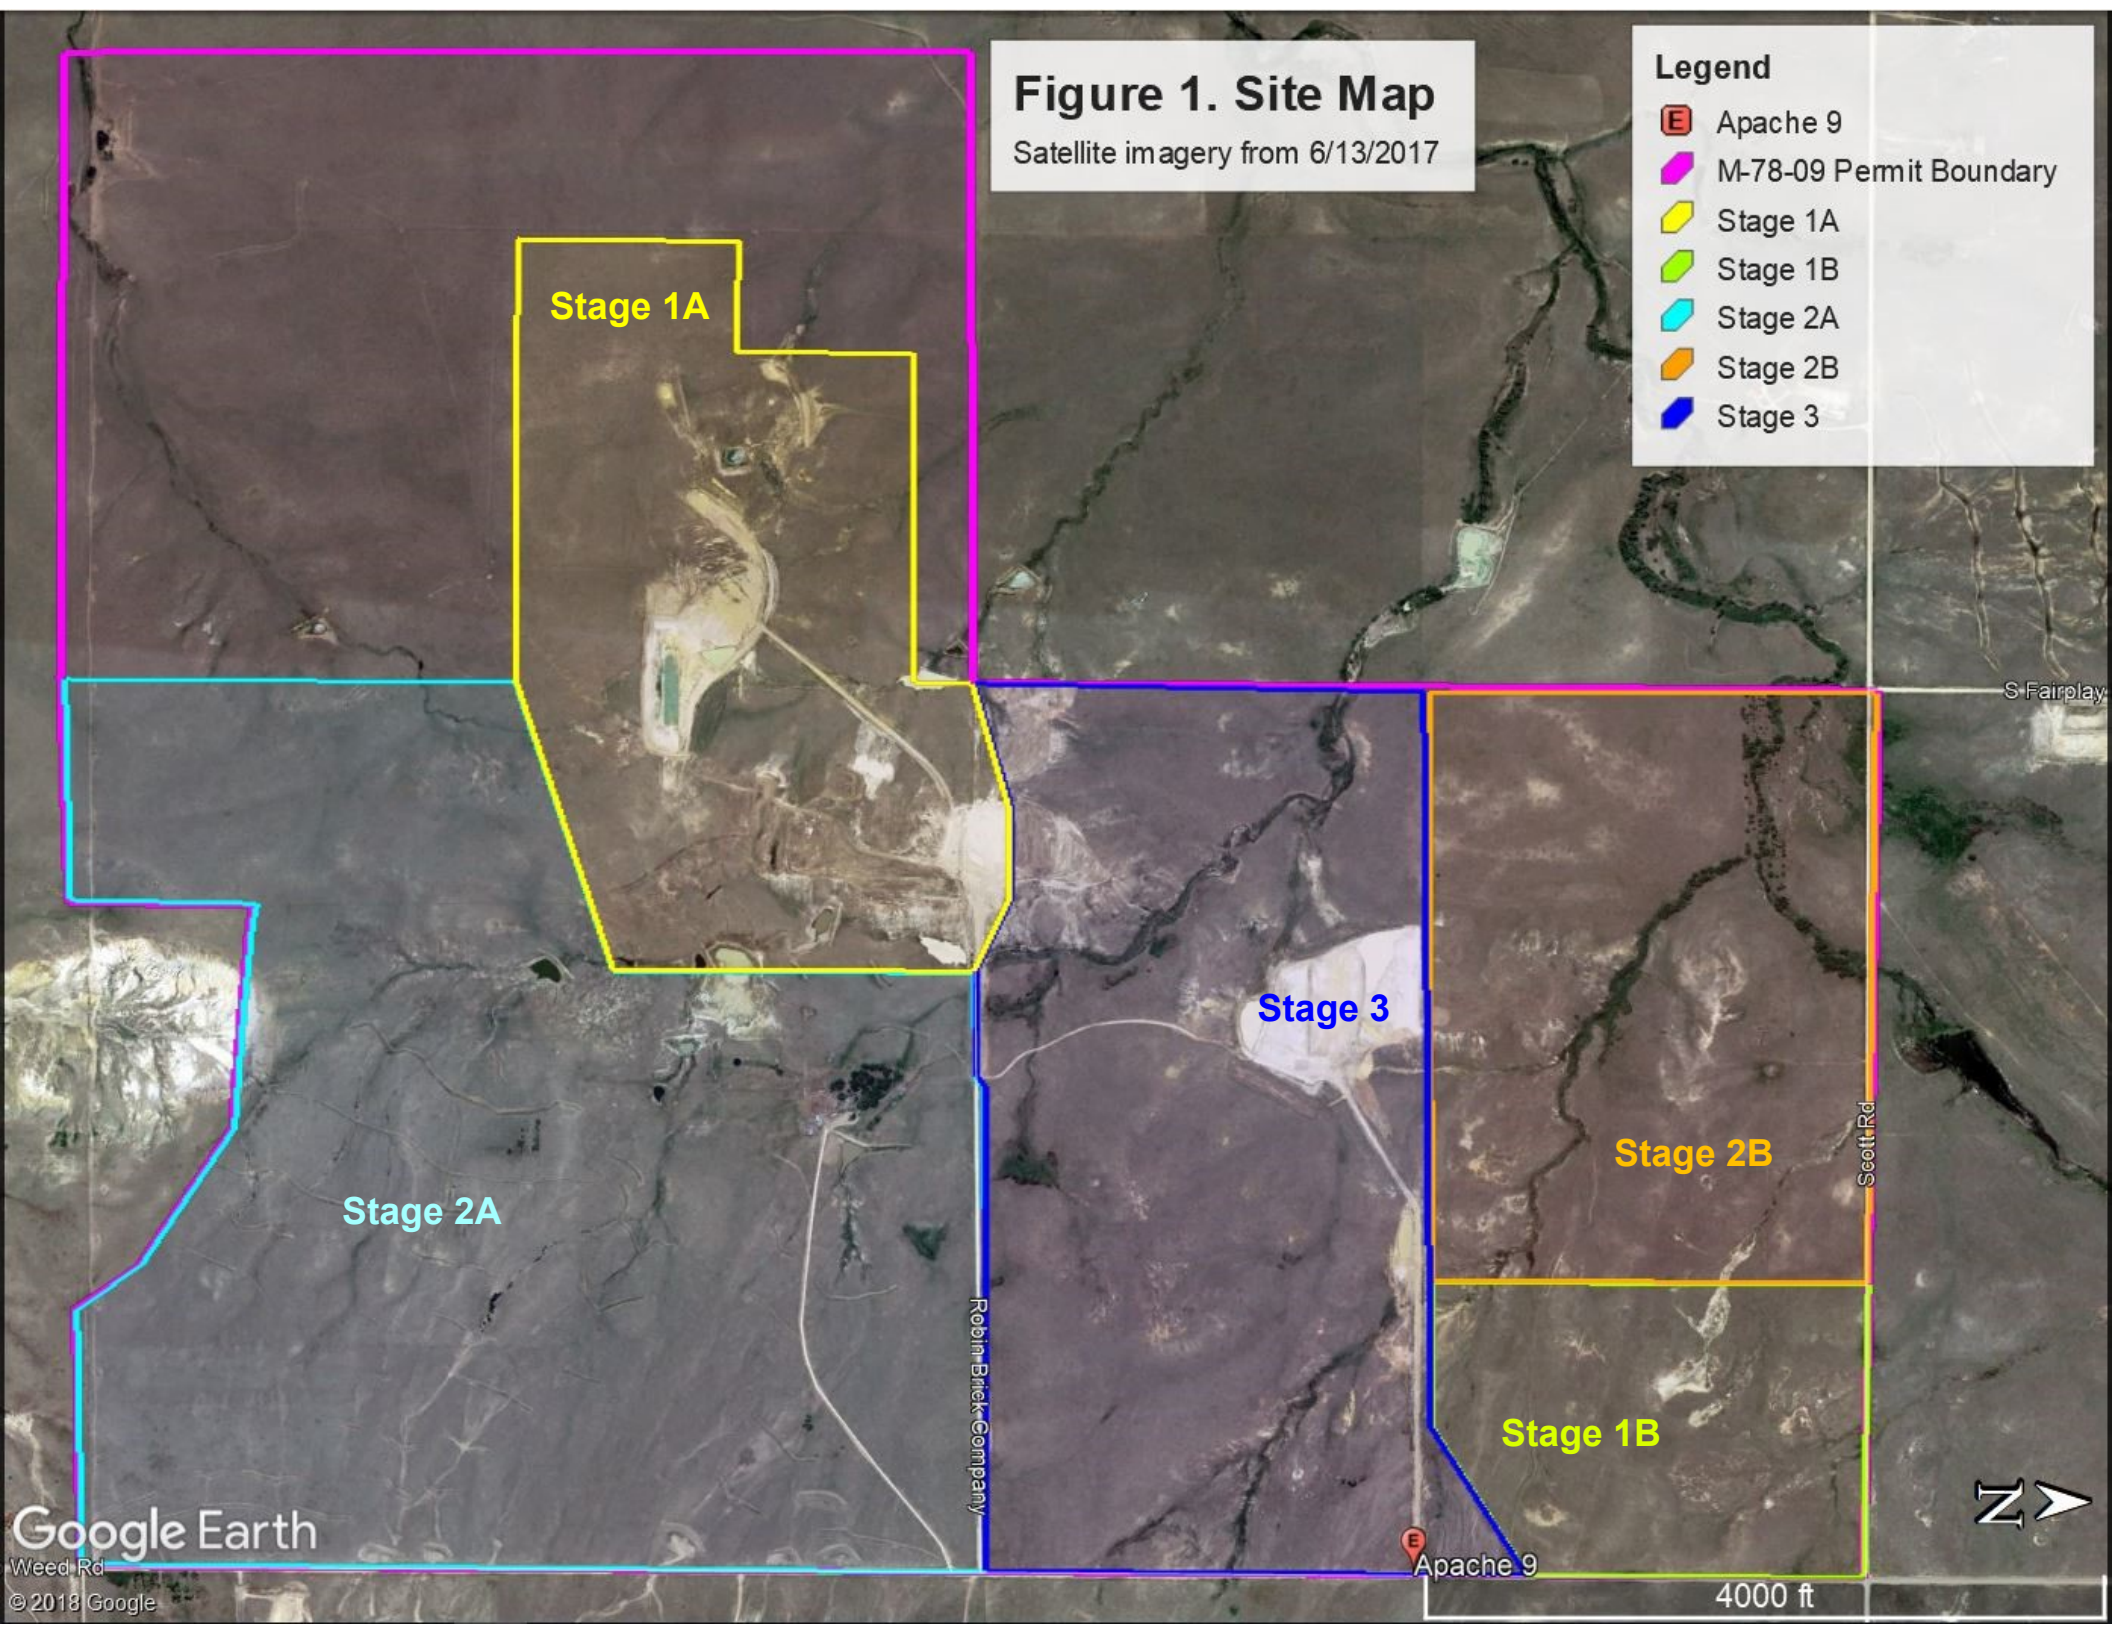
# Figure 1. Site Map

Gen. Compliance with Mine Plan: The operation appeared to be in compliance with the approved mine plan. **Figure 1** shows the five mine stages: 1A, 1B, 2A, 2B and 3. Only Stages 1A and 3 appear to have been mined to date. Google Earth was used to measure the cumulative disturbed area to date, which was estimated to be approximately 92 acres (see **Figures 2** and **3**), based on available imagery from 1999 to 2017. However, approximately 39 acres are releasable (see areas outlined in tan on **Figures 2** and **3**) based on field observations and Google Earth imagery. As such approximately 53 acres require various amounts of reclamation.
