**MINERALS PROGRAM INSPECTION REPORT**  
**PHONE: (303) 866-3567**

<b>MINE NAME:</b> Burros Mine	<b>MINE/PROSPECTING ID#:</b> M-1977-297	<b>MINERAL:</b> Uranium and vanadium	<b>COUNTY:</b> San Miguel
<b>INSPECTION TYPE:</b> Multi Person Inspection	<b>INSPECTOR(S):</b> Lucas J. West	<b>INSP. DATE:</b> October 16, 2018	<b>INSP. TIME:</b> 11:05
<b>OPERATOR:</b> Gold Eagle Mining, Inc.	<b>OPERATOR REPRESENTATIVE:</b> Kyle Turley, Mary Young	<b>TYPE OF OPERATION:</b> 110d - Designated Limited Impact	
<b>REASON FOR INSPECTION:</b> Normal I&E Program	<b>BOND CALCULATION TYPE:</b> None	<b>BOND AMOUNT:</b> \$100.00	
<b>DATE OF COMPLAINT:</b> NA	<b>POST INSP. CONTACTS:</b> None	<b>JOINT INSP. AGENCY:</b> None	
<b>WEATHER:</b> Clear	<b>INSPECTOR'S SIGNATURE:</b>

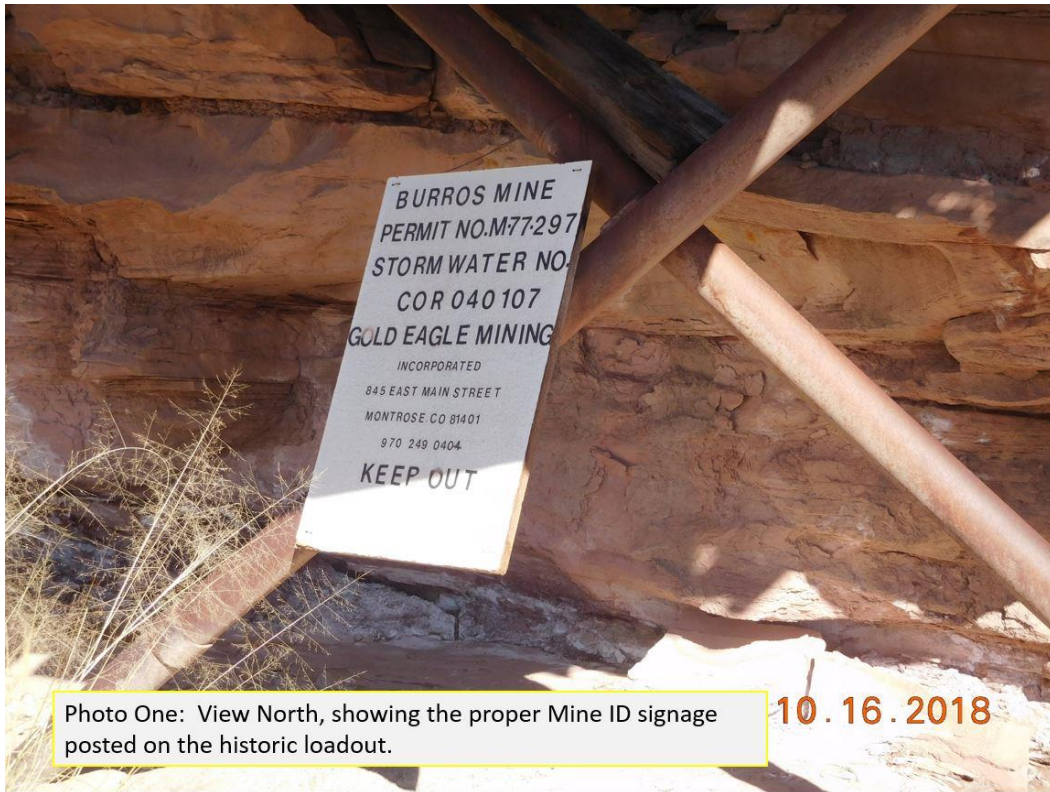
The proper mine identification signage was posted at the entrance to the site and can be seen in Photo One. The sign is posted on a historical loadout that is within the permitted area. The loadout appears to be stable and in a similar condition to the previous inspection conducted by the Division. The only work that is approved to take place on the site is ongoing weed management and the maintenance of the storm water controls on site. The storm water controls that were observed appear to be stable and functioning as designed. They will however require maintenance soon as there have been recent precipitation events in the area that have impacted the features. Photo Two shows part of the storm water control ditch near the historic loadout. The remaining storm water control features up gradient were in similar condition and require maintenance. The upper sediment pond may require the installation of a rock check dam where flow leaves the sediment pond and enters the storm water control ditch.

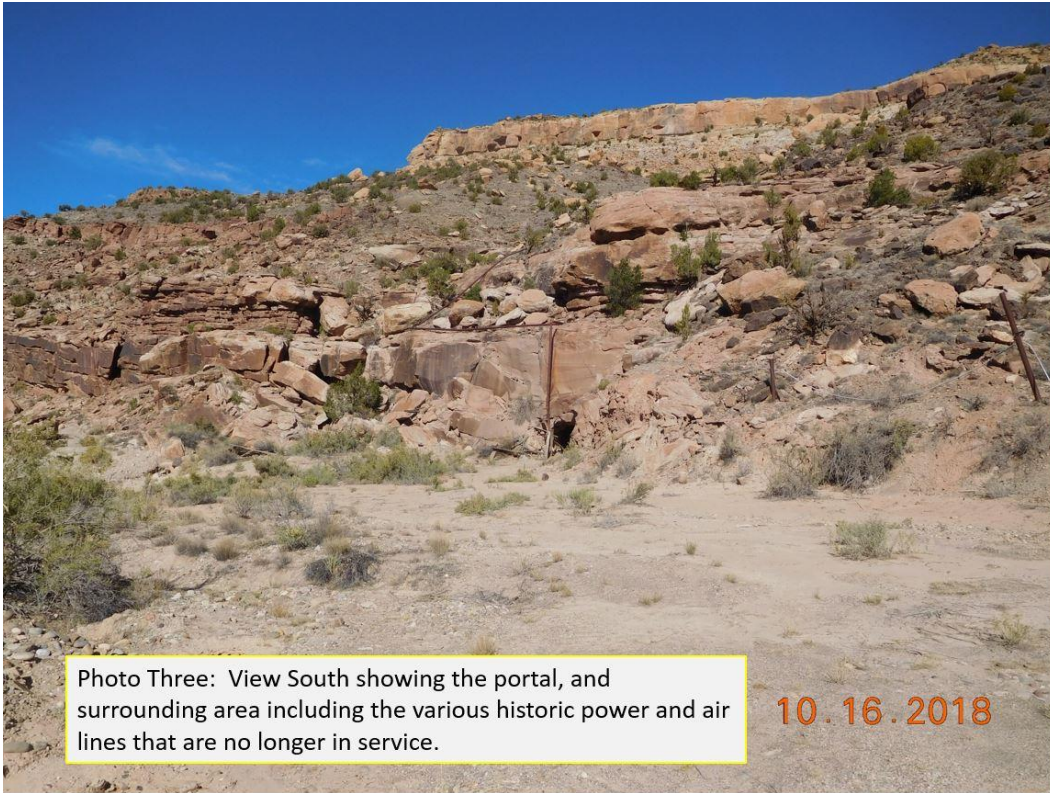
The portal has been secured with a safety closure to prevent entry. The closure is a locked steel grate closure that is in good condition and shows no signs of attempted unauthorized entry. Various pipes, lines and historic debris surround the portal and all appear to be stable and in a similar condition from the Division's previous inspection. The closure and the surrounding area can be seen in Photos Three.
