MINERALS PROGRAM INSPECTION REPORT

MINE NAME: Phantom Canyon Pit	MINE/PROSPECTING ID#: M-1994-118	MINERAL: Gravel	COUNTY: Teller
INSPECTION TYPE: Monitoring	INSPECTOR(S): Timothy A. Cazier	INSP. DATE: June 11, 2018	INSP. TIME: 14:30
OPERATOR: Fremont County	OPERATOR REPRESENTATIVE: Sterling Rife	TYPE OF OPERATION: 110c - Construction Limited Impact	
REASON FOR INSPECTION: Normal I&E Program	BOND CALCULATION TYPE: None	BOND AMOUNT: \$0.00	
DATE OF COMPLAINT: NA	POST INSP. CONTACTS: None	JOINT INSP. AGENCY: None	
WEATHER: Clear	INSPECTOR'S SIGNATURE:

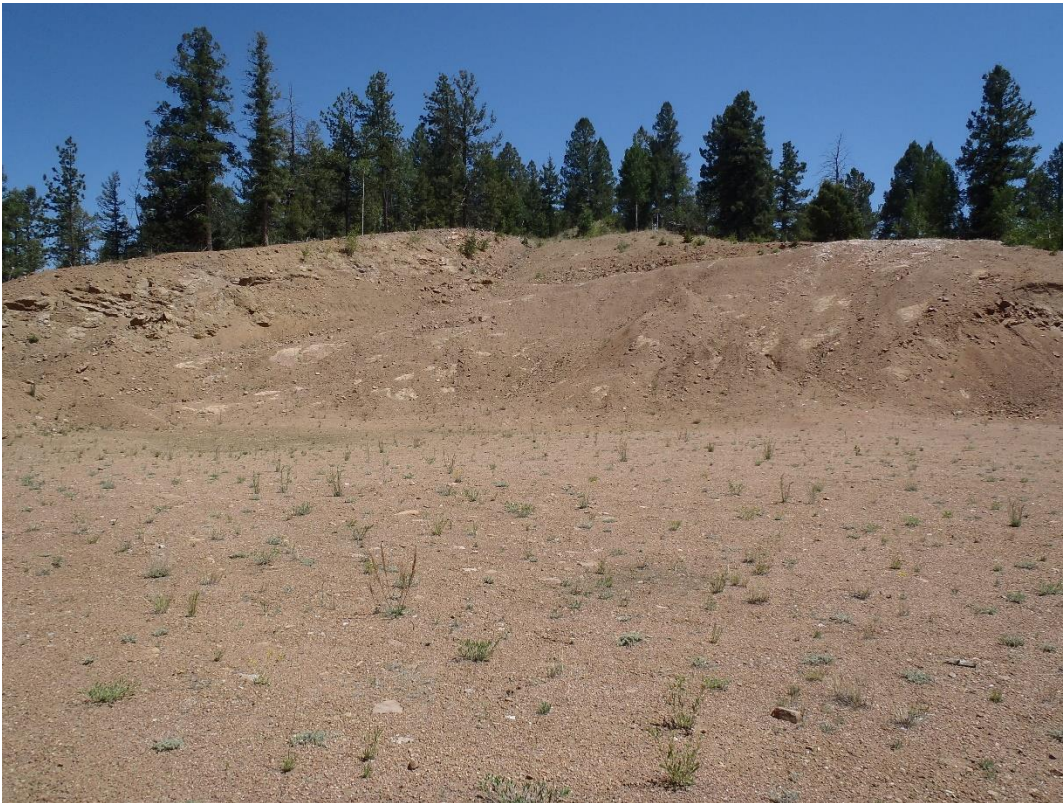
Gen. Compliance with Mine Plan: The operation appeared to be in compliance with the approved mine plan. Google Earth was used to measure the disturbed area, which was estimated to be slightly more than one acre, based on 2017 imagery. Highwalls were estimated to vary between 30 and 35 feet in height and appeared stable (see **Photos 1 and 2**). Highwall slopes were estimated to be at approximately 2.5:1V (see **Photos 3**).

Photo 1. Active highwall (looking south).

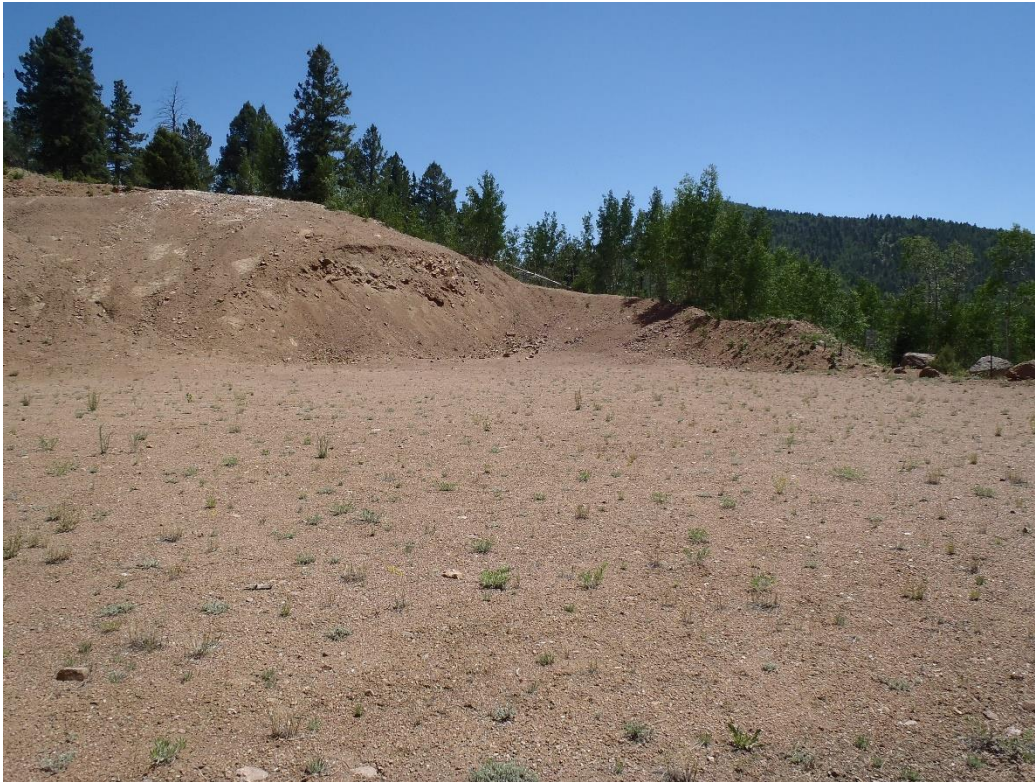
Photo 2. Active highwall (looking SW).

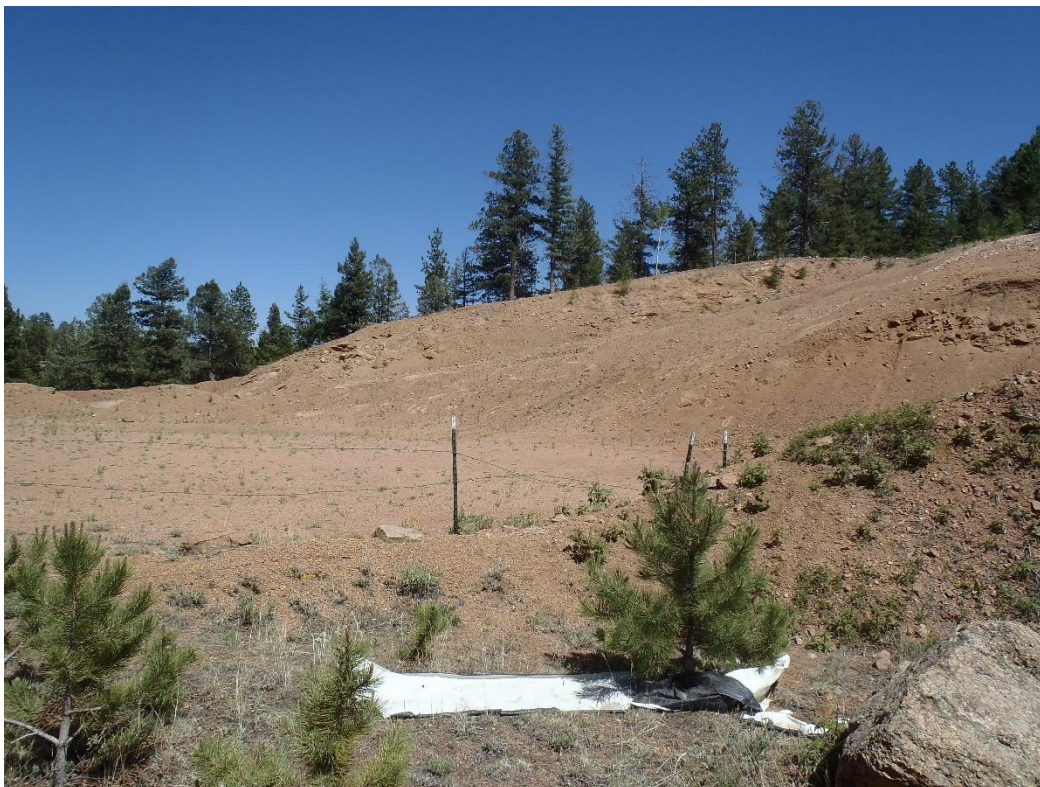
Photo 3. Active highwall (~2.5H:1V, looking east, note fence marking west boundary).

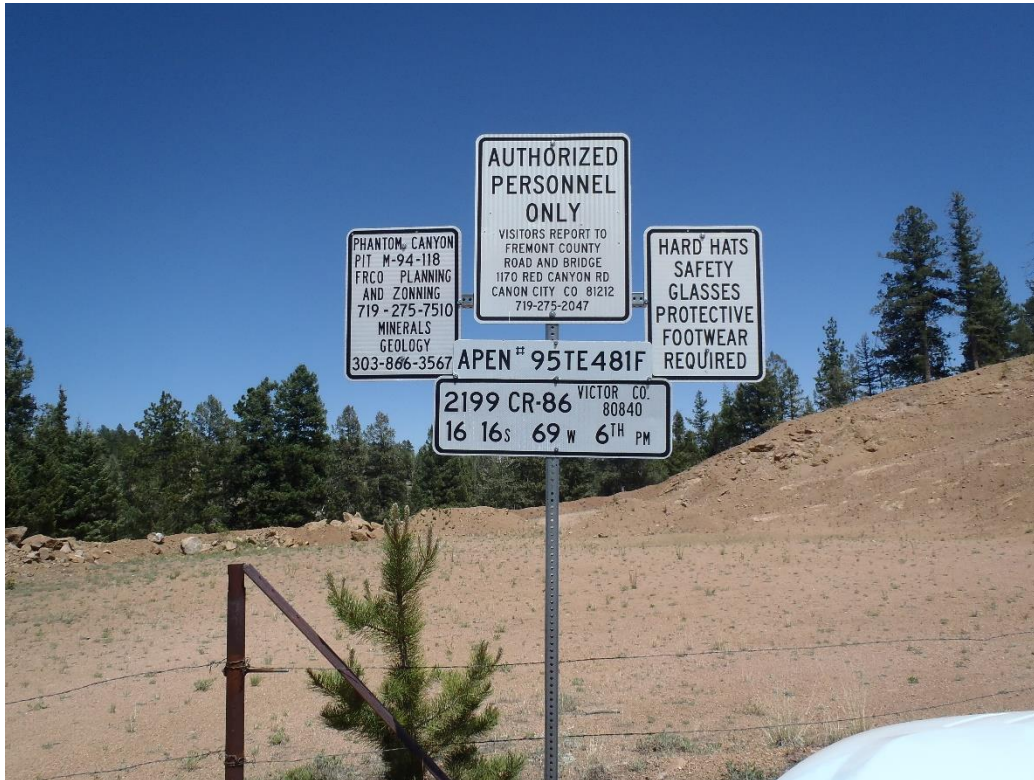
Signs and Markers: The permit sign was properly posted (see **Photo 4**) and boundary markers were observed to delineate the permit boundary (see **Photo 5**) with painted arrows in the pit area pointing in the direction of the T-post markers (see **Photo 6**).

Photo 4. Permit sign (at entrance).

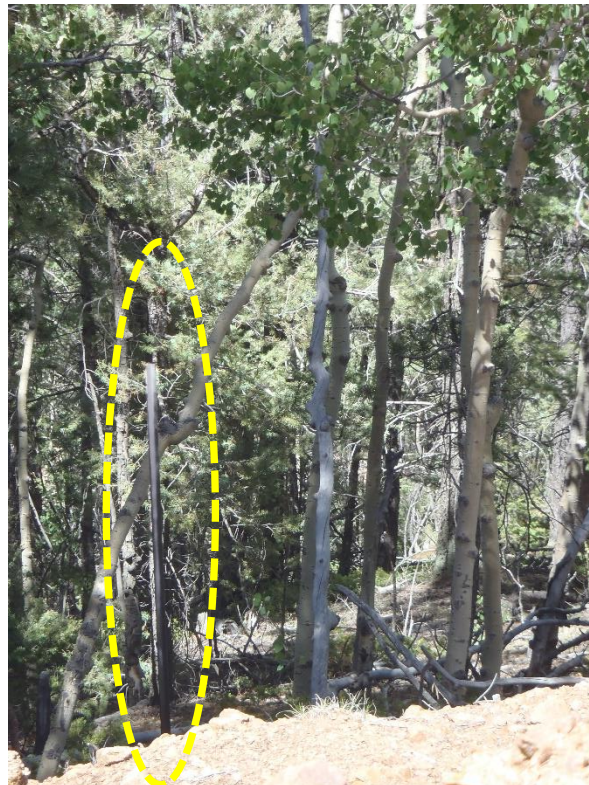
Photo 5. T-post, NE corner.

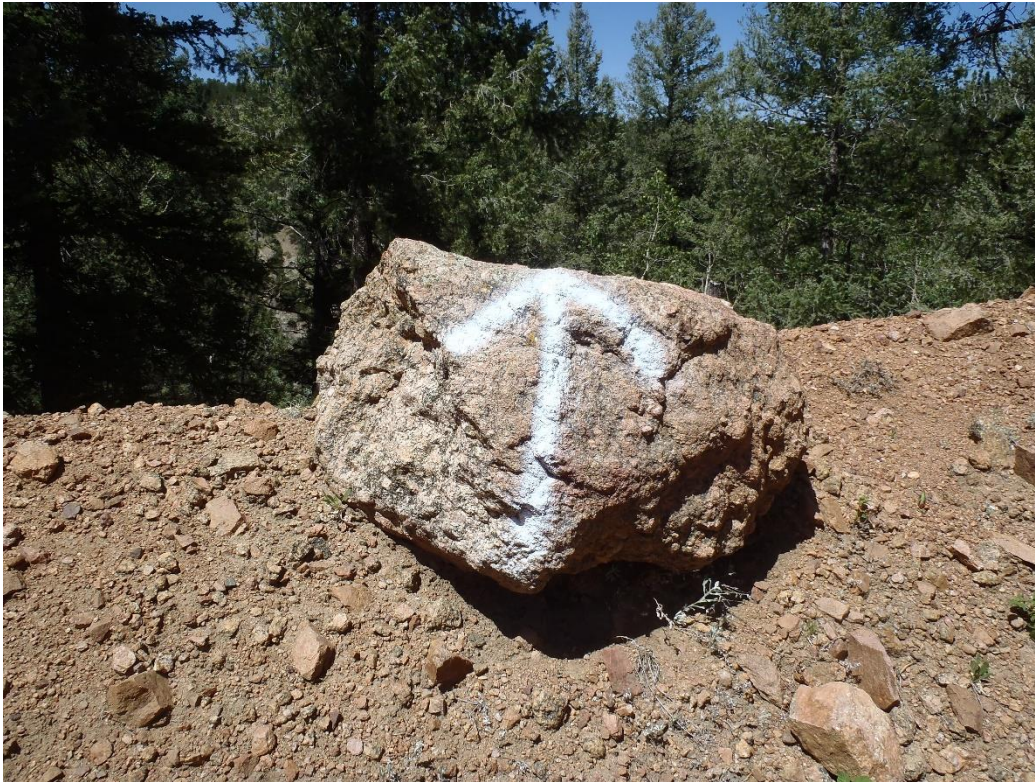
Photo 6. Arrow on berm pointing towards boundary marker in Photo 5.

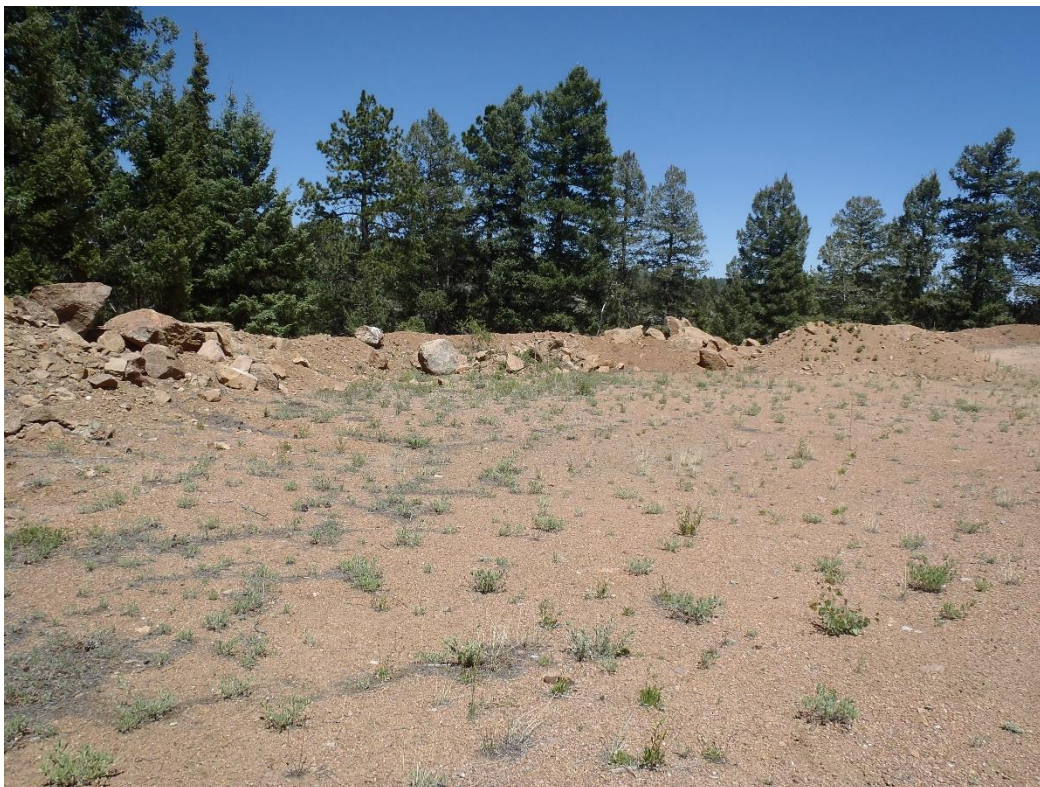
Storm Water MGT Plan: No oil or fuel spills observed. Stormwater drains to the pit, is contained by berms (see **Photo 7**) and infiltrates.

Photo 7. Berms acting to contain stormwater (north end, looking east).

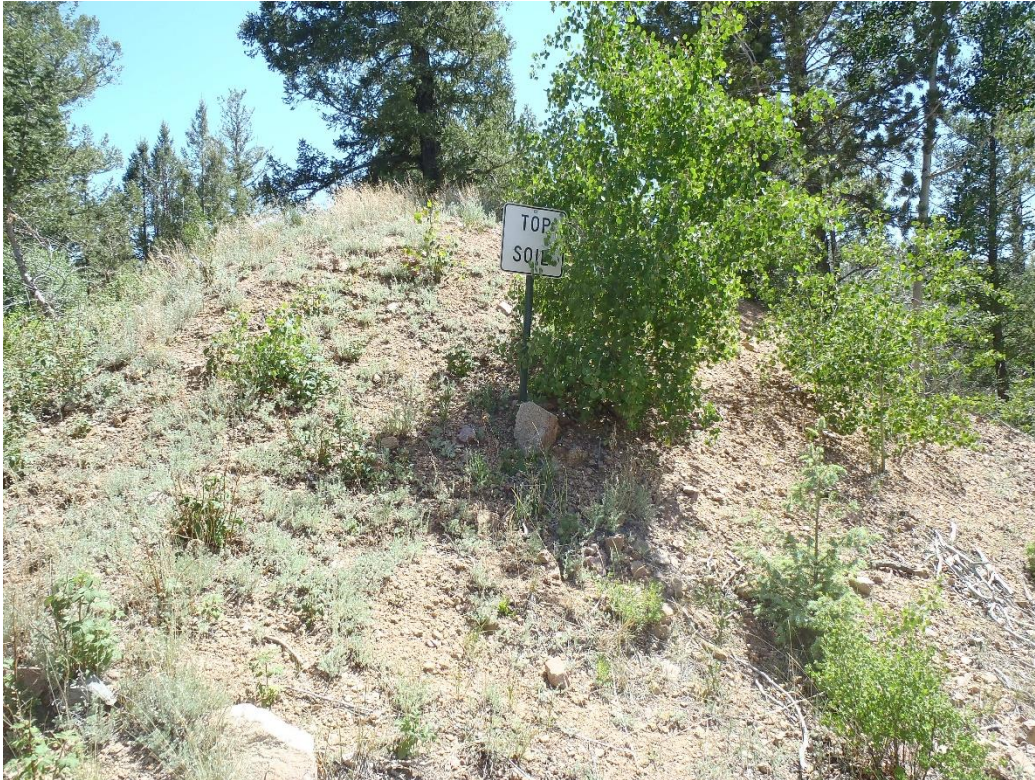
Topsoil: A topsoil stockpile was observed on the south end of the pit (uphill side) and labeled as such (see **Photo 8**).

Photo 8. Topsoil stockpile with sign (looking south).
