COLORADO DIVISION OF RECLAMATION, MINING AND SAFETY
MINERALS PROGRAM INSPECTION REPORT
PHONE: (303) 866-3567

MINE NAME: Halde Pit	MINE/PROSPECTING ID#: M-2008-014	MINERAL: Sand and gravel	COUNTY: Kit Carson
INSPECTION TYPE: Monitoring	INSPECTOR(S): Elliott R. Russell	INSP. DATE: May 12, 2014	INSP. TIME: 16:00
OPERATOR: Halde Sand & Gravel, Inc.	OPERATOR REPRESENTATIVE: None	TYPE OF OPERATION: 112c - Construction Regular Operation

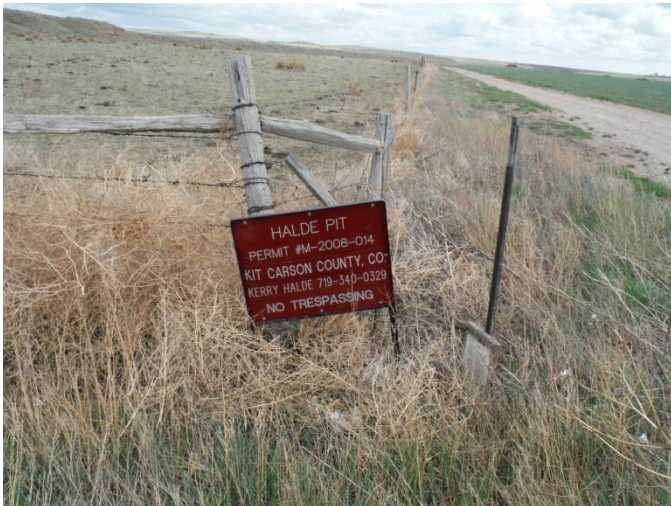
Permit identification sign at entrance; looking south.

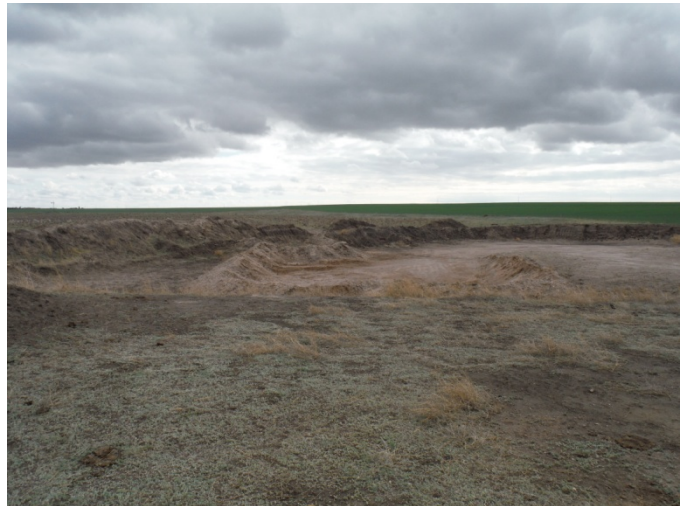
Northern Pit; looking west.

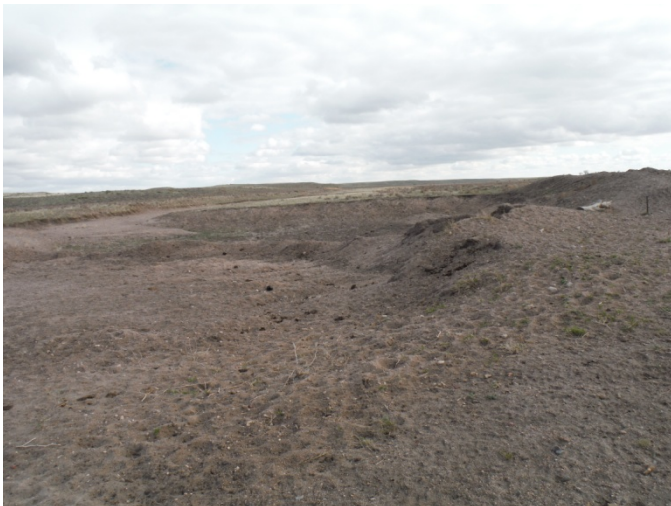
In the approved mining plan, it was stated that earthen berms and/or silt fences would be utilized, as necessary, to prevent off-site damages resultant of surface run-off water. It was also stated that all mining would stop within 50 feet of Landsman Creek. The southern pit is just adjacent to the creek bed may have been pre-existing, but since that area is within the permit boundary and appears to have been mined since 2008 this area will need to meet the conditions of the mining plan as well. **The Division recommends putting an earthen berm between the mining activities and the creek to ensure there is no off-site damages from erosion and sediment.** This berm shall also contain and stabilize two erosion features that lead to the creek from along the access.

Southern pit; looking south.

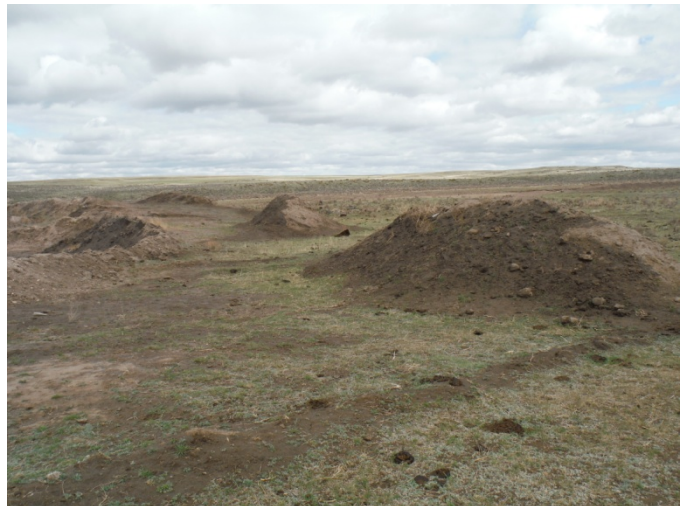
The site consisted of two pits; a northern pit located in a field that appeared to be recently active and a southern pit that was older and located near the creek bed. After further research of the permit's file, the southern pit was pre-existing but on April 8, 2008 the Division received a letter and revised maps stating that this pit would be included in the permit. The northern pit had several small stockpiles just adjacent to the pit walls. There is a high possibility of erosion of these piles due to steep slopes and no vegetation cover. As required by Rule 3.1.9, if these piles are not to be utilized for reclamation within a short time frame, they should be seeded and have vegetative cover to be protected from erosion and deterioration.

Topsoil piles along south edge of northern pit; looking southeast.

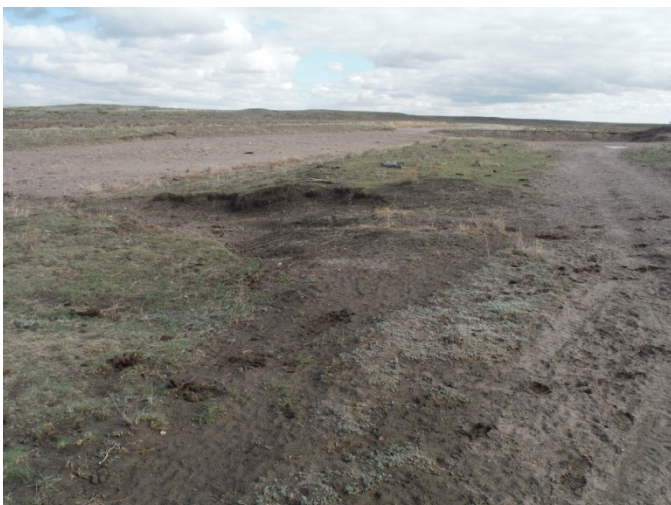
Erosion feature along access road; looking south.

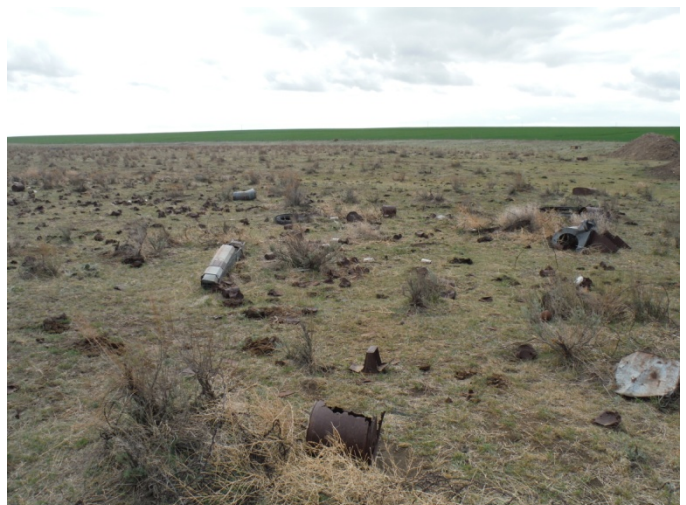
An old dump was observed just south of the northern pit; this area consisted of trash, bottles, and cans. This debris will need to be removed prior to stripping topsoil off this area to ensure clean topsoil is used during reclamation.

Old trash dump; looking southwest.

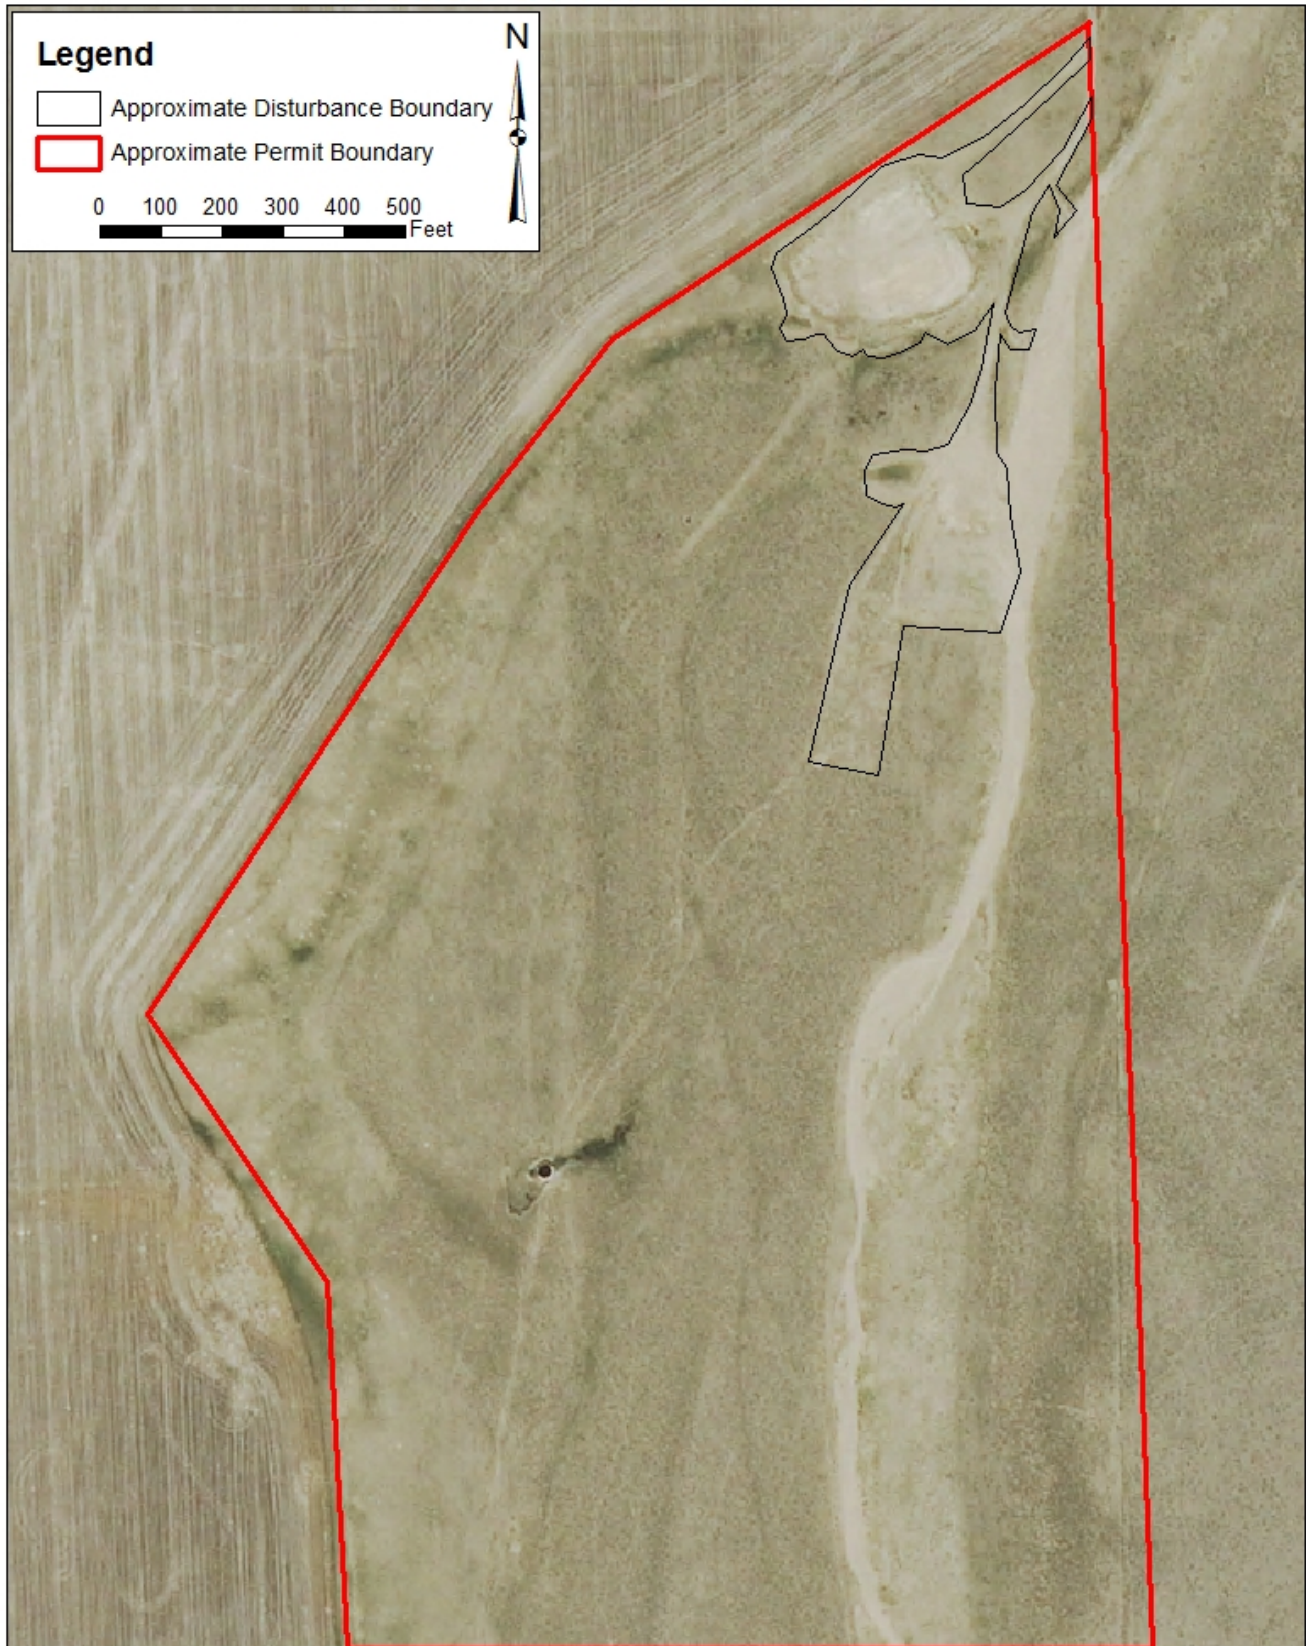
M-2008-014 Halde Pit 5/12/14

After review of the document records, the Division has created the attached map which shows the approved permit boundary (determined from georeferencing the Land Survey Plat submitted April 8, 2008) and an approximate disturbance boundary using a 2013 NAIP Aerial Image; approximate disturbance is estimated at 4.86 acres.
