MINERALS PROGRAM INSPECTION REPORT
PHONE: (303) 866-3567

MINE NAME: Climax Mine	MINE/PROSPECTING ID#: M-1977-493	MINERAL: Molybdenum	COUNTY: Summit
INSPECTION TYPE: Monitoring	INSPECTOR(S): Dustin M. Czaplá	INSP. DATE: October 3, 2018	INSP. TIME: 11:00
OPERATOR: Climax Molybdenum Company	OPERATOR REPRESENTATIVE: James Haag, Diana Kelts, Logan Tydryszewski	TYPE OF OPERATION: 112d-3 - Designated Mining Operation	
REASON FOR INSPECTION: Normal I&E Program	BOND CALCULATION TYPE: IT.Bondcalculationtype.CD.Desc	BOND AMOUNT: \$78,246,088.00	
DATE OF COMPLAINT: NA	POST INSP. CONTACTS: None	JOINT INSP. AGENCY: None	
WEATHER: Clear	INSPECTOR'S SIGNATURE:

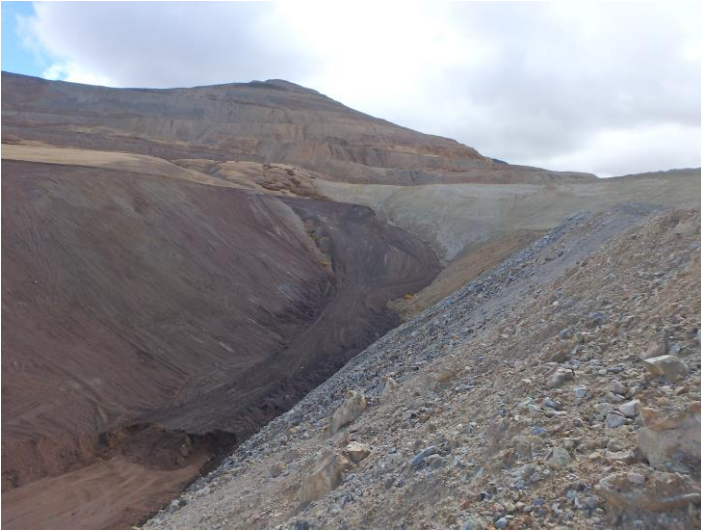
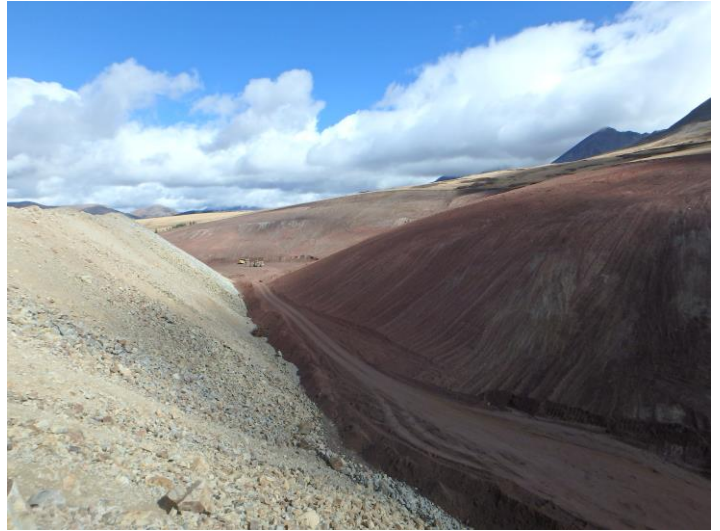
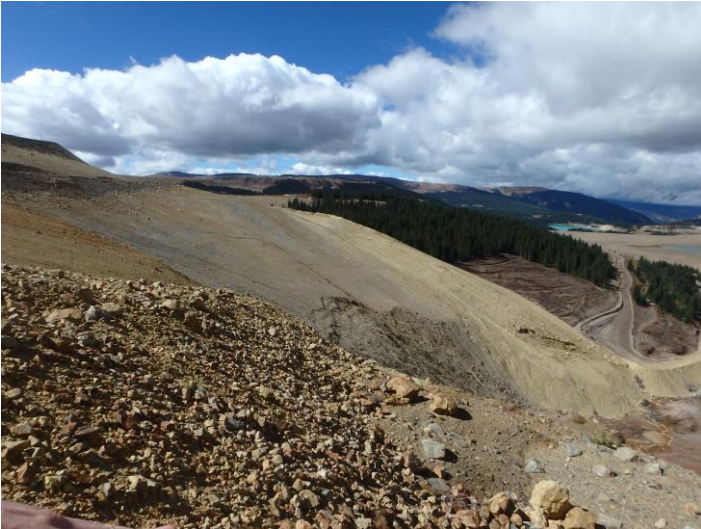
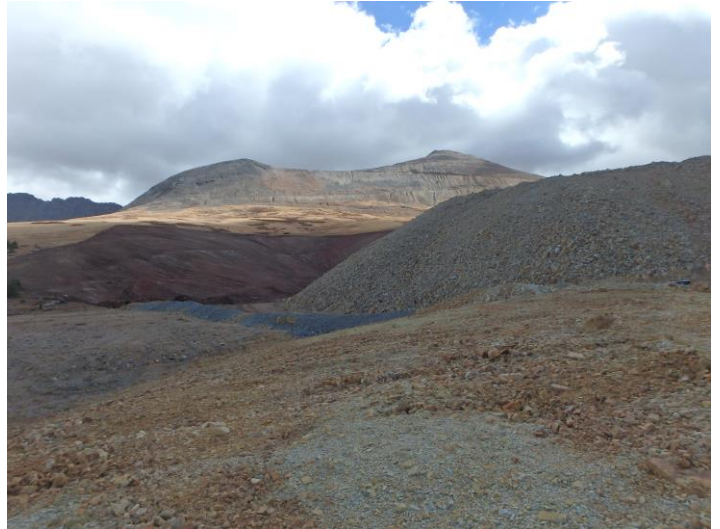
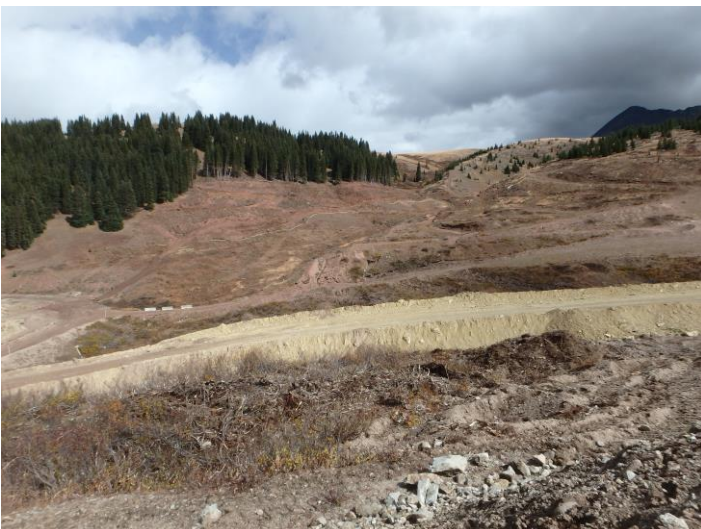
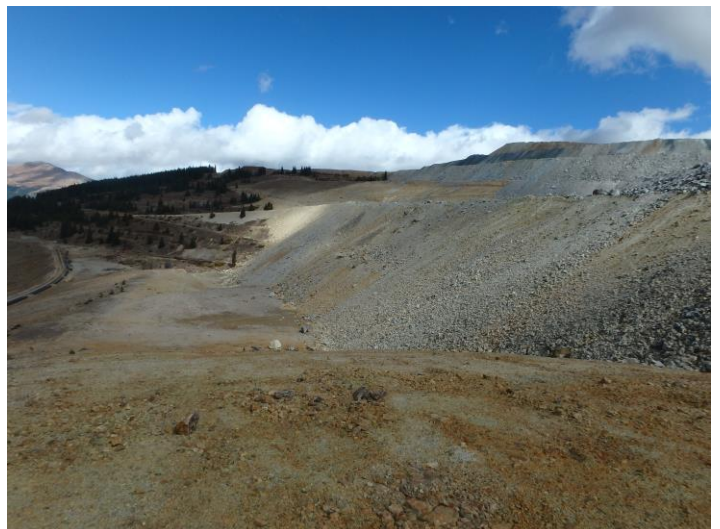
The focus of this inspection was to observe the McNulty and North 40 Overburden Storage Facilities (OSF's) in order to ensure compliance with the approved mining plan. The current expansion plan for the McNulty and North 40 OSF was approved through TR-25 in July 2017. TR-25 superseded the TR-22 plan. An addendum to TR-22, submitted to the Division in June 2014, detailed an interim configuration for the McNulty OSF, to be utilized until the McNulty expansion area could be cleared and prepared for deposition. Clearing of trees has taken place in the expansion area. Contact and non-contact water collection systems are to be installed as part of the OSF expansion area preparation. These are not yet constructed. The June 2014 addendum altered the then approved operational bench widths in several areas, but the overall slopes were to remain between approximately 2.1H:1V and 2.4H:1V. TR-25 calls for 2.4H:1V final composite slopes for the OSF. According to the Operator, the OSF slope configuration still complies with the interim slope configuration that was proposed, and that a stability evaluation was to be completed in the near future by Golder Associates. The Division has requested to receive a copy of the Golder report once completed. Signs of slope instability were not noted during this inspection.
