MINERALS PROGRAM INSPECTION REPORT
PHONE: (303) 866-3567

MINE NAME: SR-11 Mine	MINE/PROSPECTING ID#: M-1977-451	MINERAL: Uranium and vanadium	COUNTY: San Miguel
INSPECTION TYPE: Multi Person Inspection	INSPECTOR(S): Lucas J. West	INSP. DATE: October 16, 2018	INSP. TIME: 12:24
OPERATOR: Cotter Corporation	OPERATOR REPRESENTATIVE: Kyle Turley, Mary Young	TYPE OF OPERATION: 112d-1 - Designated Mining Operation	
REASON FOR INSPECTION: Normal I&E Program	BOND CALCULATION TYPE: None	BOND AMOUNT: \$100.00	
DATE OF COMPLAINT: NA	POST INSP. CONTACTS: None	JOINT INSP. AGENCY: None	
WEATHER: Clear	INSPECTOR'S SIGNATURE:

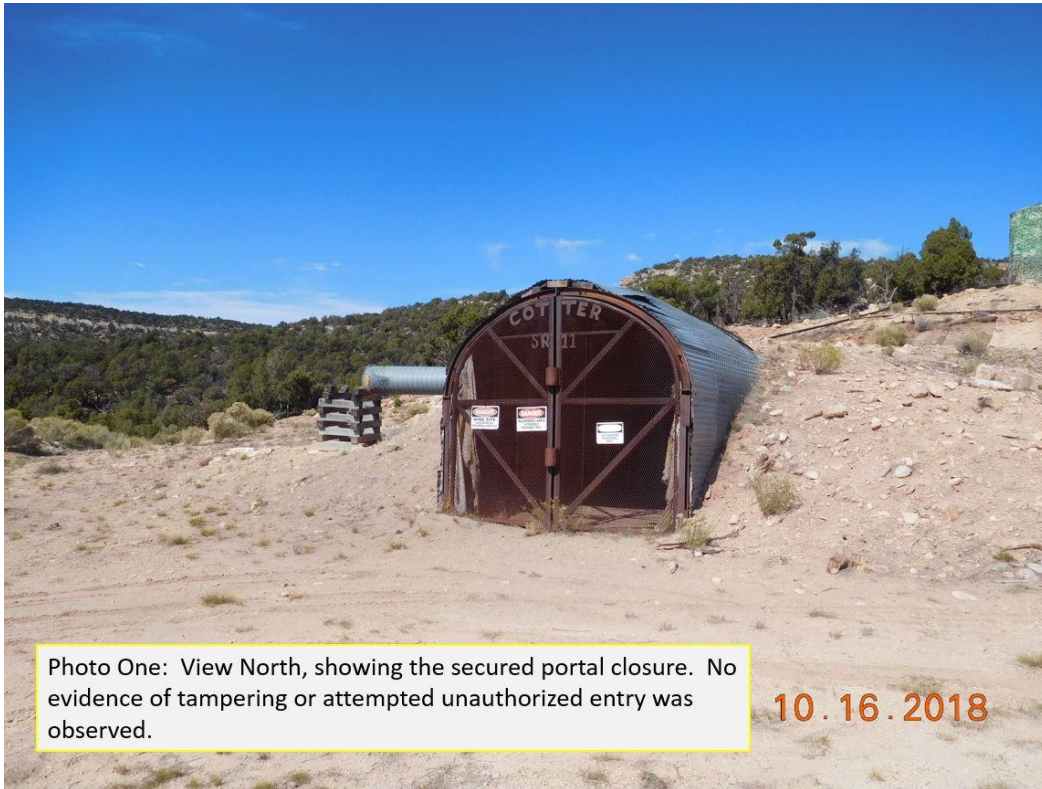
The proper mine identification signage was posted at the entrance to the site, and the permit boundaries are clearly marked. There was no equipment on site during the inspection. Due to the Court Action no activity has taken place on site since the previous inspection. This inspection was limited to the surface facilities. The portal has been secured by a locked gate shown in Photo One. The portal closure is in good condition and shows no signs of attempted unauthorized entry. Adjacent to the portal is an administrative office trailer which has also been secured. Photo Two shows the trailer, which is in good condition, the windows are all secured and the office remains vacant.
