MINERALS PROGRAM INSPECTION REPORT
PHONE: (303) 866-3567

MINE NAME: Arthur L Schmeiser	MINE/PROSPECTING ID#: M-1985-109	MINERAL: Sand and gravel	COUNTY: Lincoln
INSPECTION TYPE: Monitoring	INSPECTOR(S): Patrick Lennberg	INSP. DATE: November 8, 2018	INSP. TIME: 13:30
OPERATOR: Lincoln County	OPERATOR REPRESENTATIVE: Fred Lundy and Rick Ashcraft	TYPE OF OPERATION: 110c - Construction Limited Impact	
REASON FOR INSPECTION: Normal I&E Program	BOND CALCULATION TYPE: None	BOND AMOUNT: \$0.00	
DATE OF COMPLAINT: NA	POST INSP. CONTACTS: None	JOINT INSP. AGENCY: None	
WEATHER: Windy	INSPECTOR'S SIGNATURE:

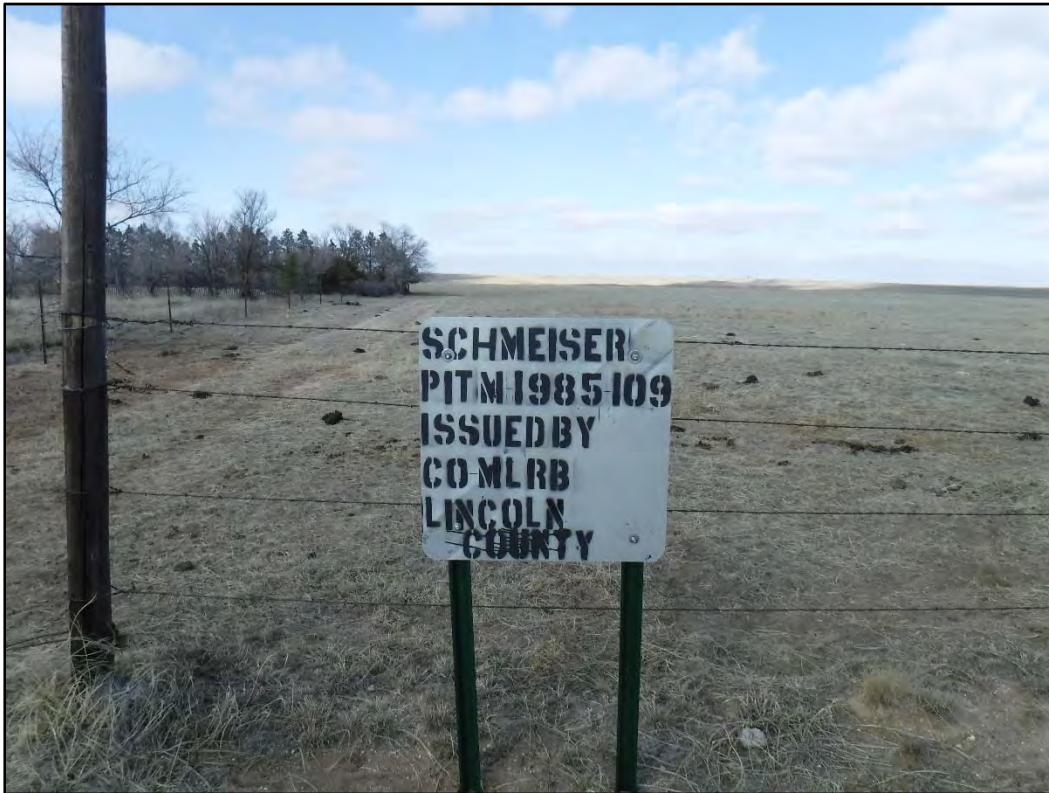
Mining has been conducted within the permit boundary. All permit boundary markers, green T-posts, are clearly visible along perimeter of the site. The mine permit sign is visible at the entrance used off of Co Rd 2a (**Photo 1**) and is also present at the historic entrance to the pit. Due to uncertain access agreements an alternate route to the pit was used. After the inspection it was determined the access agreement was current and in place.

Photo 1: Mine permit sign

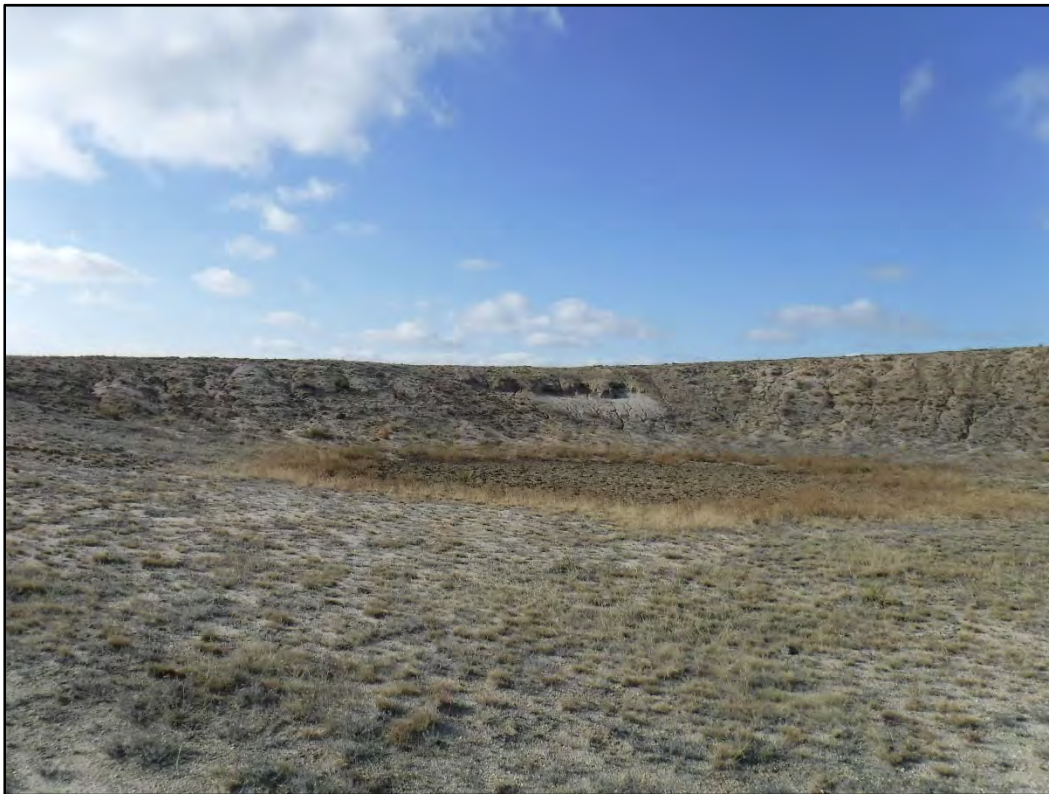
There was a small area that was noted that appeared to have ponded water from the recent precipitation but was dry at the time of inspection.

The operator has worked in the past to establish the approved grass mixture but vegetation establishment has proven to be difficult during the recent drought years. There are some bare areas along the slopes. The slopes have well established erosion rills and the site is not fenced off from grazing in the area. The Division

Photo2: Erosion rills and bare areas on slopes and area of ponding during precipitation, center.

recommends the operator recontour the slopes to eliminate the rills and create a horizontal furrow mid-slope to help revegetation and reclamation. This, along with erecting a fence around the pit area was discussed in the field with operator. During this discussion the operator mentioned that they might want to expand the pit if suitable material was present and the land owner agreed. If the pit were to be expanded an amendment would be required to expand the permit boundaries.

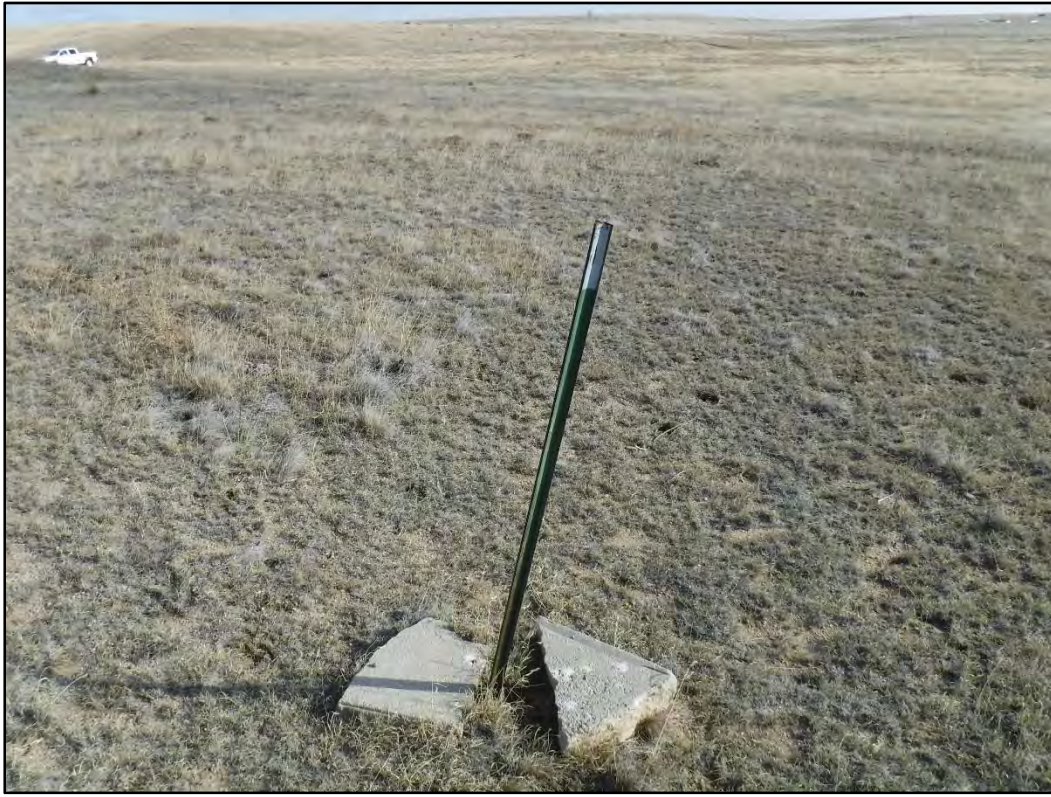
Photo 3: Southwest boundary marker.

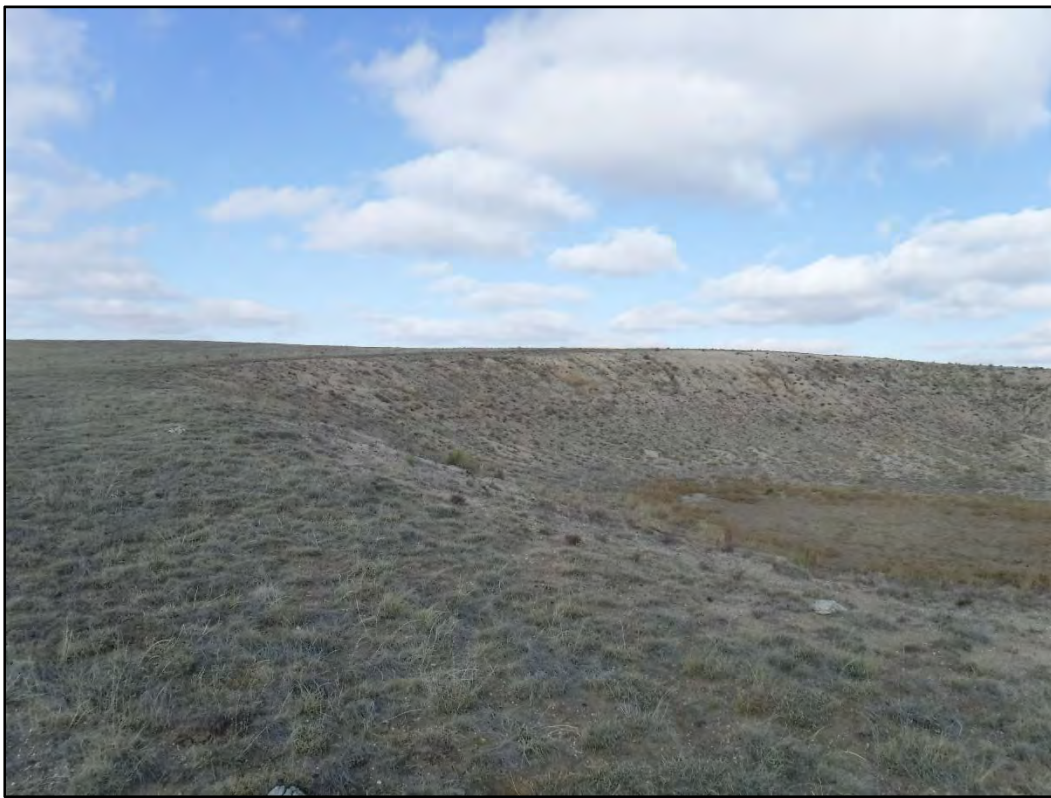
Photo 4: Looking east at the side slopes on the eastern wall of the pit.

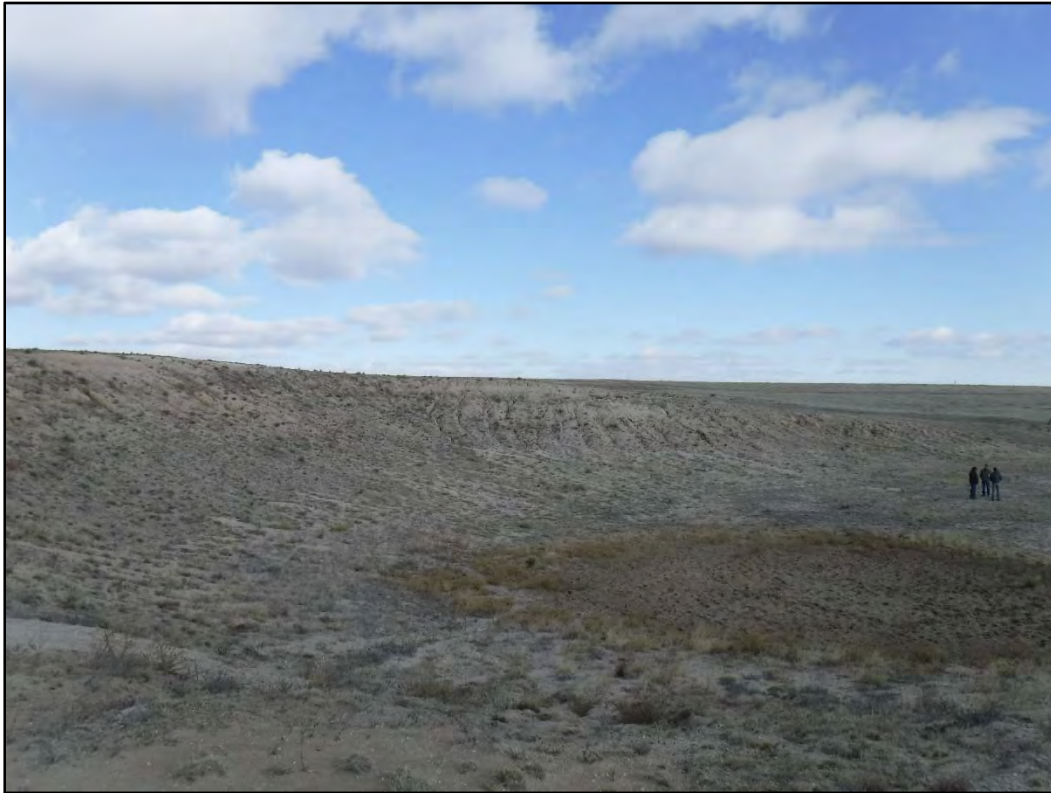
Photo 5: Looking east at the side slopes on the eastern wall of the pit.

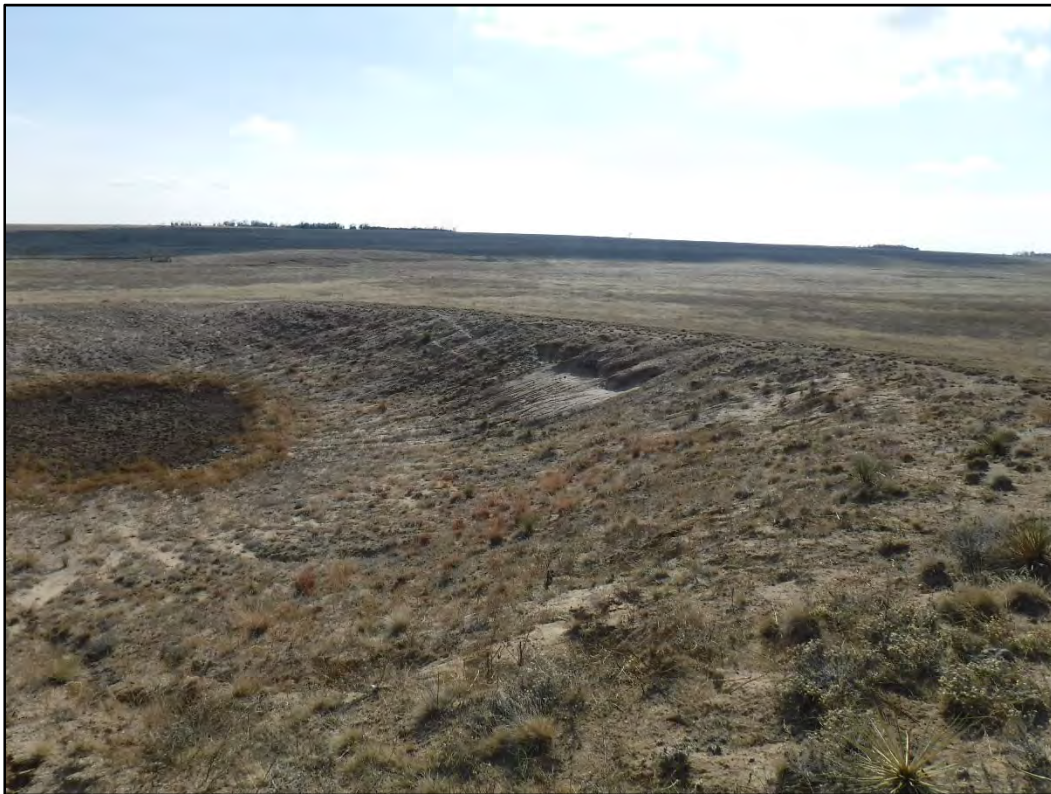
Photo 6: Looking southwest at the side slopes on the western wall of the pit.

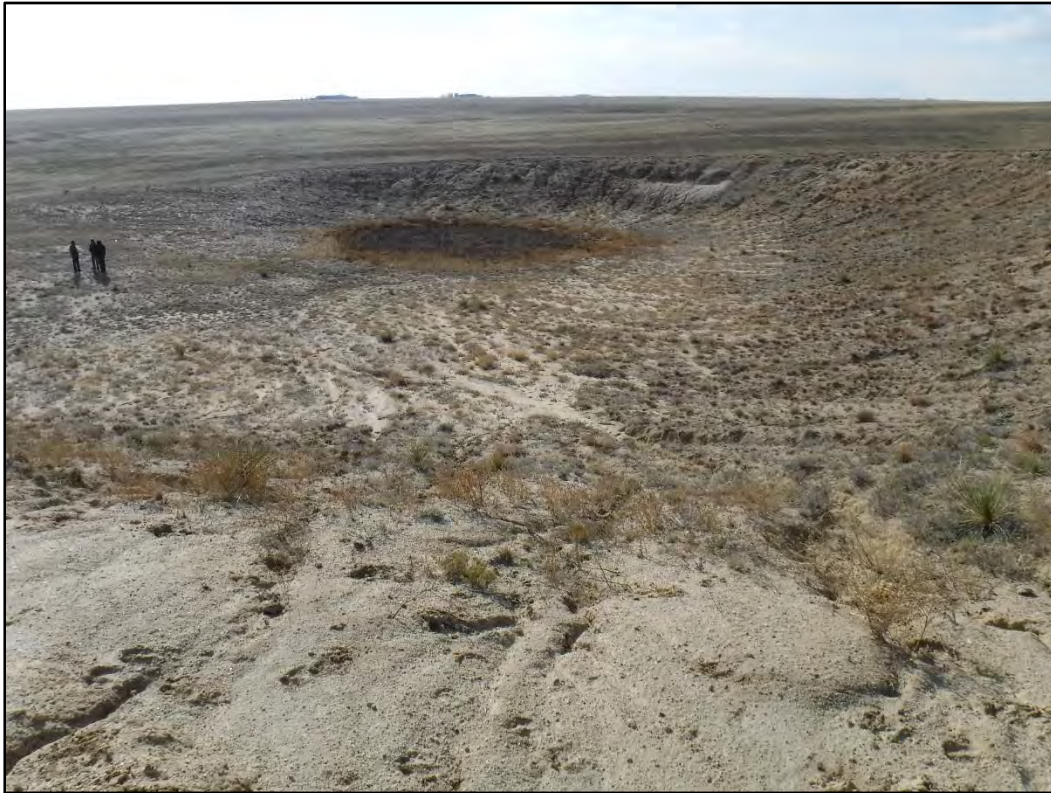
Photo 7: Looking west at the side slopes on the western wall of the pit.

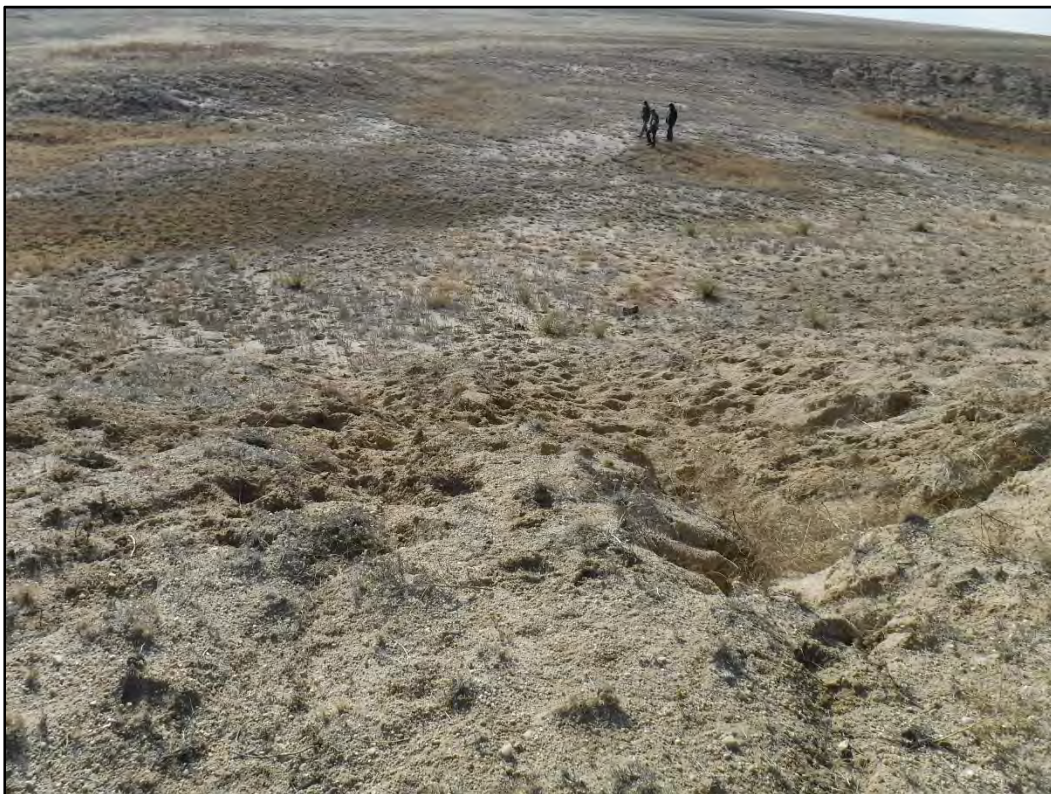
Photo 8: Typical erosion rills along the side slopes.

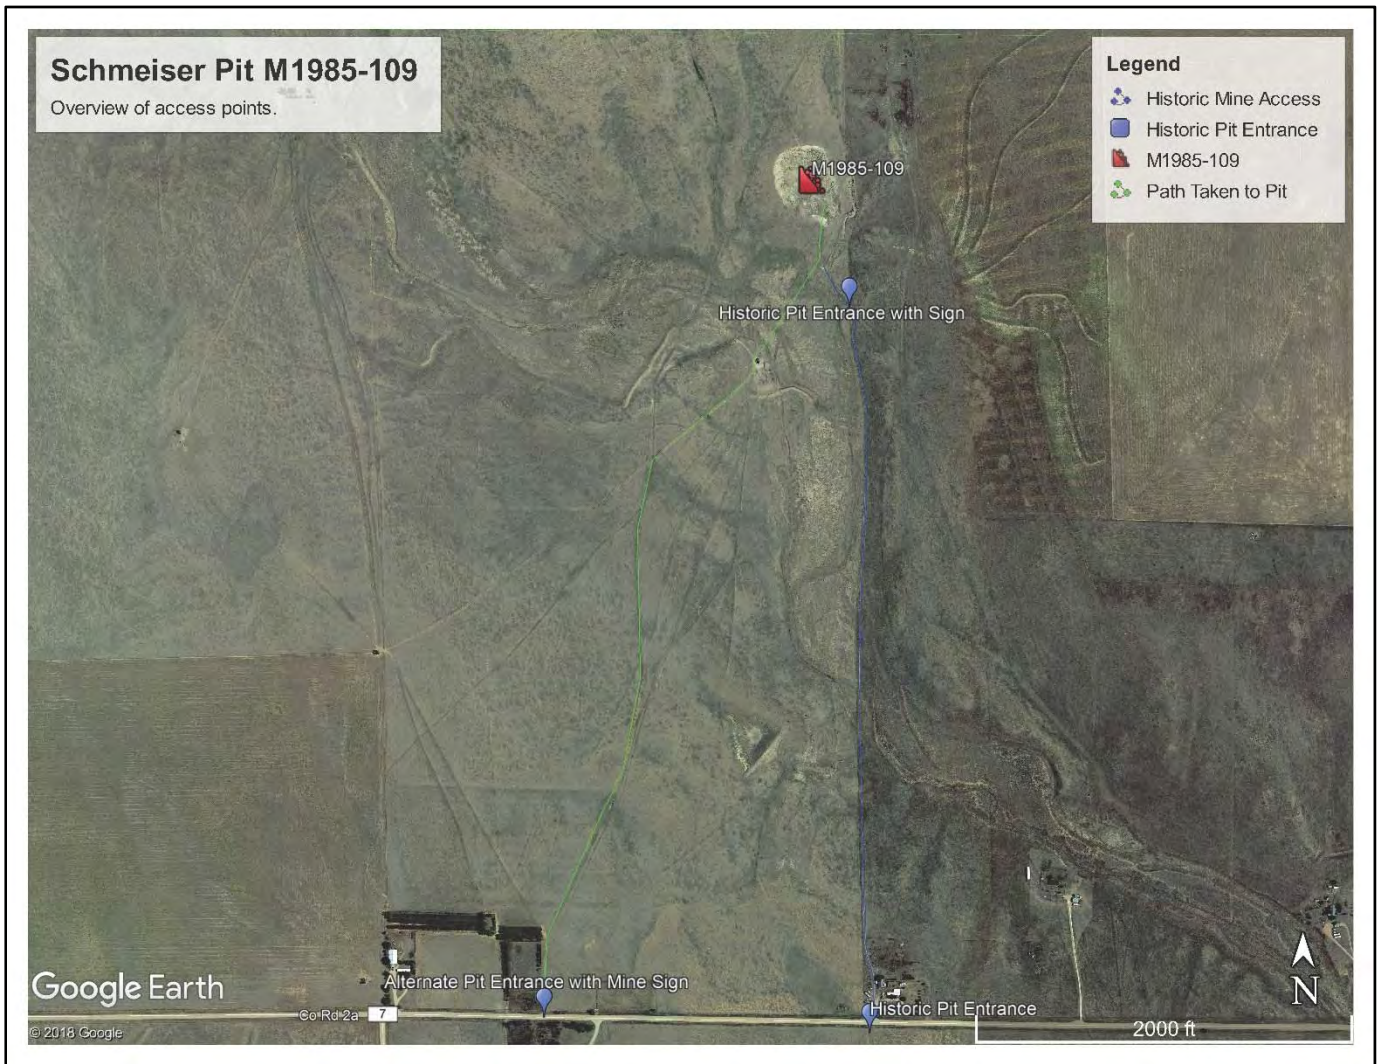
Photo 9: Image showing two routes into the site.
