**MINERALS PROGRAM INSPECTION REPORT**  
**PHONE: (303) 866-3567**

<b>MINE NAME:</b> Pickenpaugh Gravel Pit	<b>MINE/PROSPECTING ID#:</b> M-1978-078	<b>MINERAL:</b> Sand and gravel	<b>COUNTY:</b> Lincoln
<b>INSPECTION TYPE:</b> Monitoring	<b>INSPECTOR(S):</b> Patrick Lennberg	<b>INSP. DATE:</b> November 8, 2018	<b>INSP. TIME:</b> 12:30
<b>OPERATOR:</b> Lincoln County	<b>OPERATOR REPRESENTATIVE:</b> Fred Lundy and Rick Ashcraft	<b>TYPE OF OPERATION:</b> 112c - Construction Regular Operation	
<b>REASON FOR INSPECTION:</b> Normal I&E Program	<b>BOND CALCULATION TYPE:</b> None	<b>BOND AMOUNT:</b> \$0.00	
<b>DATE OF COMPLAINT:</b> NA	<b>POST INSP. CONTACTS:</b> None	<b>JOINT INSP. AGENCY:</b> None	
<b>WEATHER:</b> Windy	<b>INSPECTOR'S SIGNATURE:</b>

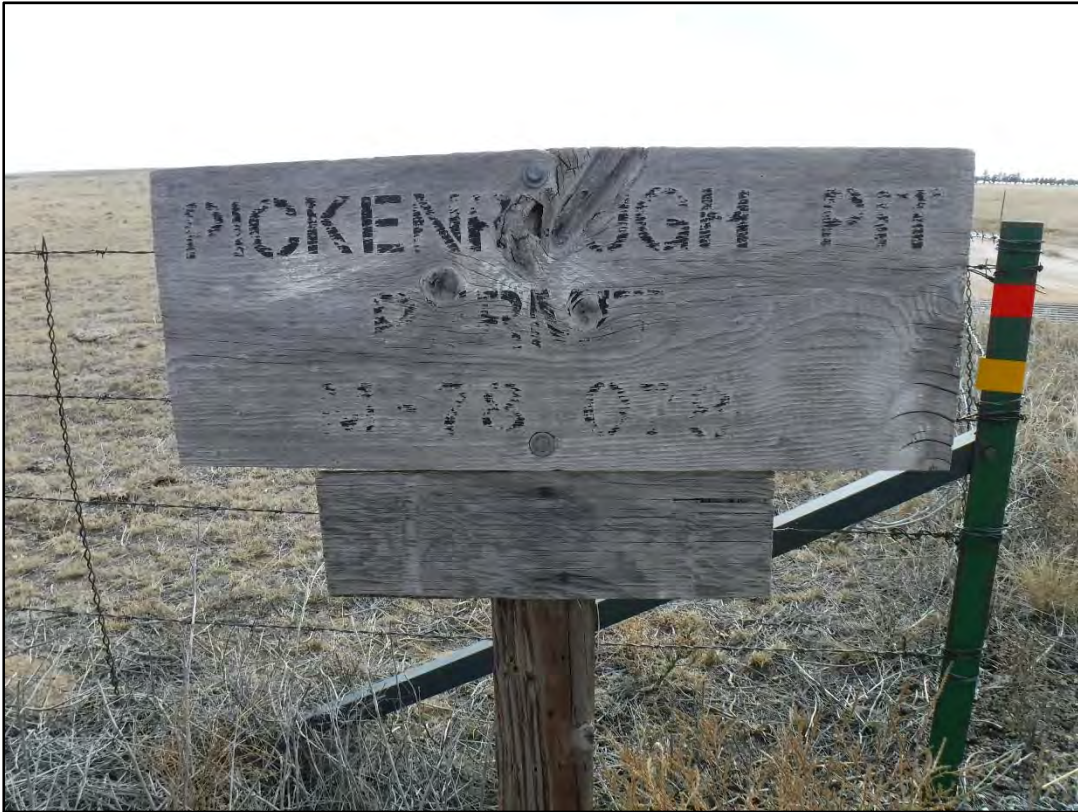
Mining is being conducted within the permit boundary. All permit boundary markers, green T-posts, are clearly visible along perimeter of the site. The mine permit sign is visible at the entrance off of Co Rd 94 but is faded and becoming difficult to read (**Photo 1**). Operator should replace the sign before it becomes illegible. During the inspection the operator asked if there are any issues to importing material from other sites to be blended with onsite material and then used. It was determined that this practice was suitable for pit operations and will not require a permit revision.

**Photo 1:** Mine permit sign.

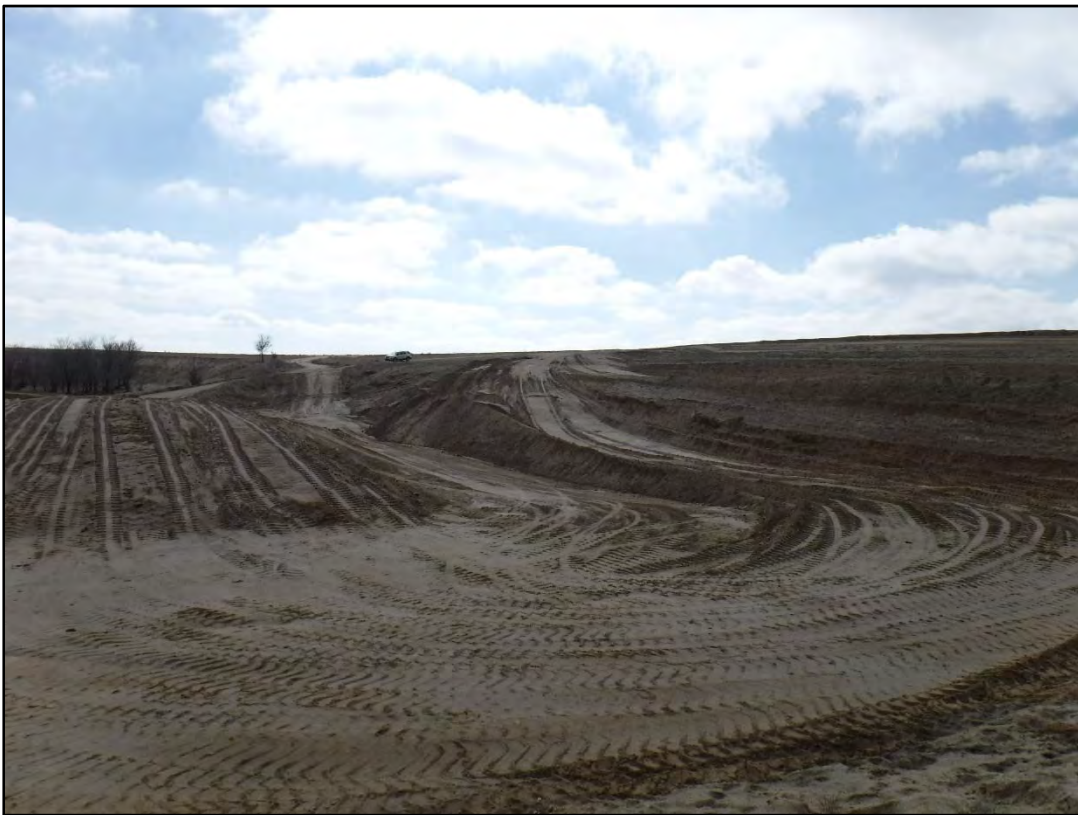
Sufficient backfill material appeared to be available. Mining is moving to the northwest at depths approaching 20 feet. The highwalls are terraced and sloped near 3H:1V (**Photo 2**)

**Photo 2:** Mine excavation and highwalls

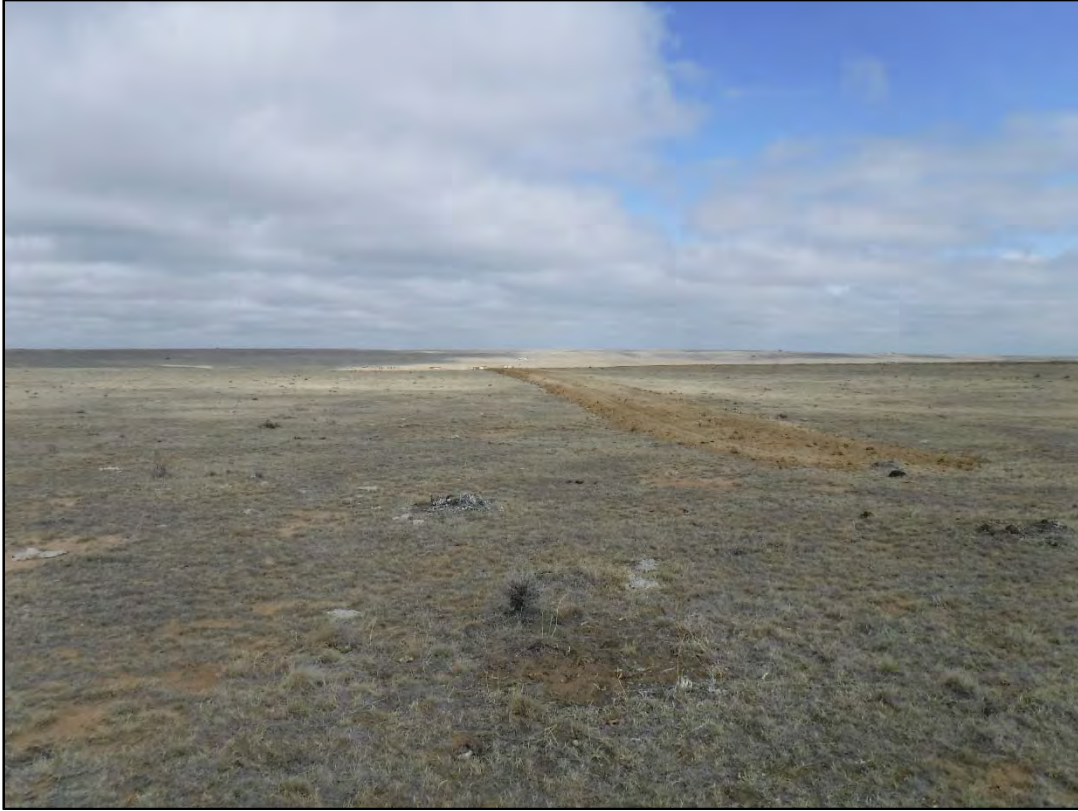
There are several topsoil stockpiles located throughout the site. Topsoil has been placed along the trees located near the bottom of pit in an area that was mined in the past. The stockpile has been contoured to minimize erosion. An additional topsoil stockpile was beginning to be placed along the northwest permit boundary (**Photo 3**). There was another topsoil pile along the northern boundary as well. Topsoil was being salvaged to a depth of 12-inches to insure there was sufficient growth medium for reclamation.

**Photo 3:** Topsoil beginning to be stockpiled along NW boundary.

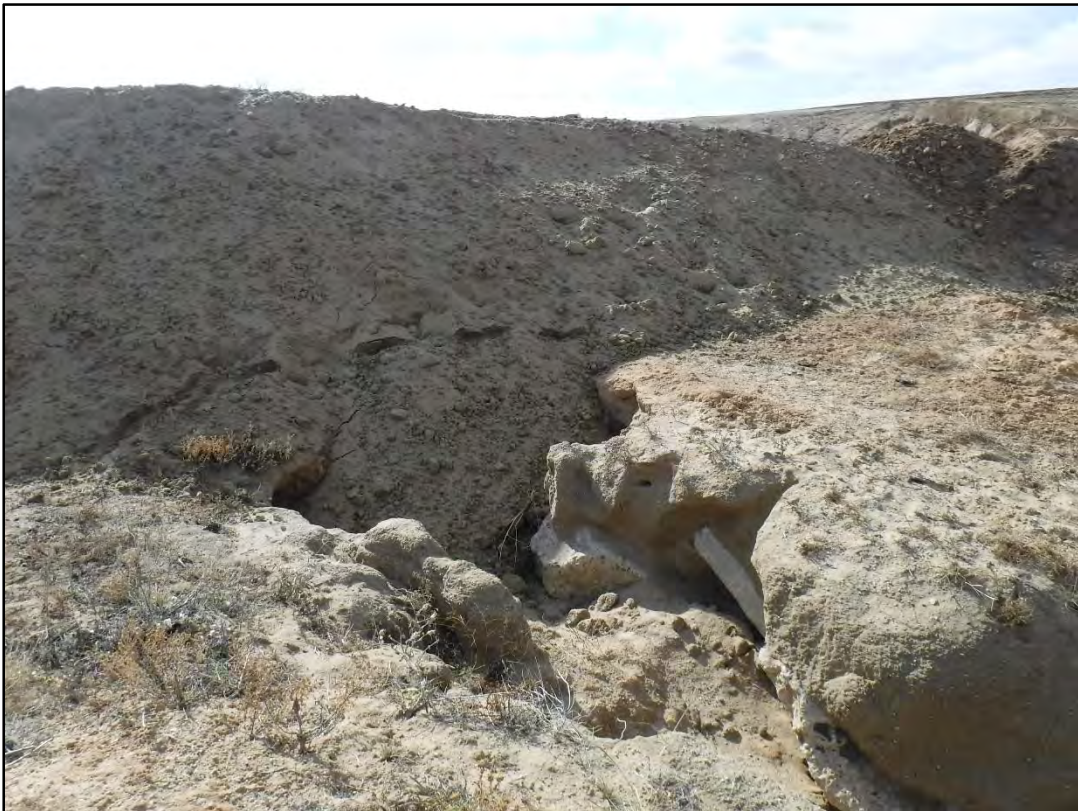
The operator maintains a current Stormwater Discharge Permit for the site. The Water Management Plan for the site was modified in TR-01 in 2010. A berm (**Photo 4**) is maintained across the primary drainage, flowing northeast, to prevent stormwater runoff from leaving the site.

**Photo 4:** Berm across drainage to prevent off site damage.

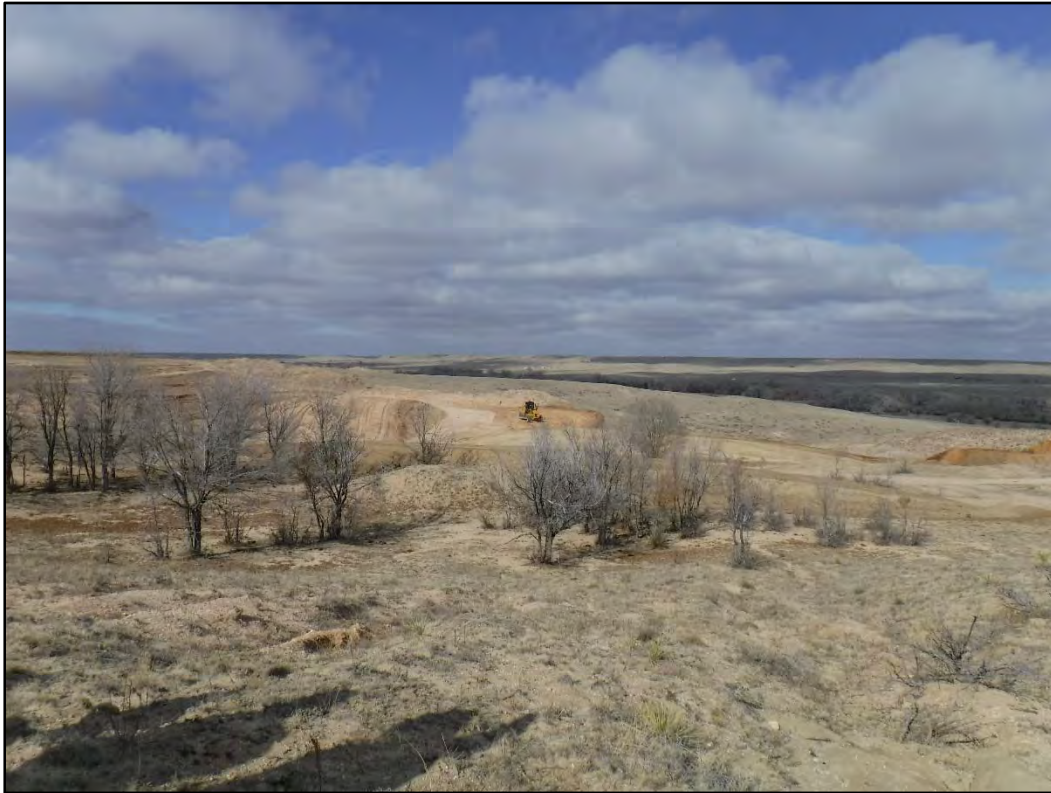
No erosion problems were observed at the time of inspection. There are some erosion rills associated with old mining reclamation on the south side of the pit, near Co Rd 11.6, but any material transported is confined to treed area and within the permit boundaries (**Photo 5**). This area will need the erosion rills graded out, top soil applied and revegetated during site reclamation.

**Photo 5:** Looking north from Co Rd 11.6 across old reclamation with erosion rills

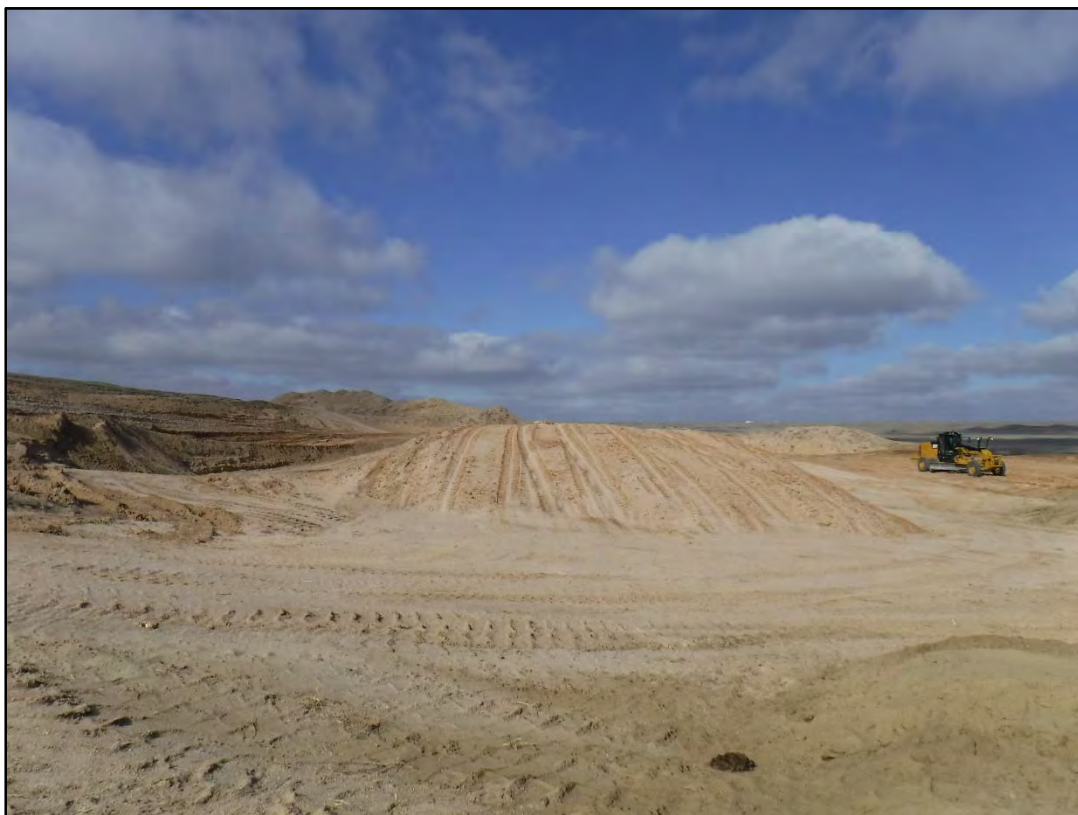
**Photo 6:** Recently placed stockpile of material to be blended with import material.
