**MINERALS PROGRAM INSPECTION REPORT**  
**PHONE: (303) 866-3567**

<b>MINE NAME:</b> Aldrich Gravel Pit	<b>MINE/PROSPECTING ID#:</b> M-1983-109	<b>MINERAL:</b> Sand and gravel	<b>COUNTY:</b> Kiowa
<b>INSPECTION TYPE:</b> Monitoring	<b>INSPECTOR(S):</b> Amy Eschberger	<b>INSP. DATE:</b> October 10, 2018	<b>INSP. TIME:</b> 11:45
<b>OPERATOR:</b> Kiowa County	<b>OPERATOR REPRESENTATIVE:</b> Rick Spady	<b>TYPE OF OPERATION:</b> 110c - Construction Limited Impact	
<b>REASON FOR INSPECTION:</b> Normal I&E Program	<b>BOND CALCULATION TYPE:</b> None	<b>BOND AMOUNT:</b> \$0.00	
<b>DATE OF COMPLAINT:</b> NA	<b>POST INSP. CONTACTS:</b> None	<b>JOINT INSP. AGENCY:</b> None	
<b>WEATHER:</b> Cloudy	<b>INSPECTOR'S SIGNATURE:</b>

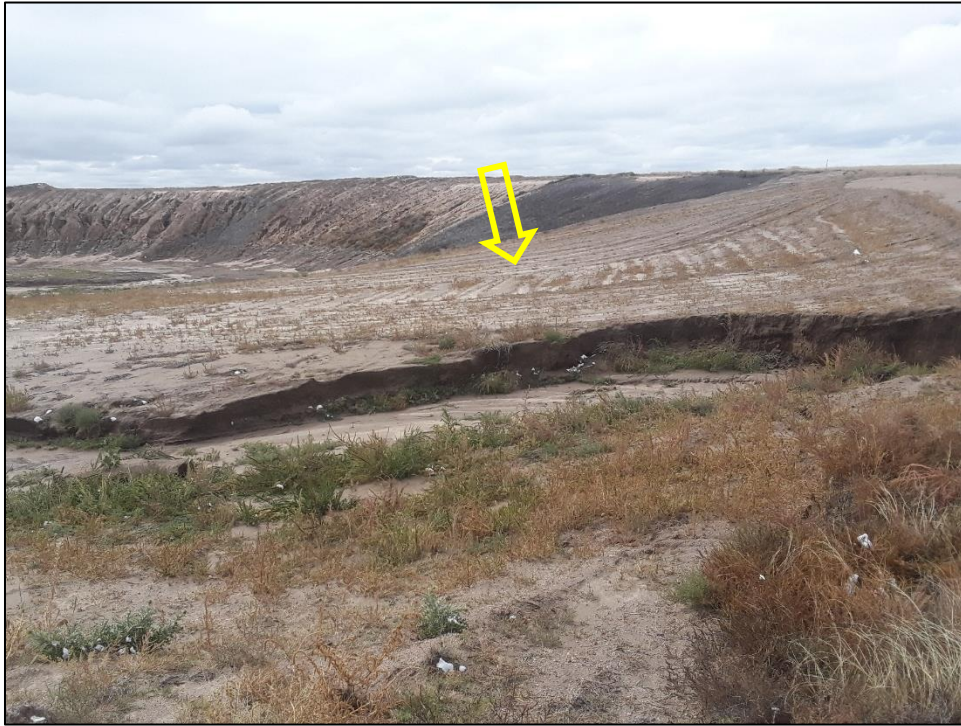
**Photo 1.** View looking west across northern portion of highwall that was graded to 3H:1V or flatter (indicated with arrow). Adjacent un-named drainage visible in foreground.

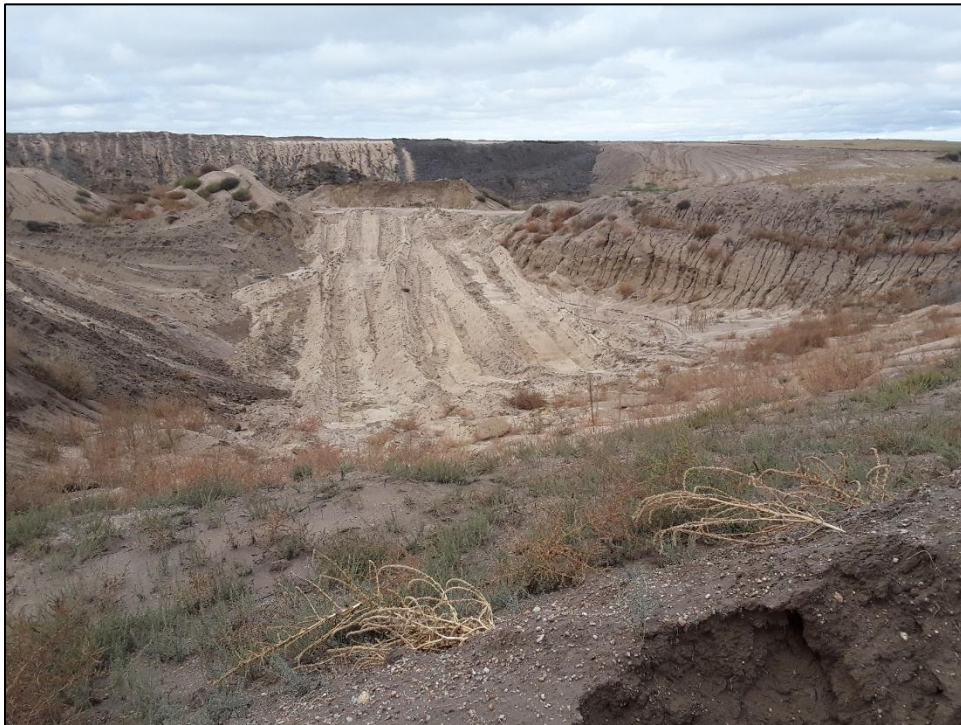
**Photo 2.** View looking north across southern edge of disturbance where topsoil has been stripped (portion of topsoil berm visible in foreground) in preparation of expanding the pit southeastward.

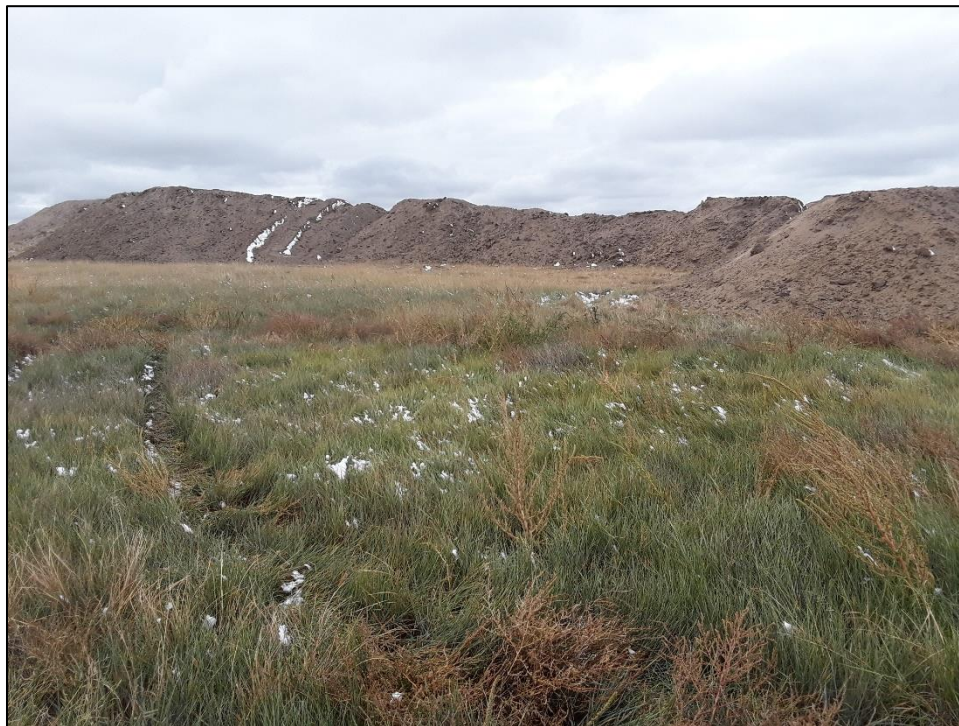
**Photo 3.** View looking northeast from outside and west of permit area, showing salvaged topsoil stored along western edge of pit.

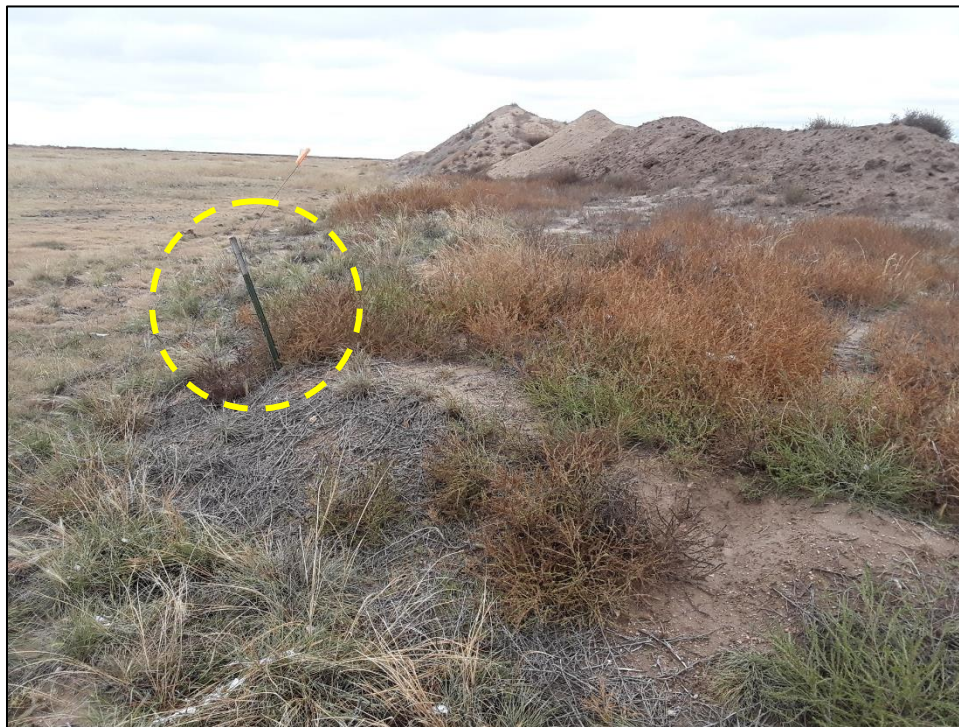
**Photo 4.** View looking north, showing T-post (circled) marking western edge of permit boundary.

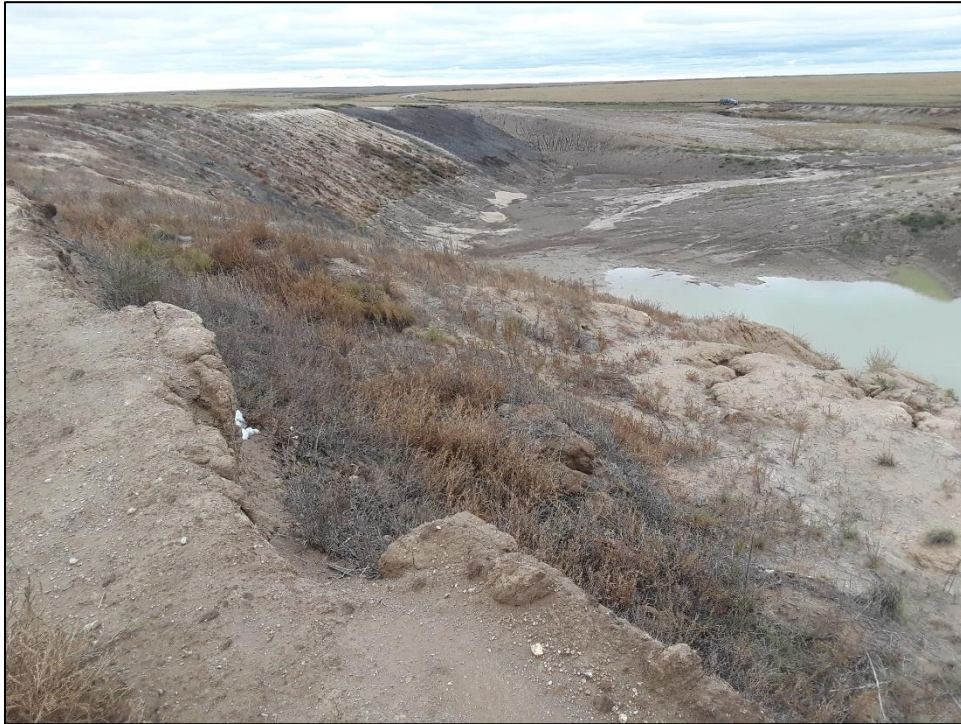
**Photo 5.** View looking north across northwestern pit highwall, a portion of which has been graded to 3H:1V. Vegetative cover of pit walls consisted primarily of annual weeds.

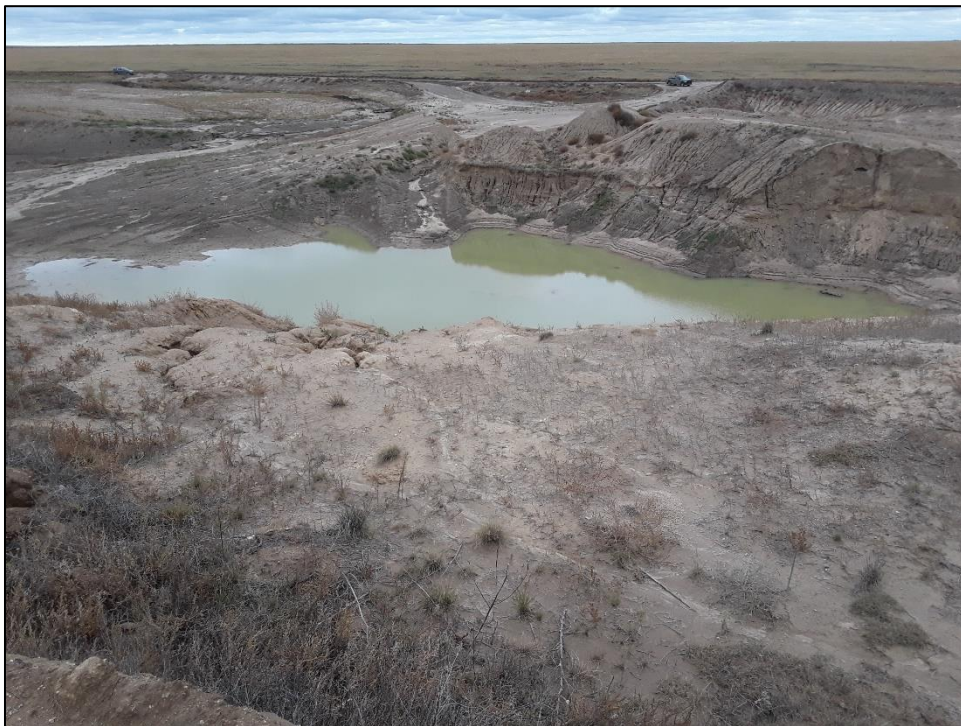
The pit floor had some ponded water during the inspection due to a recent storm event. The operator should be aware, the Division of Water Resources requires that all stormwater contained on site either infiltrate into the ground or be released to the natural stream system within 72 hours, or all work must cease until a substitute water supply plan or augmentation plan is obtained. Mined material was stockpiled on the pit floor. Salvaged topsoil was stored along the edges of the pit.

**Photo 6.** View looking east across pit from its western edge. Note pit floor holding some water during inspection due to recent storm event.

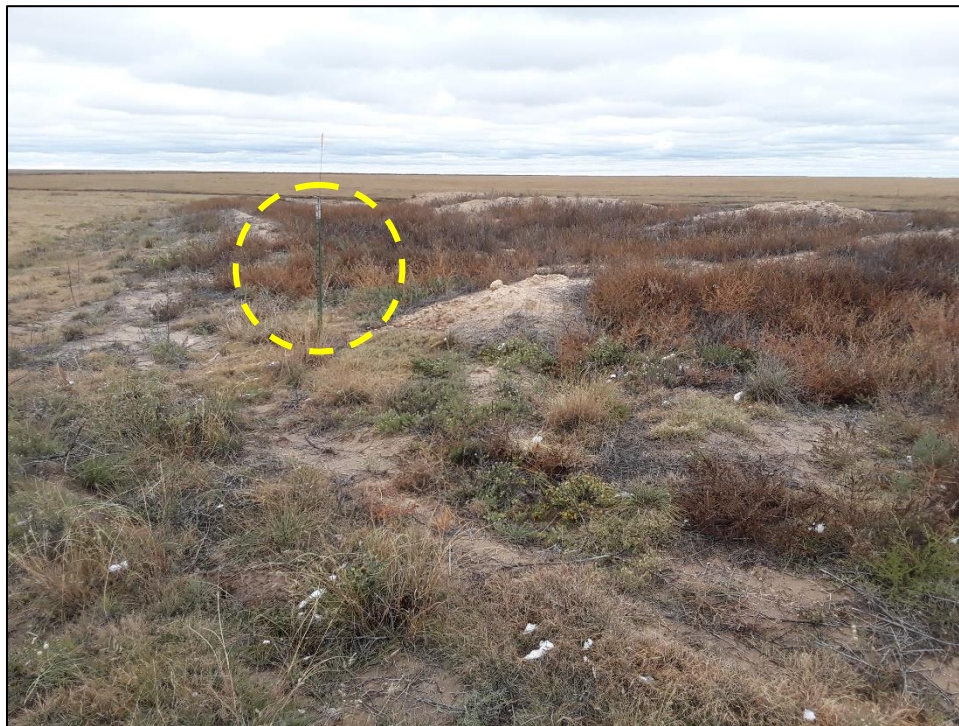
**Photo 7.** View looking east, showing T-post (circled) marking northern edge of permit boundary.

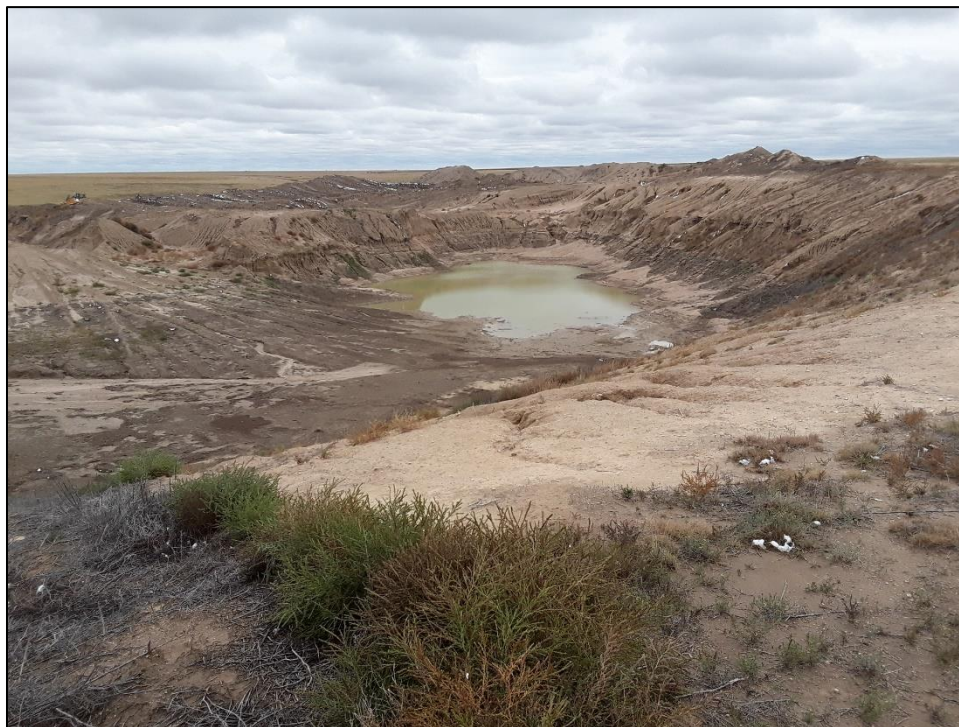
**Photo 8.** View looking south across pit from its northern edge. Note pit floor holding some water during inspection due to recent storm event.

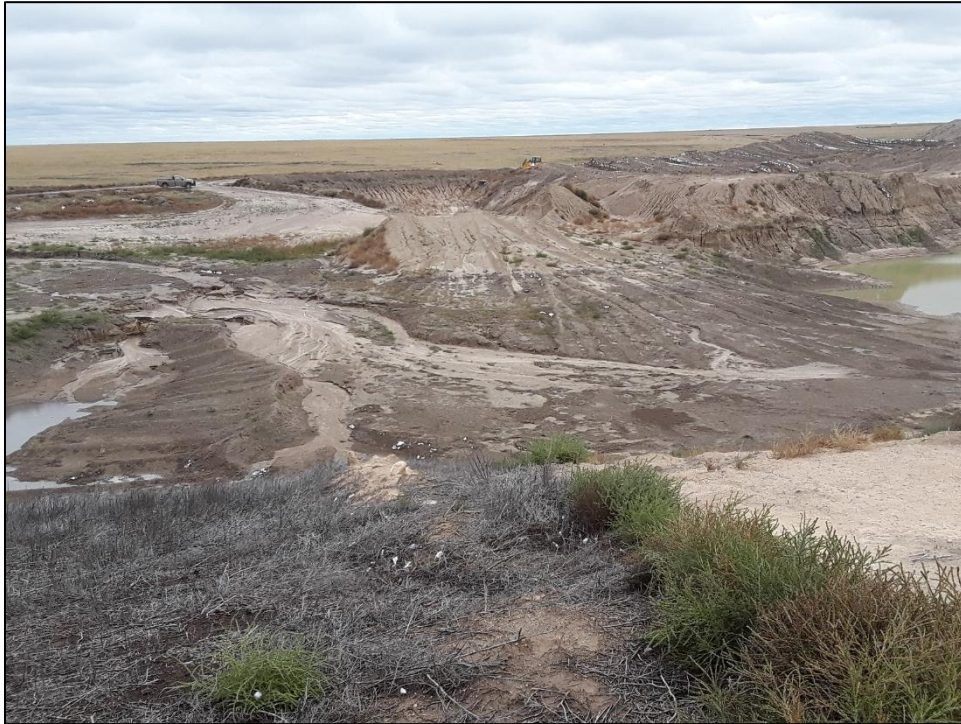
**Photo 9.** View looking east across pit, showing material stockpiling area on pit floor.

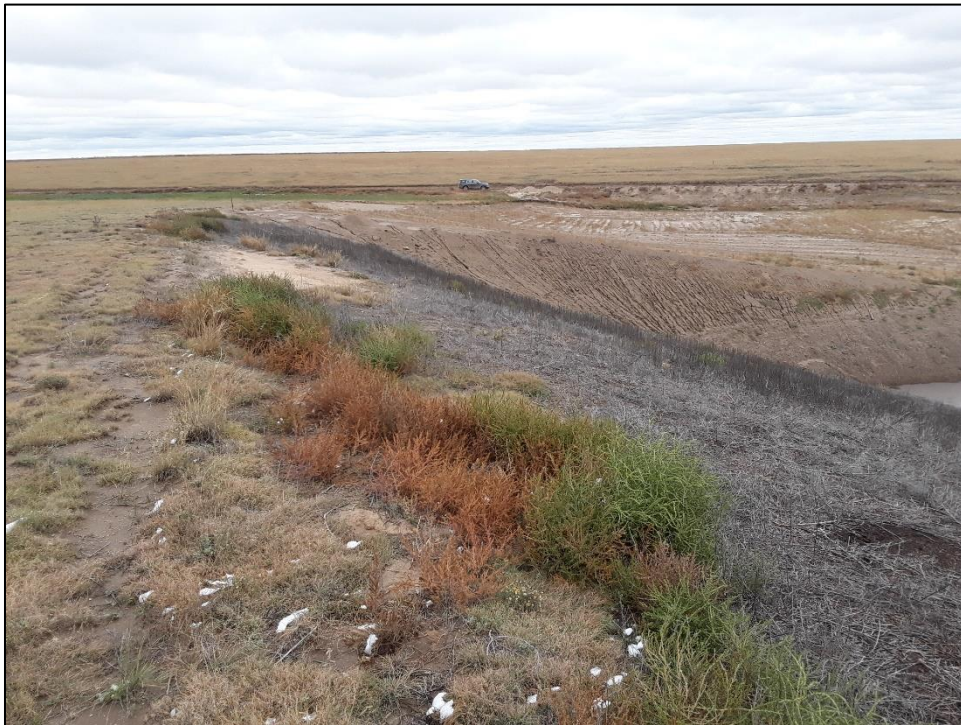
**Photo 10.** View looking east across northern edge of pit disturbance. Vegetative cover of pit area consisted mainly of annual weeds.
