**MINERALS PROGRAM INSPECTION REPORT**  
**PHONE: (303) 866-3567**

| <b>MINE NAME:</b><br>Barnett Pit | <b>MINE/PROSPECTING ID#:</b><br>M-1991-074 | <b>MINERAL:</b><br>Gravel | <b>COUNTY:</b><br>Kiowa |
| <b>INSPECTION TYPE:</b><br>Monitoring | <b>INSPECTOR(S):</b><br>Amy Eschberger | <b>INSP. DATE:</b><br>October 10, 2018 | <b>INSP. TIME:</b><br>12:50 |

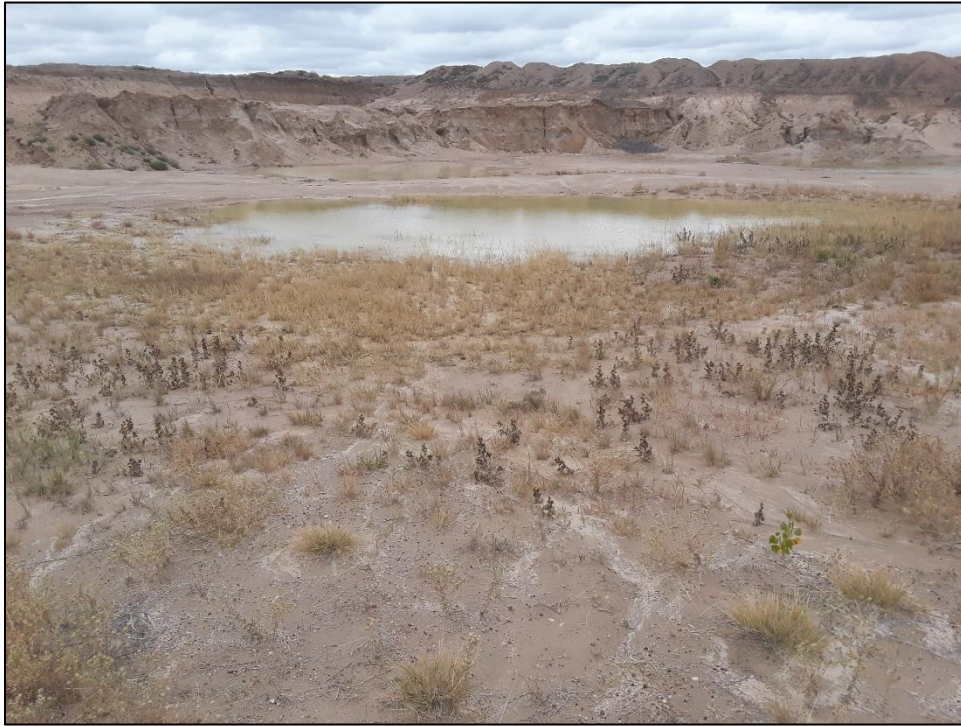
The pit floor had some ponded water during the inspection due to a recent storm event. The operator should be aware, the Division of Water Resources requires that all stormwater contained on site either infiltrate into the ground or be released to the natural stream system within 72 hours, or all work must cease until a substitute water supply plan or augmentation plan is obtained.

**Photo 1.** View looking north across active pit. Note pit floor holding some water during inspection due to recent storm event.

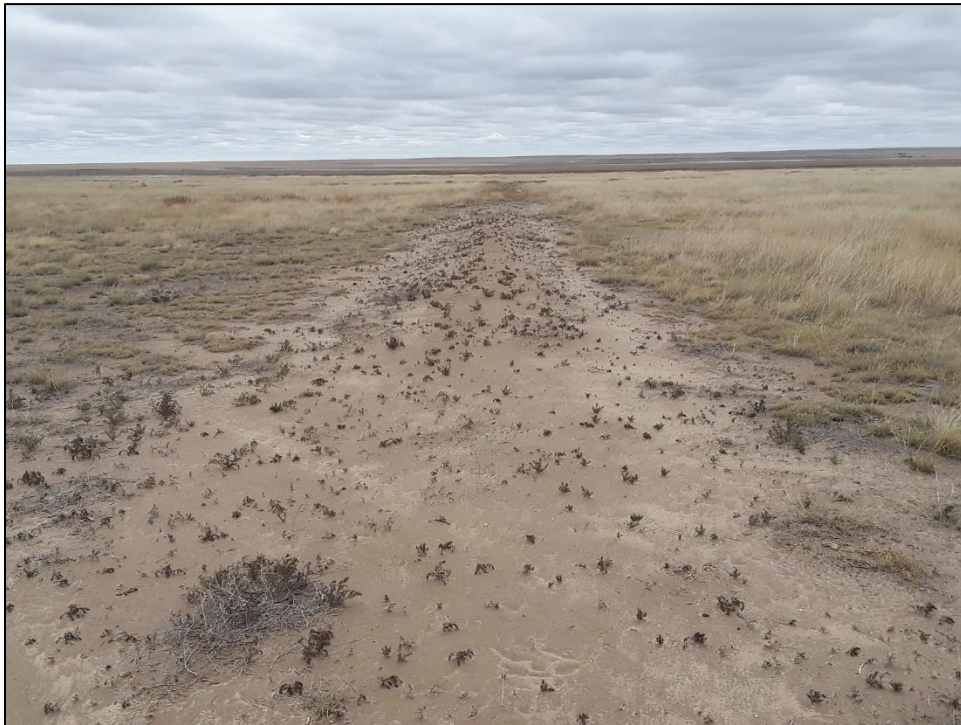
The operation appears to be following the approved mining plan. However, the Division does recommend the operation exercise caution in the active mining area as current disturbances are very close to the eastern and western permit boundaries. No problems were observed.

**Photo 2.** View looking south, showing berm marking western permit boundary.

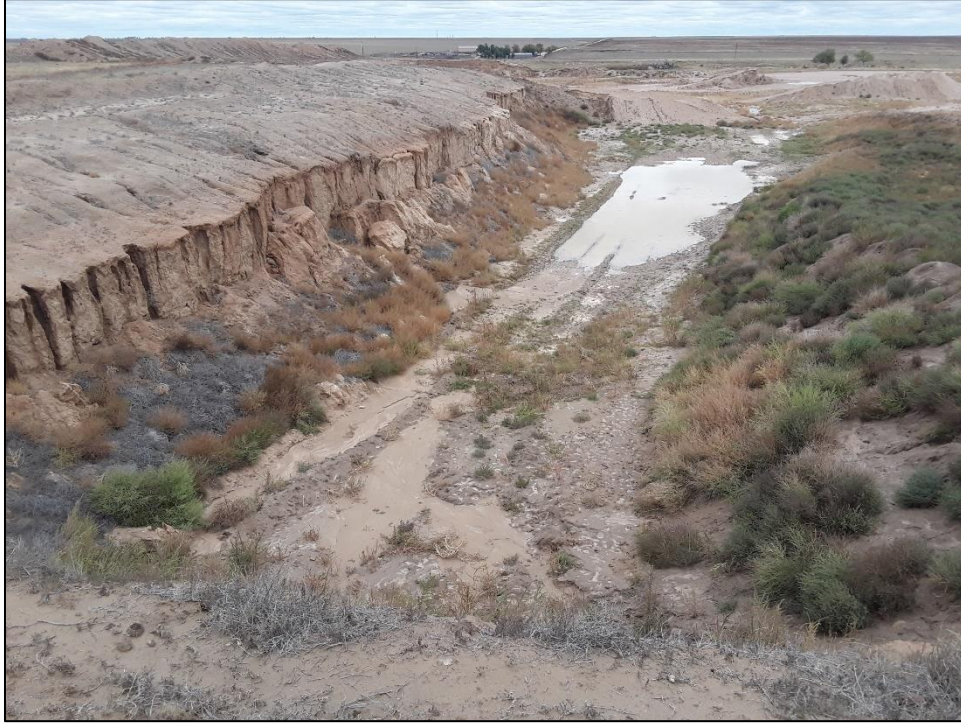
**Photo 3.** View looking east across active pit from its western edge. Note pit floor holding some water during inspection due to recent storm event.

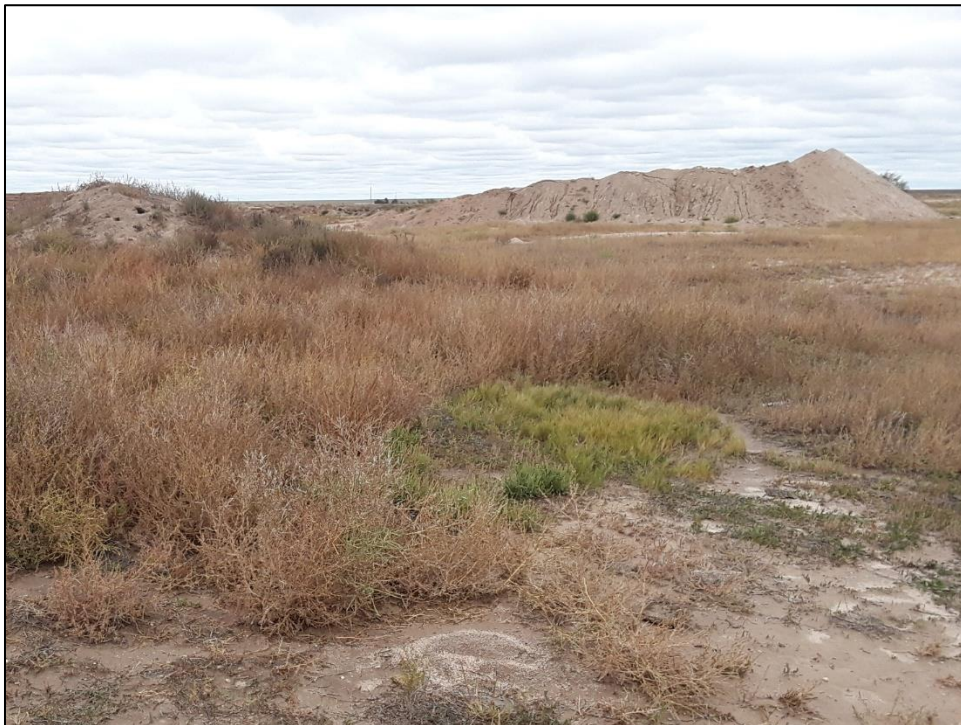
**Photo 4.** View looking east across active pit area, showing mined material stockpiled on pit floor (in background).

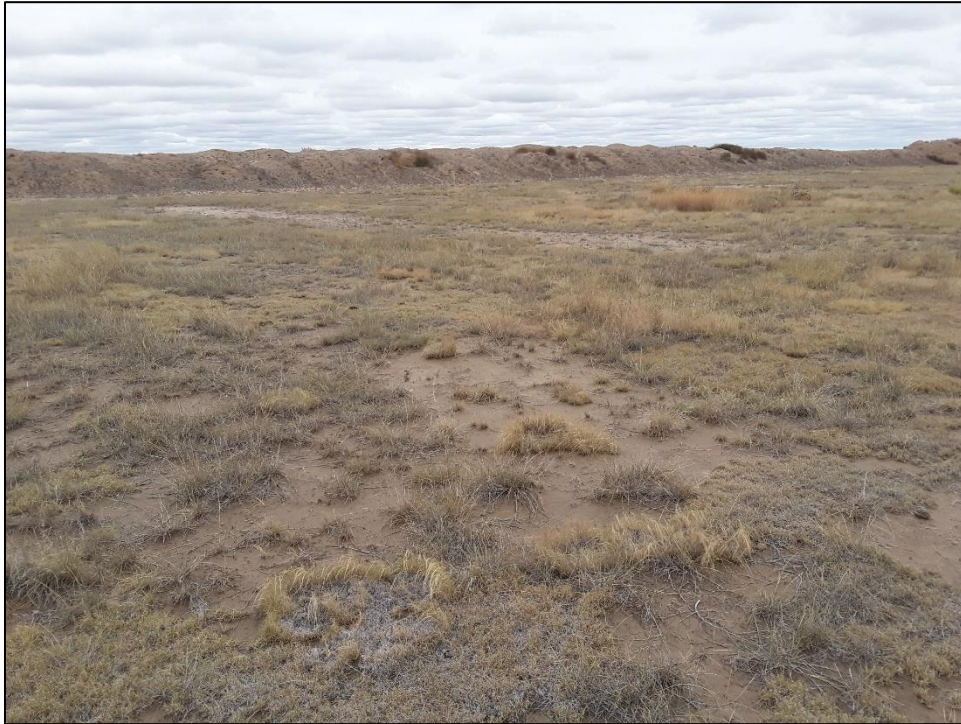
**Photo 5.** View looking northwest across strip of land located north of active pit where topsoil was stripped in preparation for pit advancement (some years ago judging by the grasses volunteering into the area). The salvaged topsoil is stored along the northern permit boundary (visible in background).

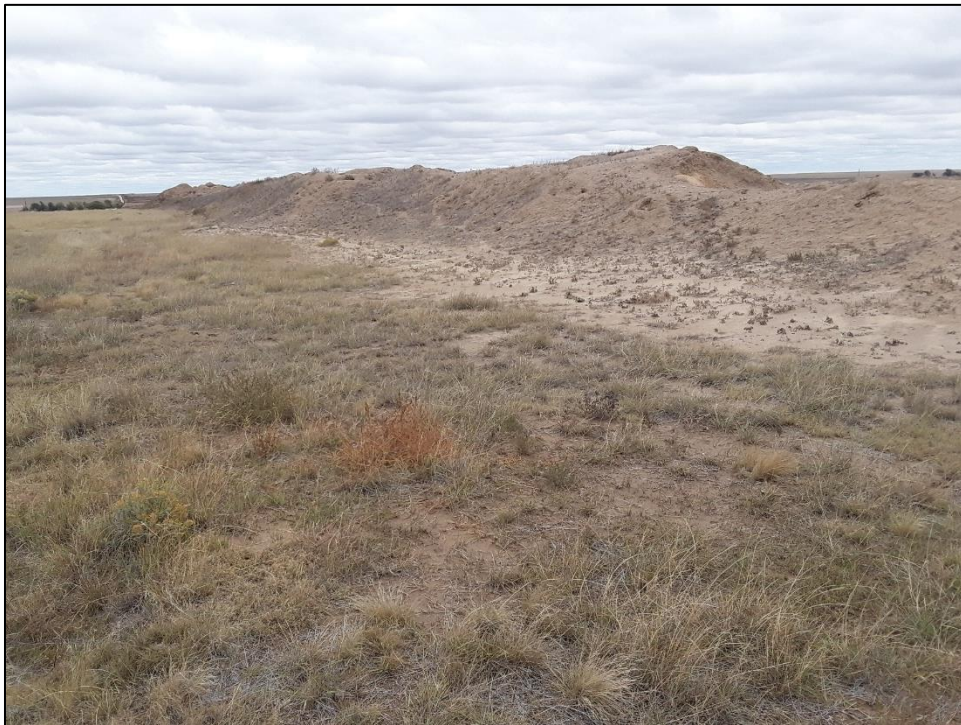
**Photo 6.** View looking southeast at topsoil stockpile stored along northern permit boundary, which appeared to be stable with some vegetative cover.

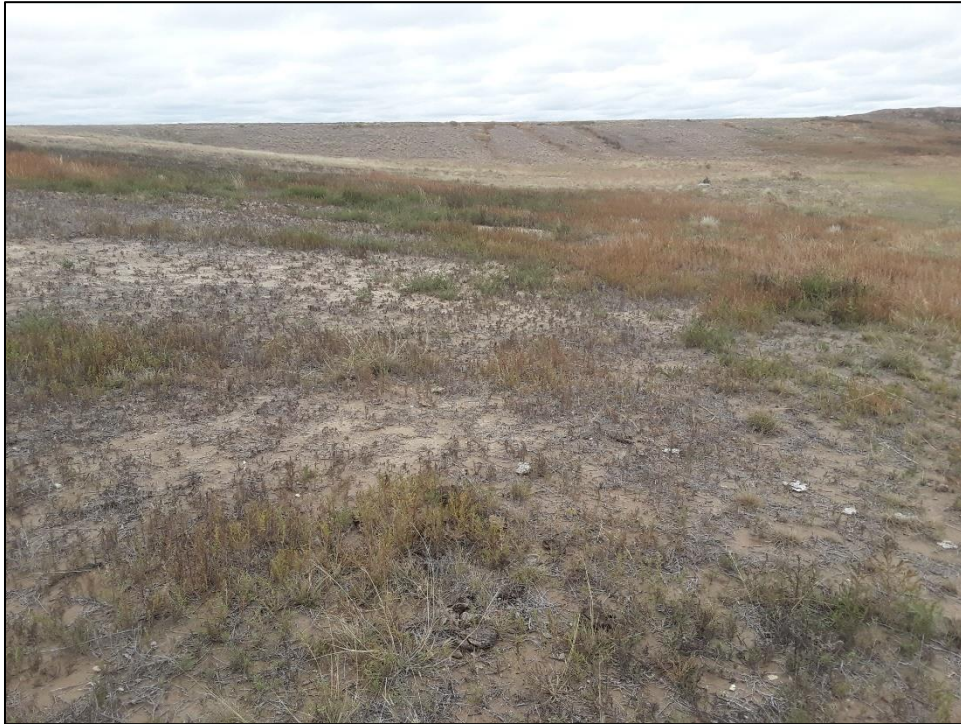
Disturbed areas located in the southern portion of the site were graded to slopes of 3H:1V or flatter, retopsoiled, and seeded in 2011/2012. Vegetative cover in these areas consists of a mixture of native grasses, forbs, and some annual weeds. Some portions of the reclaimed slopes have less vegetative cover at this time and may require reseeding.

**Photo 7.** View looking northwest across reclaimed southern portion of site. Slopes are graded to 3H:1V or flatter. Vegetative cover consists of native grasses, forbs, and annual weeds. Some portions of slopes may need to be reseeded.

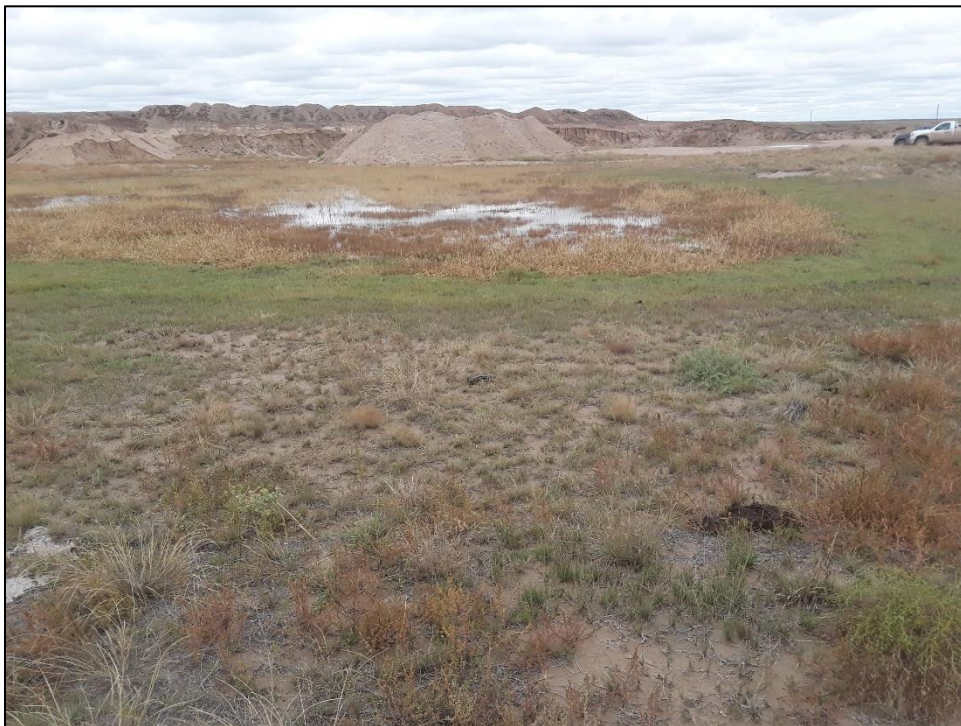
**Photo 8.** View looking north across reclaimed southern portion of site. Slopes are graded to 3H:1V or flatter. Vegetative cover consists of native grasses, forbs, and annual weeds. (Active mining area visible in background)

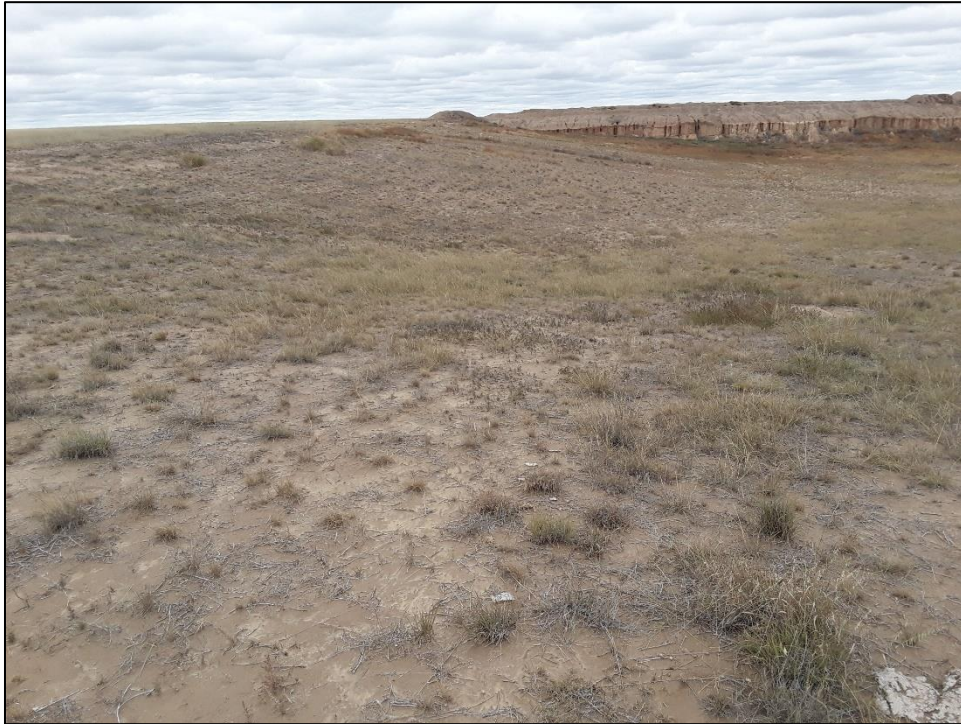
**Photo 9.** View looking north across western reclaimed highwall. Slopes are graded to 3H:1V or flatter. Vegetative cover consists of native grasses, forbs, and annual weeds. Some portions of slopes may need to be reseeded.

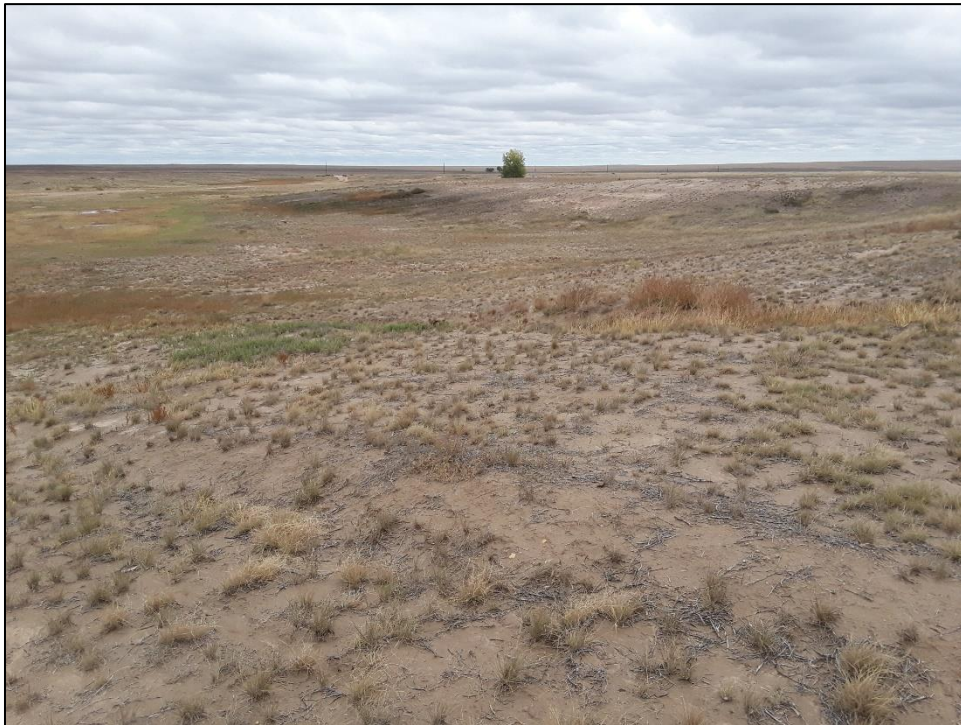
**Photo 10.** View looking southeast across reclaimed southern portion of site. Slopes are graded to 3H:1V or flatter. Vegetative cover consists of native grasses, forbs, and annual weeds. Some portions of slopes may need to be reseeded.
