MINERALS PROGRAM INSPECTION REPORT
PHONE: (303) 866-3567

MINE NAME: Hankins Stone Quarry #1	MINE/PROSPECTING ID#: M-2000-154	MINERAL: Stone	COUNTY: San Miguel
INSPECTION TYPE: Monitoring	INSPECTOR(S): Lucas J. West	INSP. DATE: October 23, 2018	INSP. TIME: 10:37
OPERATOR: Hankins Stone Company, Inc.	OPERATOR REPRESENTATIVE: None	TYPE OF OPERATION: 112c - Construction Regular Operation	
REASON FOR INSPECTION: Normal I&E Program	BOND CALCULATION TYPE: Complete Bond	BOND AMOUNT: \$25,054.56	
DATE OF COMPLAINT: NA	POST INSP. CONTACTS: None	JOINT INSP. AGENCY: None	
WEATHER: Clear	INSPECTOR'S SIGNATURE:

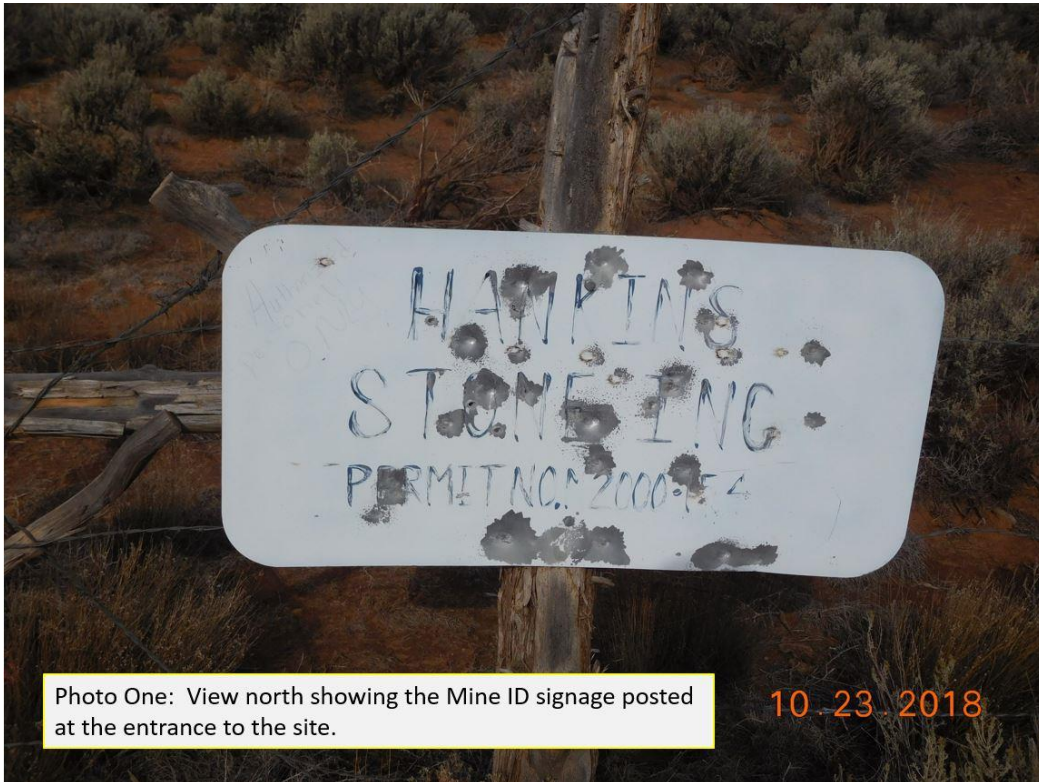
The proper Mine Identification sign was posted at the entrance to the site and can be seen in Photo One. The permit boundaries are well marked with a series of T-Posts and earthen berms. There was equipment including a Front End Loader, Dozer and Skidster located on site however they were not active. The site consists of two staging areas, an active mining area, over burden or spoil storage area. The two staging areas are in good condition and free from trash and debris. The western staging area has material stacked and on pallets as well as staged for packaging. The two staging areas can be seen in Photos Two and Three. The active mining area consists of approximately three acres of the affected lands. The highwalls are small, approximately 4 feet tall and in total span about 100 Linear Feet. An example of the active mining area can be seen in Photo Four. The highwalls and active mining areas are in good condition and appear to be stable. The area demonstrates positive drainage and no signs of settling, slumping or erosion was observed during this inspection. The large overburden or spoil storage area is vegetated and in good condition and appears to be stable. .

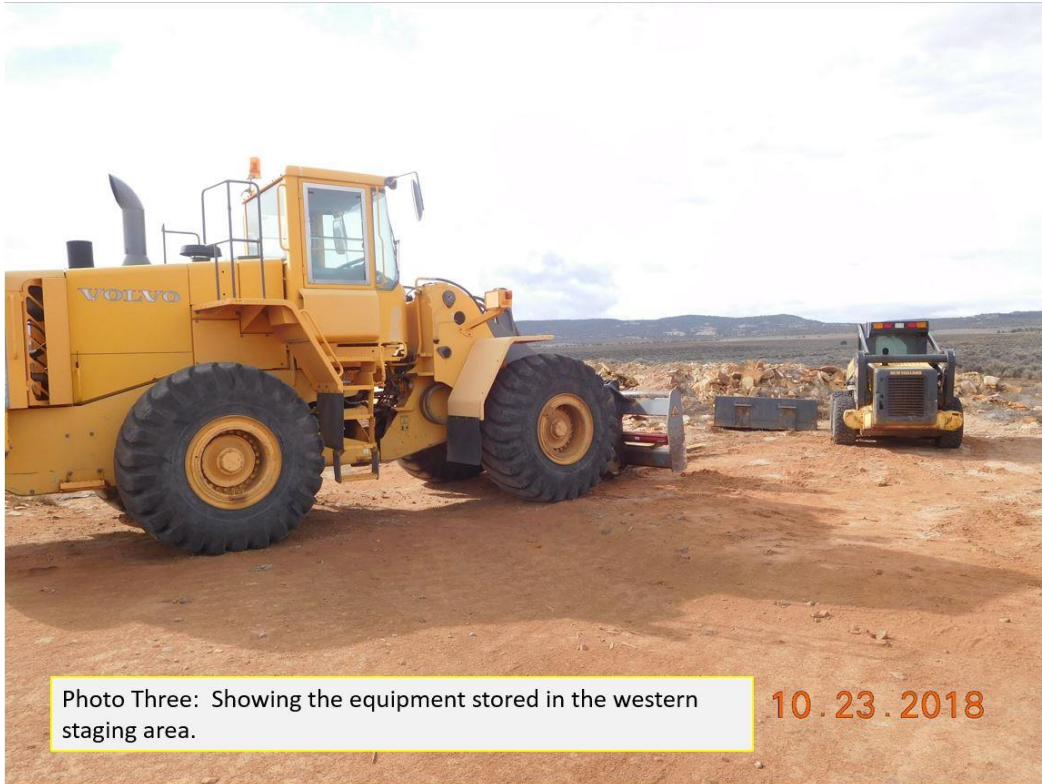
Photo Three: Showing the equipment stored in the western staging area.

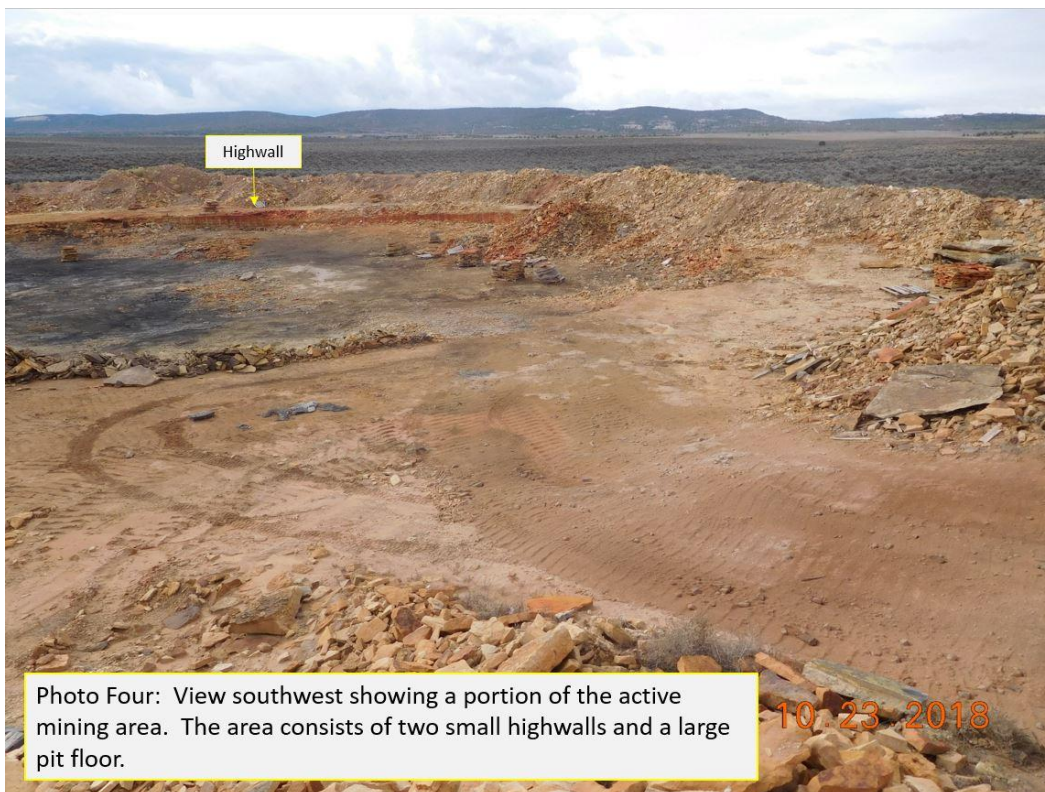
Photo Four: View southwest showing a portion of the active mining area. The area consists of two small highwalls and a large pit floor.

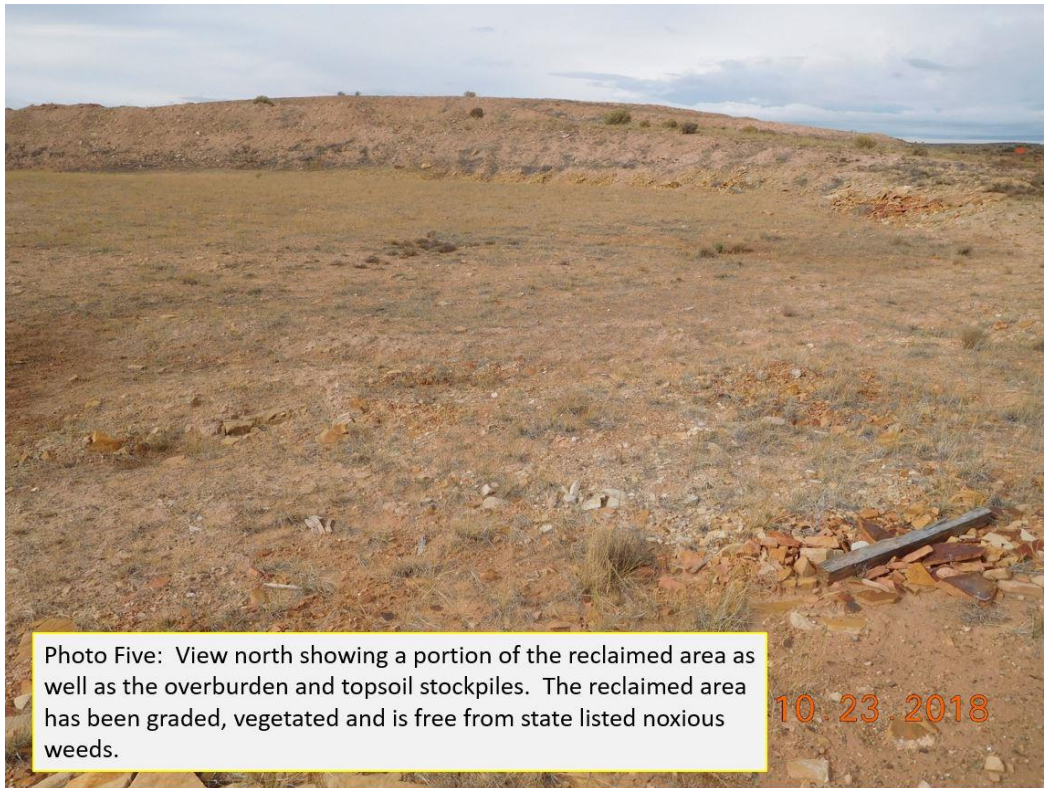
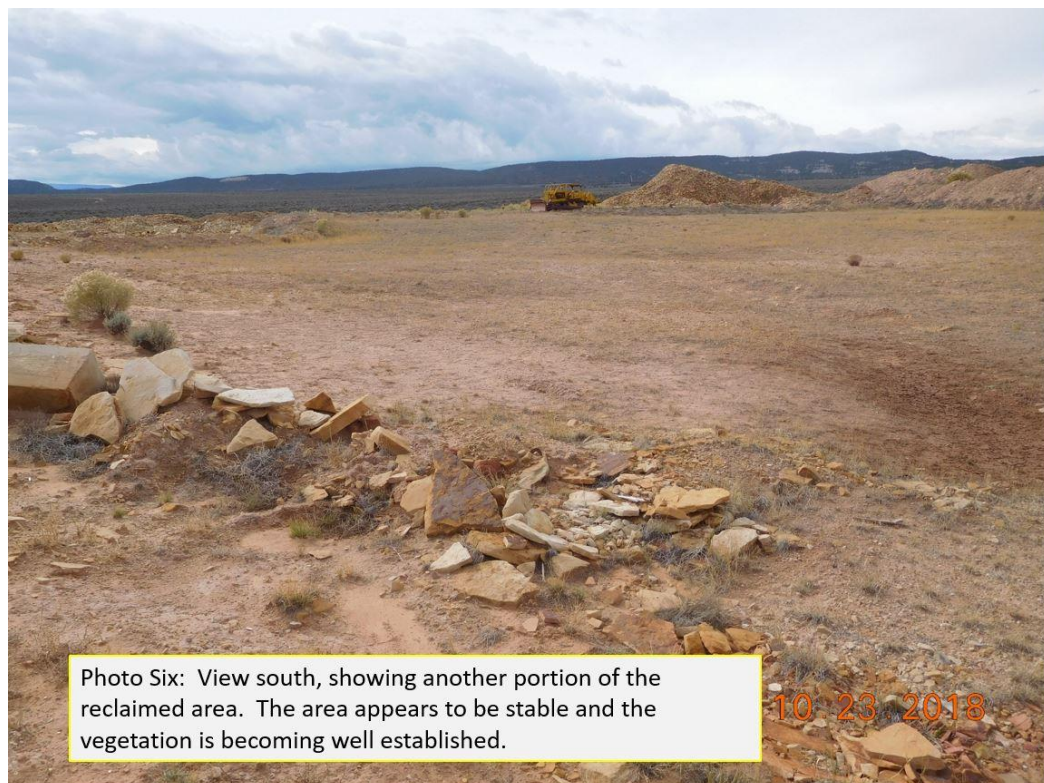
Near the center of the affected lands is an approximately 1.5 acre area that has been reclaimed. The reclamation consisted of grading to a near flat and stable condition, replacement of the topsoil and revegetation. The grading appears to be stable and no signs of erosion were noted. The vegetation was established but sparse due to the lack of moisture during the previous growing season. It is however trending towards the dense and diverse cover that will be required upon final reclamation. The site as a whole as well as the reclaimed area is free from any state listed noxious weeds. The reclaimed area can be seen in Photos Five and Six.
