MINERALS PROGRAM INSPECTION REPORT
PHONE: (303) 866-3567

MINE NAME: Liberty Mine	MINE/PROSPECTING ID#: M-2013-070	MINERAL: Uranium /vanadium	COUNTY: Mesa
INSPECTION TYPE: Monitoring	INSPECTOR(S): Amy C. Yeldell	INSP. DATE: October 30, 2018	INSP. TIME: 12:30
OPERATOR: Liberty Mining, LLC	OPERATOR REPRESENTATIVE: None	TYPE OF OPERATION: 110d - Designated Limited Impact	
REASON FOR INSPECTION: Normal I&E Program	BOND CALCULATION TYPE: None	BOND AMOUNT: \$93,862.42	
DATE OF COMPLAINT: NA	POST INSP. CONTACTS: None	JOINT INSP. AGENCY: U.S.BLM	
WEATHER: Clear	INSPECTOR'S SIGNATURE:

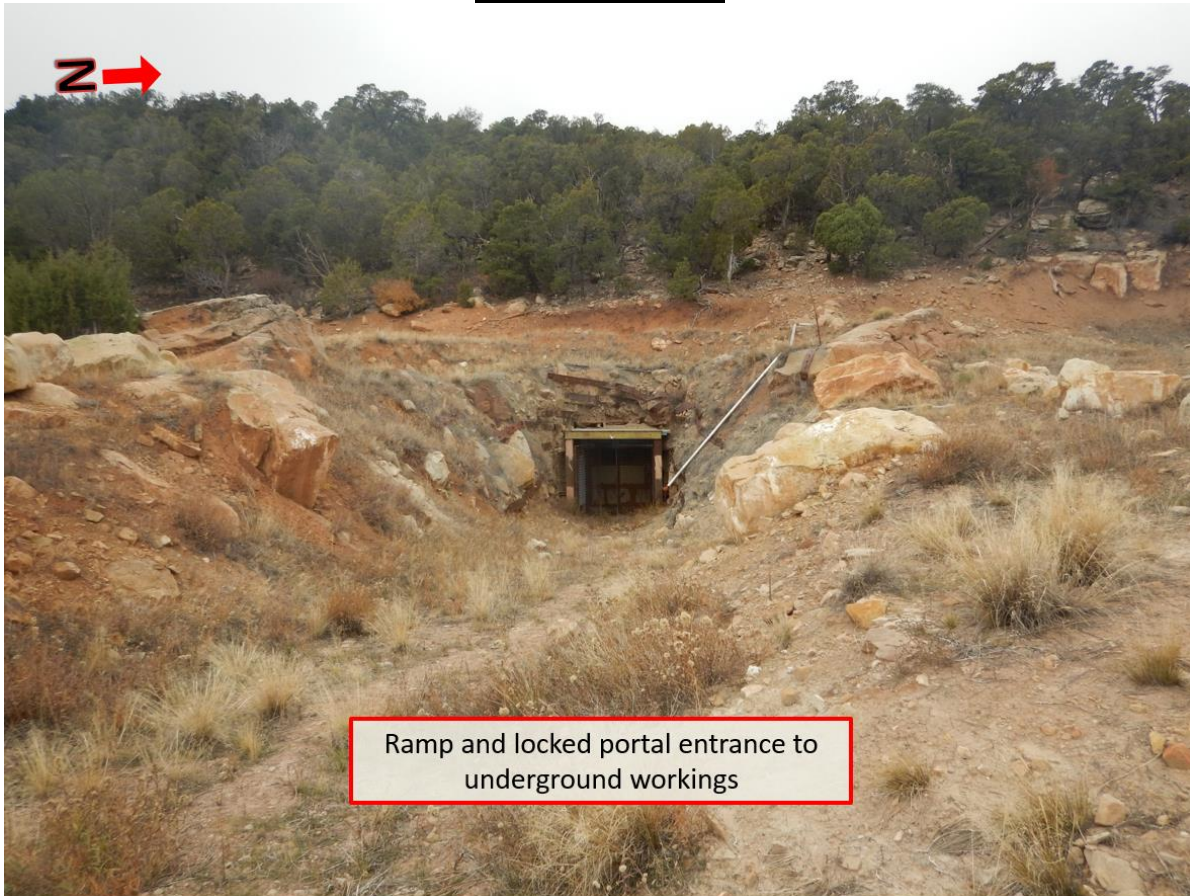
The Portal is sealed with locked grates and PUFF. The exterior grate was partially opened at the time of the inspection but the inner grate was locked. The portal remains locked and secured. In a few areas it appears that a rodent (likely packrat) has been eating through the PUFF. As long as the metal grate remains closed the Division does not see a need at this time to make repairs. Please notify the Division ahead of time in writing if repairs becomes necessary.

Ramp and locked portal entrance to underground workings

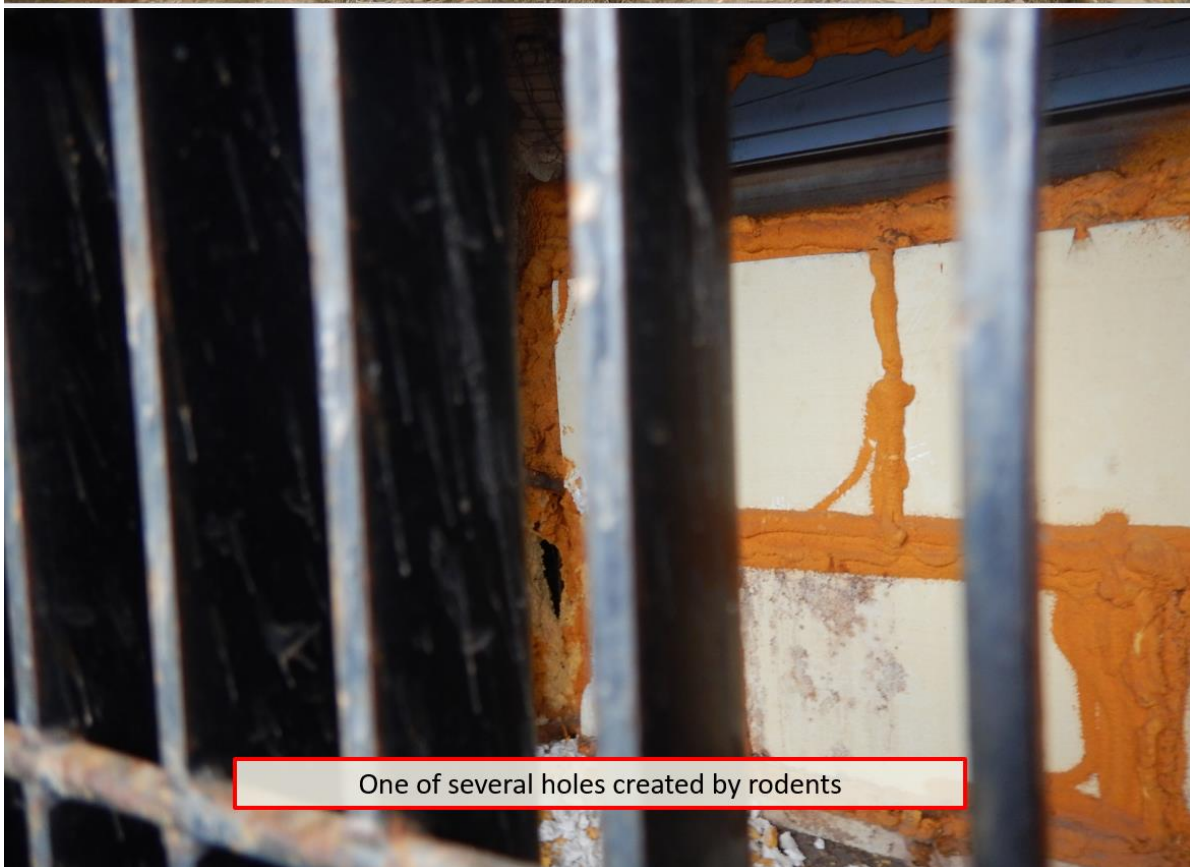
One of several holes created by rodents
