**Denver Field Branch**  
**Mine Site Evaluation Narrative**

Company: Bowie Resources, LLC  
Site: Bowie No. 1 Mine  
Permit No: C-1981-038  
Date of Inspection: November 8, 2018  
Inspection Type: Oversight partial  
Weather: Overcast and cold with dry ground conditions  
Operator Representative(s): Basil Bear  
State Official(s): Janet Binns (Division of Reclamation, Mining and Safety)  
OSMRE Official(s): Tom Medlin (#562)

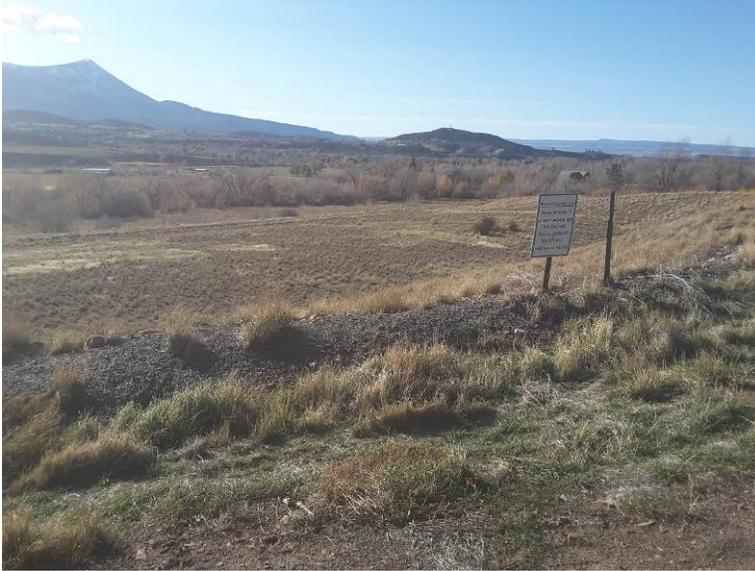
Mine and permit identification signs were located at all points of public access and contained the required information. See Figure 1.

Figure 1. Typical mine and permit identification sign, Loadout area.

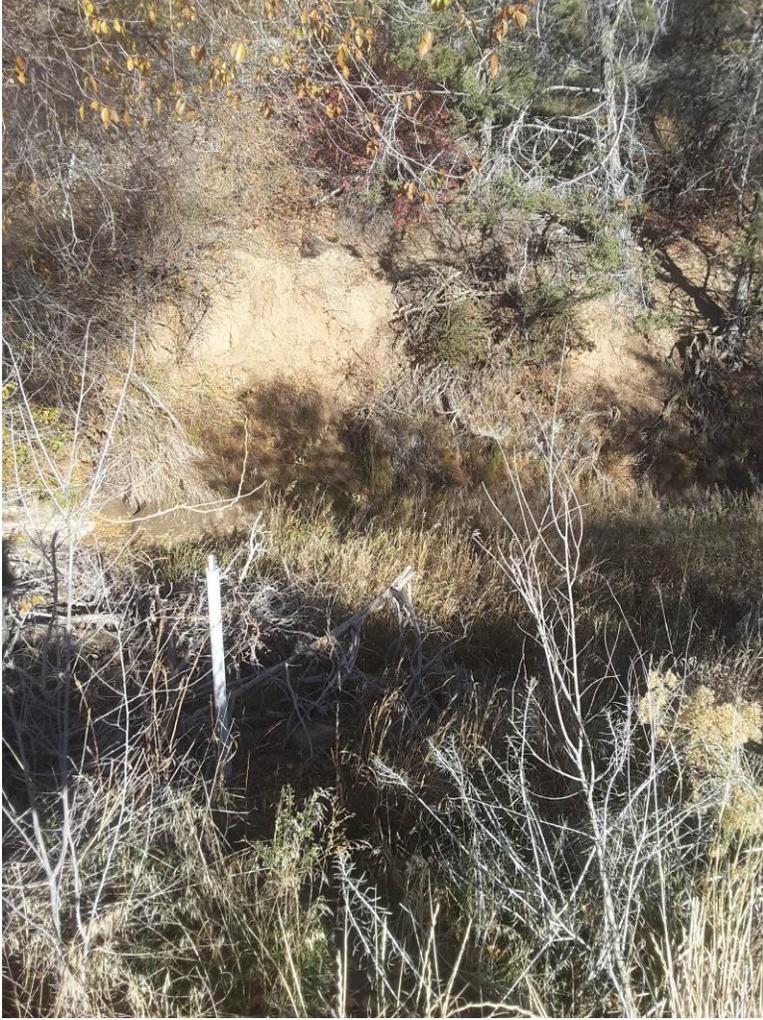
Perimeter markers in the form of two-inch PVC pipe over steel t-posts clearly identified the permit area. See Figure 2.

Figure 2. Typical mine site perimeter marker, Loadout area.

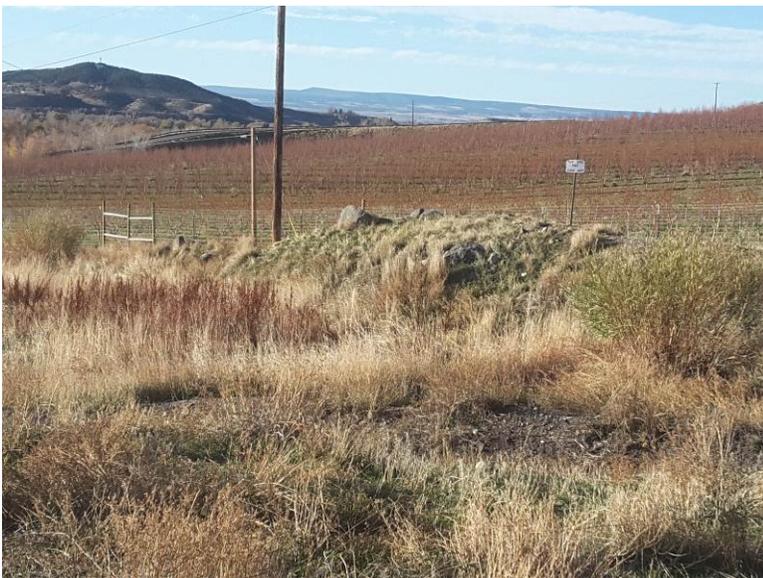
The topsoil stockpile at the Loadout area was properly marked, well-vegetated, and no evidence of resource loss was noted. See Figure 3.

Figure 3. Topsoil stockpile and marker, Loadout area.

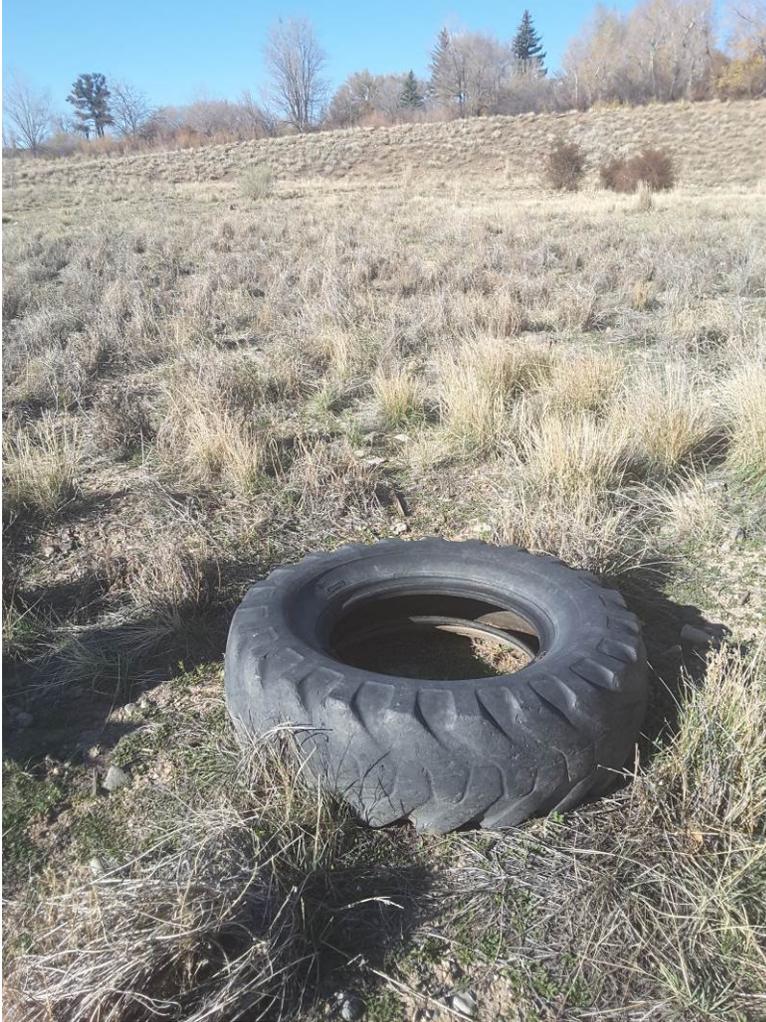
Conditions throughout the permit area were generally orderly and tidy. A dumpster was stationed at the Loadout area for control of noncoal waste. Limited instances of public dumping were observed at the Highway Coal Stockpile portion of the Loadout area. Mr. Bear collected an automobile wheel and tire during the inspection and mentioned he would return with help to dispose of a large abandoned tractor tire. See Figure 4. Nearby on private land within the permit area a trash pile had formed; Mr. Bear agreed to address this issue as well. See Figure 5.

Figure 4. Abandoned tractor tire, Highway Coal Stockpile portion of Loadout area.

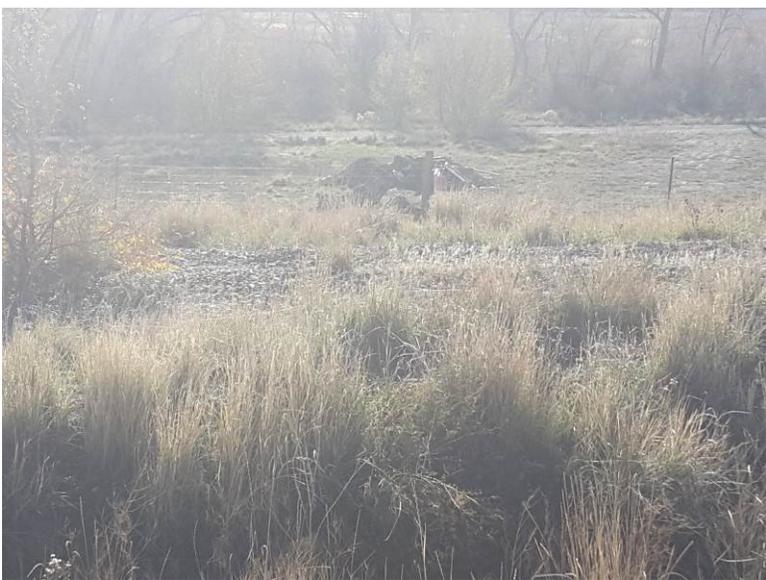
Figure 5. Trash pile on private land, on-permit; Highway Coal Stockpile portion of Loadout area.

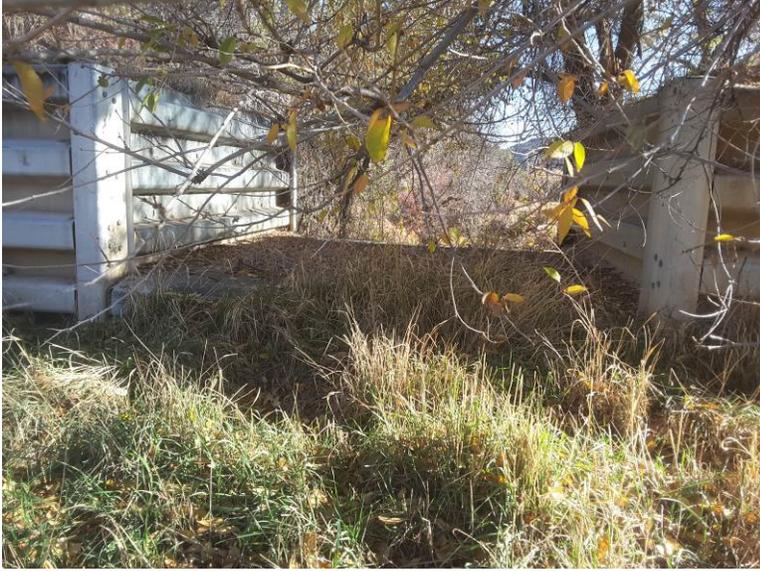
The Team inspected all active and reclaimed sediment ponds throughout the mine site: two functioning ponds at the Loadout area, six reclaimed ponds at the East Mine, and two active ponds at the West Mine. With the exception of the pond at the Highway Coal Stockpile portion of the Loadout area, which contained a small amount of water, all ponds were completely dry. All active ponds exhibited stable embankments vegetated with perennial species, unobstructed inlets and spillways, and ample sediment storage capacity; the ponds would function as designed during precipitation events. See Figures 6 and 7. Sediment control ditches, undisturbed area diversions, and related culverts throughout the site were also inspected and found to be in good repair.

Figure 6. Unobstructed principal spillway, Loadout Pond.

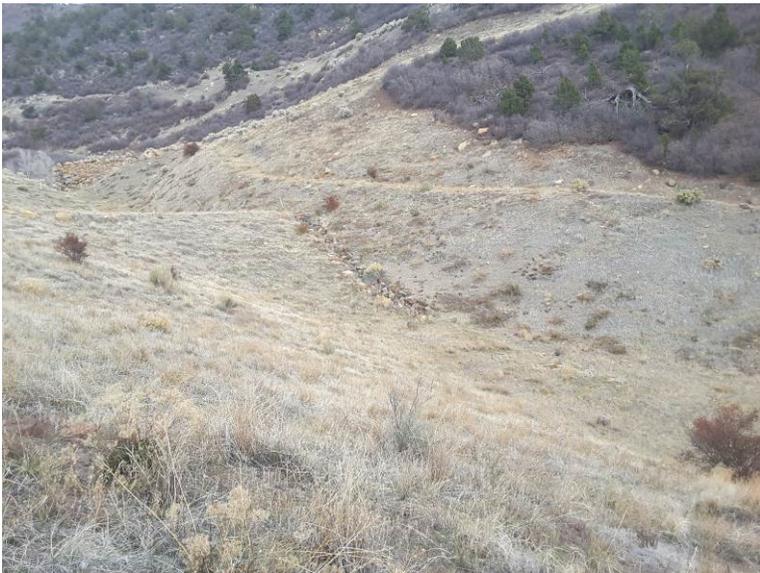
Figure 7. Ponds W-1 and W-2, West Mine.

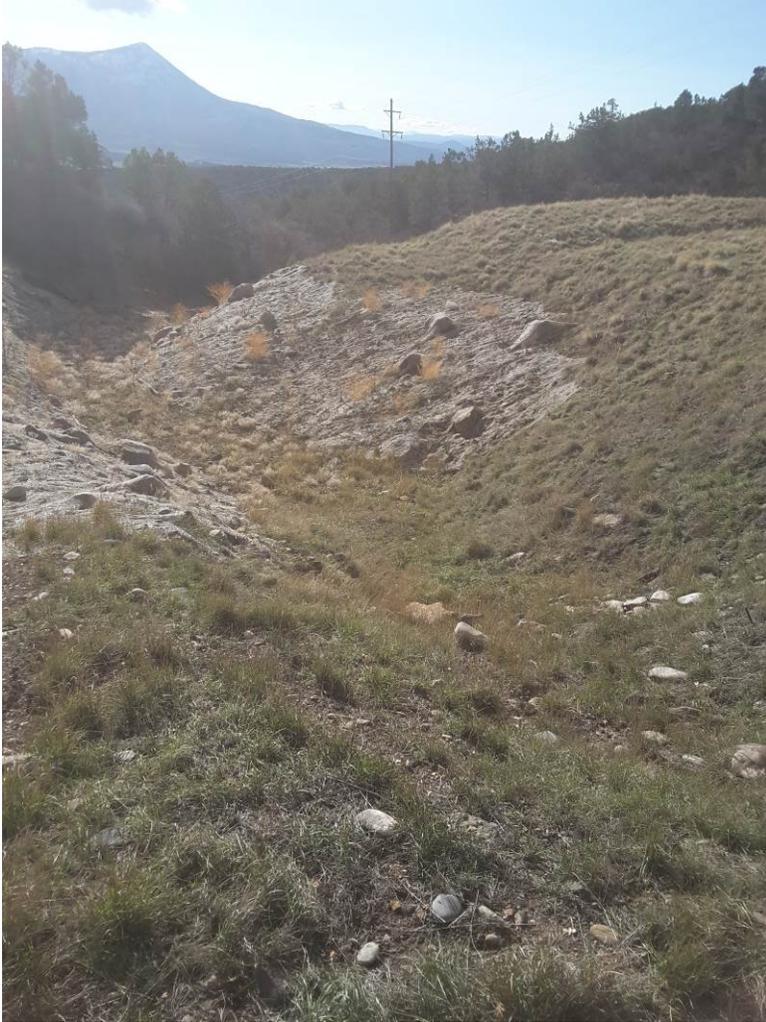
No issues were noted with the reclaimed sediment ponds at the East Mine. Straw-mesh matting had been laid in the reclaimed ponds to aid in germination and control against erosion. The matting was in good condition and functioning as designed: no erosion was noted and desirable perennial grasses, forbs, and shrubs were establishing. See Figure 8.

Figure 8. Reclaimed Pond 4, East Mine.

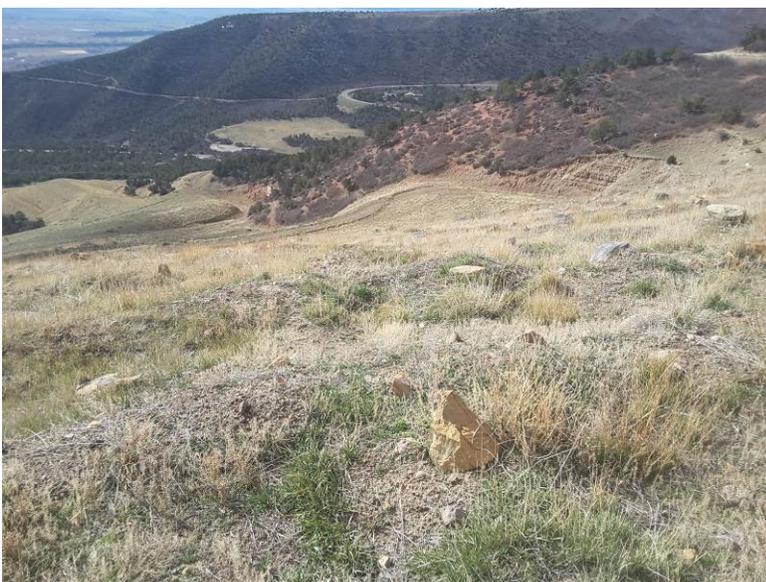
Vegetation throughout the permit area was well established, likely due to recent, favorable weather conditions and extensive surface pocking implemented during initial reclamation. Species of note included winterfat, fourwing saltbush, small burnett, antelope bitterbrush, and Woods' rose. See Figure 9.

Figure 9. Reclaimed/revegetated East Mine slope, looking toward ROM area in far midground.
