COLORADO
Division of Reclamation,
Mining and Safety
Department of Natural Resources

Permit Number: C-1981-012 Mine Name: New Elk Mine Operator: New Elk Coal Company, LLC Operator Address: Mr. Louis Head 12250 Highway 12 Weston, CO 81091	County: Las Animas Operation Type: Underground Permit Status: Active Ownership: Private
	Operator Representative Present: Nick Mason
Operator Representative Signature: (Field Issuance Only)

Inspection Start Date: November 14, 2018 Inspection Start Time: 12:00 Inspection End Date: November 15, 2018 Inspection End Time: 14:45		Inspection Type: Coal Complete Inspection Inspection Reason: Normal I&E Program Weather: Clear	
Joint Inspection Agency: None		Joint Inspection Contacts: 	
Post Inspection Agency: None		Post Inspection Contacts: 	
Inspector(s): Robert D. Zuber, P.E.	Inspector's Signature:

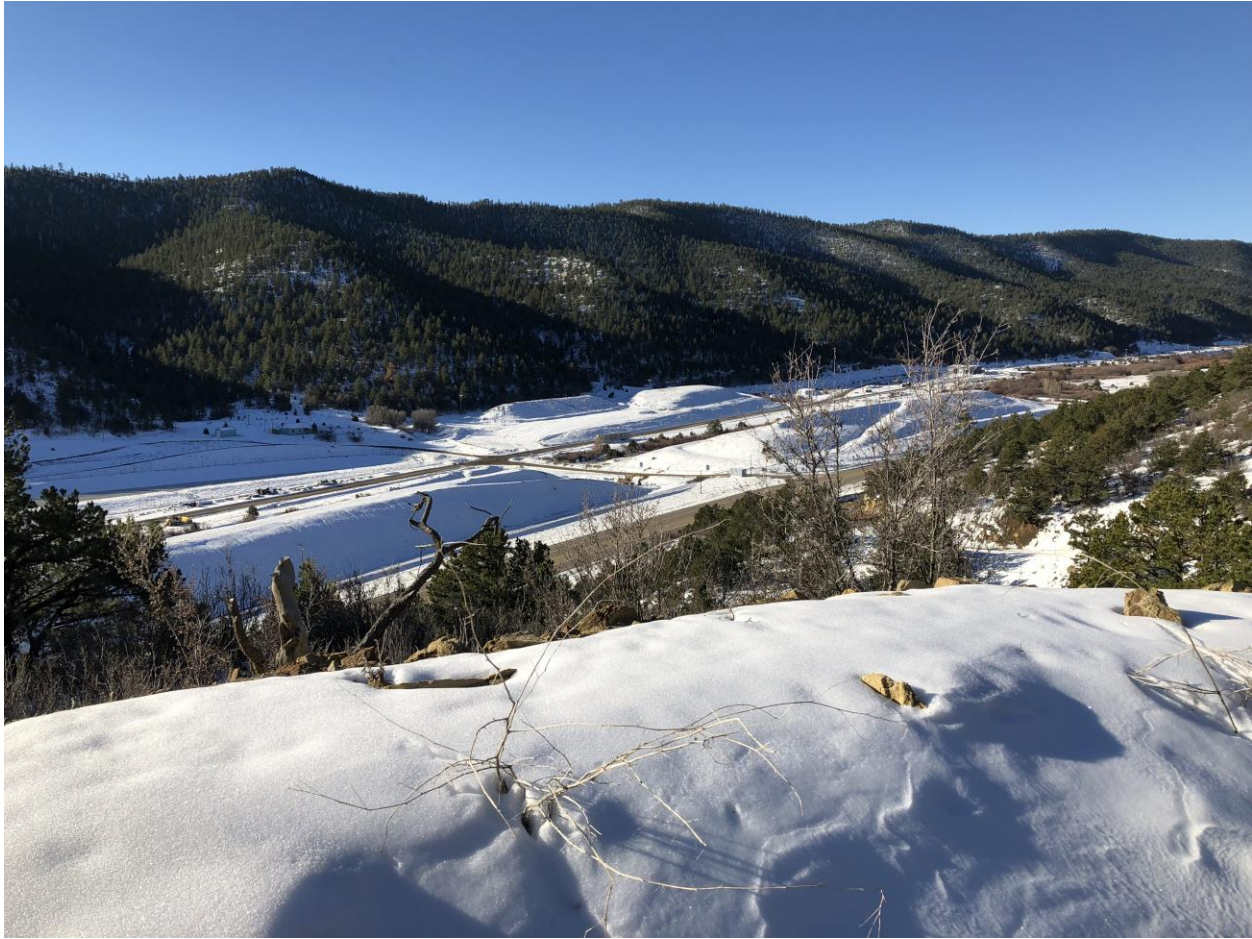
Waste piles and soil piles (photo from RDA road)

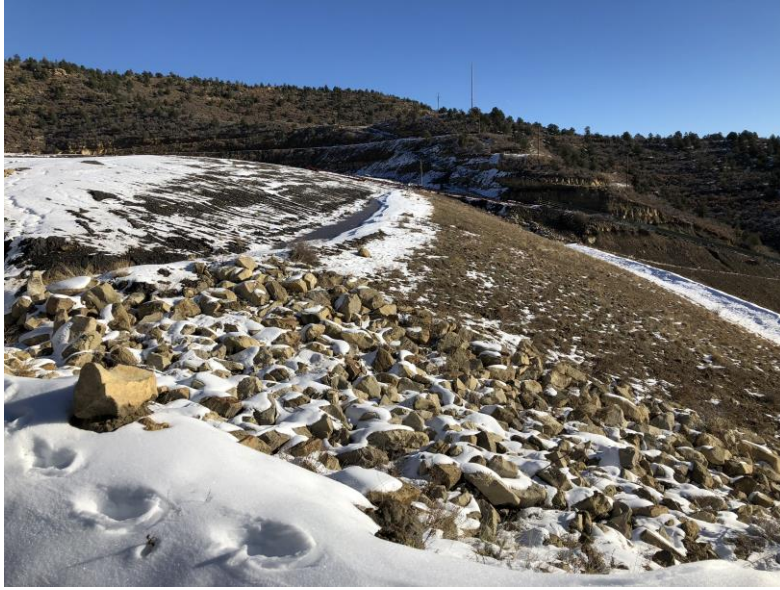
No erosion was seen on the reclaimed portion of the RDA. The ditch between the upper and lower portions of the RDA is in good shape. No ponding, erosion, or other problems with the upper portion of the RDA were seen (although NECC still needs to spread some piles of material). No signs of blowouts below the clear water ditches were seen.

RDA – interface between upper portion (left side of photo) and lower portion

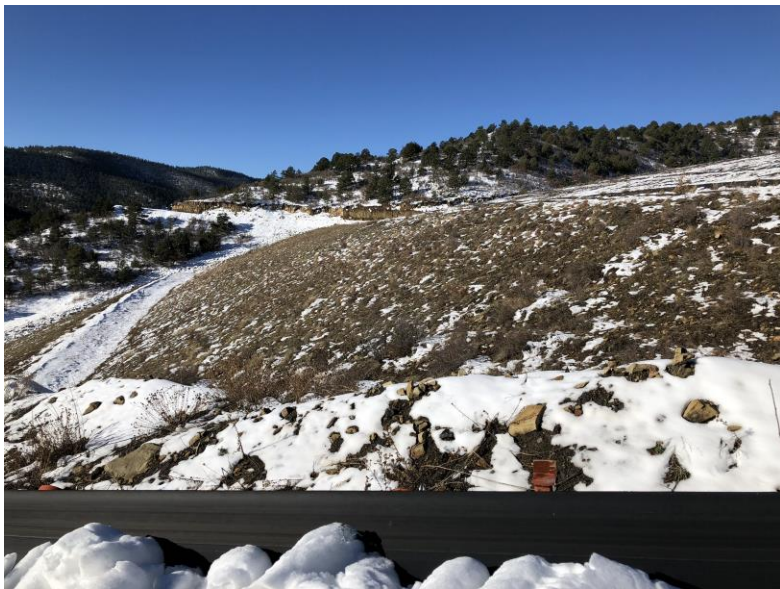
RDA – lower portion

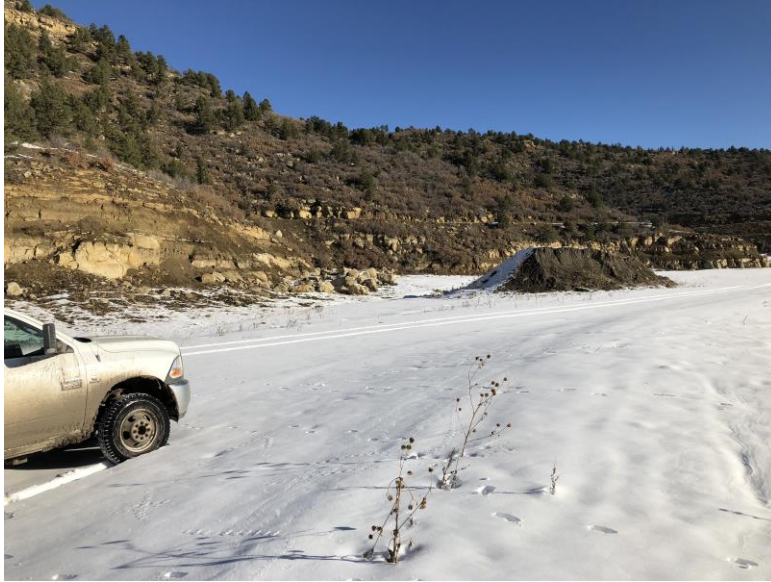
RDA – upper portion and hillside below clearwater ditch (D55)

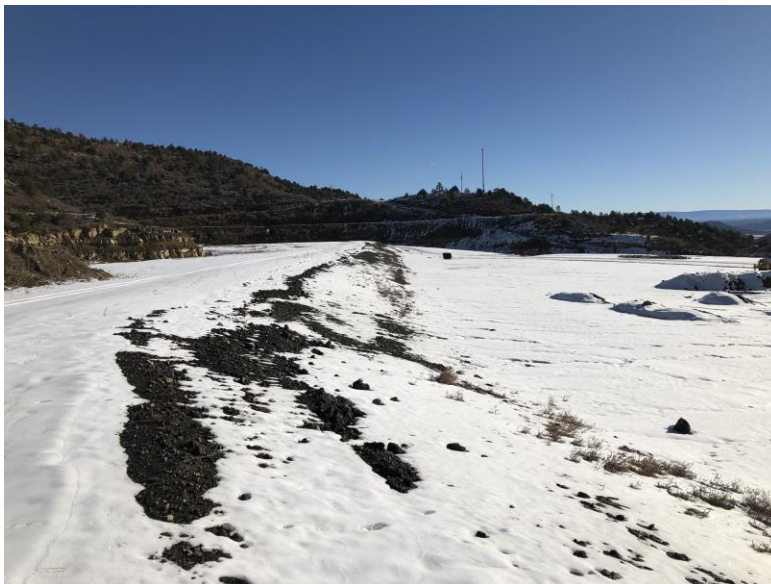
RDA – upper portion showing drainage divide

Area to right drains to front of RDA, and area to left drains to back of RDA.

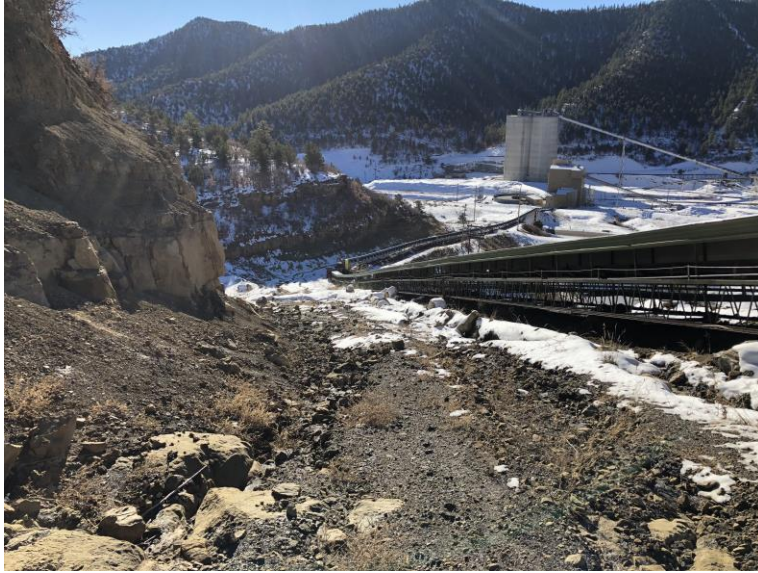
No significant problems with roads were observed. The fill slope below the road to the RDA is lacking in vegetation despite NECC's efforts with hydro-mulching. This area requires frequent monitoring to look for excessive sediment loading onto the undisturbed area below. The road beside the conveyor to the RDA is in rough shape and should be monitored often for erosion. For all roads, if significant erosion occurs it should be repaired promptly.

Road next to RDA conveyor

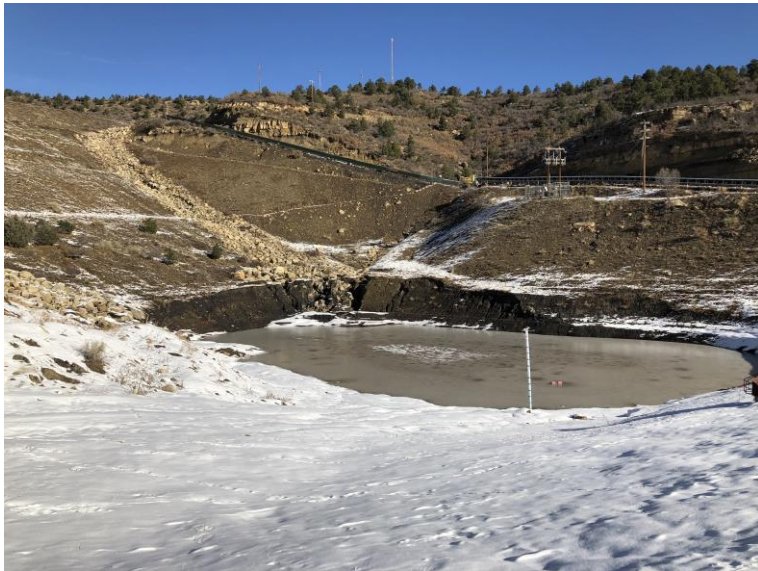
Ponds 001A, 004A, 006A, 007A, and 08 were inspected. None of them were discharging, but all held at least a small amount of water/snow/ice. The impounded water in Pond 08 appeared to be more than 13 feet below the primary spillway. No water was seen flowing into the ponds from the pipe and pump systems on site. No significant issues were seen with the embankments or spillways of any ponds, although the top of the Pond 08 dam lacks vegetation.

RDA and Pond 08

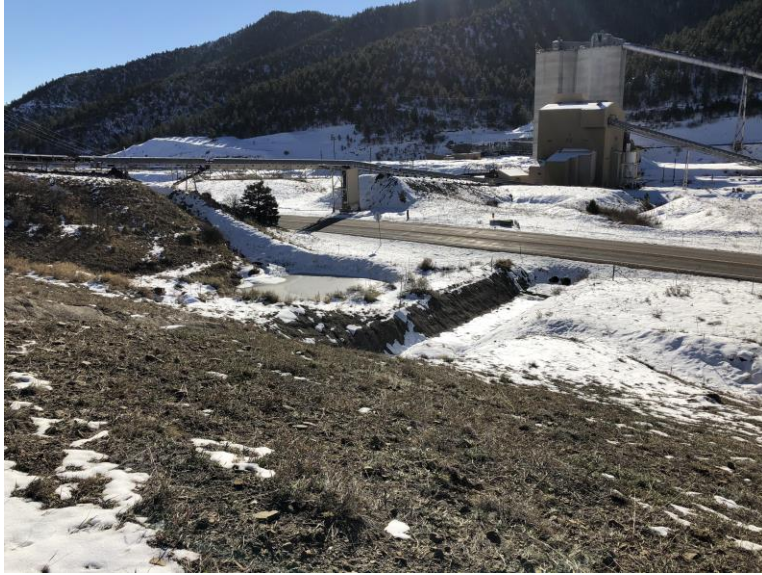
Containment Area 5 was holding significant water, but no signs of past discharge were detected. Containment Areas 1, 2, 3, and 4 were mostly dry. There were no signs of problems with any of the containment areas.

Containment Area 5 and area below Pond 08, with Prep. Plant in background

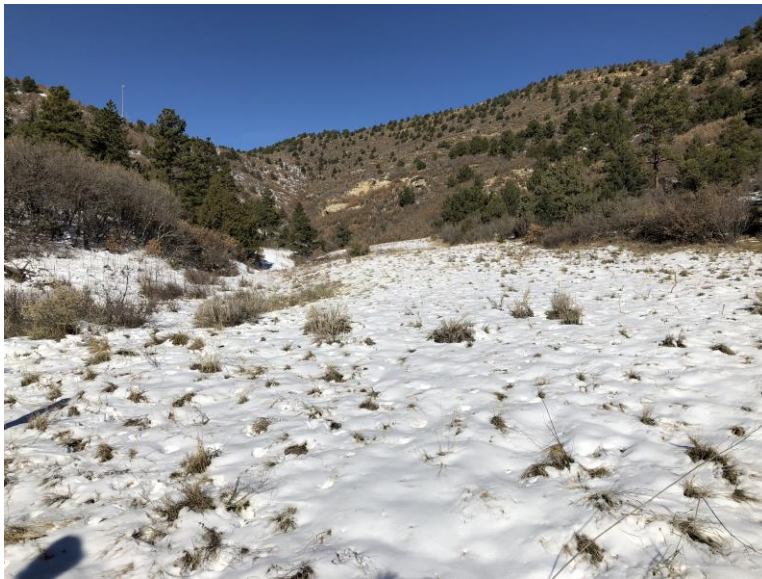
- Within the SAE by Pond 007A, BMPs appear to be functioning. There was no discharge from this outfall.
- No problems were seen with the SAE east of DWDA#2, and the riprap below this area is stable.
- No problems were seen with the SAE a quarter mile east of Pond 08, along Highway 12.

SAE that is approximately 0.25 miles east of Pond 08

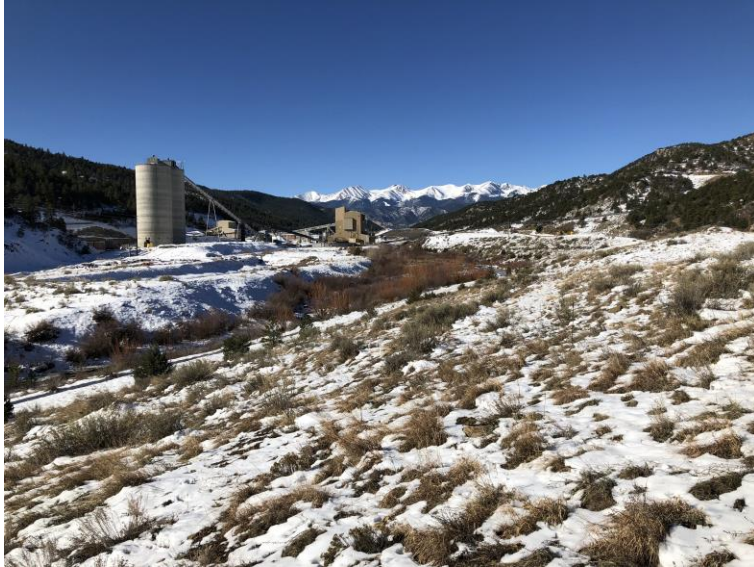
Lower portion of site

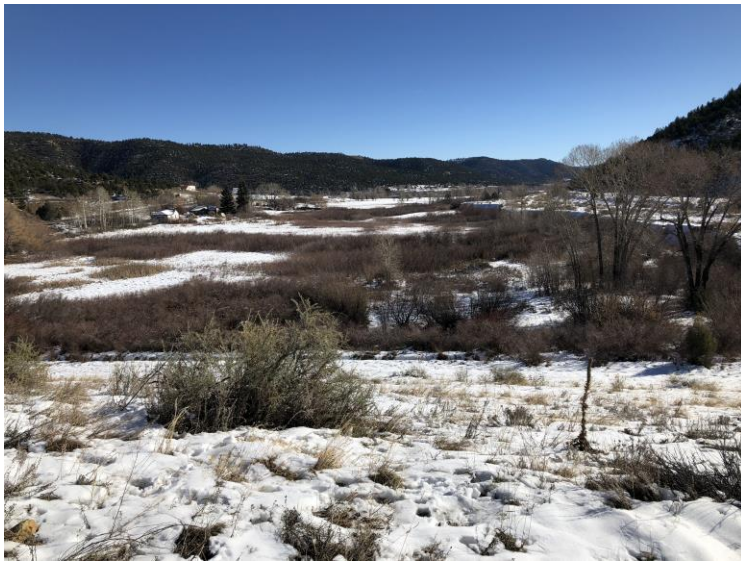
No problems were identified with the AVF below the mine site.

AVF below site

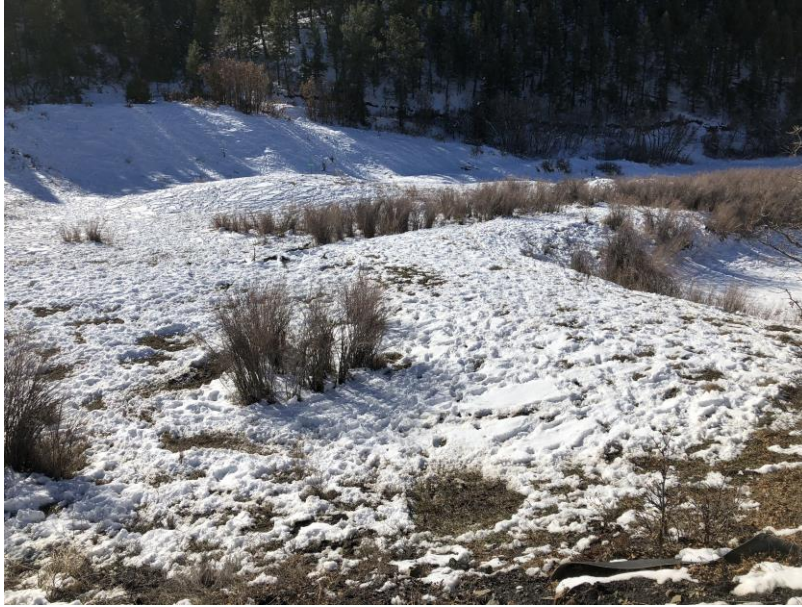
No problems were seen with the topsoil stockpile by Containment Area 1.

Containment Area #1 and topsoil stockpile (with hundreds of hoof prints from elk)

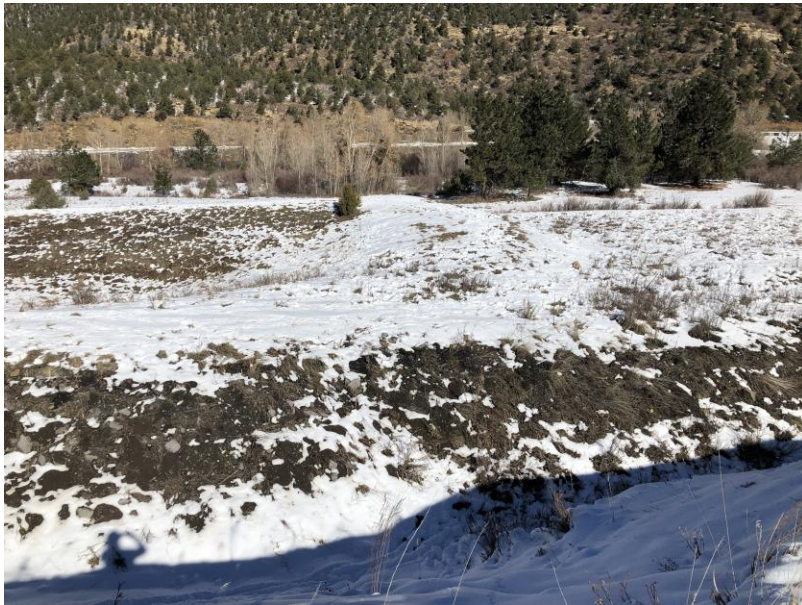
Containment Area #2

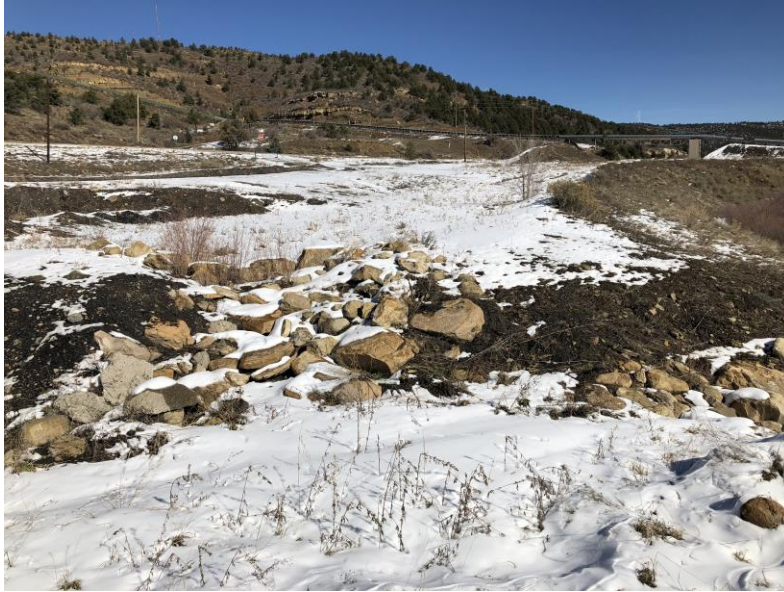
SAE east of DWDA#2

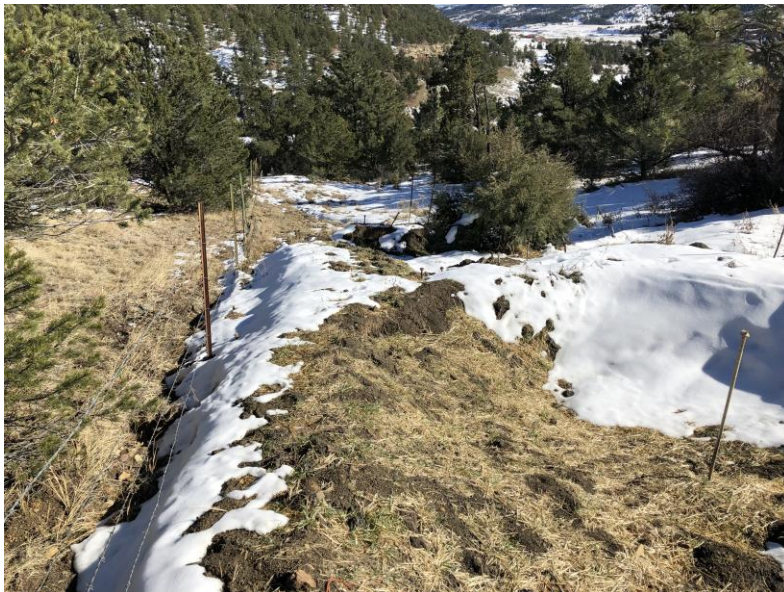
The sediment and erosion BMPs at the Northwest Fan (former Golden Eagle site) require no maintenance at this time.

BMPs at Northwest Fan site
