**PERMIT INFORMATION**

<b>Permit Number:</b> C-1996-084 <b>Mine Name:</b> Lorencito Canyon Mine <b>Operator:</b> New Elk Coal Company, LLC <b>Operator Address:</b> Mr. Louis Head 12250 Highway 12 Weston, CO 81091	<b>County:</b> Las Animas <b>Operation Type:</b> Surface <b>Permit Status:</b> Permanent Cessation <b>Ownership:</b> Private
	<b>Operator Representative Present:</b>  Nick Mason
<b>Operator Representative Signature: (Field Issuance Only)</b>

**INSPECTION INFORMATION**

<b>Inspection Start Date:</b> November 15, 2018 <b>Inspection Start Time:</b> 07:00 <b>Inspection End Date:</b> November 15, 2018 <b>Inspection End Time:</b> 08:00		<b>Inspection Type:</b> Coal Partial Inspection <b>Inspection Reason:</b> Normal I&E Program <b>Weather:</b> Clear	
<b>Joint Inspection Agency:</b>  None		<b>Joint Inspection Contacts:</b>  	
<b>Post Inspection Agency:</b>  None		<b>Post Inspection Contacts:</b>  	
<b>Inspector(s):</b>  Robert D. Zuber, P.E.	<b>Inspector's Signature:</b>

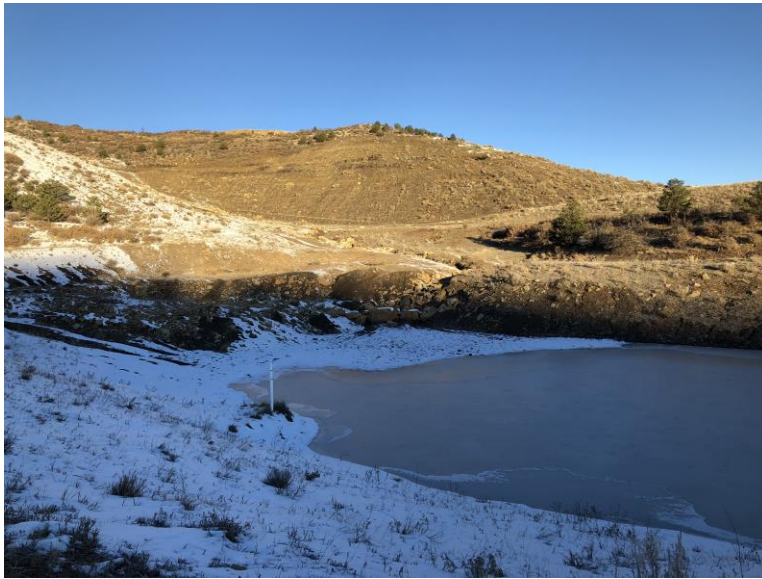
The rills and bare spots on the hillside above Pond 6 do not appear to have gotten worse in recent weeks. The same can be said about rills on the hillside above the pond cleaning dump area, although snow on this north-facing hill precluded a thorough inspection.

**Area in Pond 6 watershed**

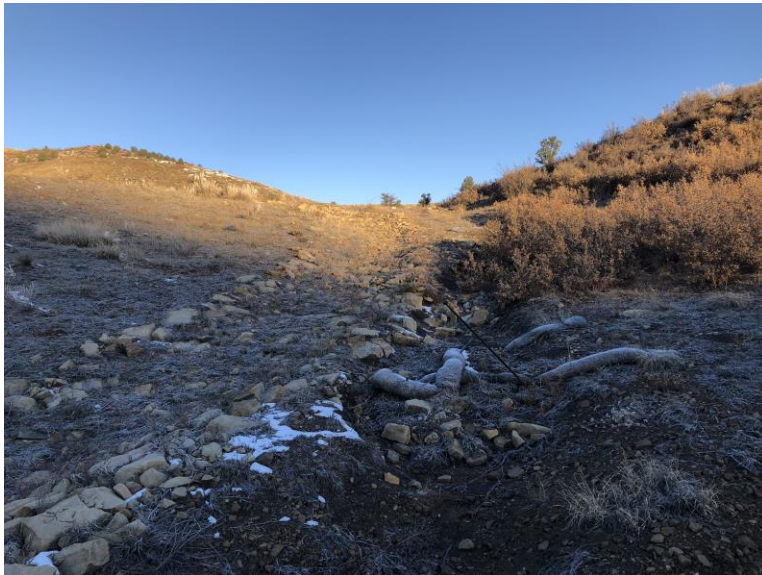
Two ponds were inspected: 6 and 9A. Both contained water/ice/snow. Pond 6 was not discharging. Pond 9A was only inspected from the fill above, so it could not be said that it was not discharging (although it is highly unlikely that it was discharging based on the observed water level). No problems were identified with embankments, spillways, or other features of the ponds.

**Channel and sediment control below Pond 6**

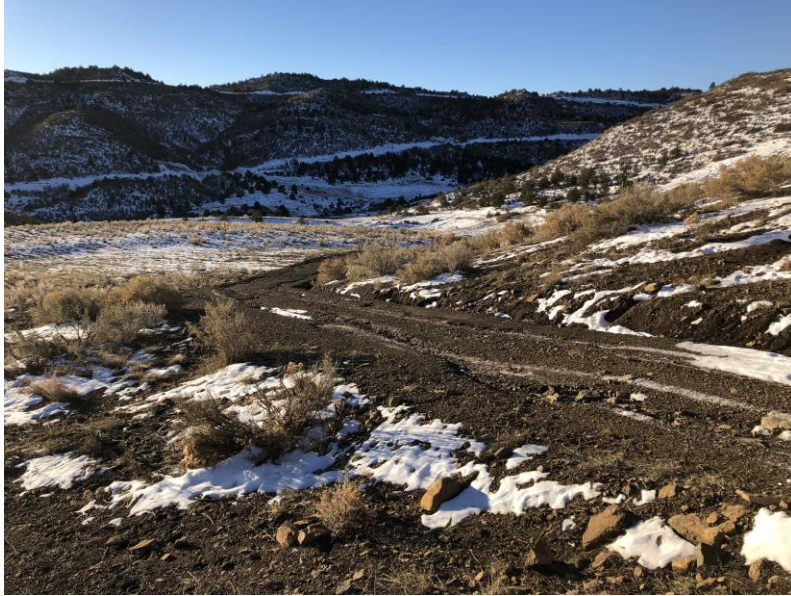
Maintenance is needed on the road to Pond 6.

**Road to Pond 6 in need of repair**

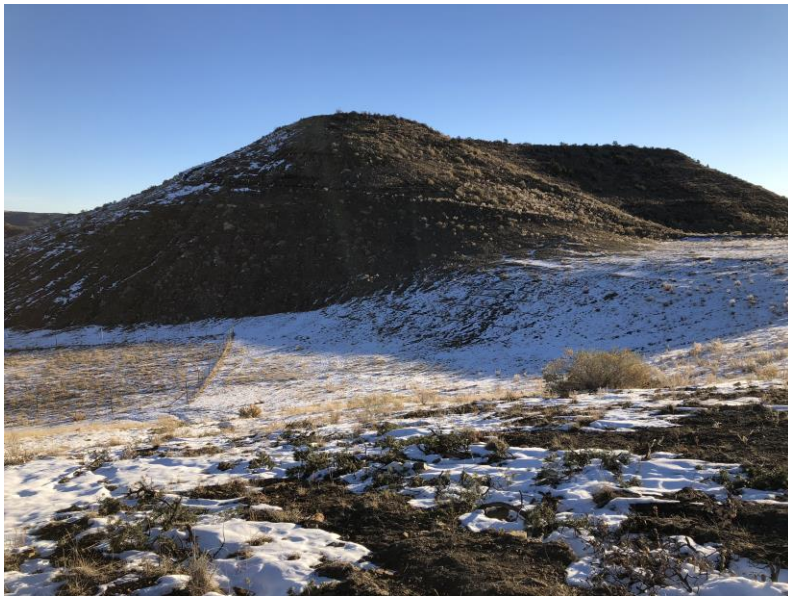
The hill known as “the knob” looked to be stable, with no gullies. Rills were seen (as in the past), and NECC staff indicated that branches will be placed in them. If possible, that should be done this winter, prior to spring 2019 runoff.

NECC staff have addressed some of the erosion on hills near the shrub plot with branches.

**“The knob” and shrub plot, with erosion control branches in foreground**

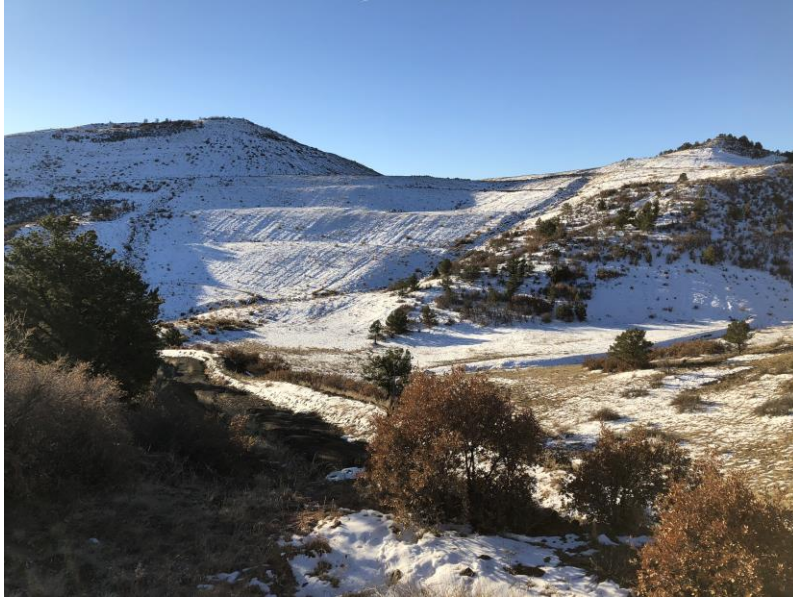
**Fill 8**

Fills 7, 8, and 9 were inspected. No large rills or gullies were seen.

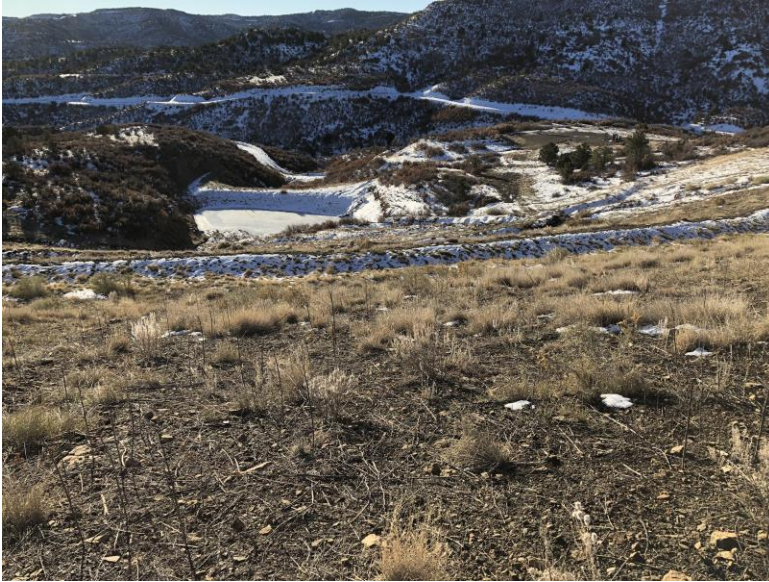
**Pond 9A with Fill 9 in foreground**
