**MINERALS PROGRAM INSPECTION REPORT****PHONE: (303) 866-3567**

<b>MINE NAME:</b> Dellacroce Pit	<b>MINE/PROSPECTING ID#:</b> M-1993-050	<b>MINERAL:</b> Gravel	<b>COUNTY:</b> El Paso
<b>INSPECTION TYPE:</b> Monitoring	<b>INSPECTOR(S):</b> Timothy A. Cazier	<b>INSP. DATE:</b> July 10, 2018	<b>INSP. TIME:</b> 10:40
<b>OPERATOR:</b> Raymond F. & Robert W. Dellacroce	<b>OPERATOR REPRESENTATIVE:</b> Jason Ulmer	<b>TYPE OF OPERATION:</b> 112c - Construction Regular Operation

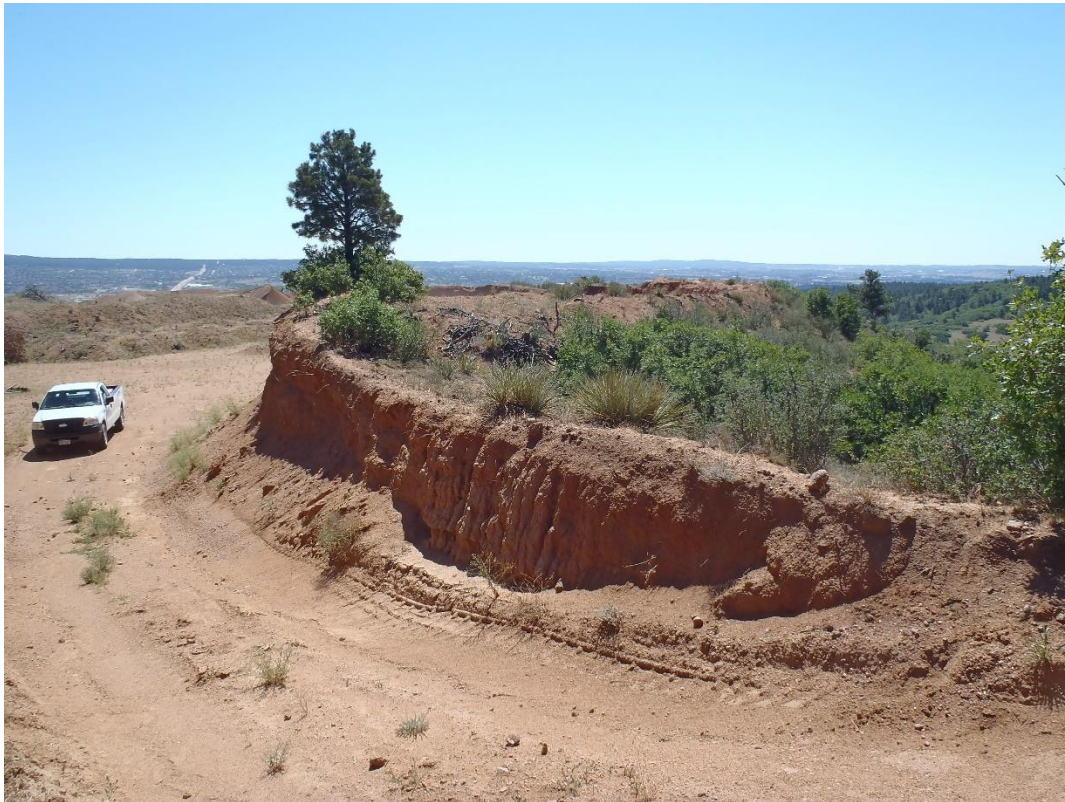
Backfilling and Grading: The site is a ridge being mined such that a visual berm remains between the active mining and the surrounding area. These visual berms (see **Photo 1**) will be pulled down using an excavator as part of the reclamation effort (see **Photo 2**). As such, sufficient backfill material is available.

Photo 1. Typical visual berm (south side, west end, looking east).

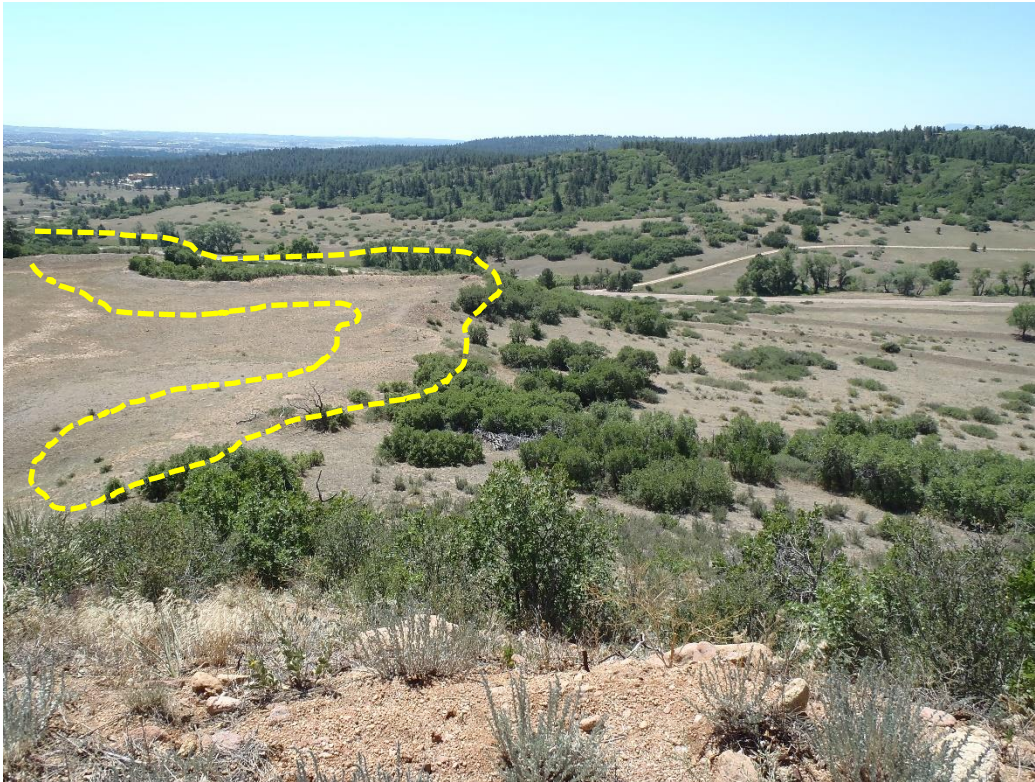
Photo 2. Reclaimed visual berm (south side, east end, looking SE).

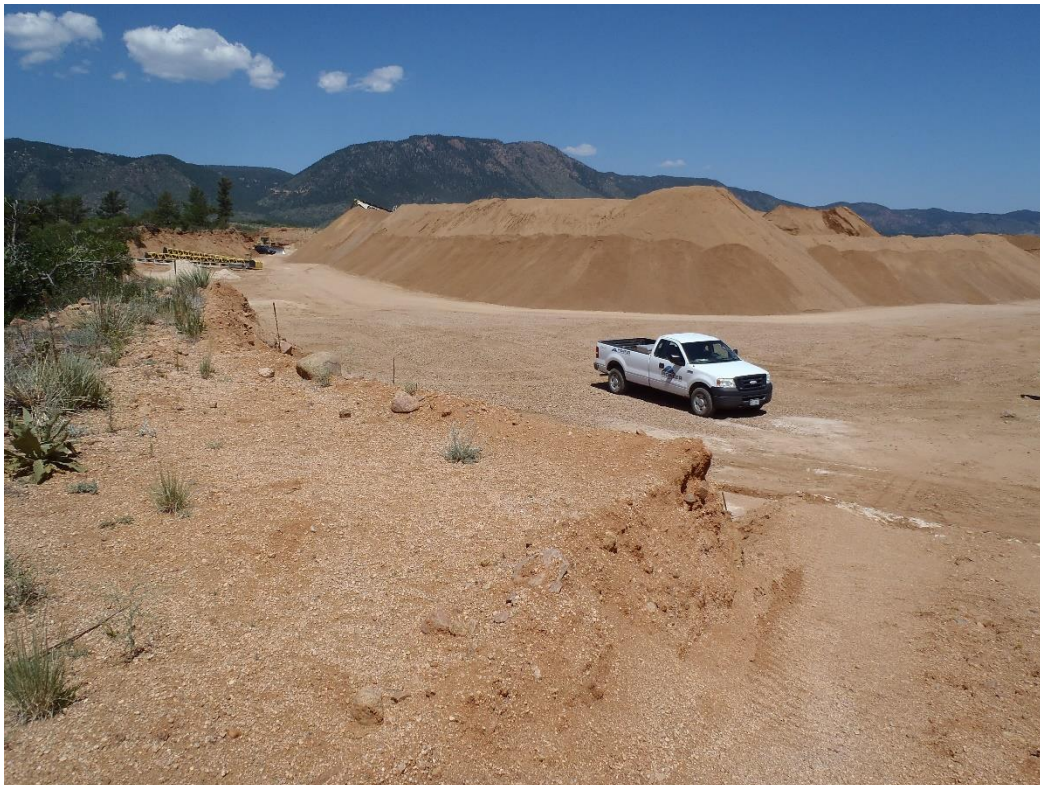
Gen. Compliance with Mine Plan: The general operation of the mine appears to be in conformance with the approved mine plan. However, there is an area of disturbance on the north side of the pit (east of Phase XI, north of Phase I, and west of Phase V) that is outside the approved affected area boundary (see **Figure 1A**). This disturbed area is estimated to be approximately 1.6 acres. **This disturbed area outside the affected area boundary is cited as Problem 2 on page 1 of this report.** Google Earth was used to measure the disturbed area, which was estimated to be approximately 25 acres, based on 2017 imagery. The maximum allowed disturbance by permit is 64.8 acres. However, based on AR-01 maps, the maximum allowed disturbed area is closer to 40.6 acres (see **Figure 1B**). Perimeter (or boundary highwalls) were near vertical and estimated to vary between 10 and 15 feet in height. Internal highwalls were estimated to be 20 feet in height. Google Earth was used to estimate the highwall lengths (see **Figure 2**) for the enclosed bond estimate. As discussed under "Backfilling and Grading" above, sloughing of these highwalls is not a concern as they will be pulled down for reclamation (see **Photo 2**). The DRMS received a phone call prior to this inspection from a nearby resident asking why they could "see the mine" at the time. During this inspection it was determined what the caller observed was stockpiled product (see **Photo 3**) having been processed on site and that it would soon be moved offsite, thereby restoring the viewshed to normal.

Photo 3. Observable (above visual berms) product stockpile (south side, looking NW).

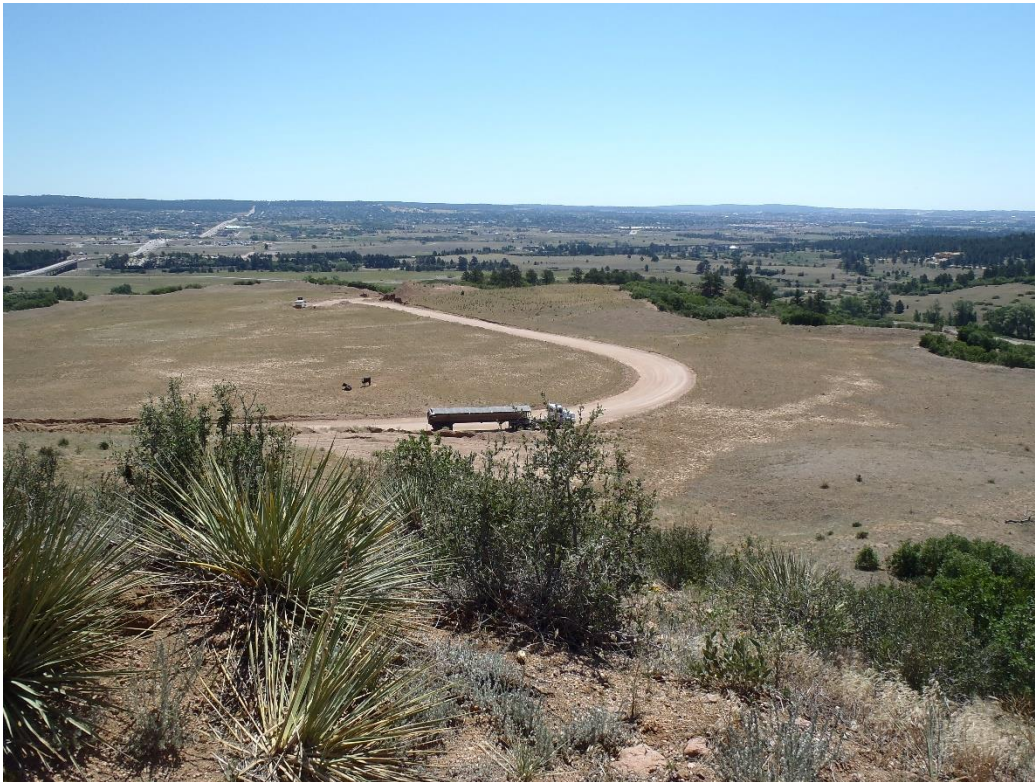
Revegetation: Revegetation on the east end of the site (Phases II through VI) was completed as of the previous inspection. This area was released from reclamation liability (see **Photo 4**). No other areas have reached the stage of reclamation where revegetation can be initiated. No noxious weeds were observed.

Photo 4. Reclaimed east end (Phases II through VI, looking east).

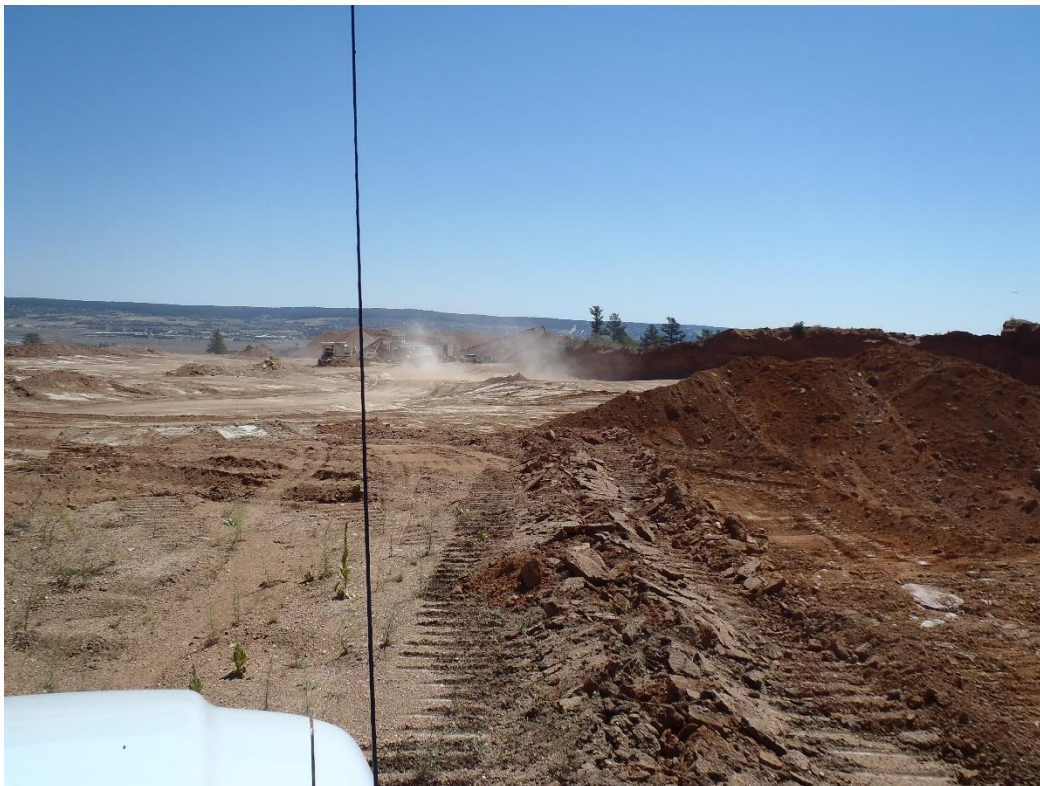
Support Facilities On-site: A screen plant, crusher, wheel loader, and dozer were observed on site (see **Photo 5**).

Photo 5. Active mining and equipment (central area, looking east).

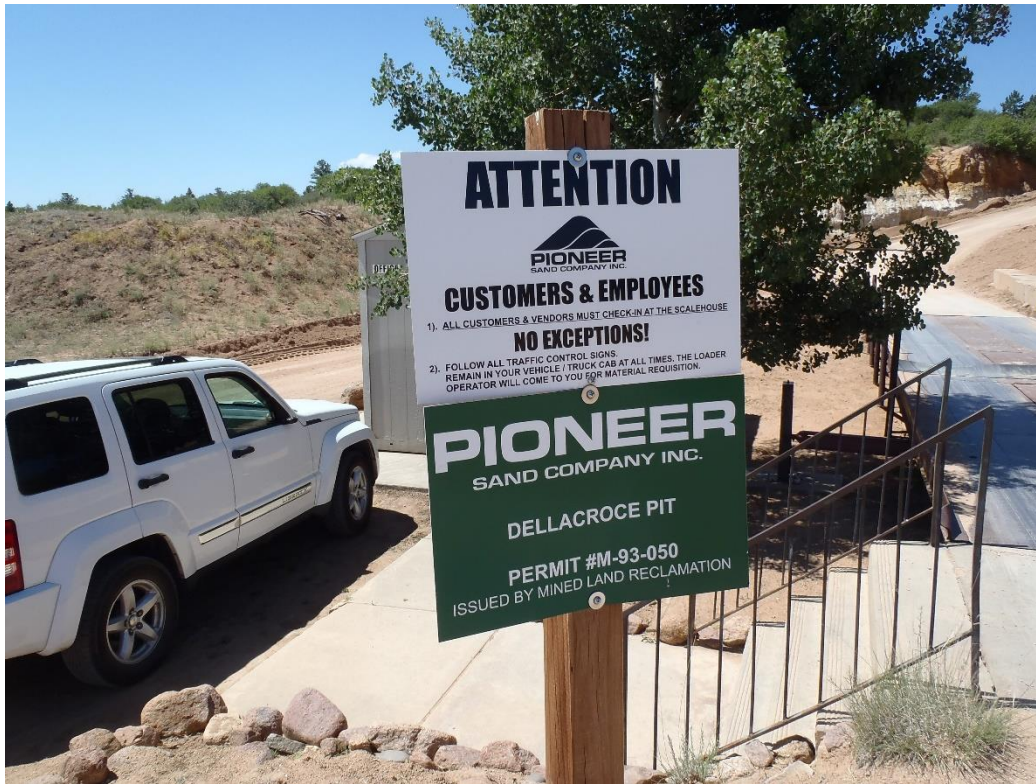
Signs and Markers: The permit sign was properly posted at the scale house (see **Photo 6**) and boundary markers were observed to delineate the permit boundary (see **Photo 7**).

Photo 6. Permit sign.

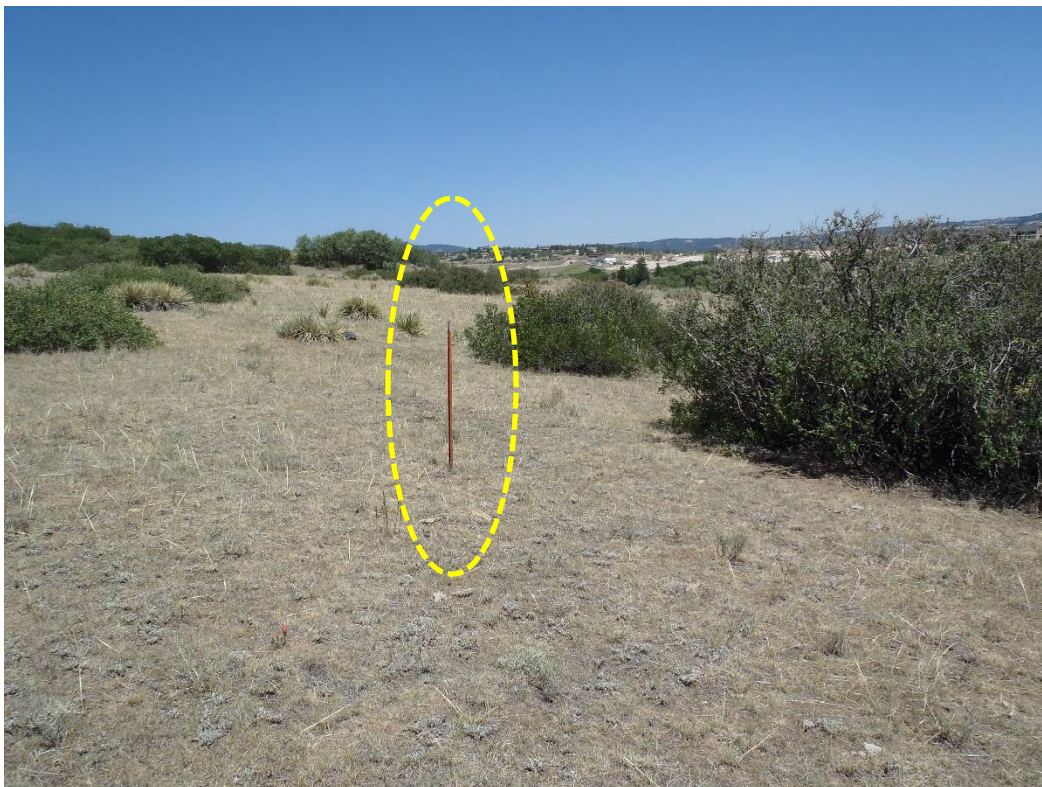
Photo 7. Typical permit boundary marker (north of entrance road, looking north).

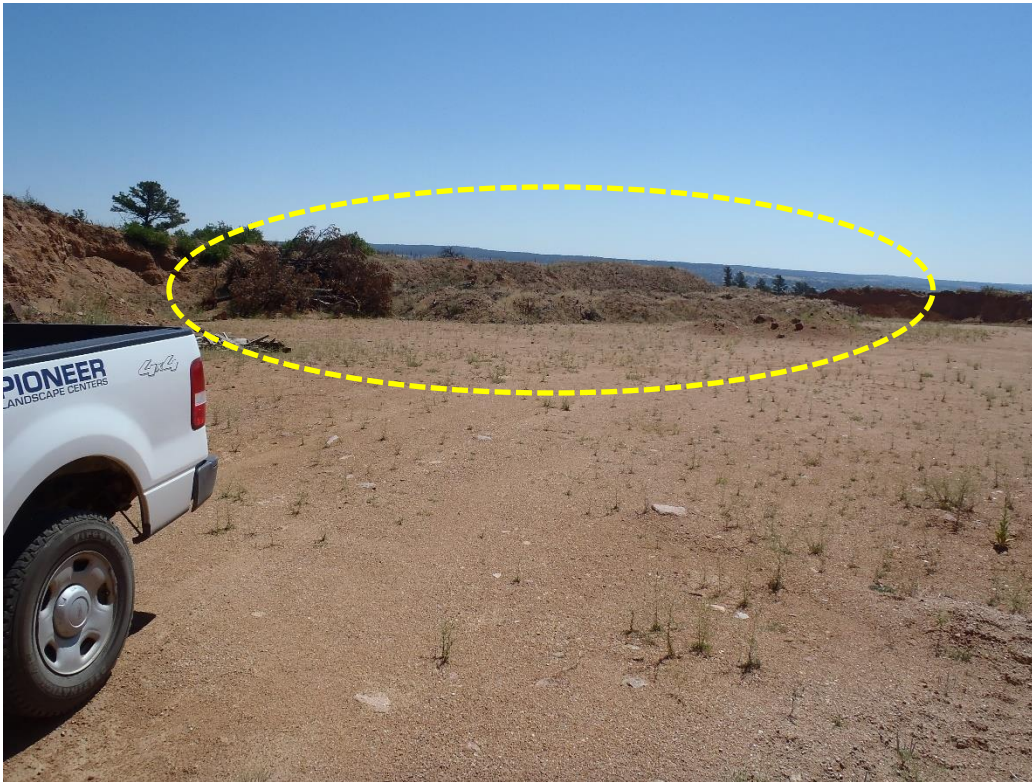
Topsoil: A topsoil stockpile was observed on the west end of the site (see **Photo 8**).

Photo 8. Topsoil stockpile (looking east from west end).

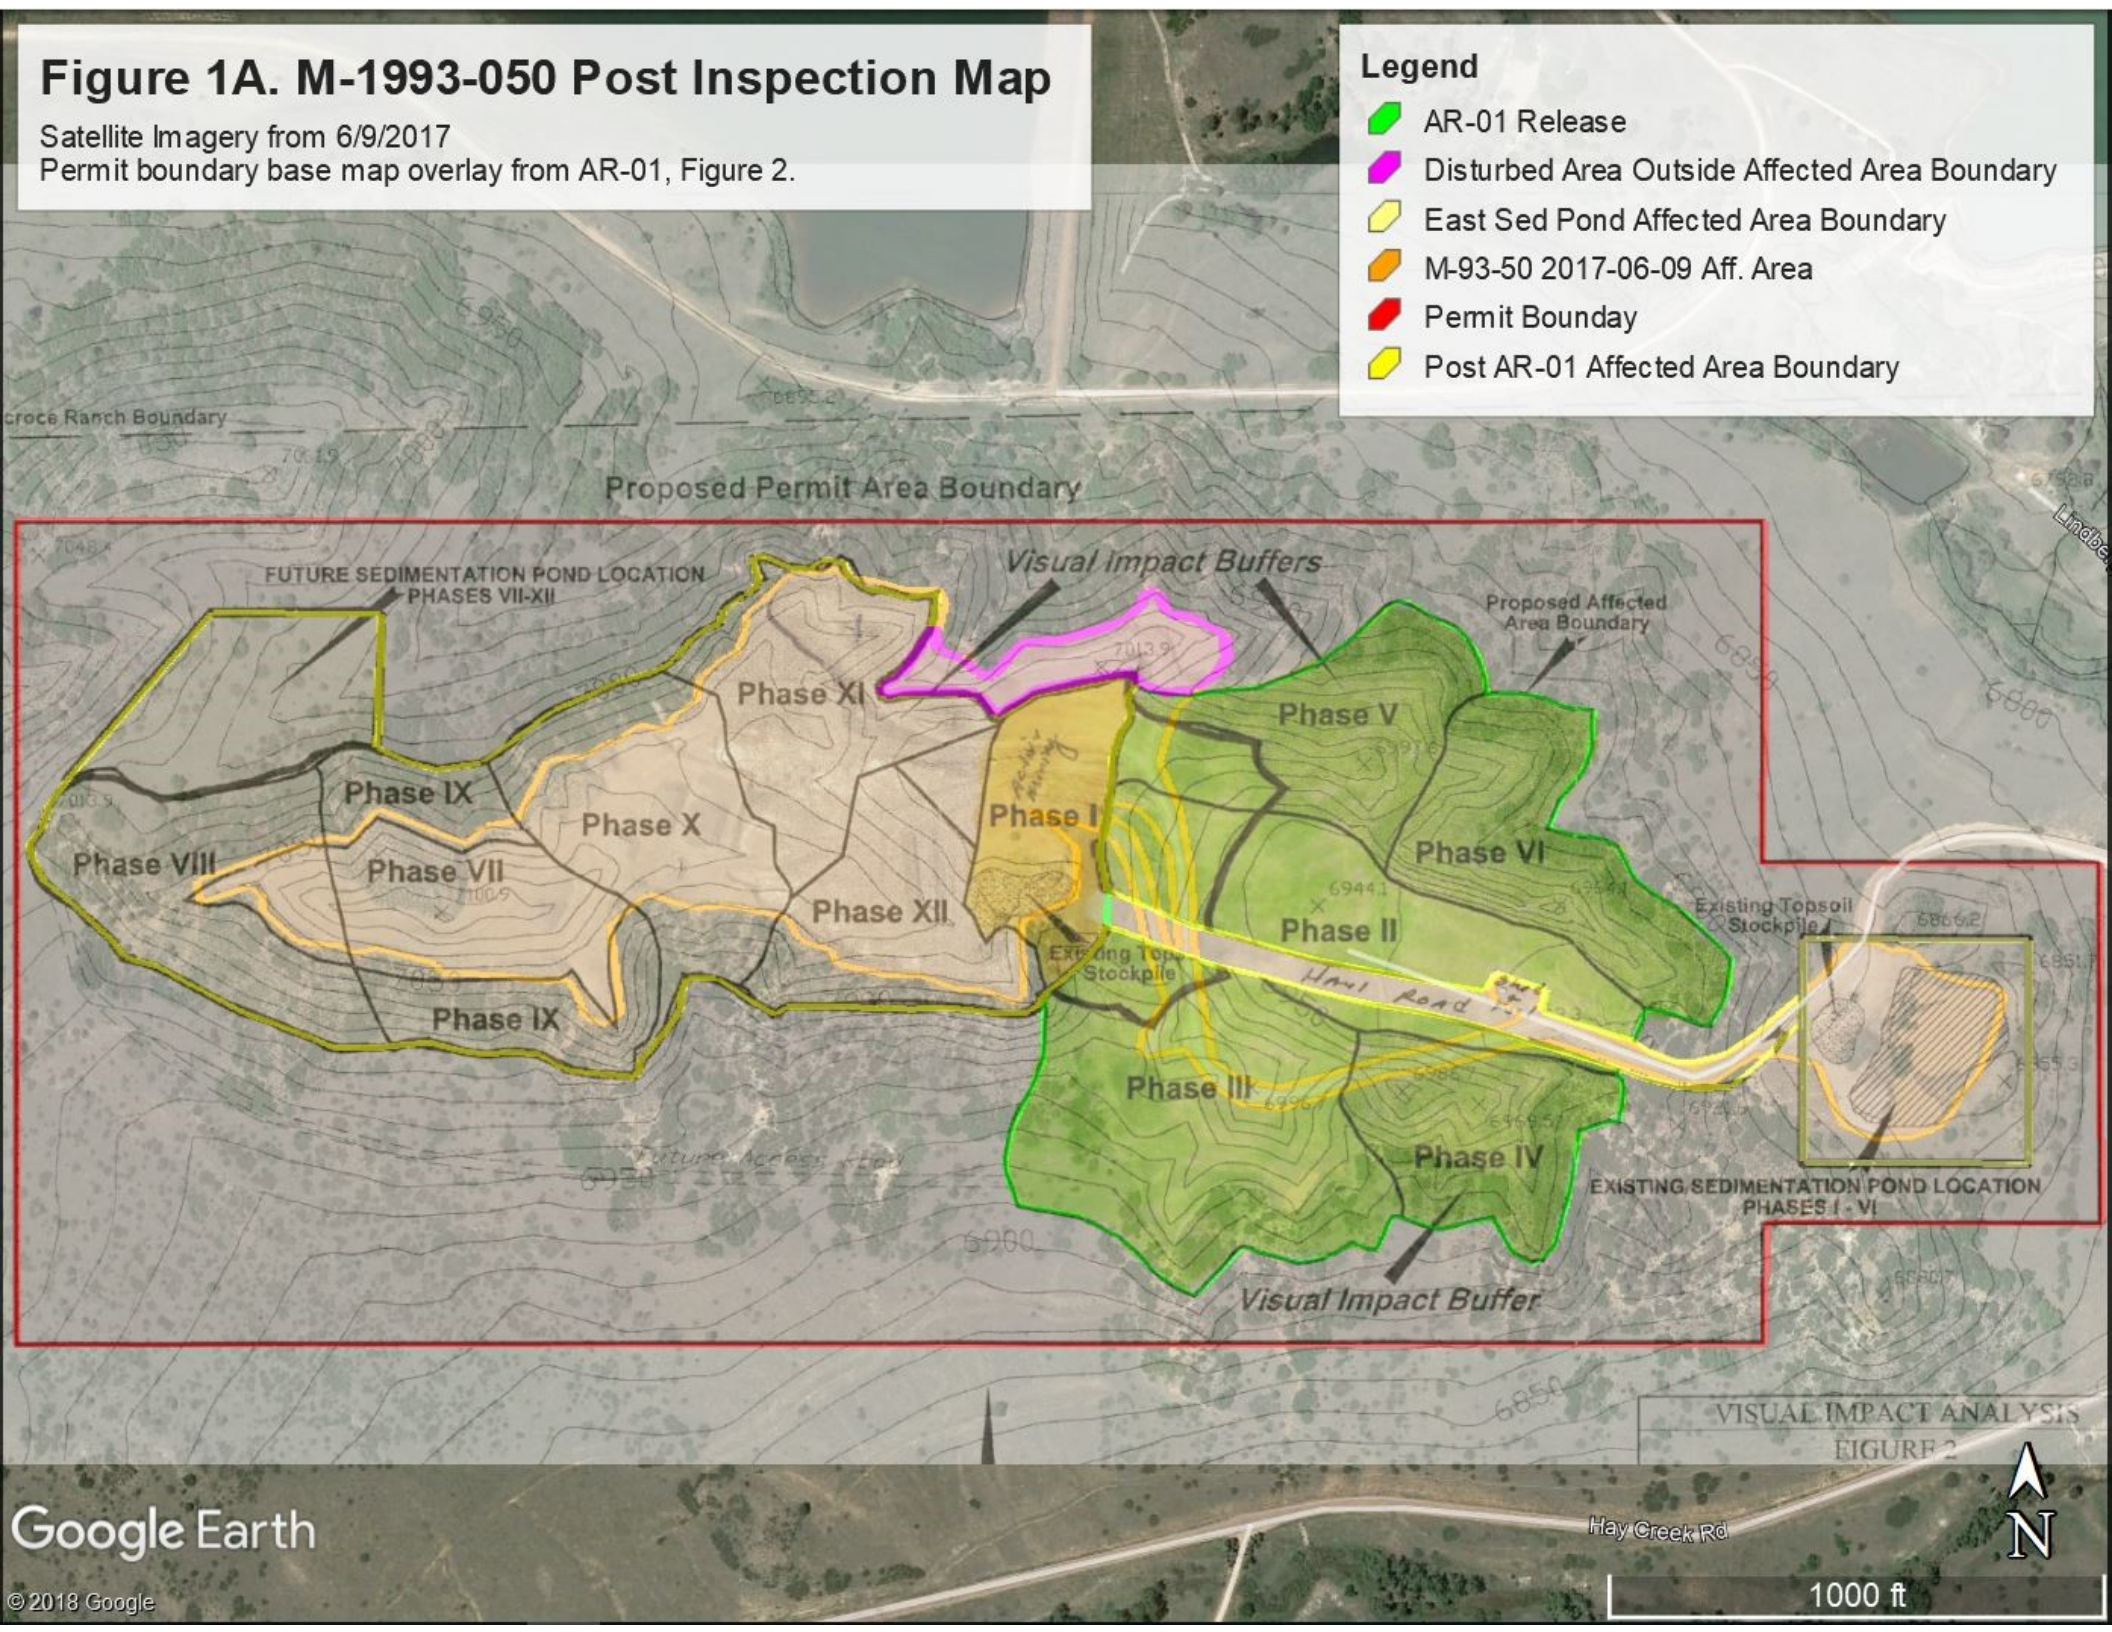
# Figure 1A. M-1993-050 Post Inspection Map

**PROBLEM/POSSIBLE VIOLATION NO. 2:** Problem: Land has been mined outside of the approved affected area boundary. This is a possible violation at this time pursuant to C.R.S. 34-32.5-116(4)(i) for failure to protect areas outside of the affected land from slides or damages occurring during the mining operation.

**CORRECTIVE ACTIONS:** Submit an amendment application to increase the affected area boundary to include the disturbed area and place affected area boundary markers to help prevent additional mining outside the affected area boundary.
