MINERALS PROGRAM INSPECTION REPORT
PHONE: (303) 866-3567

MINE NAME: Climax Mine	MINE/PROSPECTING ID#: M-1977-493	MINERAL: Molybdenum	COUNTY: Summit
INSPECTION TYPE: Monitoring	INSPECTOR(S): Jared L. Ebert	INSP. DATE: November 16, 2018	INSP. TIME: 08:45
OPERATOR: Climax Molybdenum Company	OPERATOR REPRESENTATIVE: Diana Keltz	TYPE OF OPERATION: 112d-3 - Designated Mining Operation	
REASON FOR INSPECTION: Normal I&E Program	BOND CALCULATION TYPE: None	BOND AMOUNT: \$78,246,088.00	
DATE OF COMPLAINT: NA	POST INSP. CONTACTS: None	JOINT INSP. AGENCY: None	
WEATHER: Clear	INSPECTOR'S SIGNATURE:

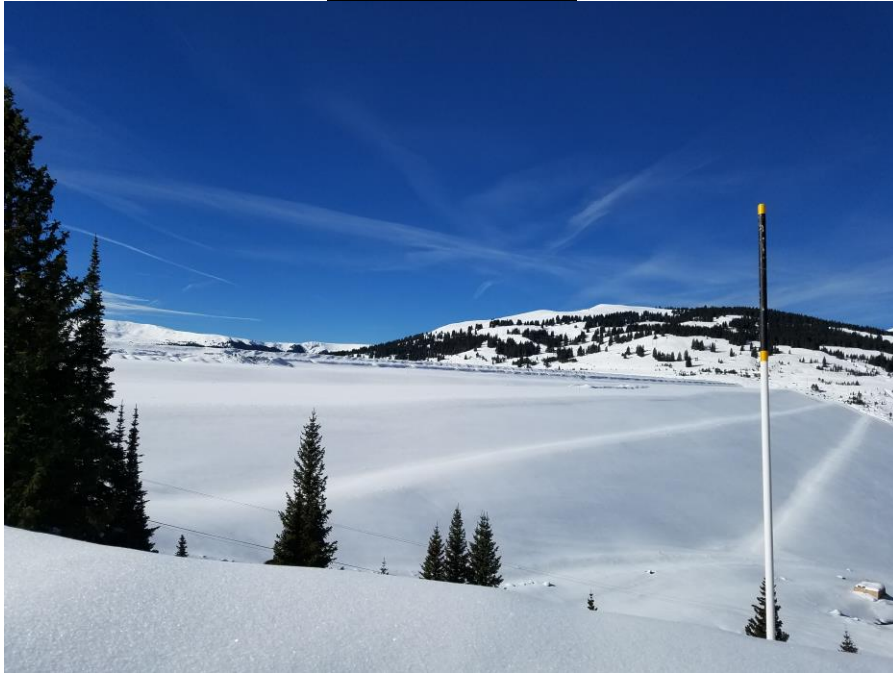
1 Dam, 3 Dam and 5 Dam were observed. These facilities were snow covered but appeared stable. The Robinson Lake Dam was also observed. This dam was snow covered but appeared stable.

Figure 1. 3 Dam, from the east side looking west.

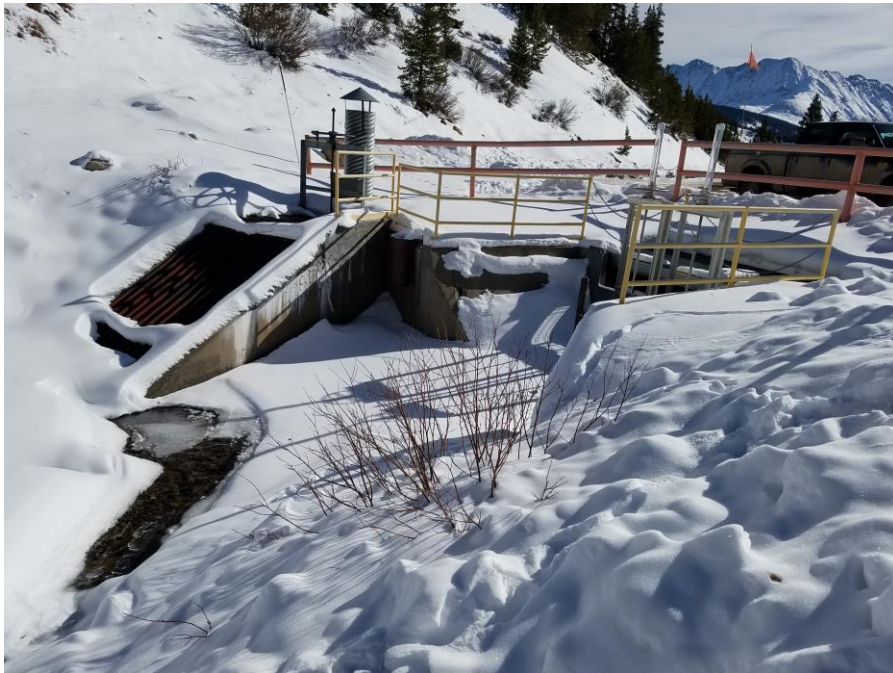
The repairs to the West Interceptor approved with Technical Revision No. 28 (TR28) have been completed. The majority of the West Interceptor was snow covered, but no problems were noted with the areas observed. The inlet and outlet structures installed at the intersection of Searle Creek were observed and appeared functional.

Figure 2. Outlet structure at the intersection of the West Interceptor and Searle Creek.

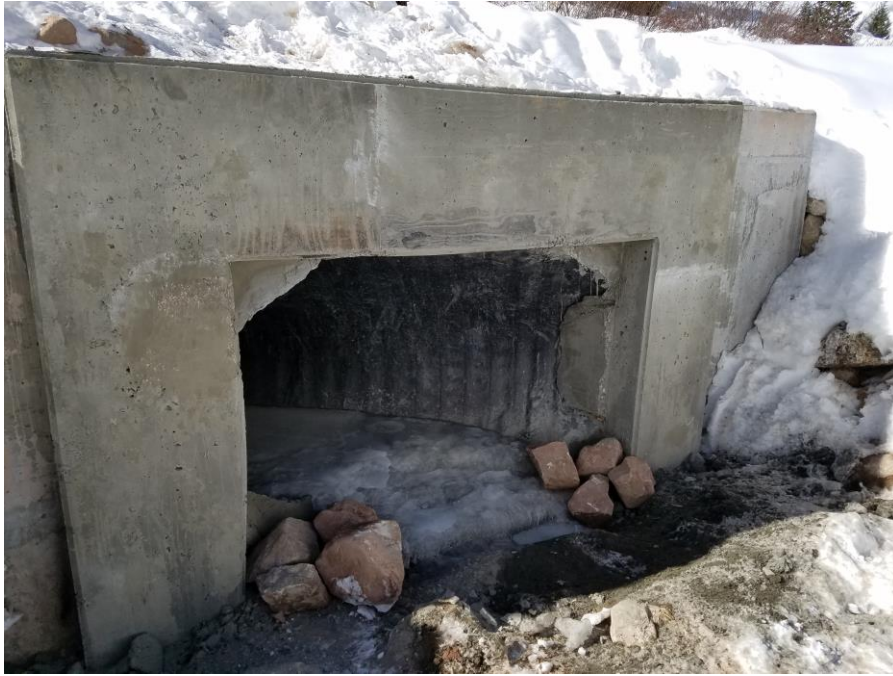
Figure 3. Outlet structure at the intersection of the West Interceptor and Searle Creek.

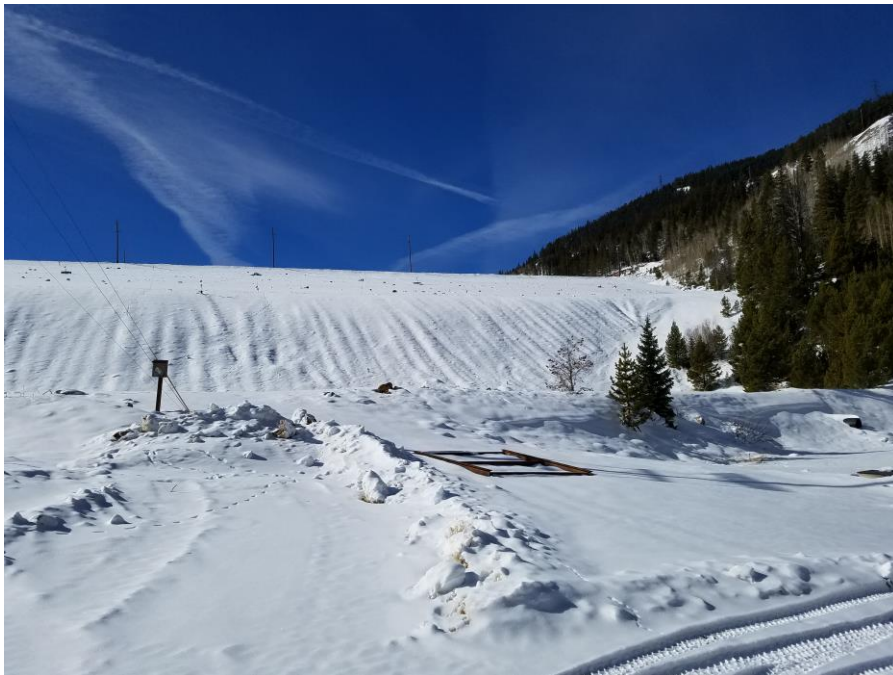
Figure 4. From the toe of 5 Dam looking southwest.

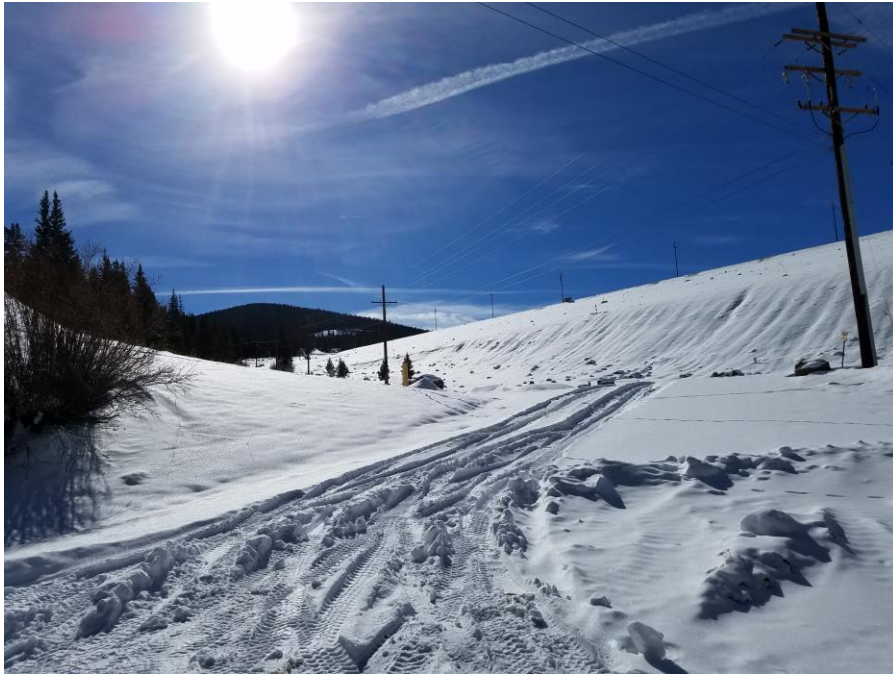
Figure 5. From the toe of 5 Dam looking southeast.

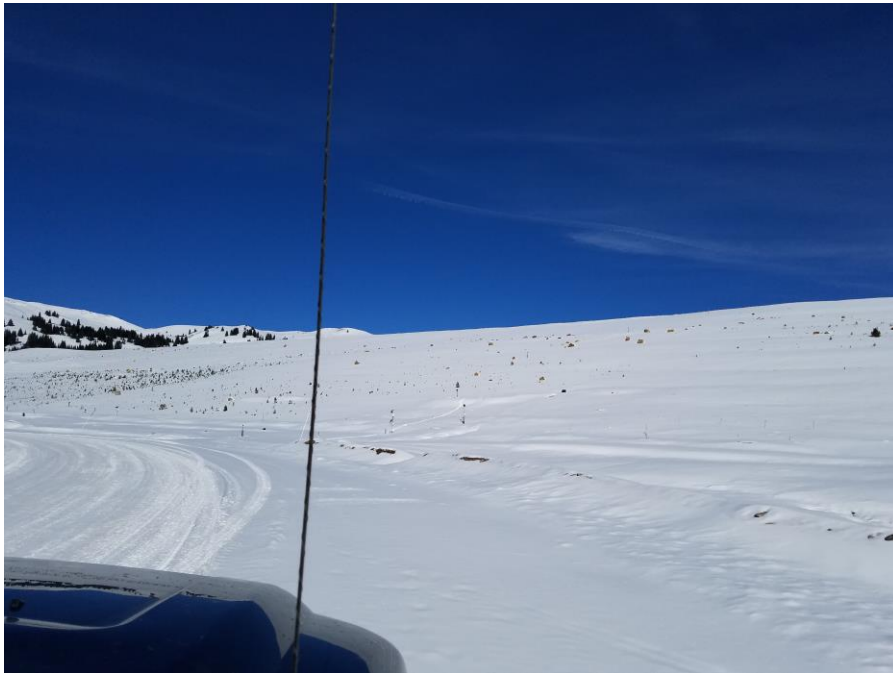
Figure 6. From the toe of 1 Dam looking northwest.

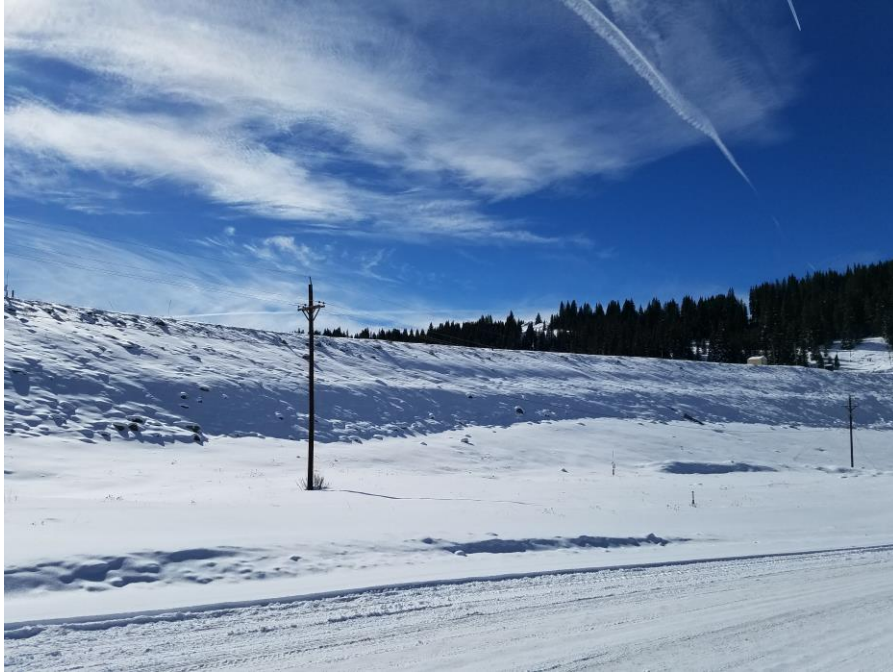
Figure 7. From the toe of Robinson Dam looking south.
