**Re: Permit No. M-2012-052; Cripple Creek & Victor Gold Mining Company; Providence Permit – July 2018 Inspection Findings and Corrective Actions**

## 1.0 Introduction

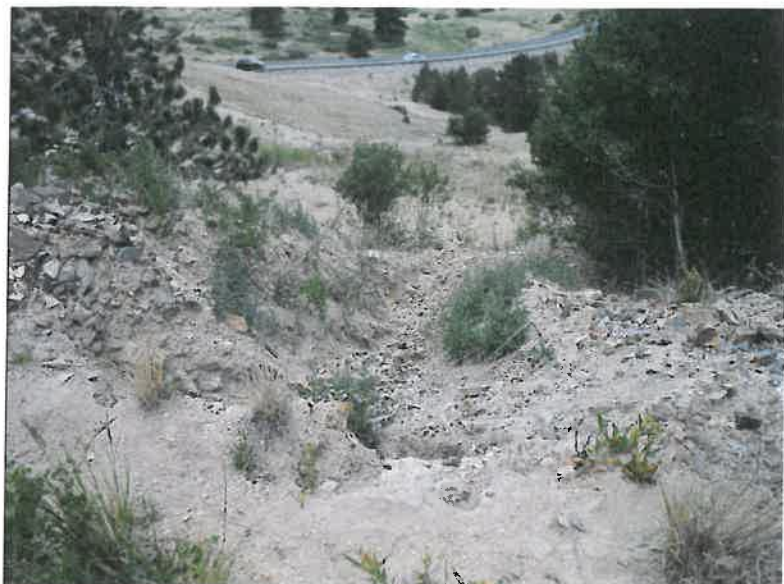
*Erosion gullies and ruts were observed on-site. This is a problem at this time for failure to protect the affected land from erosion pursuant to C.R.S. 34-32-116(4)(i).*

**Photo 1.**  
Erosion Gully 1 as shown in DRMS  
Inspection report, looking west. Photo taken  
7/12/18.

**CC&V has taken action to repair gullies and stabilize the area to prevent further erosion. Erosion gullies were filled in and graded; existing berms were reconstructed and stabilized. Photos 1-3 demonstrate before and after conditions for Gully 1, and photos 3-6 demonstrate before and after conditions for Gully 2. These repairs were completed in early November, 2018.**

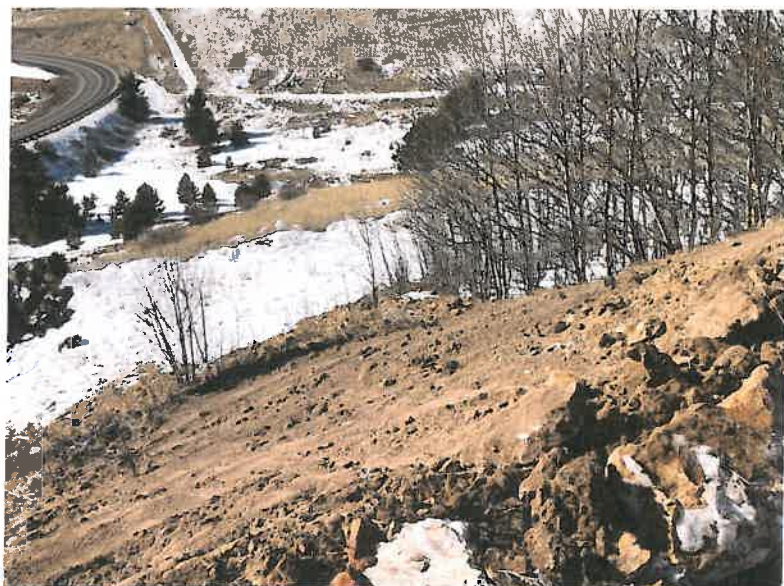
**Photo 2.**  
Erosion Gully 1 after repair, looking west.  
Photo taken 11/14/18.

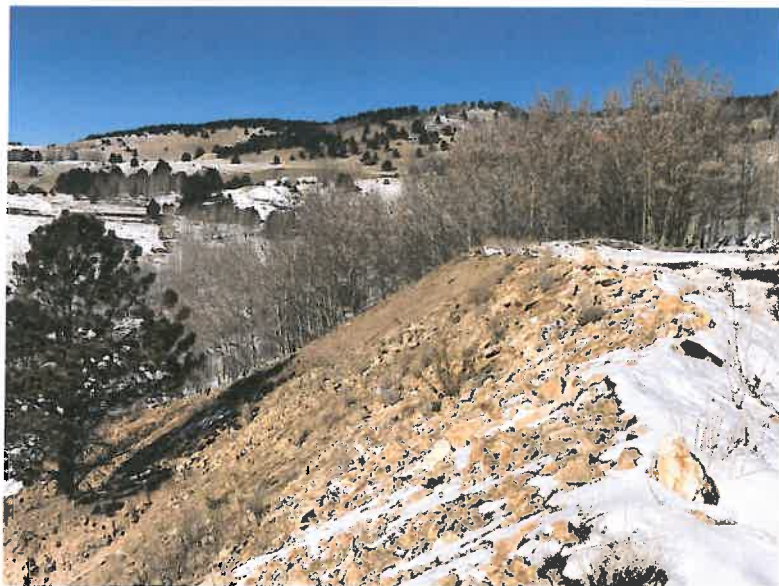
**Photo 3.**  
Erosion Gully 1 and surrounding slope after  
repair, looking north. Photo taken 11/14/18.

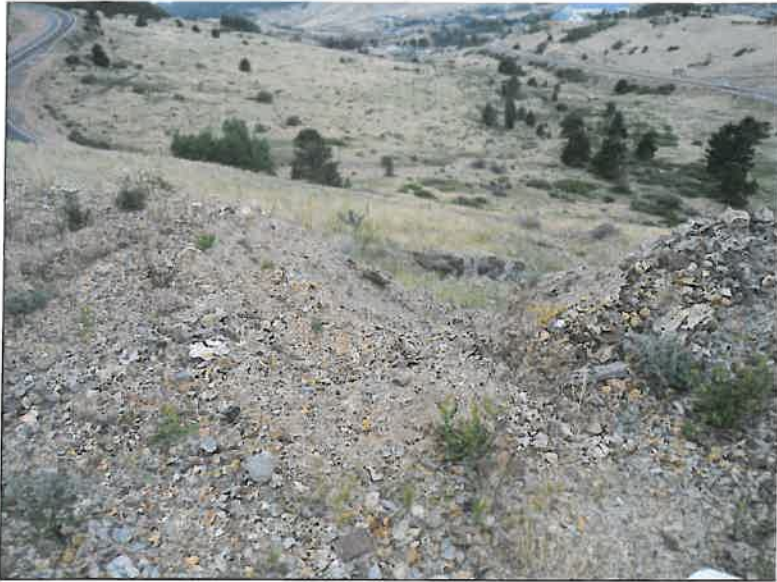
**Photo 4.**  
Erosion Gully 2 as shown in DRMS  
Inspection report, looking southwest. Photo  
taken 7/12/18.

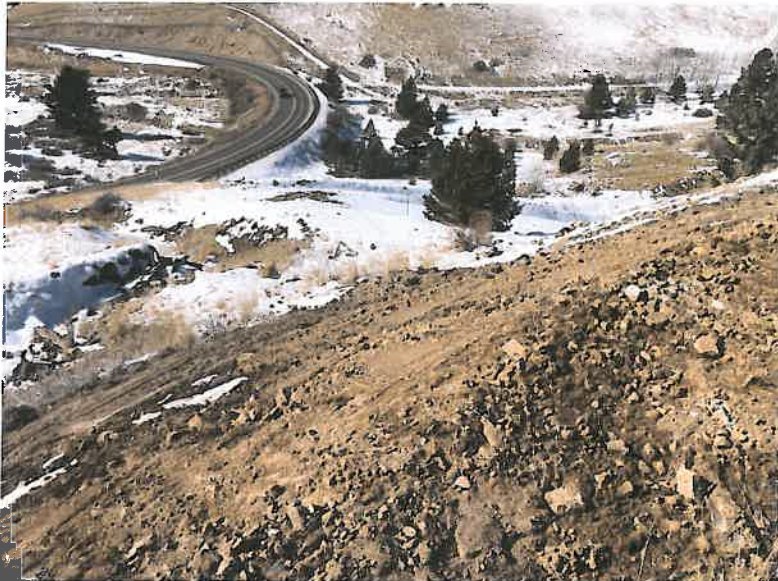
**Photo 5.**  
Erosion Gully 2 after repair, looking  
northwest. Photo taken 11/14/18.

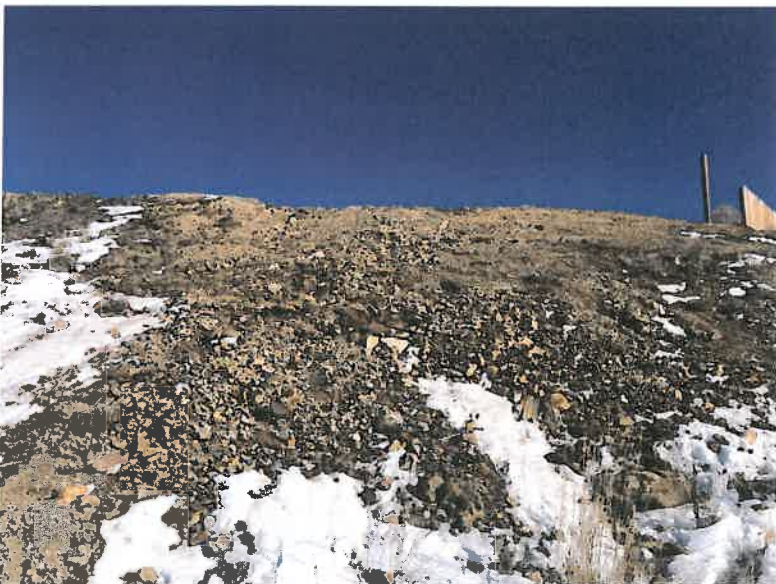
**Photo 6.**  
Erosion Gully 2 and surrounding slope after  
repair, looking east from bottom of slope. Photo  
taken 11/14/18.

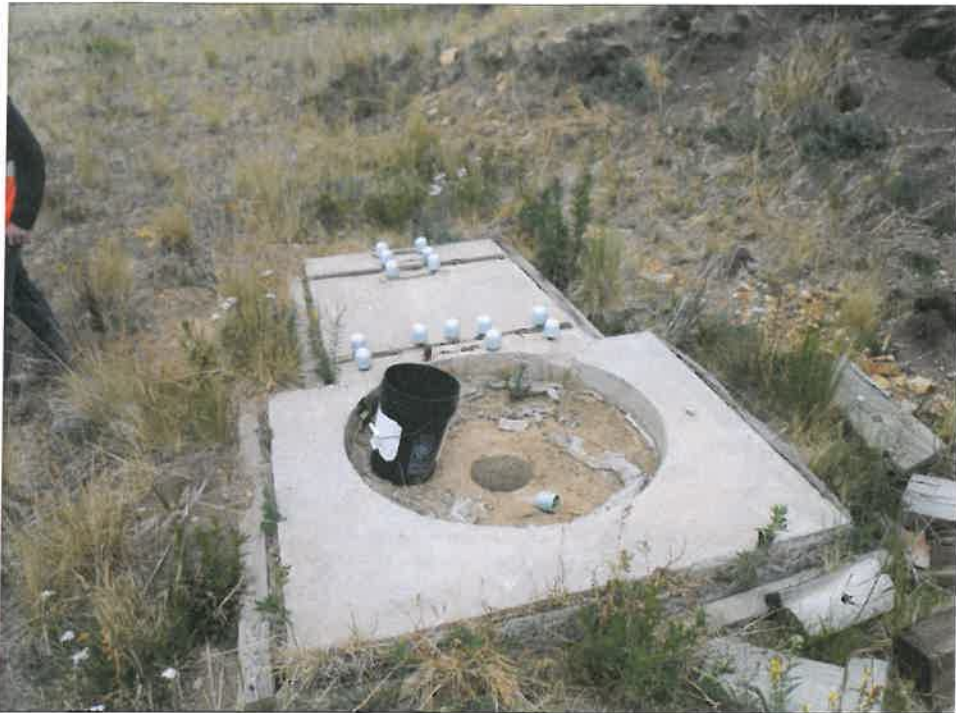
*There are two open and unsecure boreholes within the Air Raise area.*

**Photo 7.**  
Open Borehole 1 as shown in  
DRMS Inspection report, looking  
northwest. Photo taken 7/12/18.

**In order to secure the two open boreholes, metal grating was bolted over borehole openings. Each grate is secured with four 0.5" concrete anchor bolts. This correction will safeguard the boreholes without interrupting any unidentified function as vent openings for historic or current operational purposes associated with the nearby Molly Kathleen Mine. Photos 7-10 demonstrate before and after conditions of the vent boreholes. These grates were installed in early November 2018.**

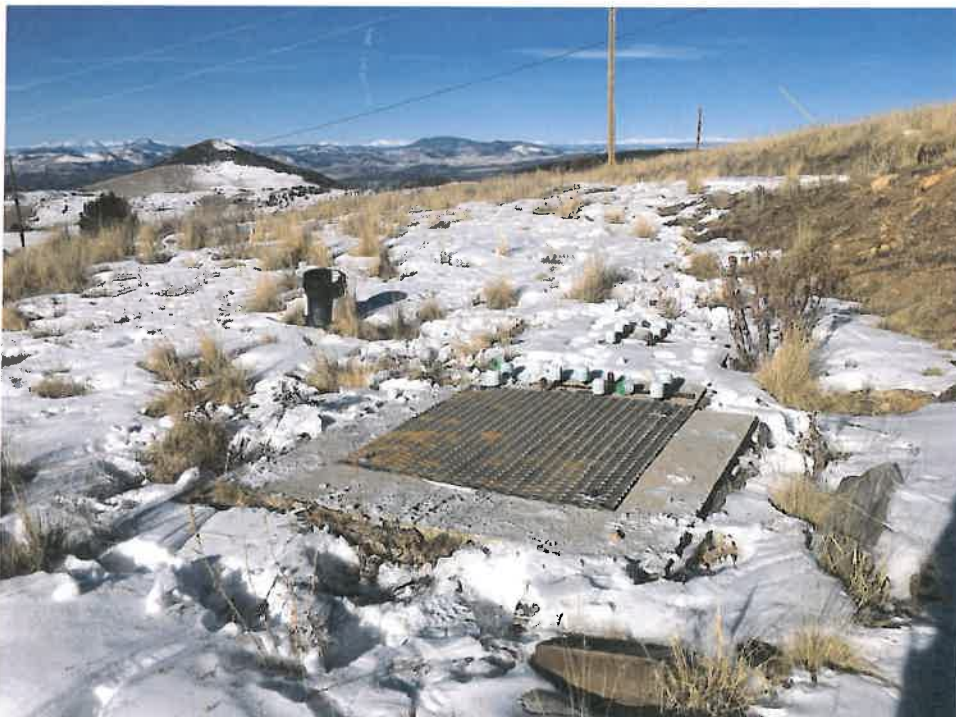
**Photo 8.**  
Open Borehole 1 after safeguard  
installed, looking west. Photo  
taken 11/19/18.

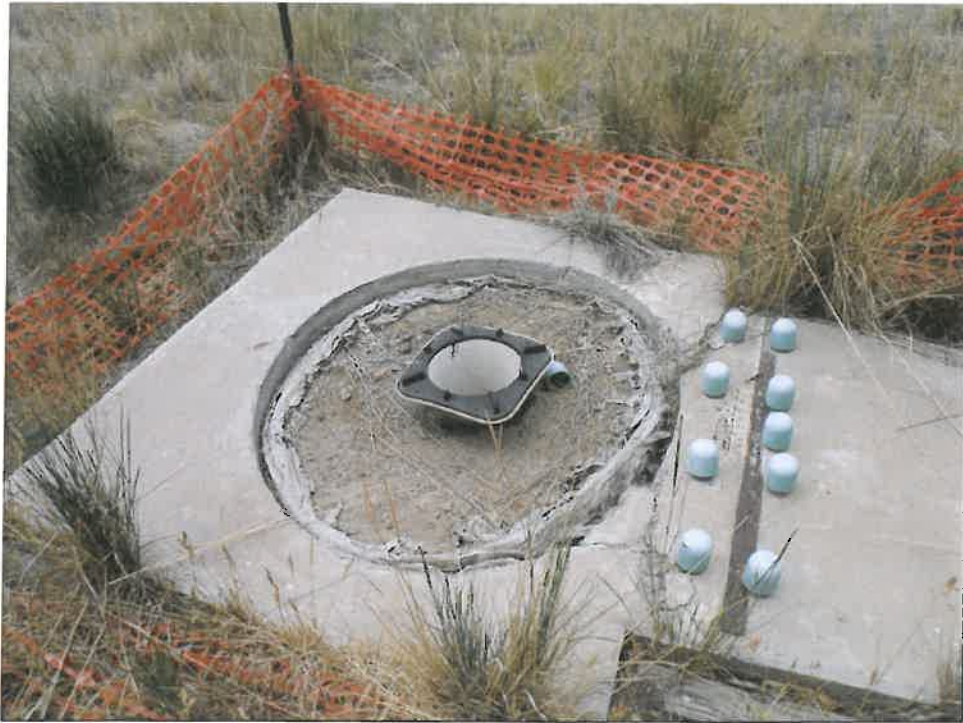
**Photo 9.**  
Open Borehole 2 as shown in  
DRMS Inspection report, looking  
west. Photo taken 7/12/18.

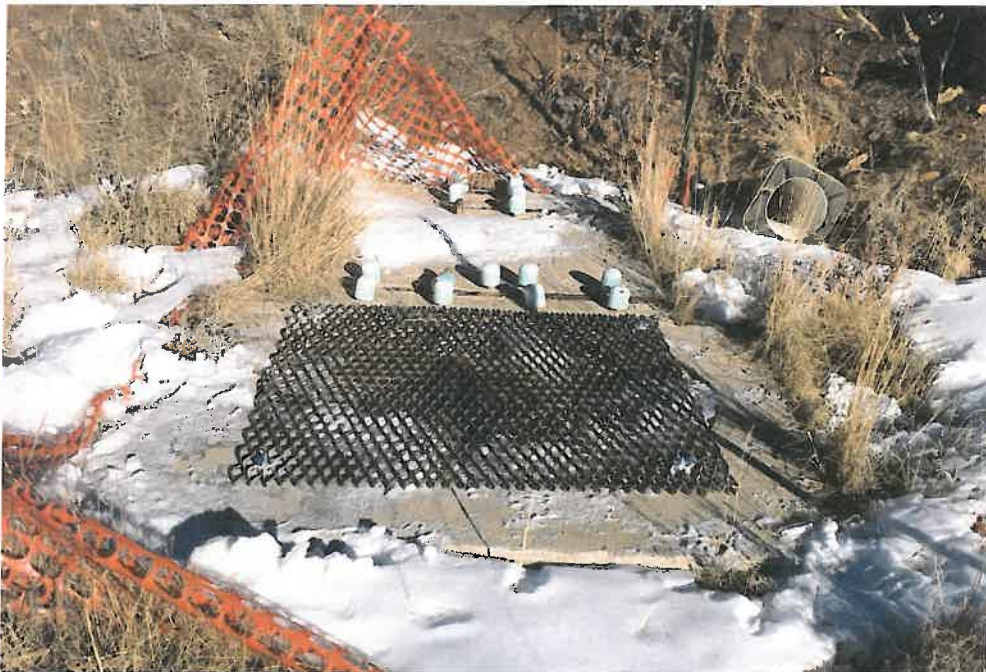
**Photo 10.**  
Open Borehole 2 after safeguard  
installed, looking north. Photo  
taken 11/19/18.

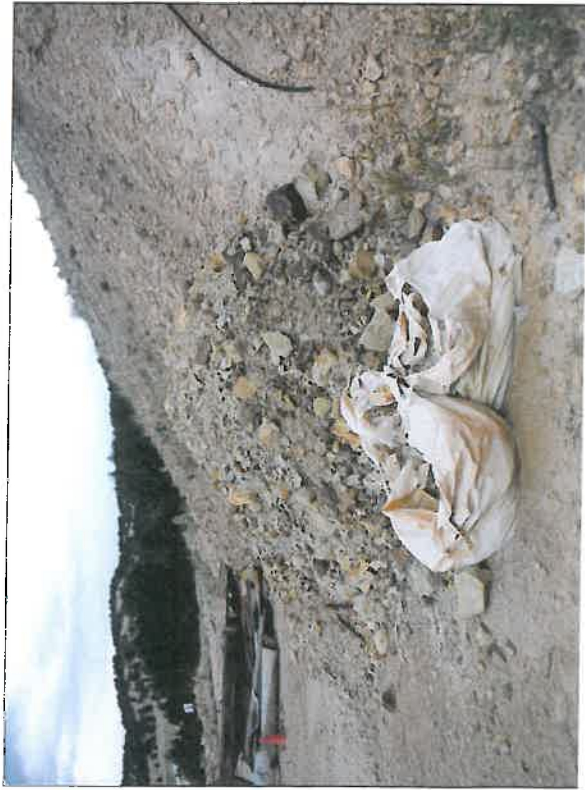
*A small stockpile of waste rock was observed on the surface of the mine site near the Sangre de Cristo Tunnel portal. The Division has no record of a geochemical analysis for this material in accordance with Stipulation No. 1 of the approved permit.*

**Photo 11. (Above)**  
Stockpile as shown in DRMS Inspection report, looking north.  
Photo taken 7/12/18.

**The identified stockpile has been removed and placed on the Valley Leach Facility, within the parameters of the approved stacking plan. The removal site was graded and smoothed to follow the slope of the existing hillside. Photos 11-14 are provided to document before and after conditions of this removed stockpile.**

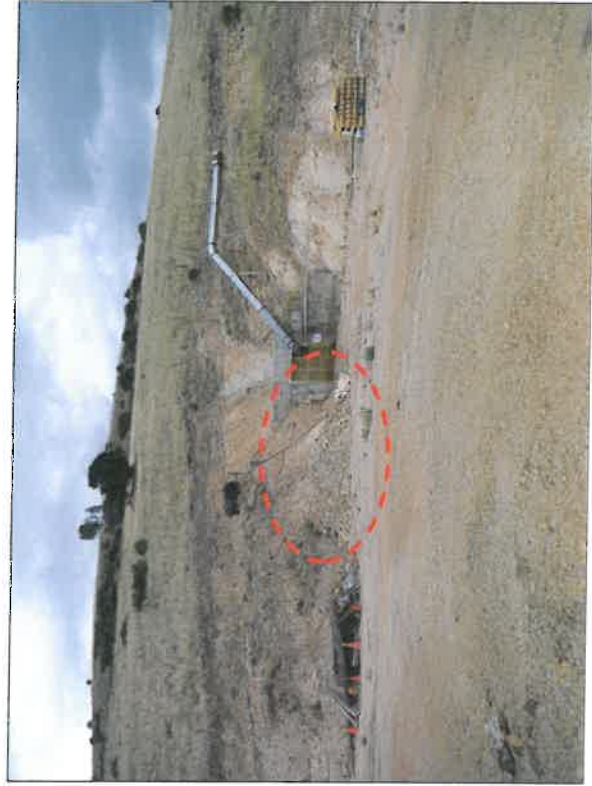
**Photo 12. (Above)**  
Stockpile (circled in red) as shown in DRMS Inspection report, looking east. Photo taken 7/12/18.

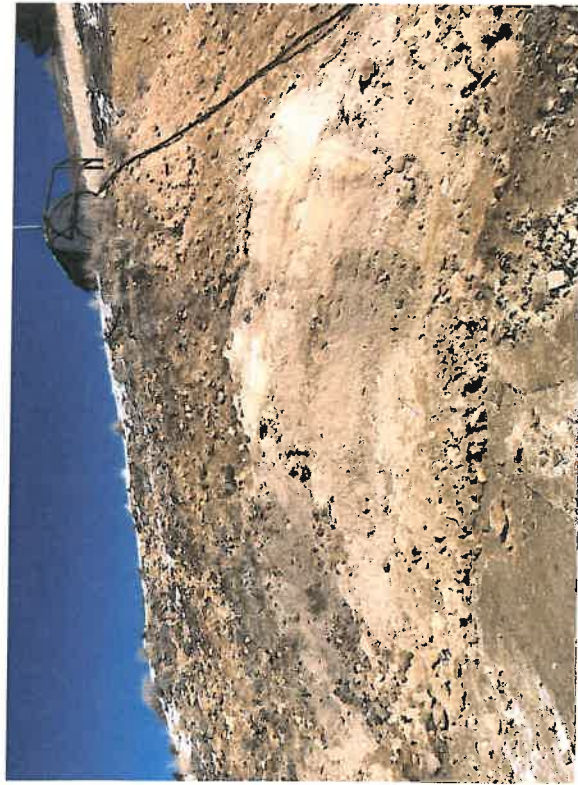
**Photo 13.**  
Removed stockpile area, looking east. Photo taken 11/14/18.

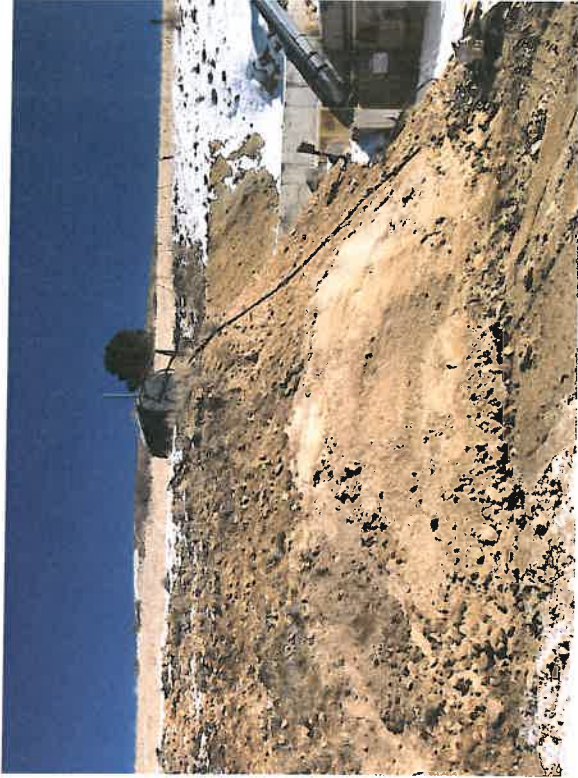
**Photo 14.**  
Removed stockpile area, looking east (Sangre de Cristo Tunnel entrance located to right side of photo). Photo taken 11/14/18.
