**COLORADO**Division of Reclamation,  
Mining and Safety

**MINERALS PROGRAM INSPECTION REPORT****PHONE: (303) 866-3567**

<b>MINE NAME:</b> Kurtz Resource Recovery & Land Development	<b>MINE/PROSPECTING ID#:</b> M-1999-006	<b>MINERAL:</b> Sand and gravel	<b>COUNTY:</b> Weld
<b>INSPECTION TYPE:</b> Monitoring	<b>INSPECTOR(S):</b> Peter S. Hays	<b>INSP. DATE:</b> November 1, 2018	<b>INSP. TIME:</b> 12:30
<b>OPERATOR:</b> Varra Companies, Inc.	<b>OPERATOR REPRESENTATIVE:</b>	<b>TYPE OF OPERATION:</b> 112c - Construction Regular Operation	
<b>REASON FOR INSPECTION:</b> Normal I&E Program	<b>BOND CALCULATION TYPE:</b> Complete Bond	<b>BOND AMOUNT:</b> \$333,800.00	
<b>DATE OF COMPLAINT:</b> NA	<b>POST INSP. CONTACTS:</b> Brad Janes	<b>JOINT INSP. AGENCY:</b> None	
<b>WEATHER:</b> Clear	<b>INSPECTOR'S SIGNATURE:</b>

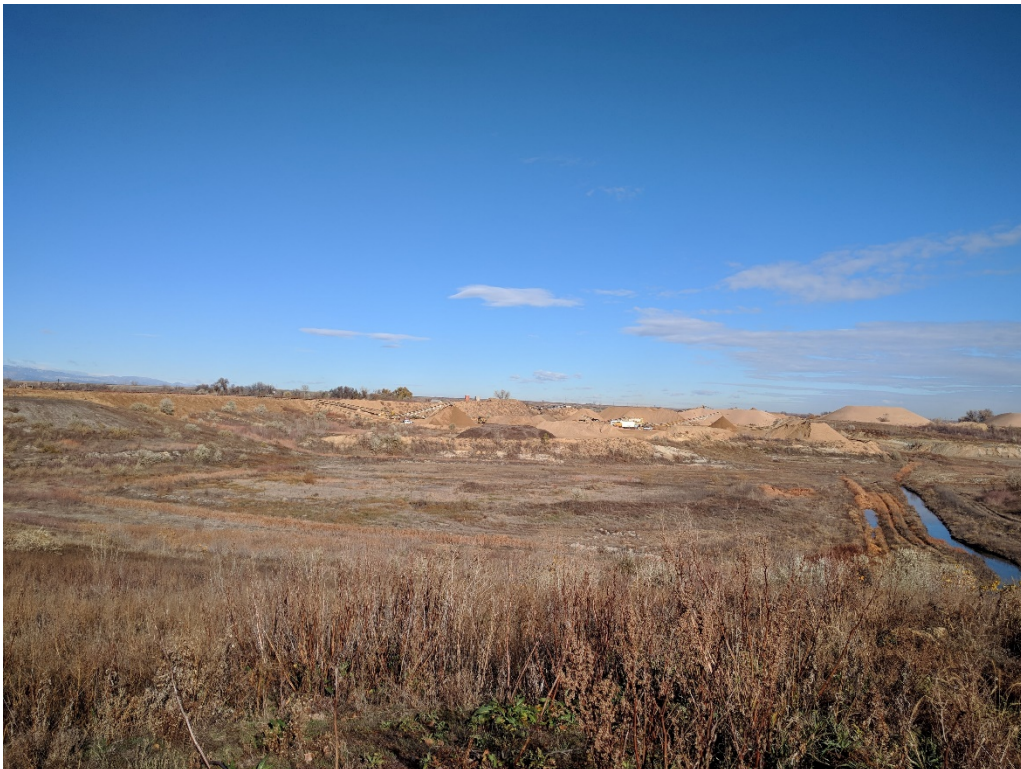
Tract A is located in the southeastern portion of the site. The tract contained the end of the conveyor line, processing plant, material stockpiles and sedimentation ponds. The tract was being actively dewatered by the Operator. The processing plant was located in the northwest corner of the tract. Material conveyed from the Heintzelman Project was being processed during the inspection. The Operator stated the northeast corner of the pit floor may be mined for a road project in the near future. The northeast corner and a portion of the eastern slope are clay lined. No additional clay lining has occurred since the last inspection. The sedimentation ponds located along the western boundary of the tract will be backfilled with waste material as mining continues. The pond backfilling operation is not currently approved in the Mining and Reclamation Plans. The Operator must submit a technical revision to update the approved Mining and Reclamation Plans and Maps to indicate this change. The oil and gas well located in the southwest corner of the tract may be removed and the peninsula may be mined out by the Operator. The Division will require the Operator to revise the approved Mining and Reclamation Plans to remove the peninsula(s) with the submittal of a technical revision or as part of a future permit amendment for the site.

View of Tract A from the south boundary looking north

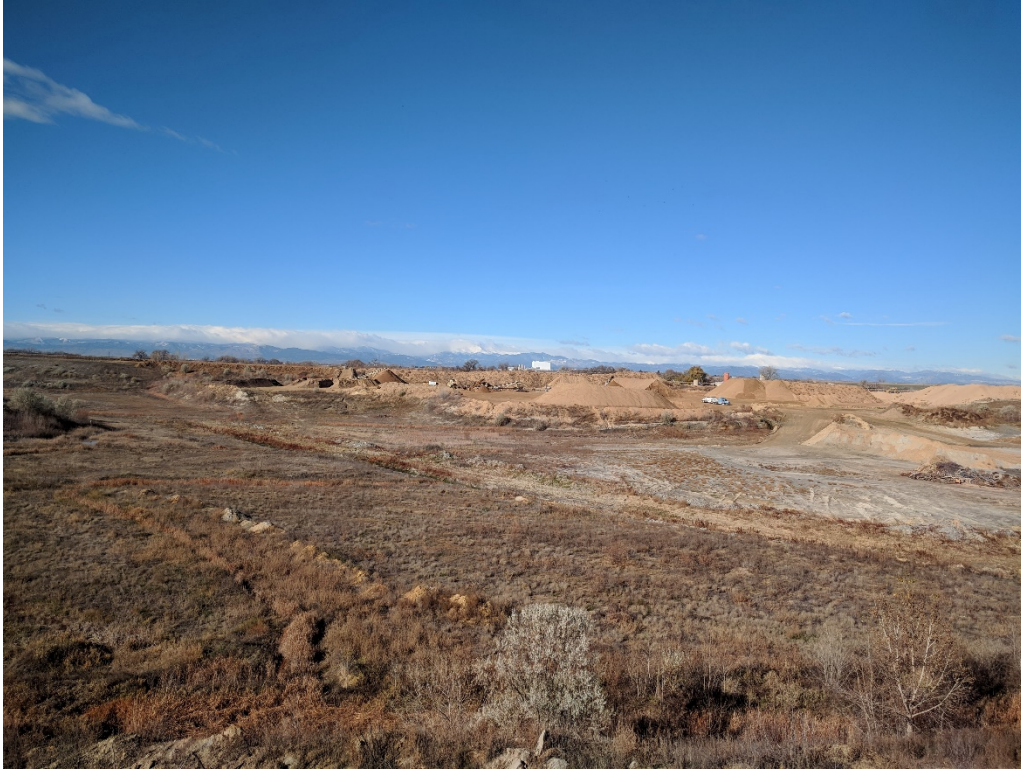
View of the processing area in Tract A looking northwest from the oil and gas peninsula

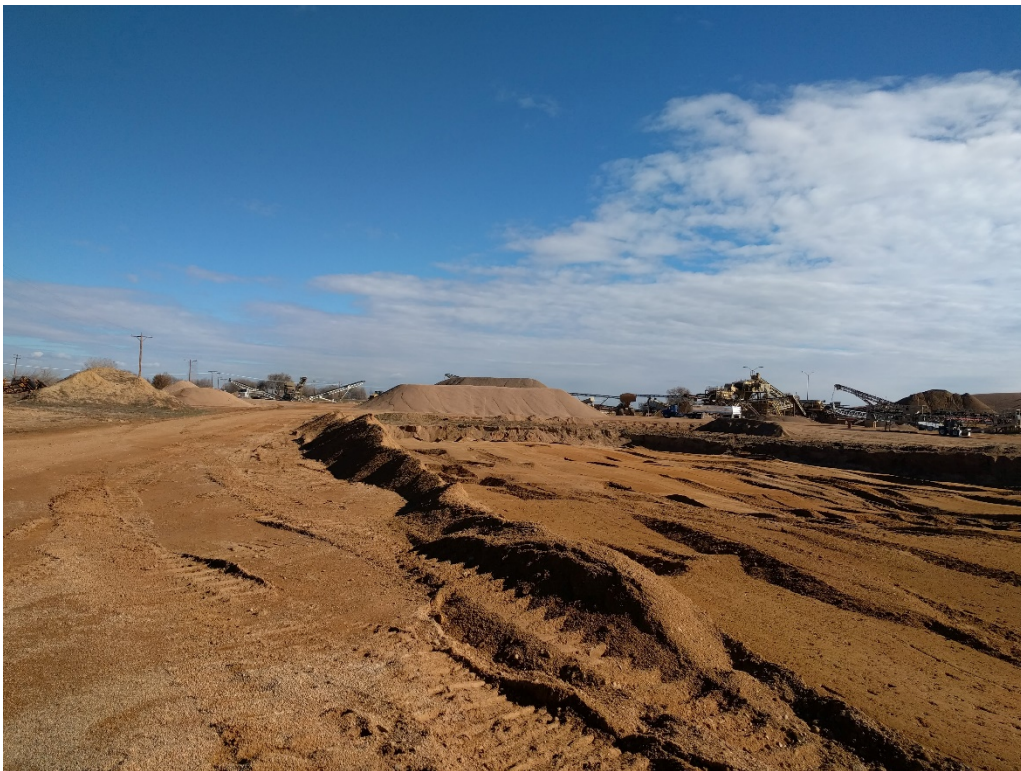
Tract B is located in the northeastern portion of the site. The tract contains processing facilities and product stockpiles. The large sand stockpile located in the eastern portion of the tract has been reduced in size since the last inspection. A new process plant area was being constructed in the southwest portion of the tract.

View of the pad preparation work for the new processing area in Tract B

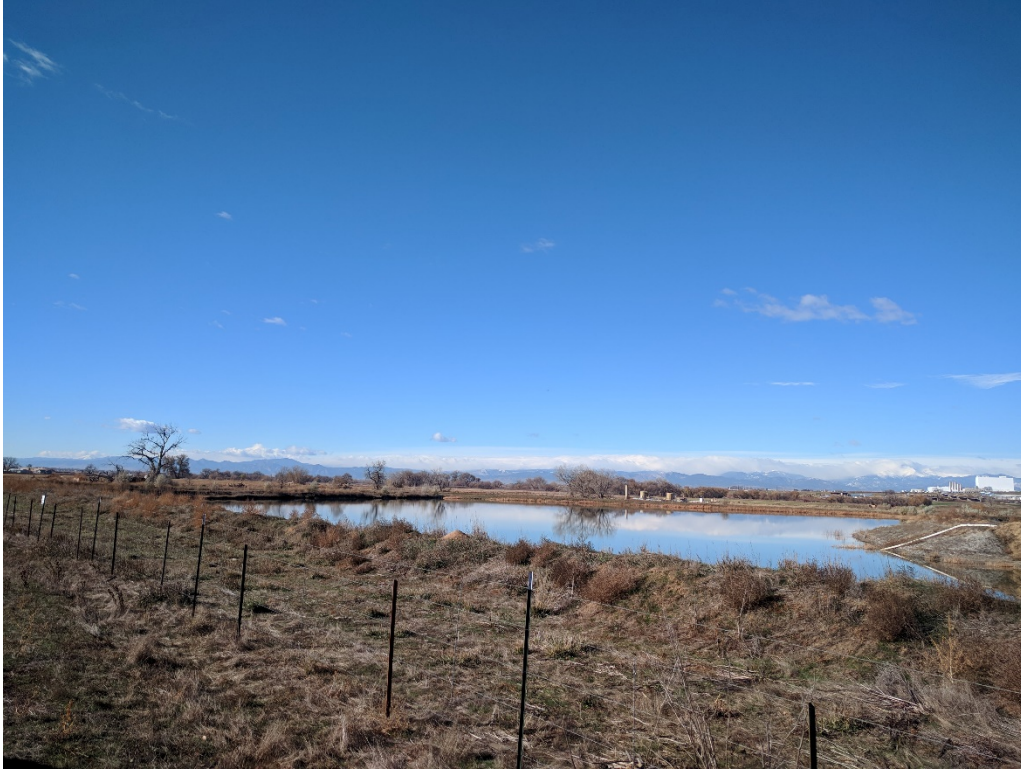
Tract C is located in the southwestern portion of the site. The mining activity in the tract is complete and reclamation activities have begun in the tract. The clay liner is approximately 75% complete with only the northeast corner remaining to be lined. The Operator stated the tract will not be lined and plans to backfill the tract in the future. The Division will require the Operator to submit a technical revision to update the Reclamation Plan for the site prior to backfilling the tract.

View of Tract C from the northeast corner of the tract looking southwest

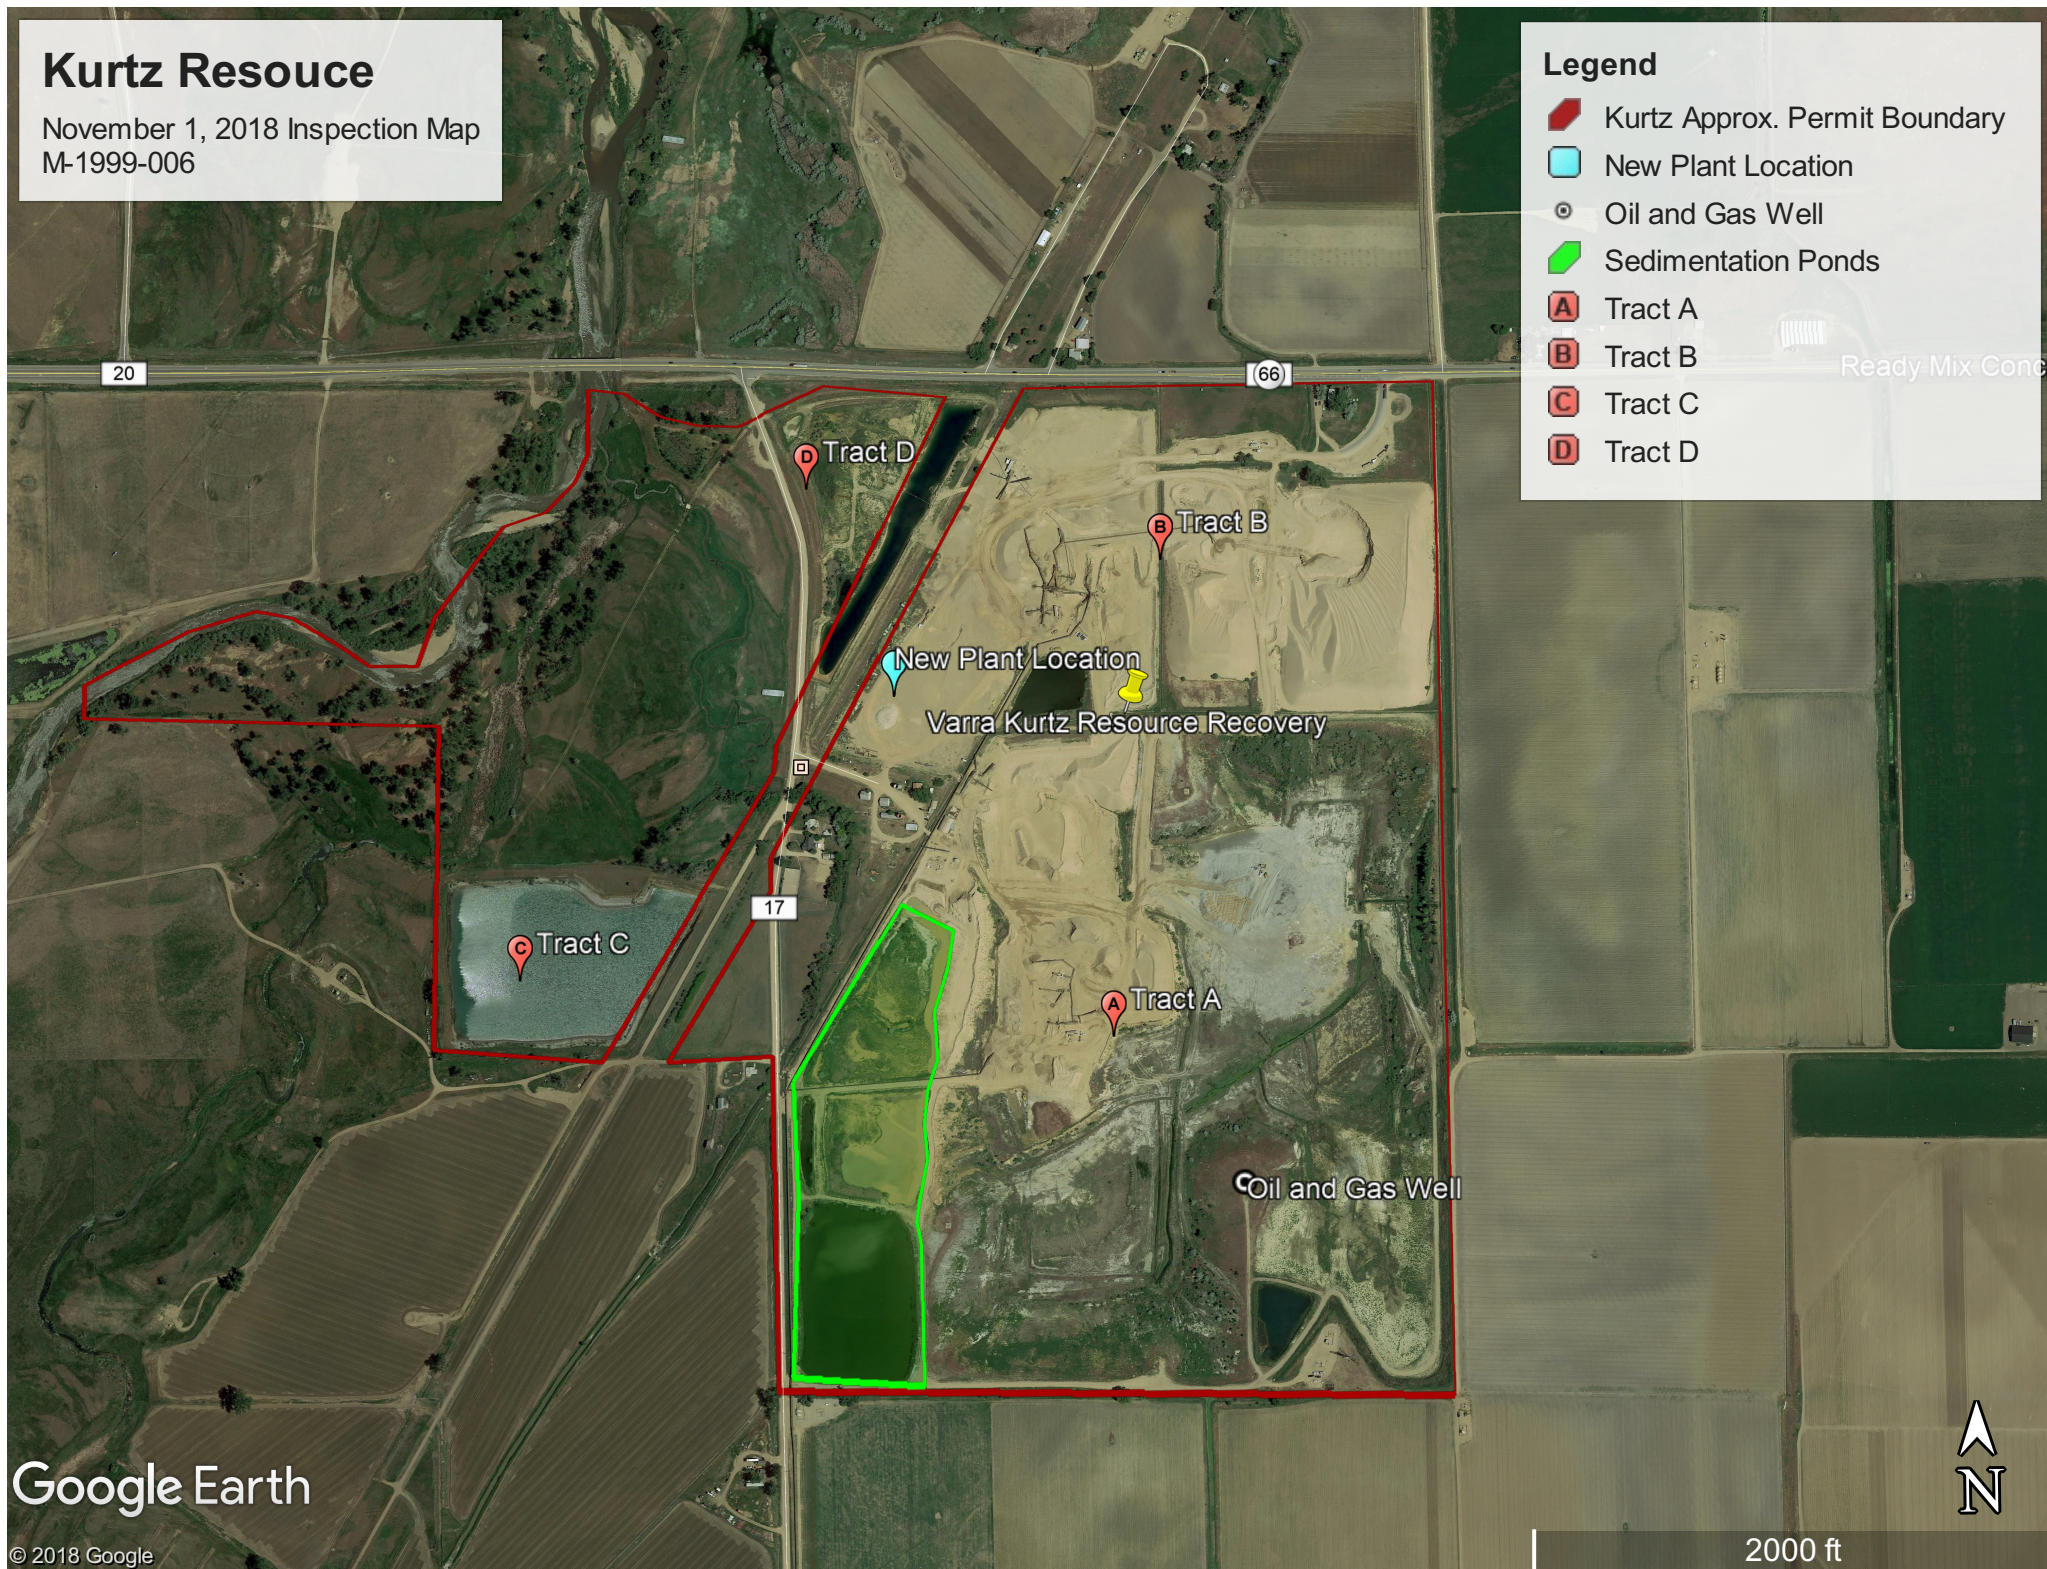
November 1, 2018 Inspection Map  
M-1999-006

The site is permitted for 295.40 acres with a maximum allowed disturbance acreage of 85.20 acres at one time. The Kurtz site is divided into four (4) tracts: Tracts A, B, C and D. The permit was most recently revised by technical revision no. 4 (TR-04) in 2011 to account for the conveyor route from the Heintzelman Project. The conveyor route was constructed in 2012 and was operational during the inspection. The site was actively mining, processing and hauling materials during the inspection. The mine sign was posted at the mine site entrance as required by Rule 3.1.12 and the permit boundaries were clearly delineated. An inspection map created by the Division based on the observations from the inspection is attached.
