**MINERALS PROGRAM INSPECTION REPORT**  
**PHONE: (303) 866-3567**

<b>MINE NAME:</b> Stevens Clay Lease	<b>MINE/PROSPECTING ID#:</b> M-1996-064	<b>MINERAL:</b> Clay (general)	<b>COUNTY:</b> Douglas
<b>INSPECTION TYPE:</b> Monitoring	<b>INSPECTOR(S):</b> Peter S. Hays	<b>INSP. DATE:</b> November 14, 2018	<b>INSP. TIME:</b> 09:00
<b>OPERATOR:</b> The Denver Brick Company	<b>OPERATOR REPRESENTATIVE:</b> Rob Tibbetts	<b>TYPE OF OPERATION:</b> 112c - Construction Regular Operation	
<b>REASON FOR INSPECTION:</b> Normal I&E Program	<b>BOND CALCULATION TYPE:</b> Partial Bond	<b>BOND AMOUNT:</b> \$148,000.00	
<b>DATE OF COMPLAINT:</b> NA	<b>POST INSP. CONTACTS:</b> None	<b>JOINT INSP. AGENCY:</b> None	
<b>WEATHER:</b> Clear	<b>INSPECTOR'S SIGNATURE:</b>

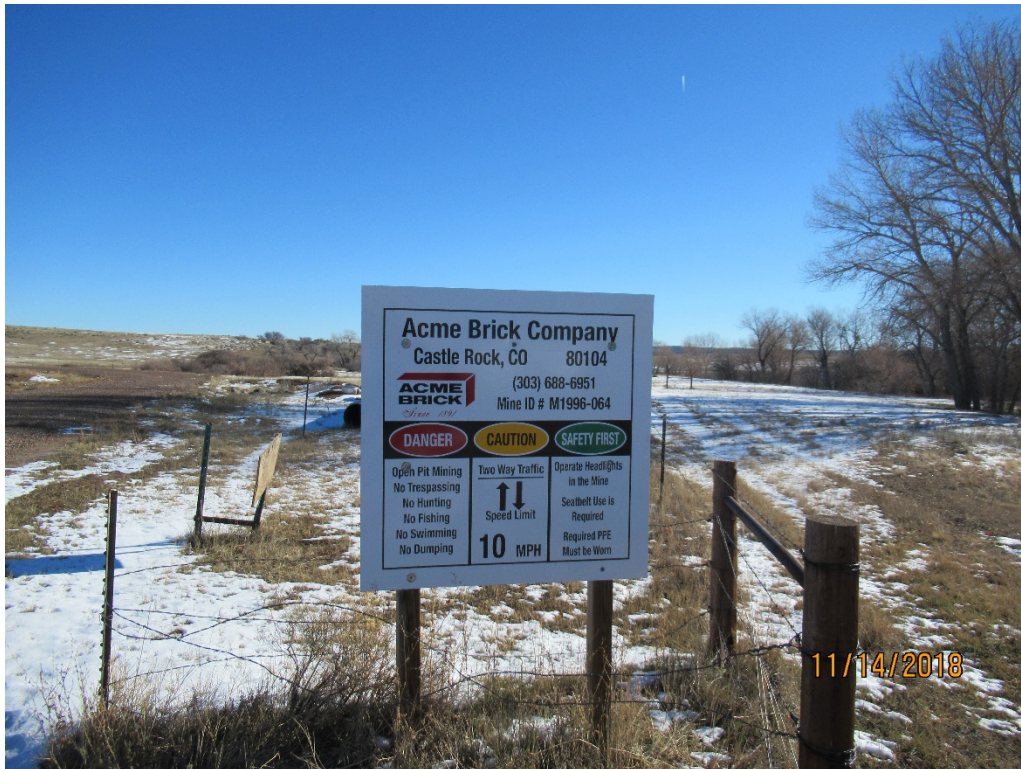
Stevens Clay Mine sign

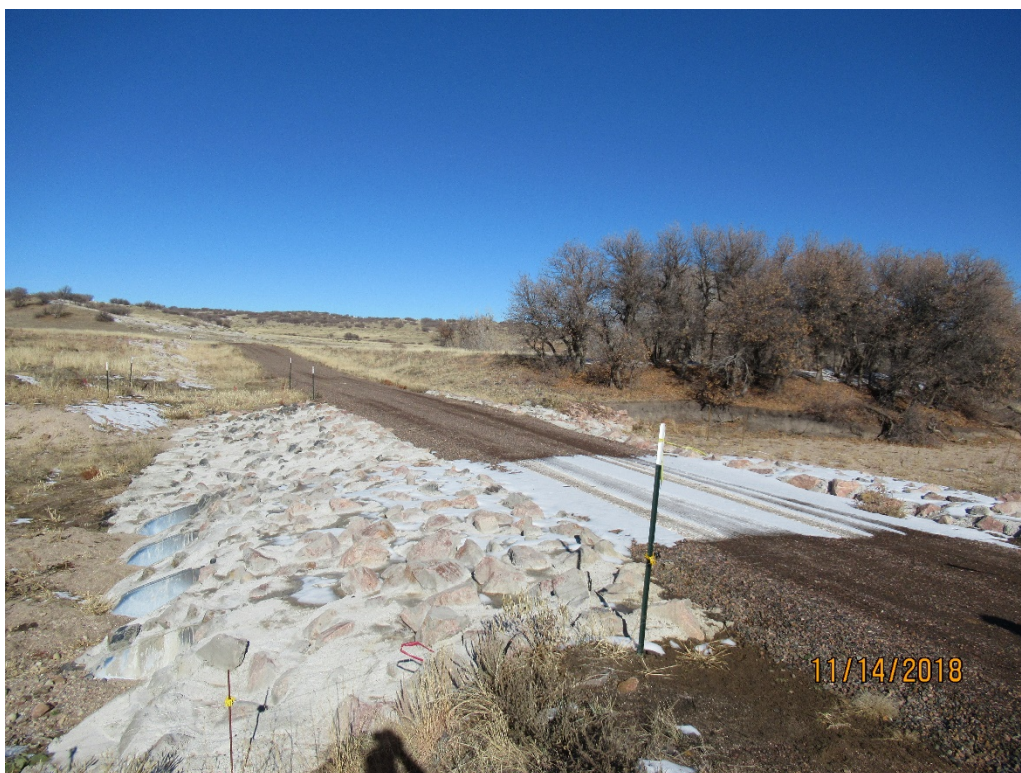
The site is an 112c Construction Materials permit for 40.20 total acres with 20.80 acres of disturbance. The Division currently holds a financial warranty in the amount of \$148,000.00, which appeared adequate to reclaim the current site disturbance. A mine sign and boundary markers were observed as required by Rule 3.1.12. The site was inactive during the inspection. The access road damaged during a flood event at the Lemon Gulch crossing in 2015 was repaired in May 2018.

Repaired section of access road

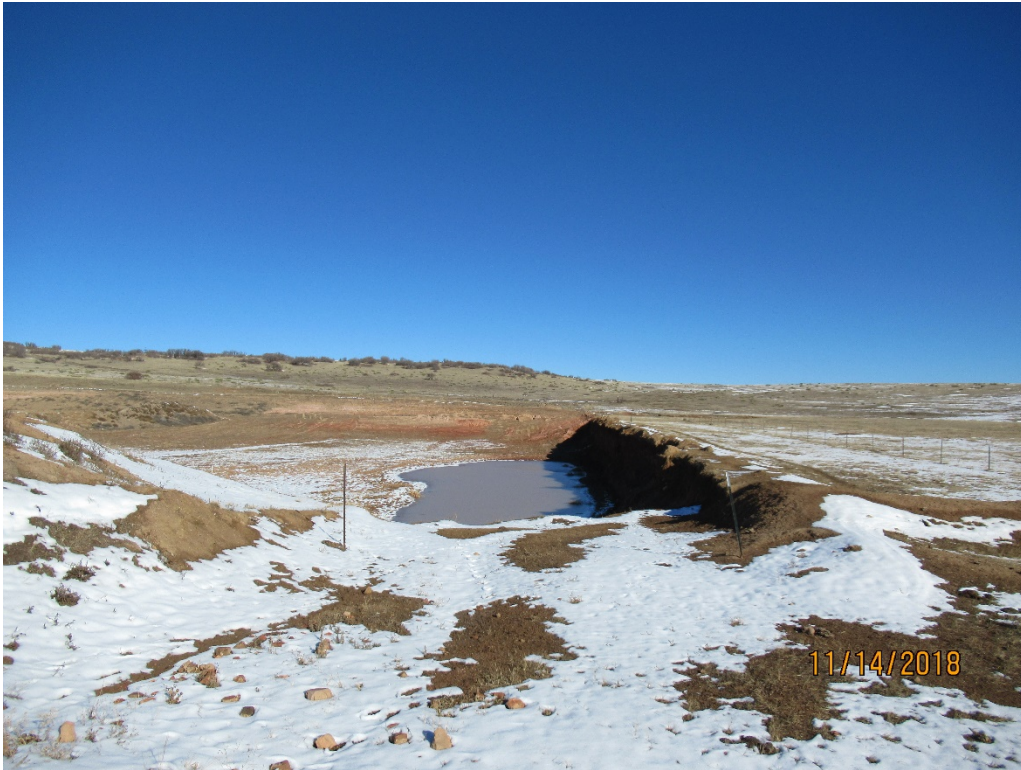
View of site from the southeast corner of the pit looking north

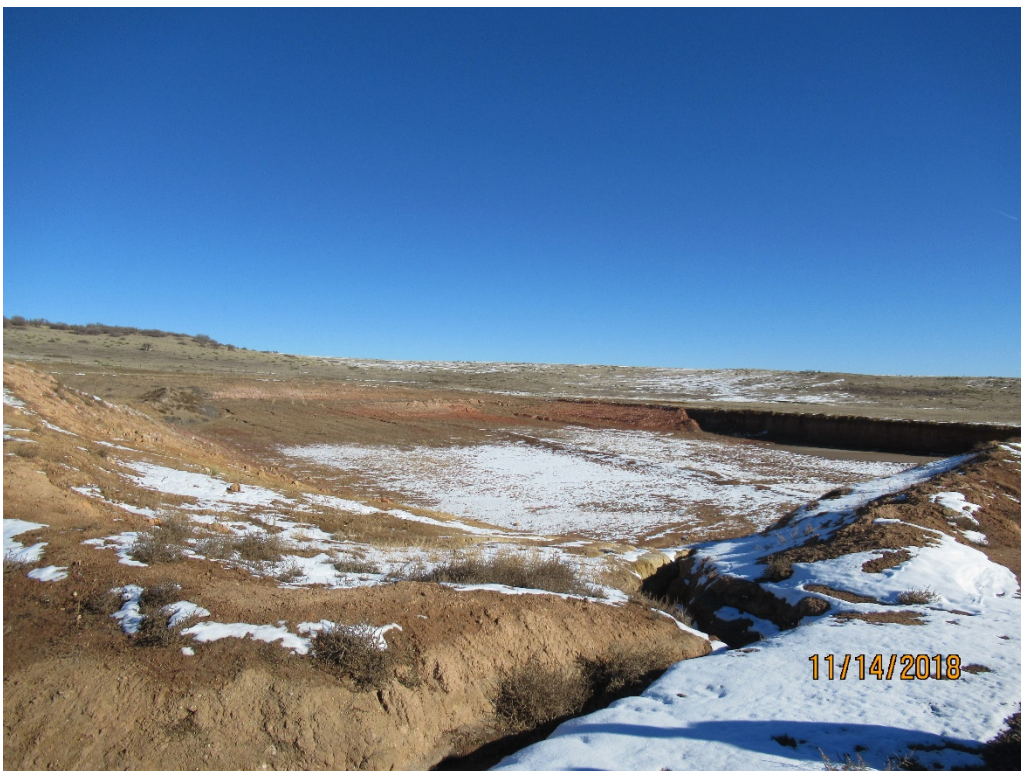
View of site from the southwest corner of the pit looking northeast
