## MINERALS PROGRAM INSPECTION REPORT

<b>MINE NAME:</b> Murdock Gravel Pit	<b>MINE/PROSPECTING ID#:</b> M-1983-112	<b>MINERAL:</b> Sand and gravel	<b>COUNTY:</b> Kiowa
<b>INSPECTION TYPE:</b> Monitoring	<b>INSPECTOR(S):</b> Amy Eschberger	<b>INSP. DATE:</b> October 11, 2018	<b>INSP. TIME:</b> 08:30
<b>OPERATOR:</b> Kiowa County	<b>OPERATOR REPRESENTATIVE:</b> Allen Watts	<b>TYPE OF OPERATION:</b> 110c - Construction Limited Impact	
<b>REASON FOR INSPECTION:</b> Normal I&E Program	<b>BOND CALCULATION TYPE:</b> None	<b>BOND AMOUNT:</b> \$0.00	
<b>DATE OF COMPLAINT:</b> NA	<b>POST INSP. CONTACTS:</b> None	<b>JOINT INSP. AGENCY:</b> None	
<b>WEATHER:</b> Cloudy	<b>INSPECTOR'S SIGNATURE:</b>

## **OBSERVATIONS**

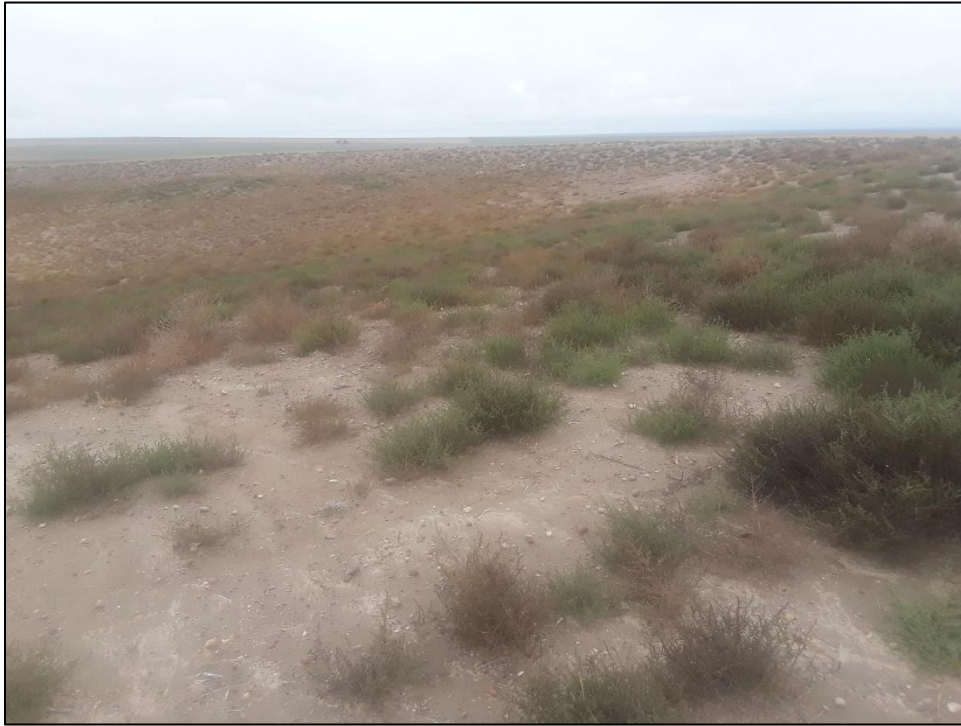
**Photo 1.** View looking south across western pit slope which was graded to 3H:1V or flatter then seeded in November 2017. Vegetative cover of the pit area consists primarily of annual weeds at this time.

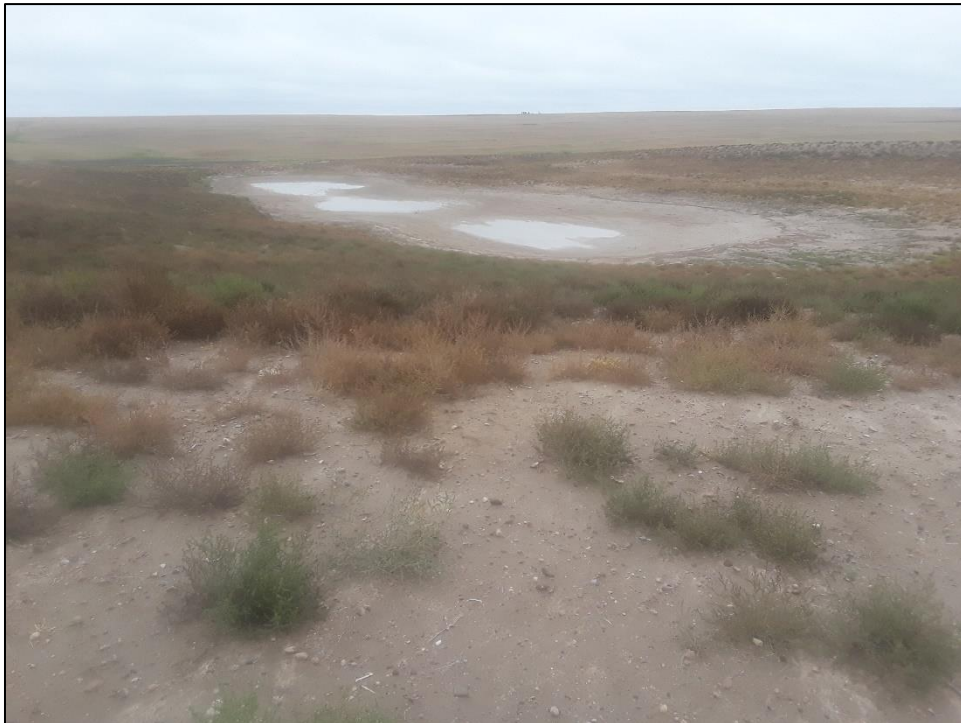
**Photo 2.** View looking southeast across pit from its northwestern edge. Note some ponded water on pit floor due to recent storm event.

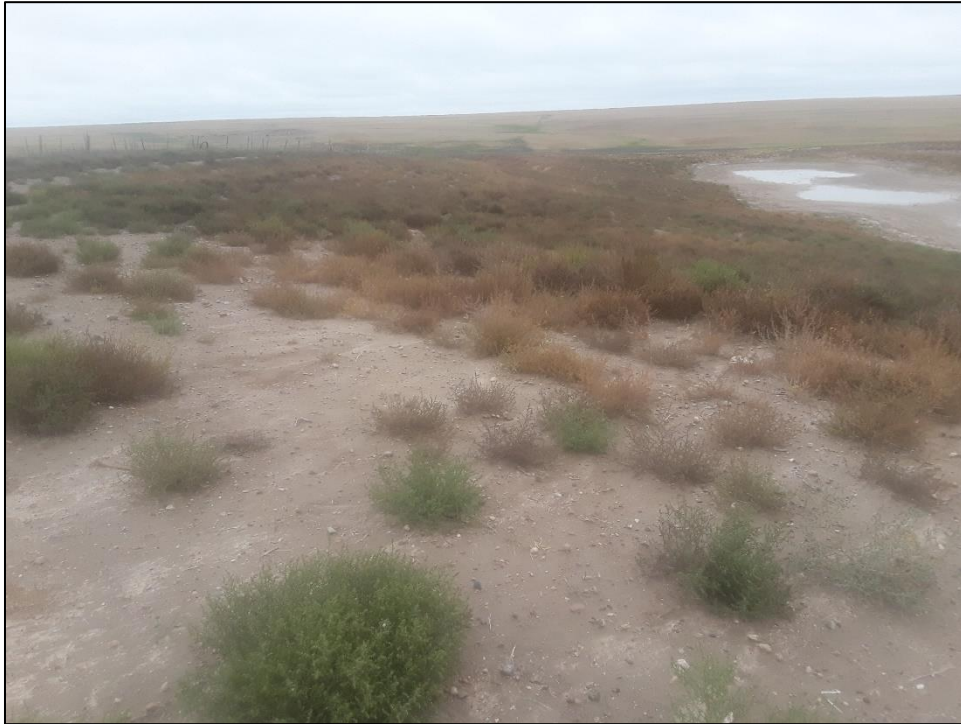
**Photo 3.** View looking east across northern pit slope which was graded to 3H:1V or flatter then seeded in November 2017. Vegetative cover of the pit area consists primarily of annual weeds at this time.

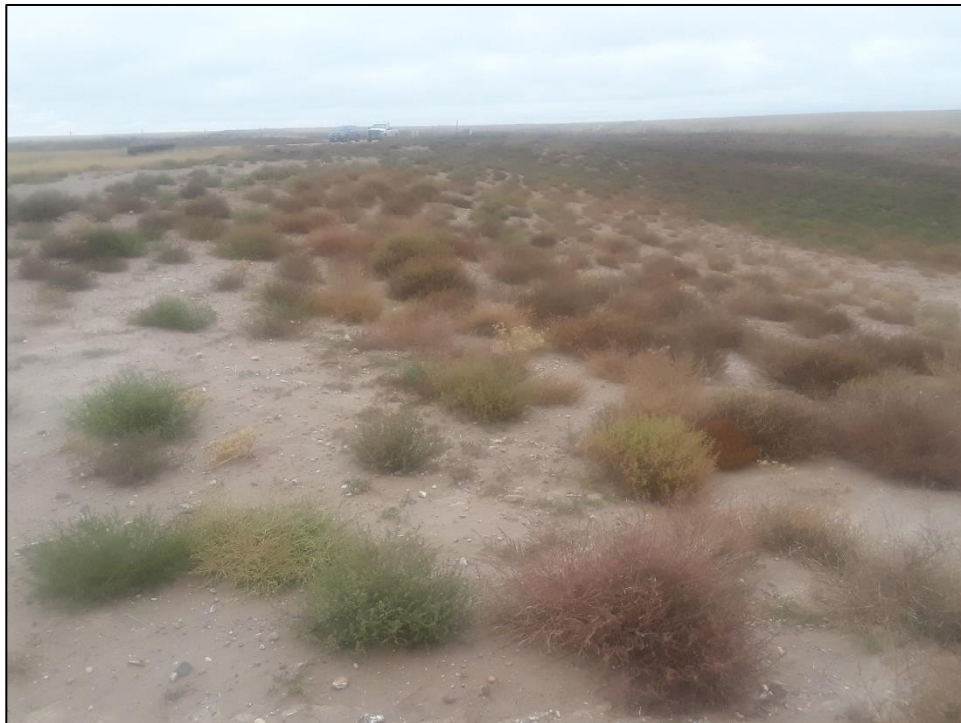
**Photo 4.** View looking north across western pit slope which was graded to 3H:1V or flatter then seeded in November 2017. Vegetative cover of the pit area consists primarily of annual weeds at this time.

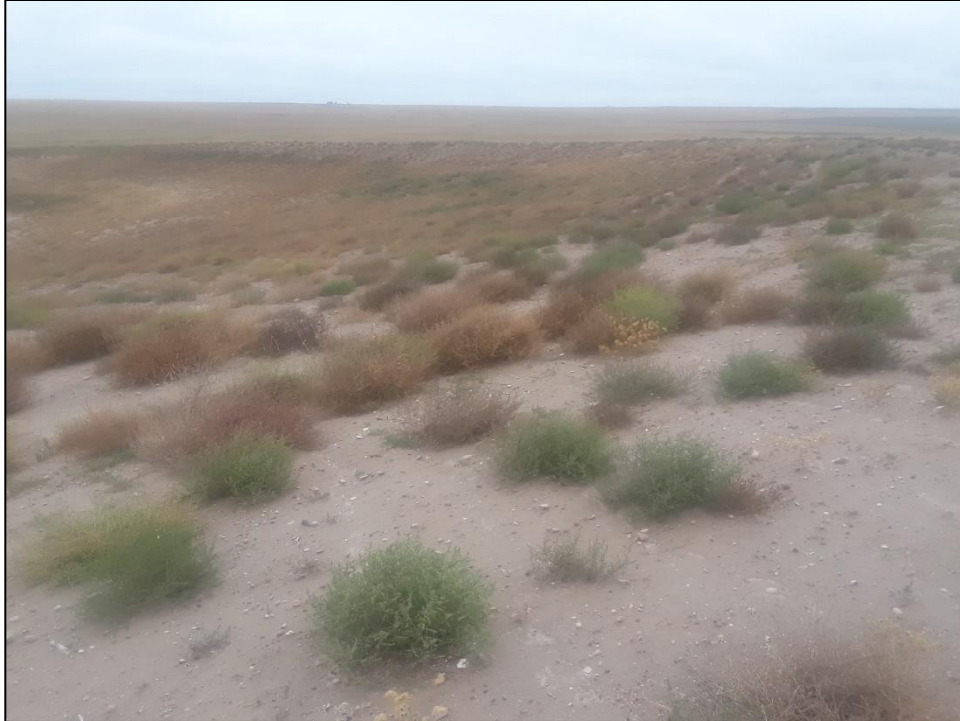
**Photo 5.** View looking south across southwestern pit slope which was graded to 3H:1V or flatter then seeded in November 2017. Vegetative cover of the pit area consists primarily of annual weeds at this time.

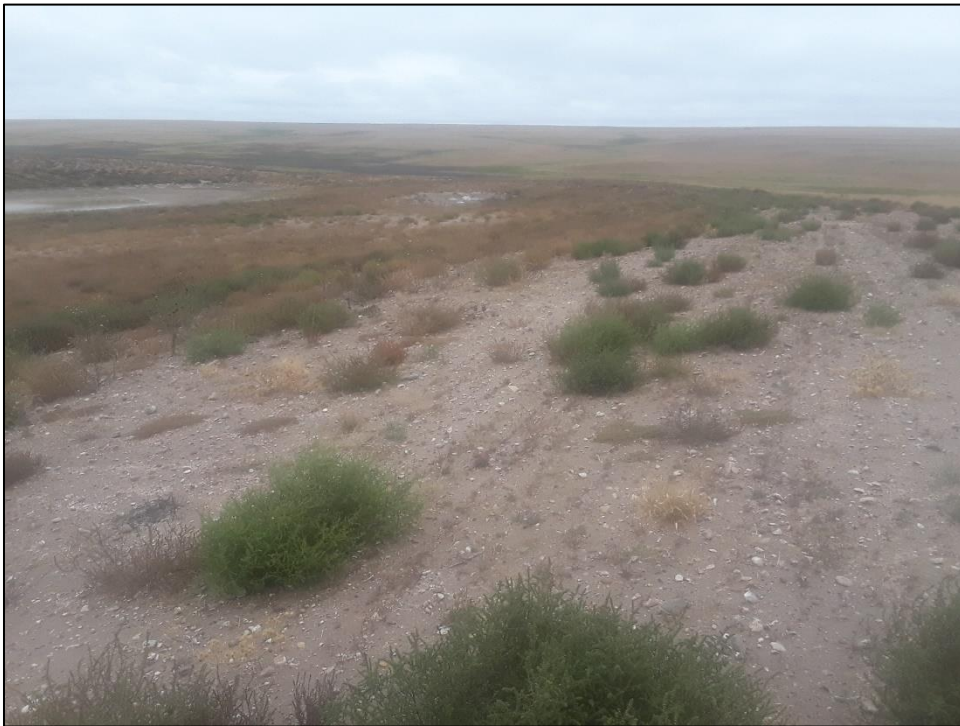
**Photo 6.** View looking east across southern pit slope which was graded to 3H:1V or flatter then seeded in November 2017. Vegetative cover of the pit area consists primarily of annual weeds at this time.

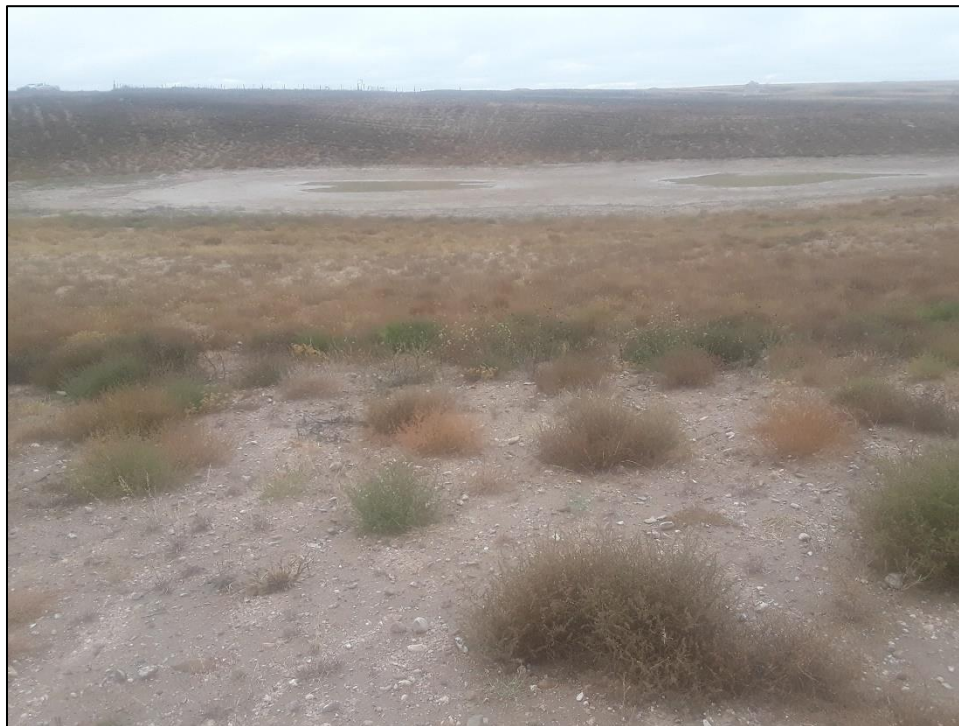
**Photo 7.** View looking north across pit from its southern edge. Note some ponded water on pit floor due to recent storm event.

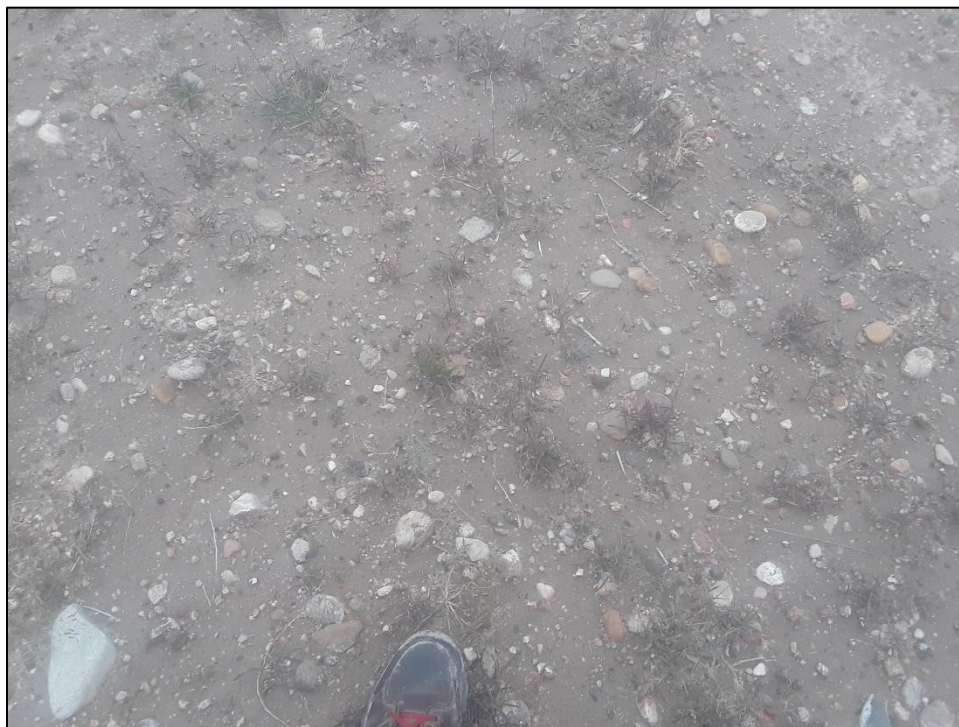
**Photo 8.** Close-up view of ground at southeastern edge of pit, showing some grass growth present along rows from drillseeding done last Fall.

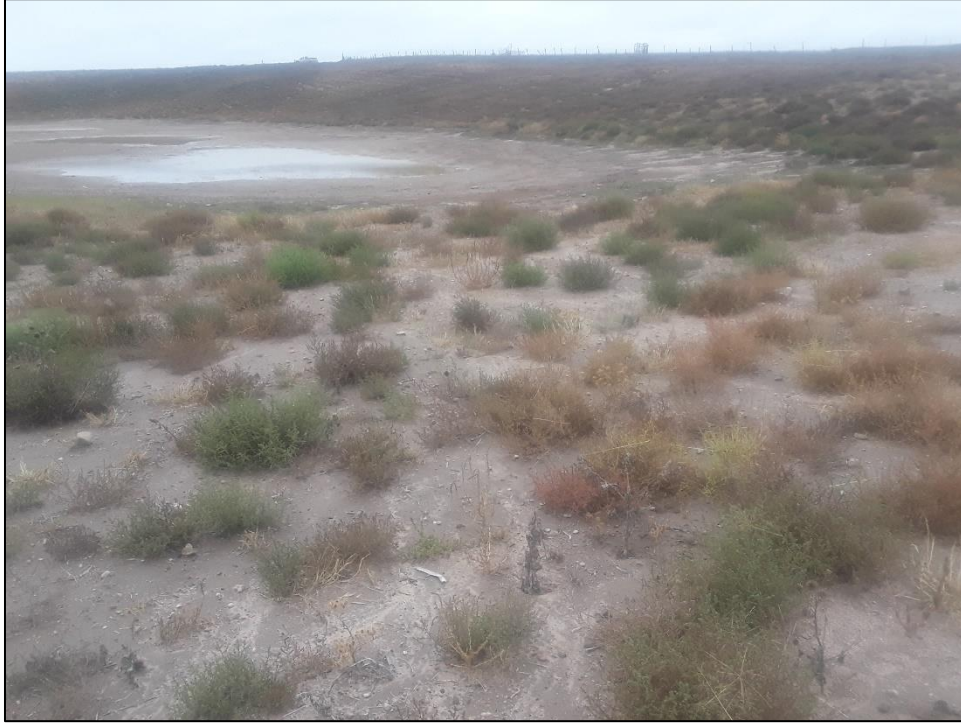
**Photo 9.** View looking northwest across pit from its eastern edge. Note eastern pit slope (shown in foreground) is graded to flatter than 3H:1V.

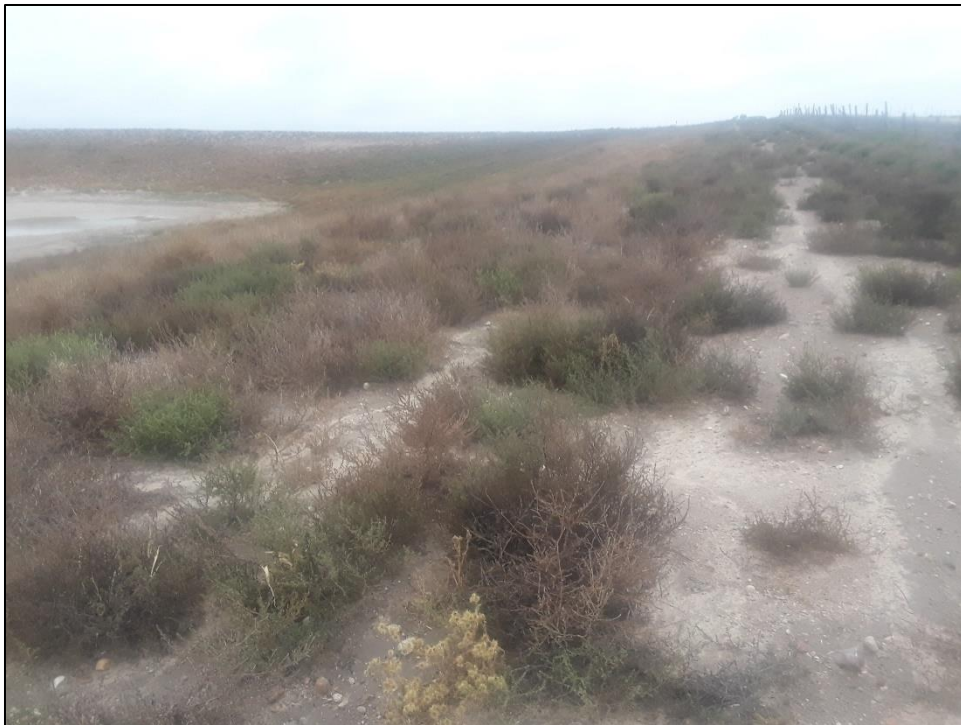
**Photo 10.** View looking west across northern pit slope which was graded to 3H:1V or flatter then seeded in November 2017. Vegetative cover of the pit area consists primarily of annual weeds at this time.
