MINERALS PROGRAM INSPECTION REPORT
PHONE: (303) 866-3567

MINE NAME: Line Camp Pit	MINE/PROSPECTING ID#: M-2001-001	MINERAL: Sand and gravel	COUNTY: Montezuma
INSPECTION TYPE: Monitoring	INSPECTOR(S): Travis H. Marshall	INSP. DATE: October 30, 2018	INSP. TIME: 11:00
OPERATOR: Stone Sand & Gravel, LLC	OPERATOR REPRESENTATIVE: Daren Stone	TYPE OF OPERATION: 112c - Construction Regular Operation	
REASON FOR INSPECTION: Surety Related	BOND CALCULATION TYPE: Complete Bond	BOND AMOUNT: \$91,917.00	
DATE OF COMPLAINT: NA	POST INSP. CONTACTS: State Engr. (Water Resources)	JOINT INSP. AGENCY: None	
WEATHER: Cloudy	INSPECTOR'S SIGNATURE:

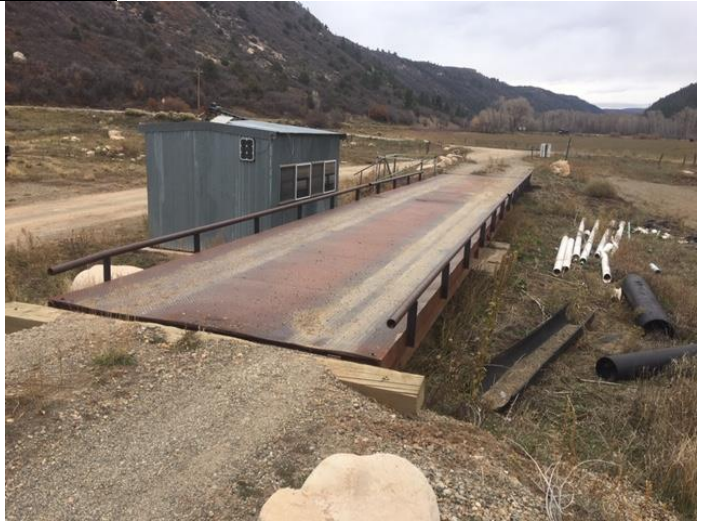
The operator requested a surety reduction in 2017 that was denied based on the amount of weeds observed at the site. During the October 2018 inspection no major infestations of weeds were observed. An infestation of thistle near the scale that appeared to have been sprayed was observed. A couple small stands of tamarisk were observed around the perimeter of the pond and is a concern but not considered a problem at this time. The minor infestation is noted in this inspection report and will be used as a tool to monitor future weed management success in future inspections.

Thistle near scale that appeared to be sprayed.

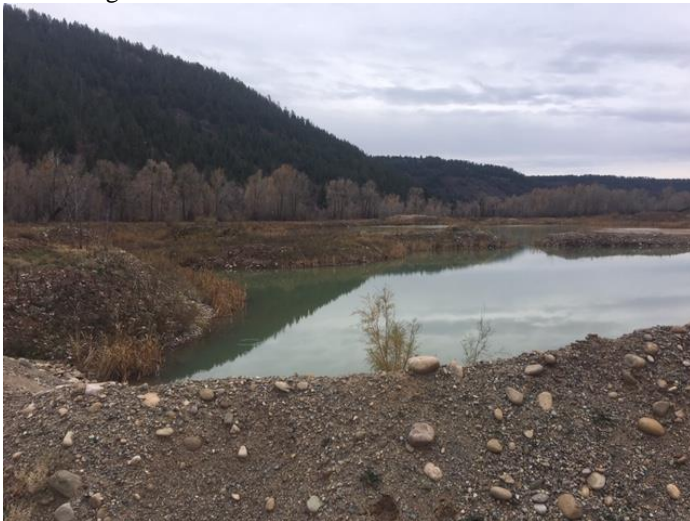
Tamarisk observed on north pond slope.

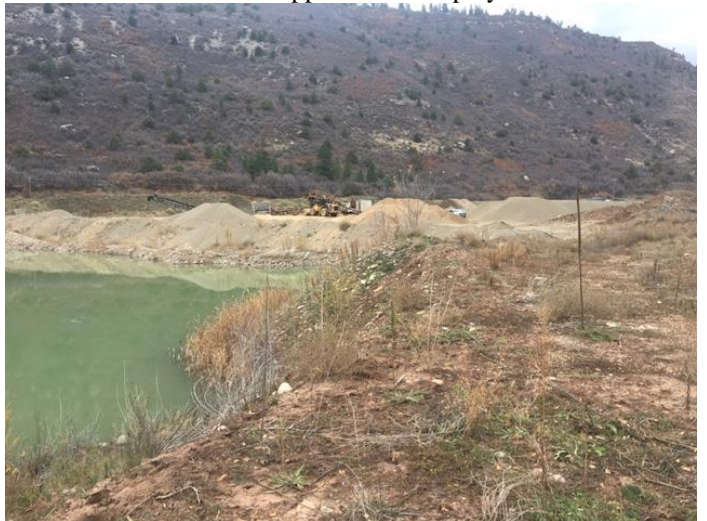
View south eastern of pond slope.

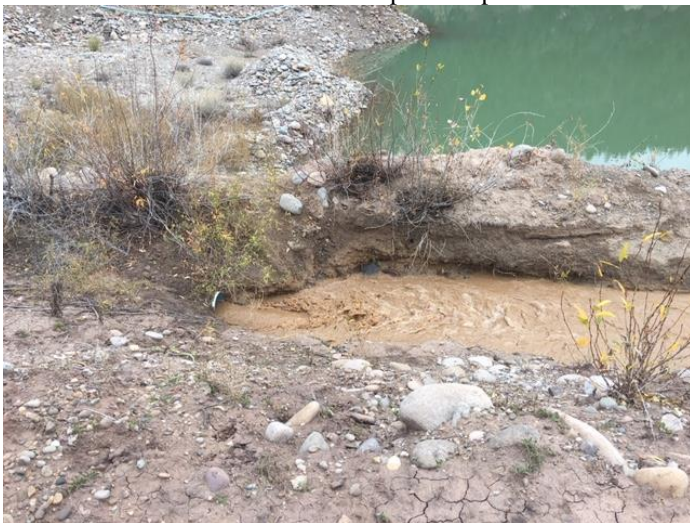
Wash plant discharge point.

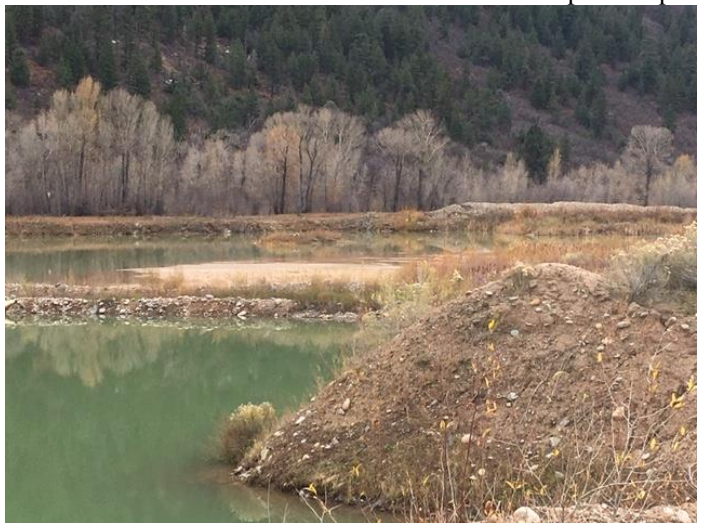
View of north pond slope.
