MINERALS PROGRAM INSPECTION REPORT
PHONE: (303) 866-3567

MINE NAME: Hansen Uranium Project	MINE/PROSPECTING ID#: P-2009-025	MINERAL: Uranium	COUNTY: Fremont
INSPECTION TYPE: Monitoring	INSPECTOR(S): Timothy A. Cazier	INSP. DATE: June 14, 2018	INSP. TIME: 10:15
OPERATOR: Black Range Minerals Colorado, LLC	OPERATOR REPRESENTATIVE: Mike Rutter	TYPE OF OPERATION: MP - Mineral Prospecting	
REASON FOR INSPECTION: Normal I&e Program	BOND CALCULATION TYPE: Partial Bond	BOND AMOUNT: \$154,936.58	
DATE OF COMPLAINT: NA	POST INSP. CONTACTS: U.S.BLM	JOINT INSP. AGENCY: U.S.BLM	
WEATHER: Clear	INSPECTOR'S SIGNATURE:

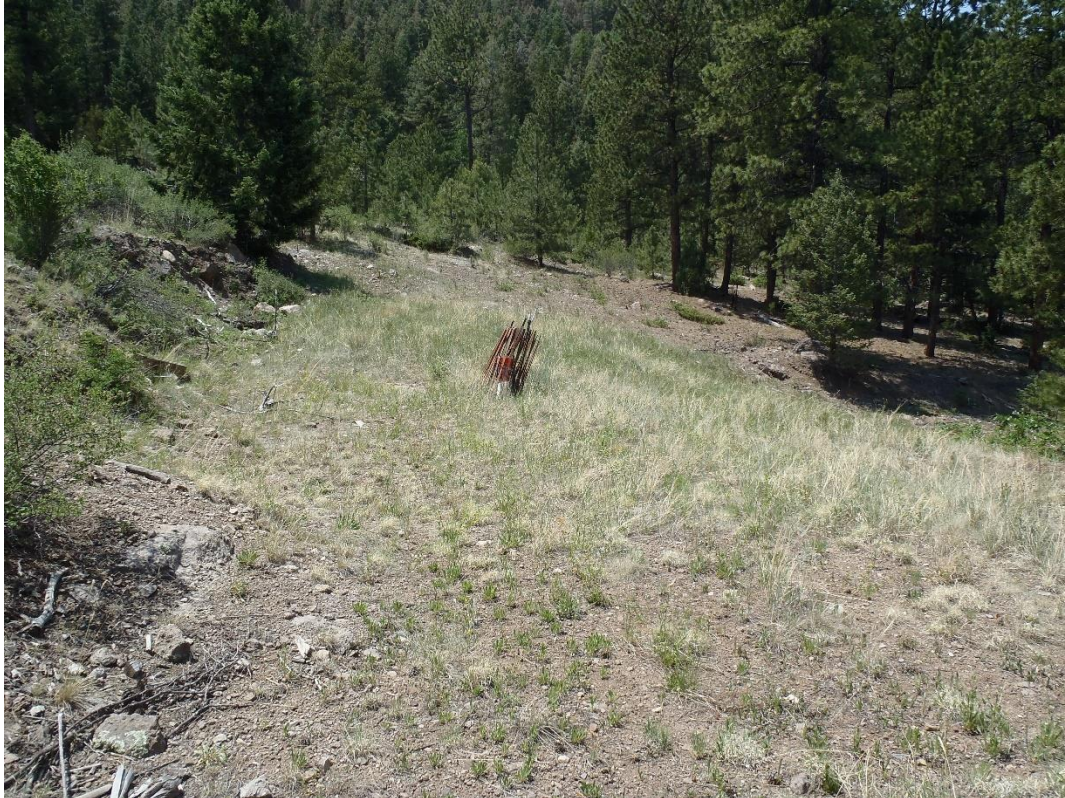
Backfilling and Grading: Drill access roads to boreholes and monitoring wells that have been abandoned are in the process of reclamation. Recontouring has occurred (see **Photo 1**). The earthwork required for reclamation of the drill pads has been completed for the sites visited during the inspection: MWC-109, HNDD0003, HNDD0006, HNDD0007, HNDD0010, HNDD0011, MW-27-290, MW-27-291, MW-27-292, MW-27-293, and MW-27-294. Mr. Rutter indicated Black Range intends to release the vibrating wire piezometers (VWP) (HNDD0003, HNDD0005, HNDD0006, HNDD0007, HNDD0009, and HNDD0011). Additional abandonment procedures required by the Colorado Division of Water Resources (DWR) are discussed below under "Hydrologic Balance". After this additional work is completed, Black Range should request a partial release for these VWPs.

Revegetation: Revegetation efforts on the drill pads was observed to be satisfactory (see **Photos 1 and 4**). No significant amount of noxious weeds were observed. However, some field bindweed was observed near the MW-27-290 and 291 monitoring wells (see **Photo 5**)

Photo 1. Recontouring and revegetation at HNDD0010 drill pad (looking west).

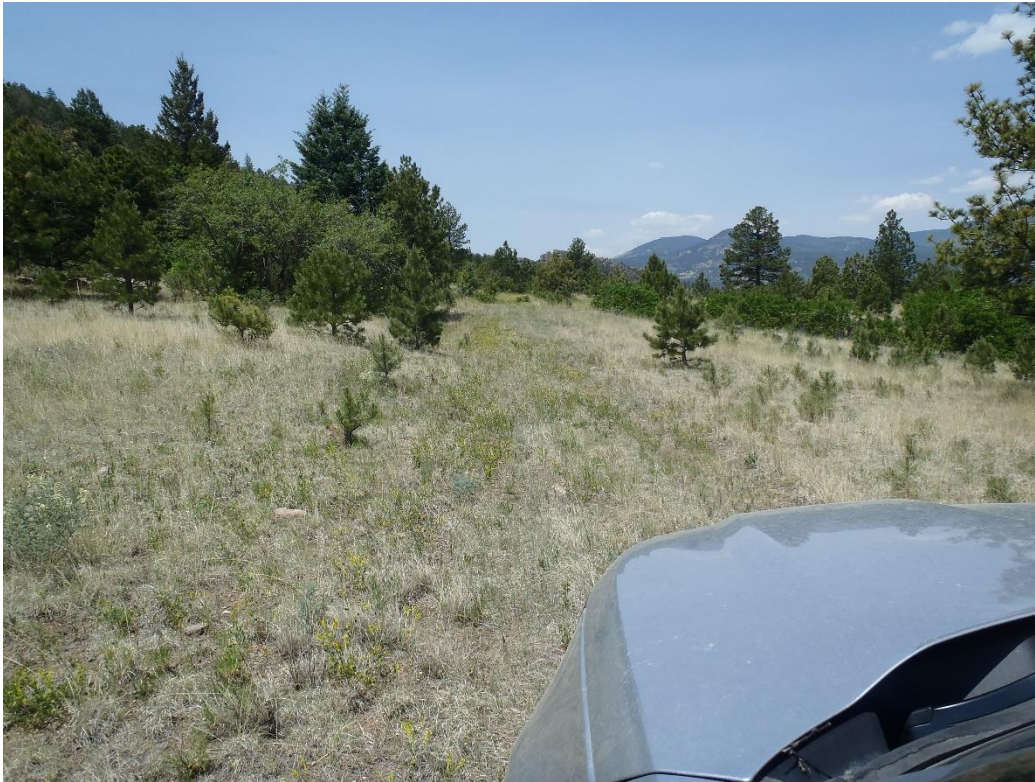
Roads: Access roads did not appear to be a source of sediment that could be tracked offsite as they were for the most part revegetated (see **Photos 2 and 3**).

Photo 2. Road between HNDD0010 and HNDD0011 (looking north).

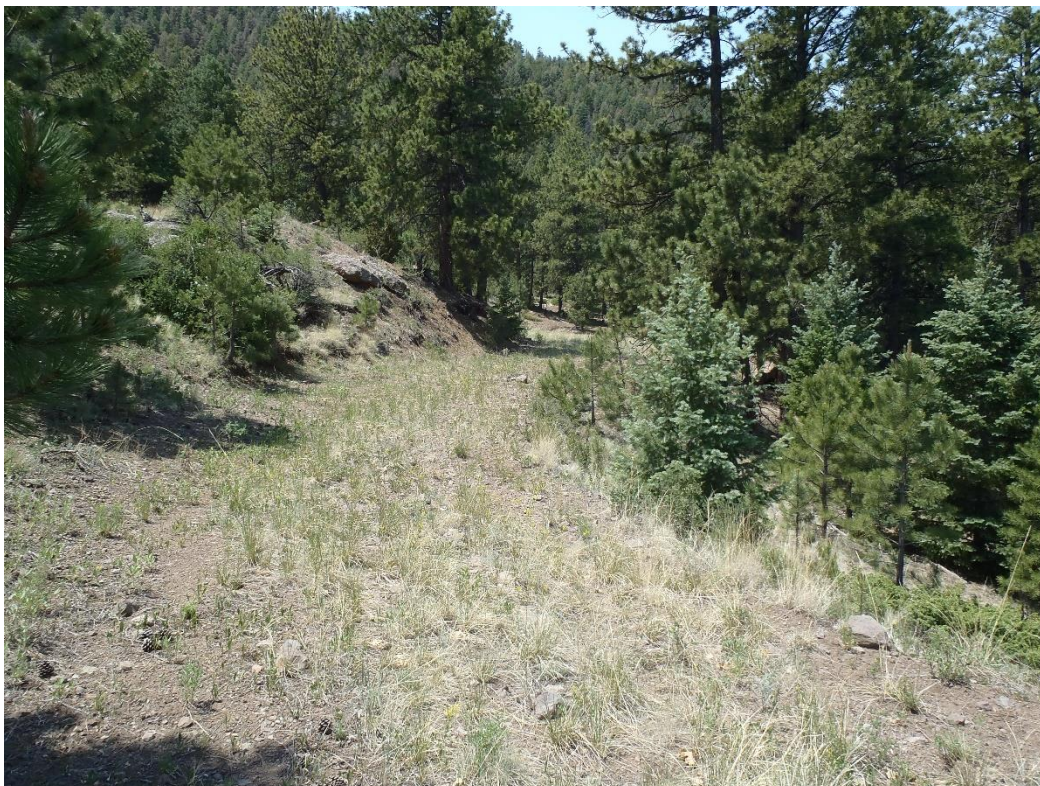
Photo 3. Road to HNDD0010 pad (looking NW).

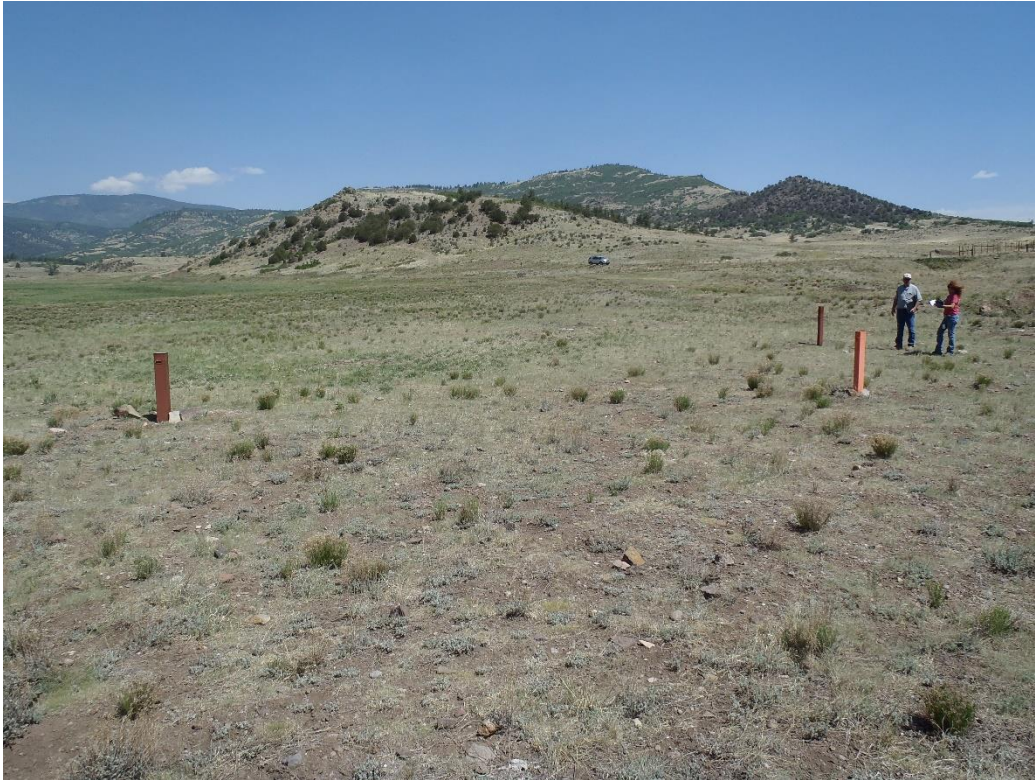
Photo 4. Revegetation at MW-27-292, -293, and -294 (looking north).

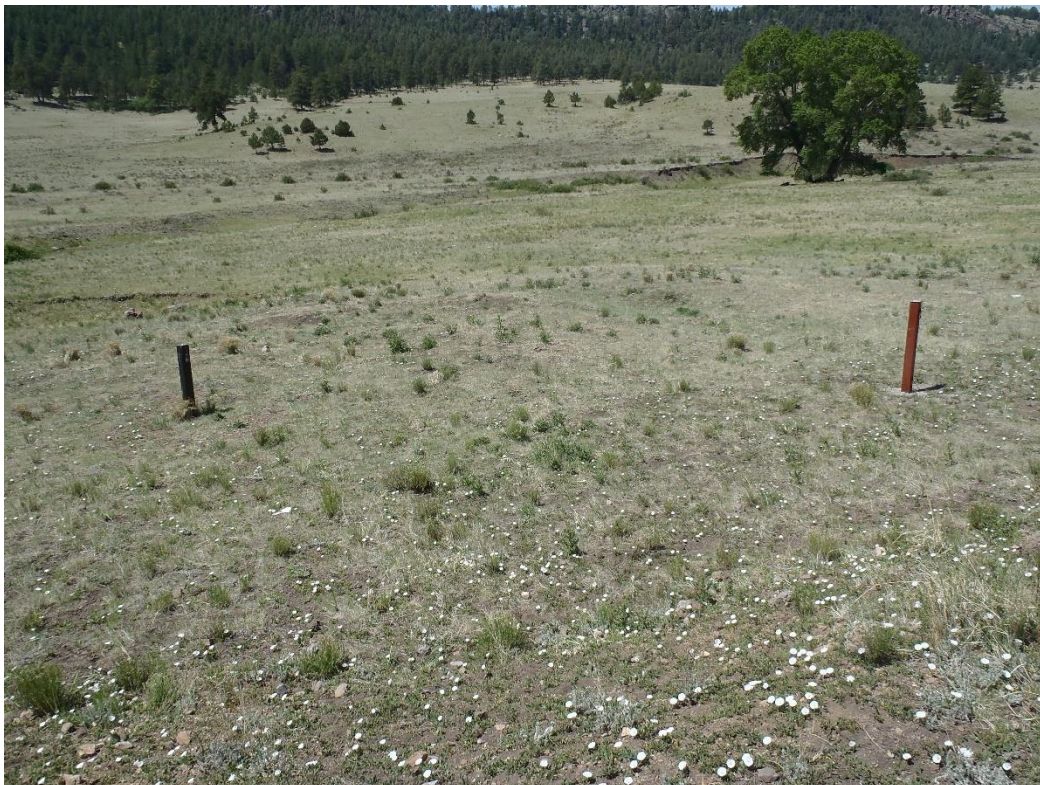
Photo 5. Revegetation at MW-27-290, and -291 (looking west; note field bindweed in foreground).

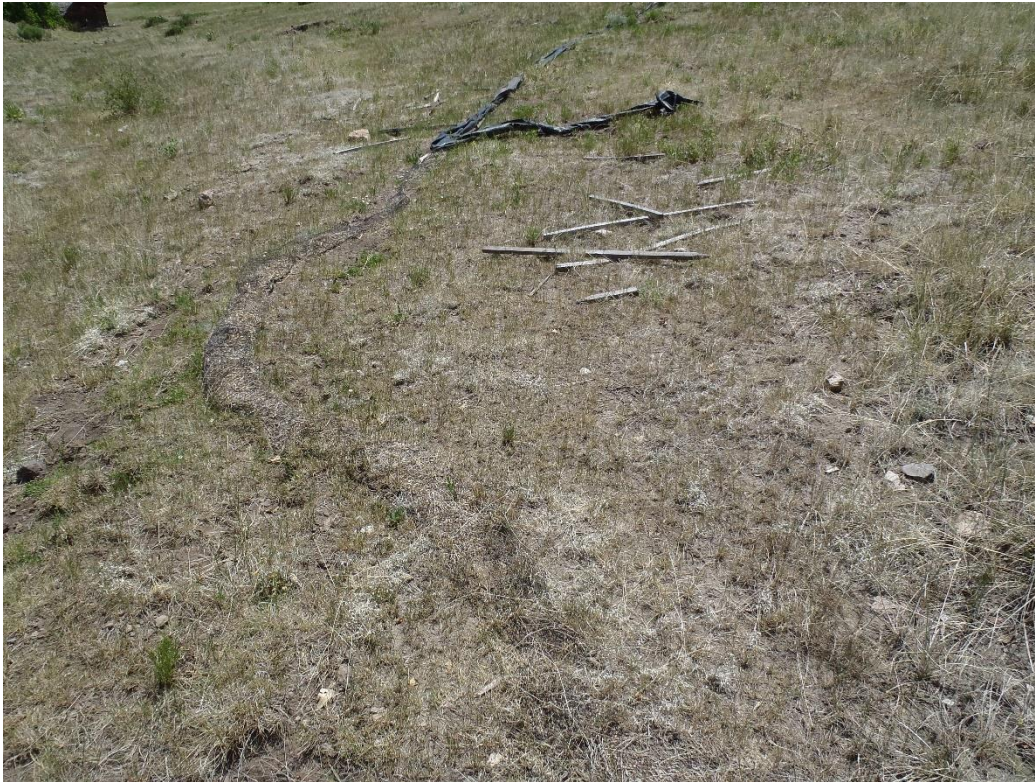
Photo 6. Silt fence and support stakes needing removal at HNDD0011 site.

Sediment Control: No erosion problems were observed and no BMPs were needed at the time of the inspection. Some silt fences have come down (see **Photos 6 and 7**), are no longer necessary and should be removed. **BMPs (silt fence, etc.) can and should be removed at all drill sites visited during this inspection.**

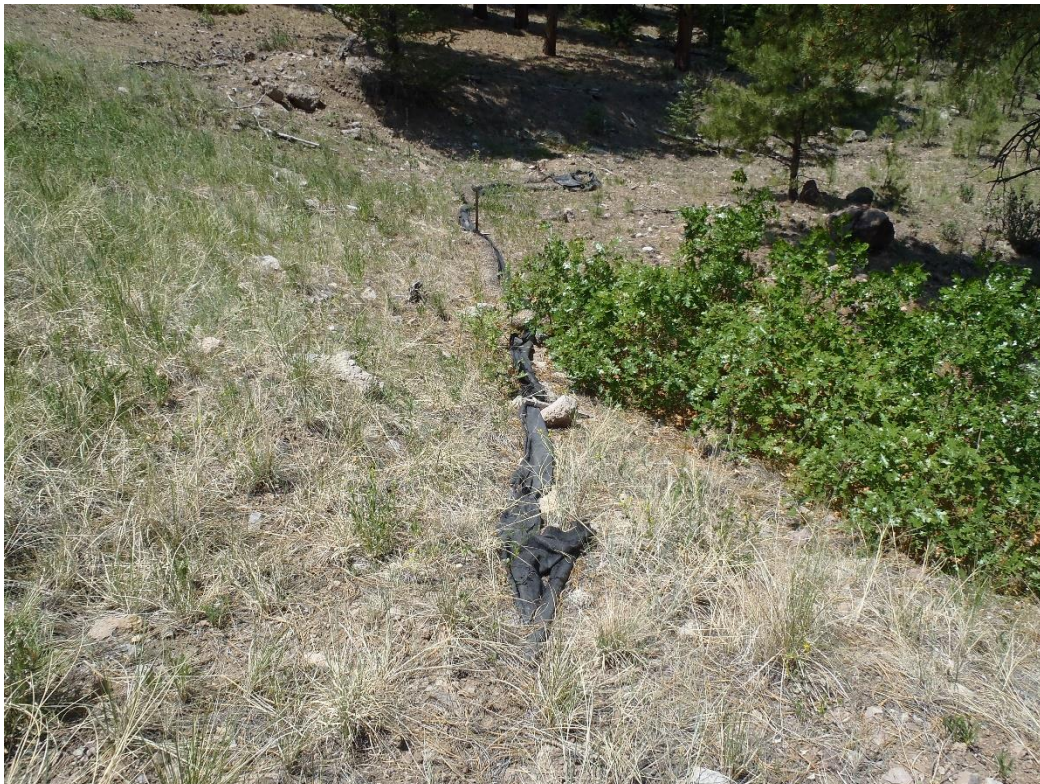
Photo 7. Silt fence needing removal at HNDD0010 site.
