MINERALS PROGRAM INSPECTION REPORT

MINE NAME: Barnes Pit	MINE/PROSPECTING ID#: M-1991-075	MINERAL: Gravel	COUNTY: Kiowa
INSPECTION TYPE: Monitoring	INSPECTOR(S): Amy Eschberger	INSP. DATE: October 11, 2018	INSP. TIME: 09:20
OPERATOR: Kiowa County	OPERATOR REPRESENTATIVE: Allen Watts	TYPE OF OPERATION: 112c - Construction Regular Operation	
REASON FOR INSPECTION: Normal I&E Program	BOND CALCULATION TYPE: None	BOND AMOUNT: \$0.00	
DATE OF COMPLAINT: NA	POST INSP. CONTACTS: None	JOINT INSP. AGENCY: None	
WEATHER: Cloudy	INSPECTOR'S SIGNATURE:

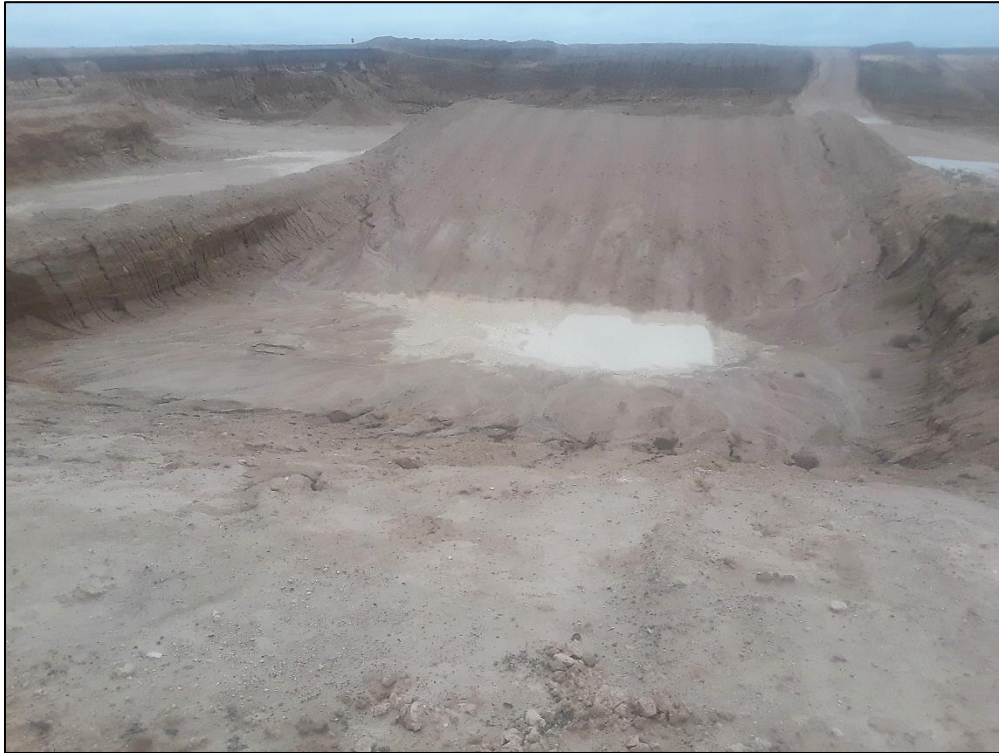
Photo 5. View looking west across pit from its eastern edge.

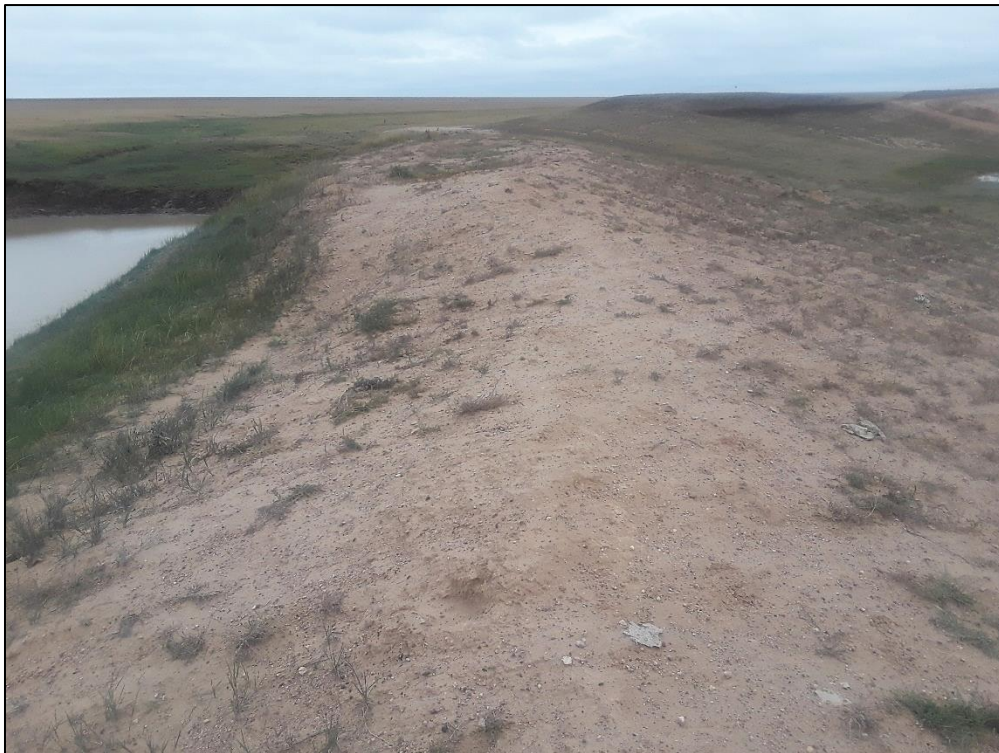
At the northwestern edge of the site, the operator has constructed a berm to separate the pit from the adjacent drainage. The drainage is typically dry, flowing only during large storm events. Water was present in the drainage during the inspection. The operation has had issues with the drainage flow overtopping the berm and entering the pit during high flow events. Mr. Watts indicated the berm was recently raised four feet higher to help prevent this from re-occurring. Additionally, the operation is backfilling the northwestern corner of the pit as overburden is made available to reduce the slopes and extend the berm southward from the drainage. The Division observed some erosional rilling and a few gullies along the northwestern pit wall which has steeper slope gradients. Backfilling this portion of the pit should resolve the erosion issues observed. Once the operator has completed backfilling this area, the Division recommends the operator retopsoil and seed the western highwall and any other disturbed areas that will not be redisturbed as soon as possible to help stabilize these areas and prevent weed growth.

Photo 6. View looking east across berm separating pit (at right) from nearby drainage (at left).
