MINERALS PROGRAM INSPECTION REPORT
PHONE: (303) 866-3567

MINE NAME: Barnes Pit	MINE/PROSPECTING ID#: M-1991-075	MINERAL: Gravel	COUNTY: Kiowa
INSPECTION TYPE: Monitoring	INSPECTOR(S): Amy Eschberger	INSP. DATE: October 11, 2018	INSP. TIME: 09:20
OPERATOR: Kiowa County	OPERATOR REPRESENTATIVE: Allen Watts	TYPE OF OPERATION: 112c - Construction Regular Operation	
REASON FOR INSPECTION: Normal I&E Program	BOND CALCULATION TYPE: None	BOND AMOUNT: \$0.00	
DATE OF COMPLAINT: NA	POST INSP. CONTACTS: None	JOINT INSP. AGENCY: None	
WEATHER: Cloudy	INSPECTOR'S SIGNATURE:

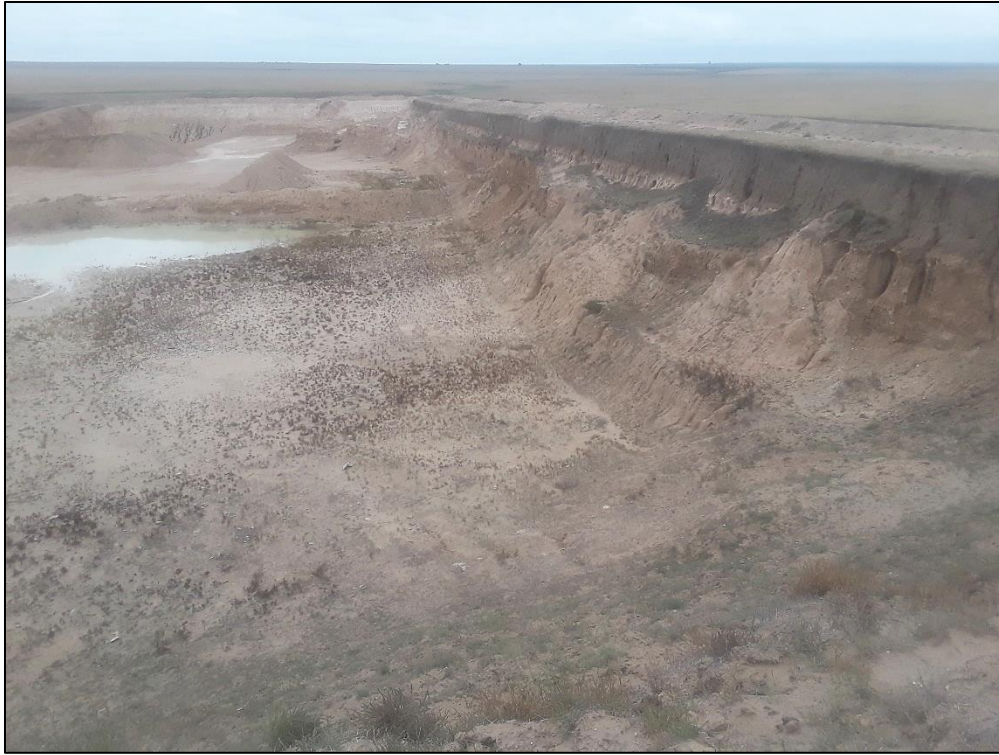
Photo 1. View looking east across active highwall along southern edge of pit, approximately 20-25 feet in height with near vertical slopes.

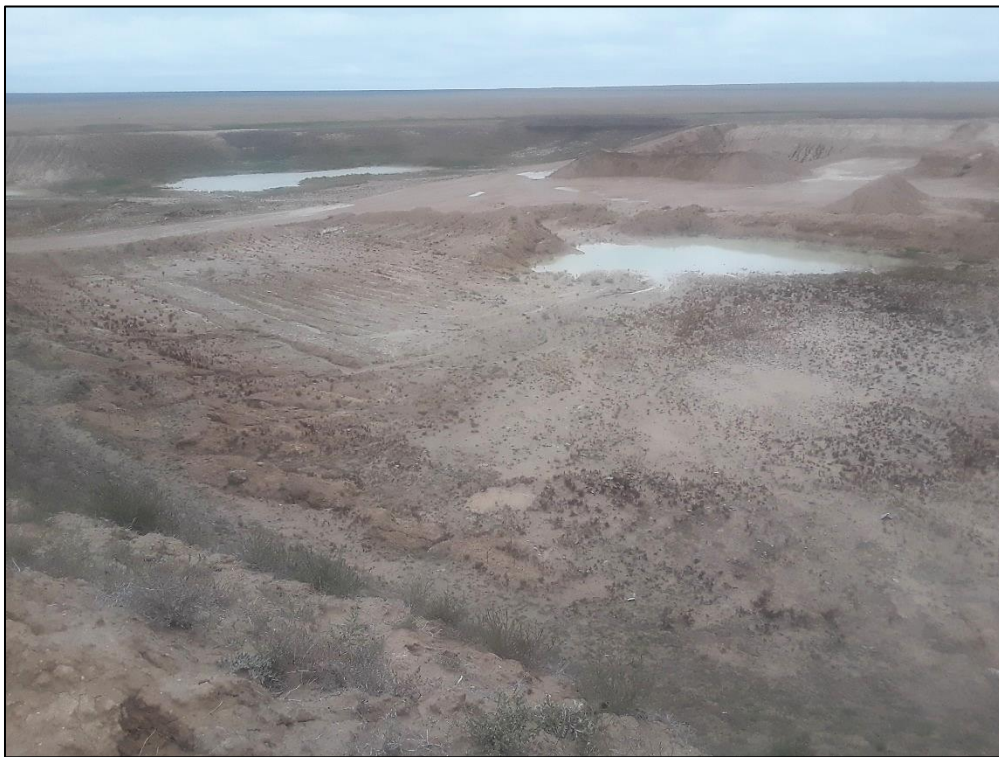
Some ponded water was present on the pit floor during the inspection due to a recent storm event. The operator should be aware, the Division of Water Resources requires that all stormwater contained on site either infiltrate into the ground or be released to the natural stream system within 72 hours, or all work must cease until a Substitute Water Supply Plan or Augmentation Plan is obtained.

Photo 2. View looking northeast across pit from its southwestern corner. Note ponded water on pit floor due to recent storm event.

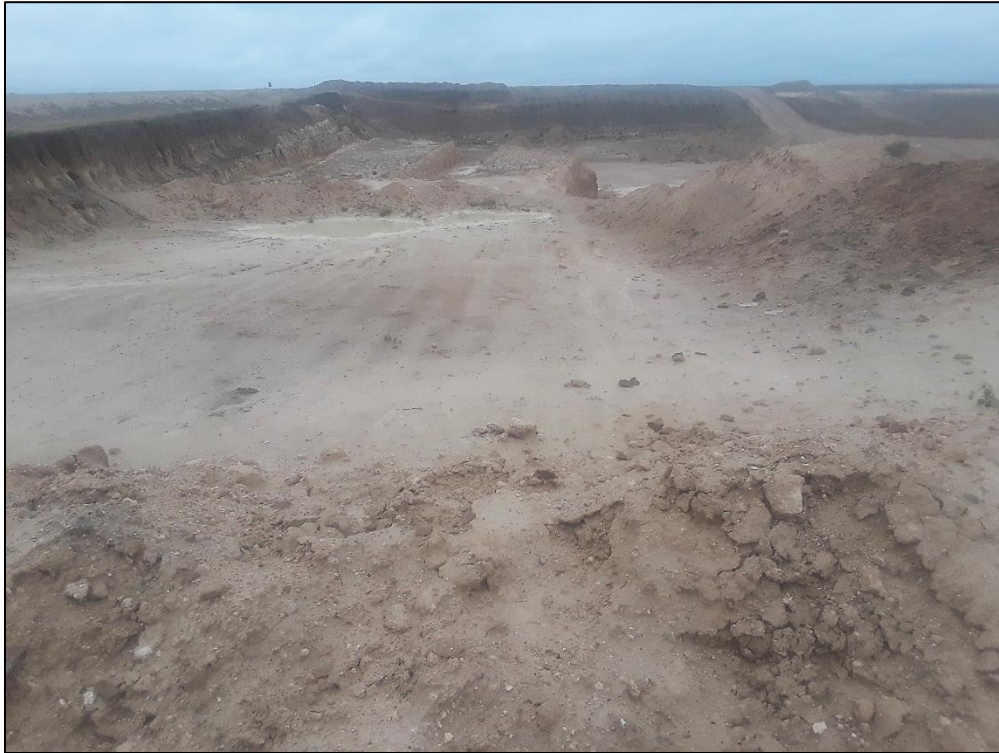
Photo 3. View looking west across pit from its southeastern edge.

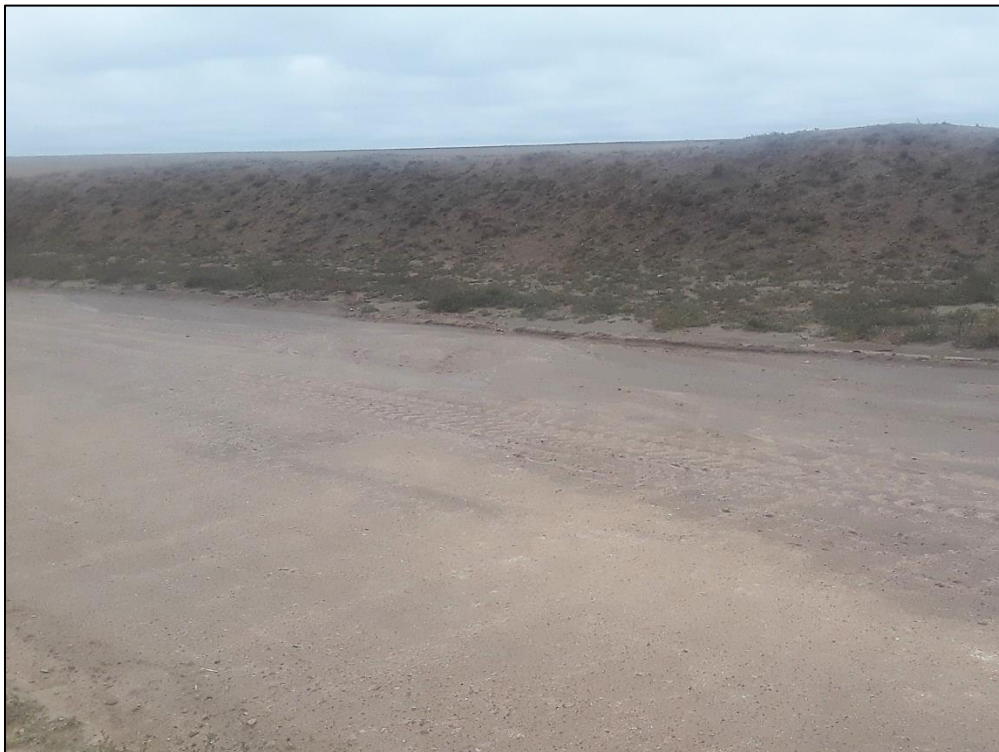
Photo 4. View of topsoil stockpile stored east of pit, which appeared to be stable with some vegetative cover.

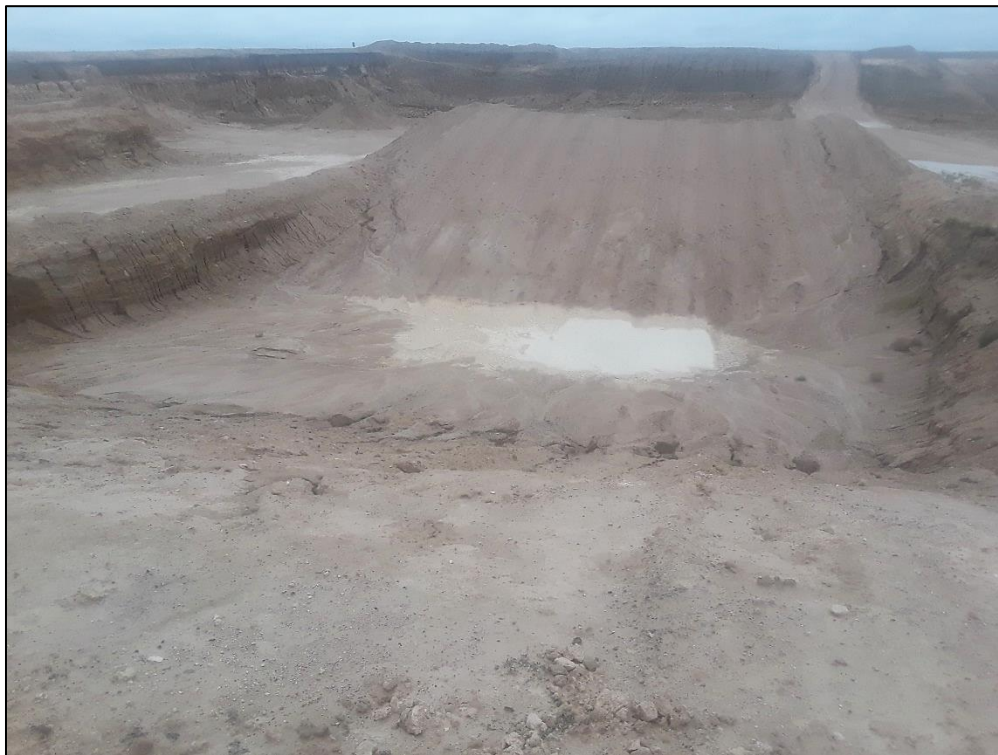
Photo 5. View looking west across pit from its eastern edge.

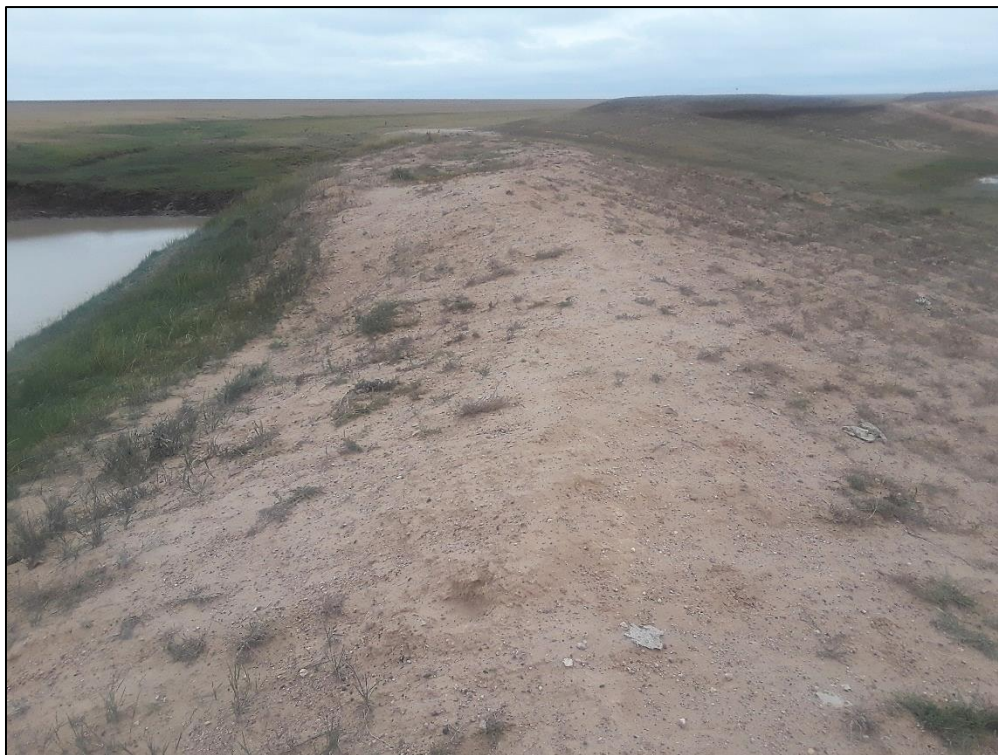
At the northwestern edge of the site, the operator has constructed a berm to separate the pit from the adjacent drainage. The drainage is typically dry, flowing only during large storm events. Water was present in the drainage during the inspection. The operation has had issues with the drainage flow overtopping the berm and entering the pit during high flow events. Mr. Watts indicated the berm was recently raised four feet higher to help prevent this from re-occurring. Additionally, the operation is backfilling the northwestern corner of the pit as overburden is made available to reduce the slopes and extend the berm southward from the drainage. The Division observed some erosional rilling and a few gullies along the northwestern pit wall which has steeper slope gradients. Backfilling this portion of the pit should resolve the erosion issues observed. Once the operator has completed backfilling this area, the Division recommends the operator retopsoil and seed the western highwall and any other disturbed areas that will not be redisturbed as soon as possible to help stabilize these areas and prevent weed growth.

Photo 6. View looking east across berm separating pit (at right) from nearby drainage (at left).

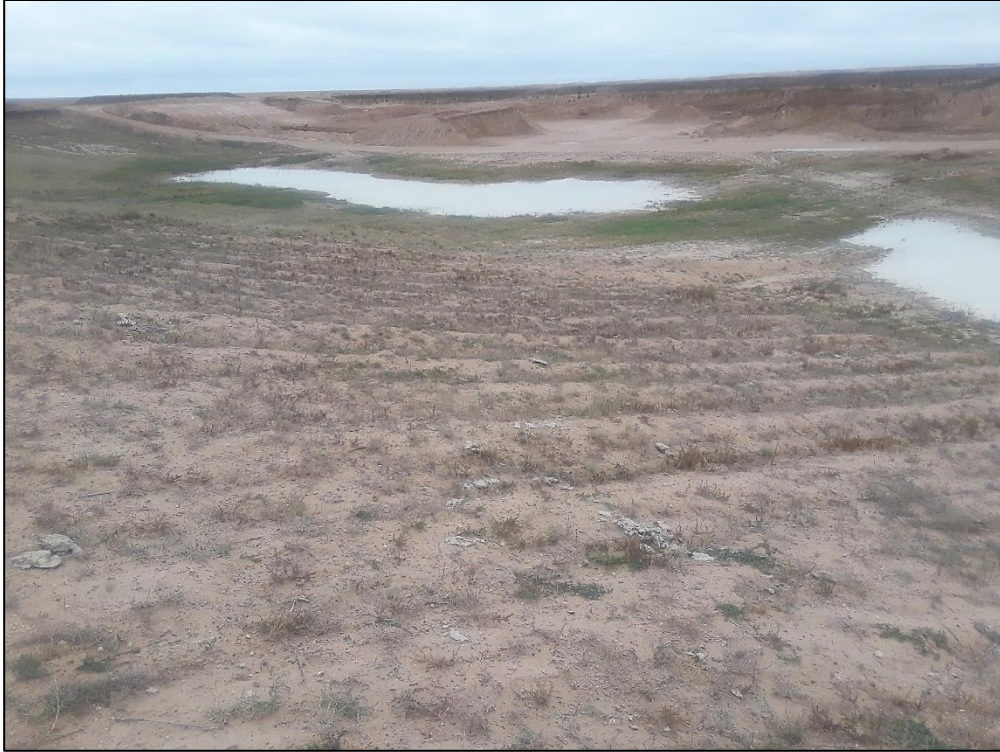
Photo 7. View looking southeast across pit from top of berm separating pit from nearby drainage. Note southern slope of berm (in foreground) graded to 3H:1V or flatter. Also note ponded water present on pit floor due to recent storm event.

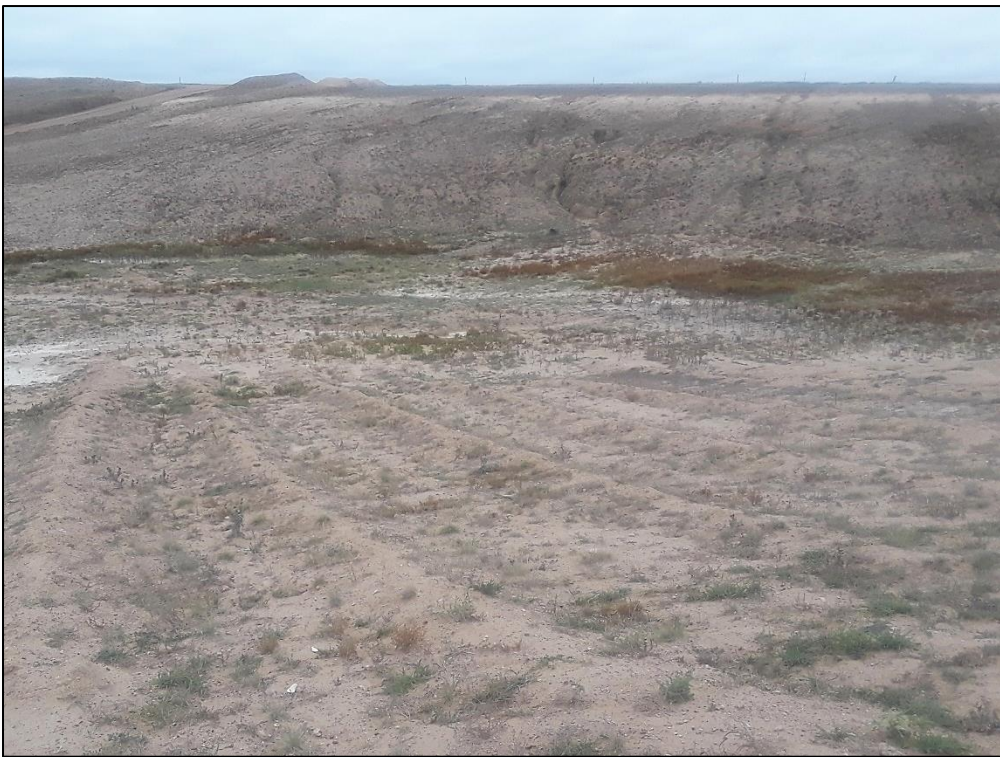
Photo 8. View looking west across northwestern portion of pit that operator is working to backfill. Steeper slopes in this area will be reduced to 3H:1V or flatter.

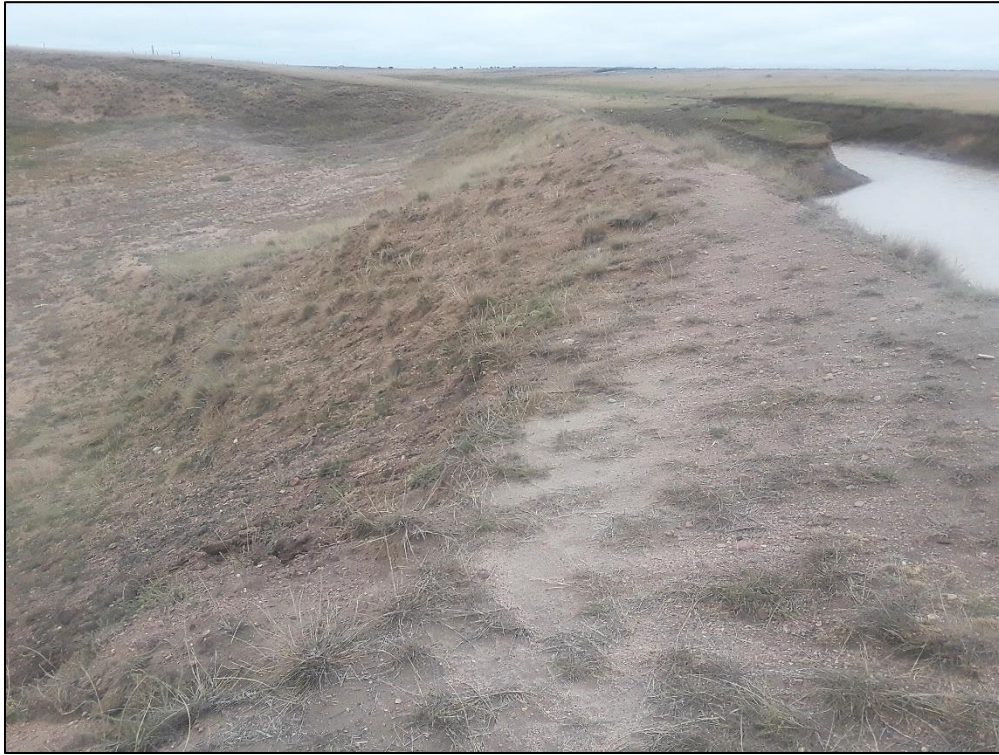
Photo 9. View looking west across western edge of berm separating pit from nearby drainage. The operator intends to place additional backfill in this area.

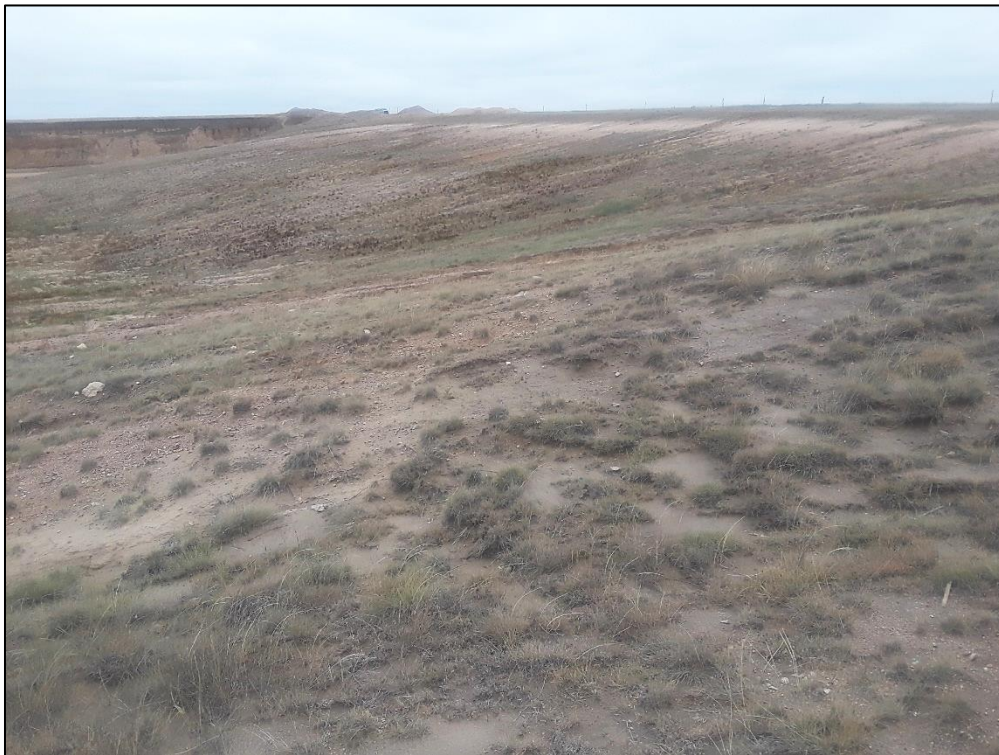
Photo 10. View looking south across portion of western pit wall graded to 3H:1V with some volunteer grass cover.
