MINERALS PROGRAM INSPECTION REPORT
PHONE: (303) 866-3567

MINE NAME: Schmidt Gravel Pit	MINE/PROSPECTING ID#: M-2000-048	MINERAL: Gravel	COUNTY: Kiowa
INSPECTION TYPE: Monitoring	INSPECTOR(S): Amy Eschberger	INSP. DATE: October 11, 2018	INSP. TIME: 10:15
OPERATOR: Kiowa County	OPERATOR REPRESENTATIVE: Allen Watts	TYPE OF OPERATION: 110c - Construction Limited Impact	
REASON FOR INSPECTION: Normal I&E Program	BOND CALCULATION TYPE: None	BOND AMOUNT: \$0.00	
DATE OF COMPLAINT: NA	POST INSP. CONTACTS: None	JOINT INSP. AGENCY: None	
WEATHER: Cloudy	INSPECTOR'S SIGNATURE:

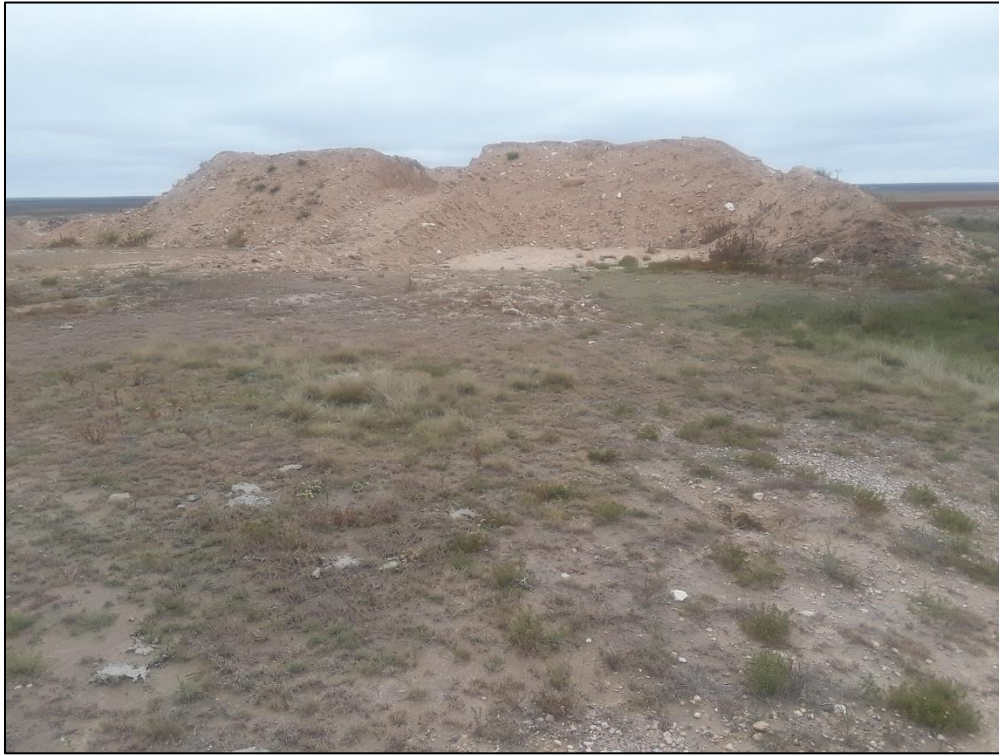
Photo 1. View looking north, showing overburden stockpile stored at northern end of site.

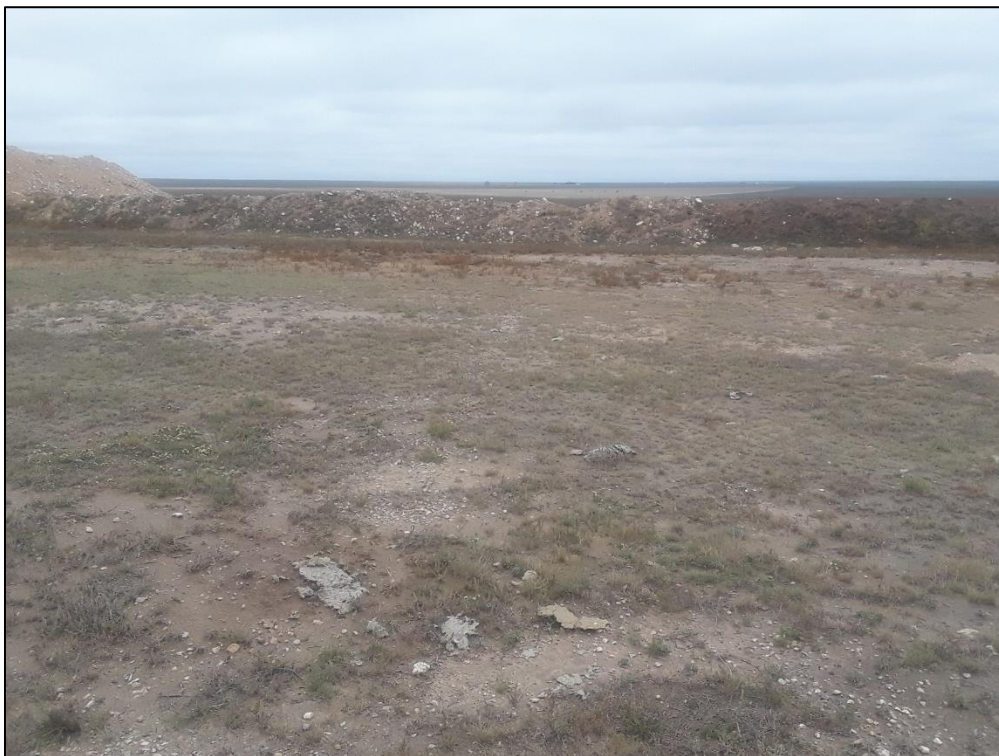
Photo 2. View looking west, showing low-lying overburden berm constructed along eastern edge of pit to direct stormwater around pit.

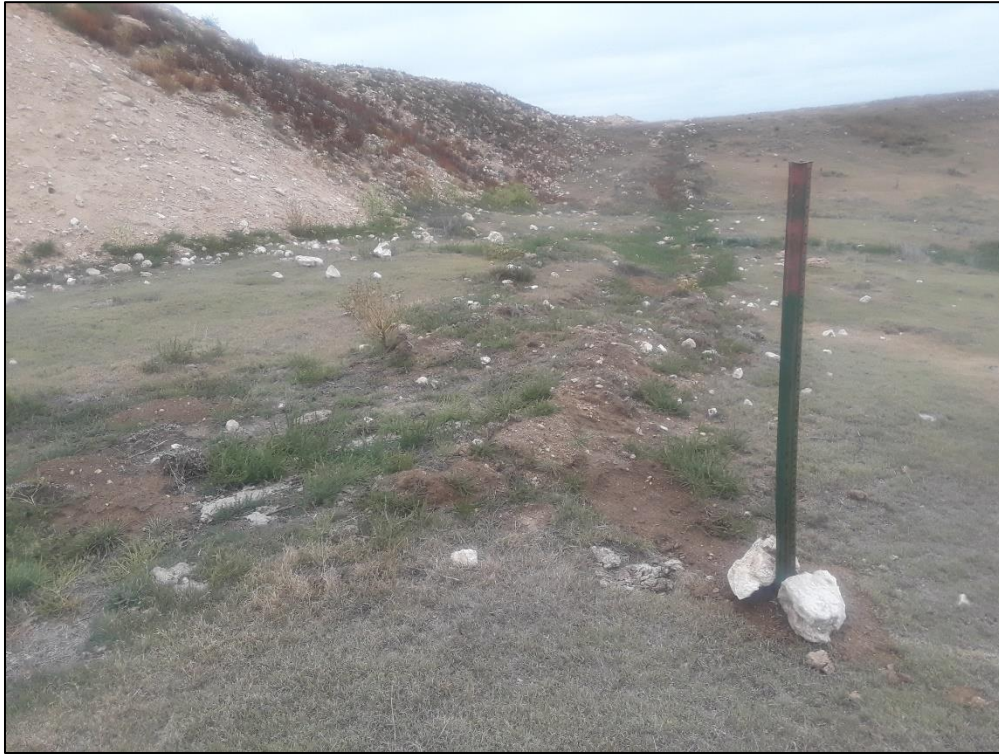
Photo 3. View looking west, showing T-post marking northeastern corner of permit boundary.

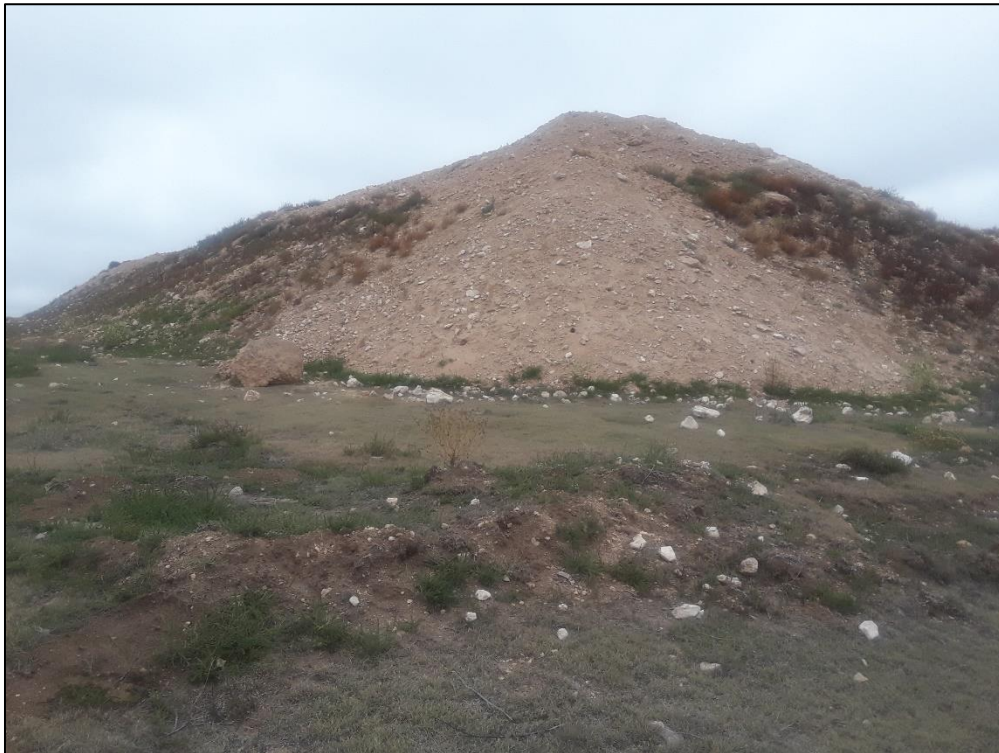
Photo 4. View looking south, showing overburden stockpile stored at northern end of site.

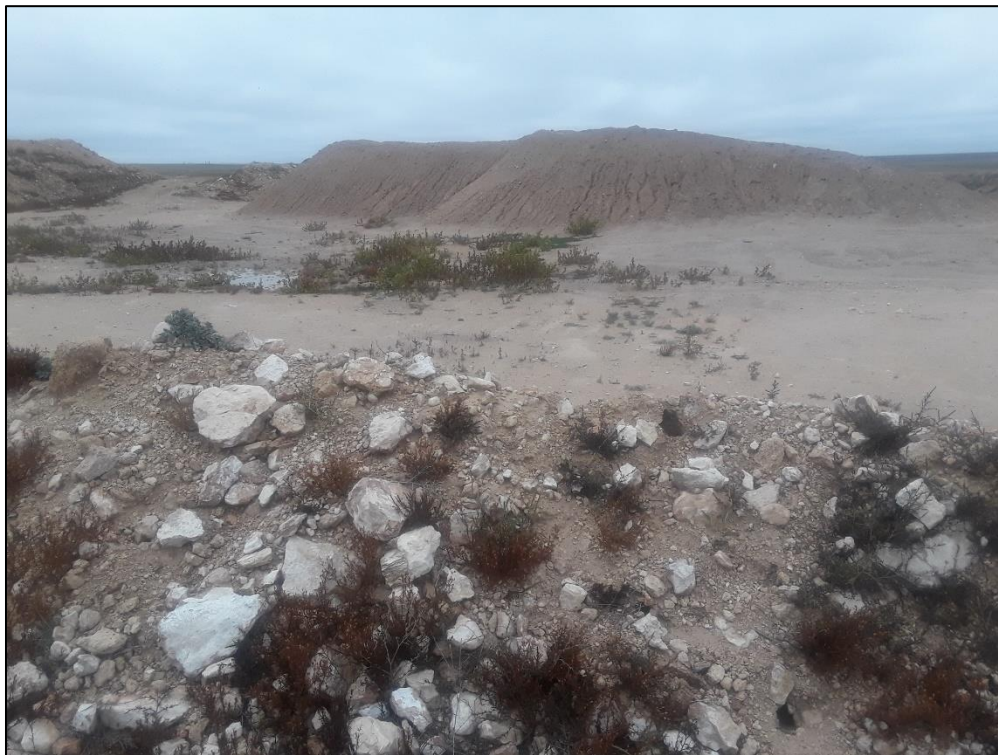
Photo 5. View looking south across pit, showing mined material stored at northern edge of pit. Low-lying overburden berm surrounding pit visible in foreground.

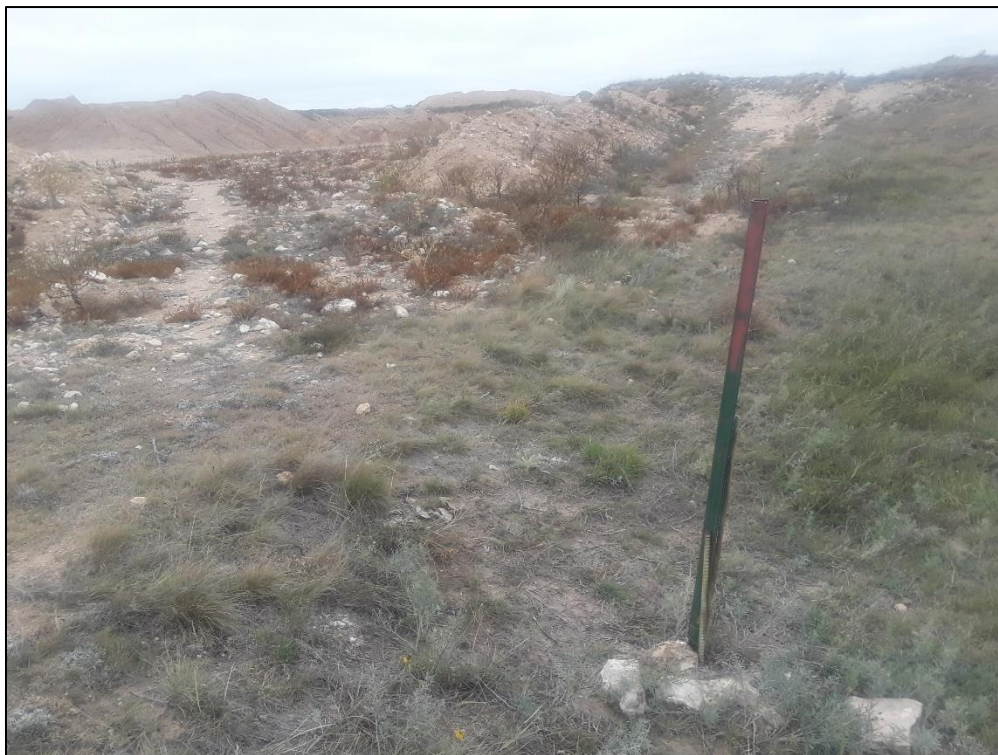
Photo 6. View looking south, showing T-post marking northwestern corner of permit boundary.

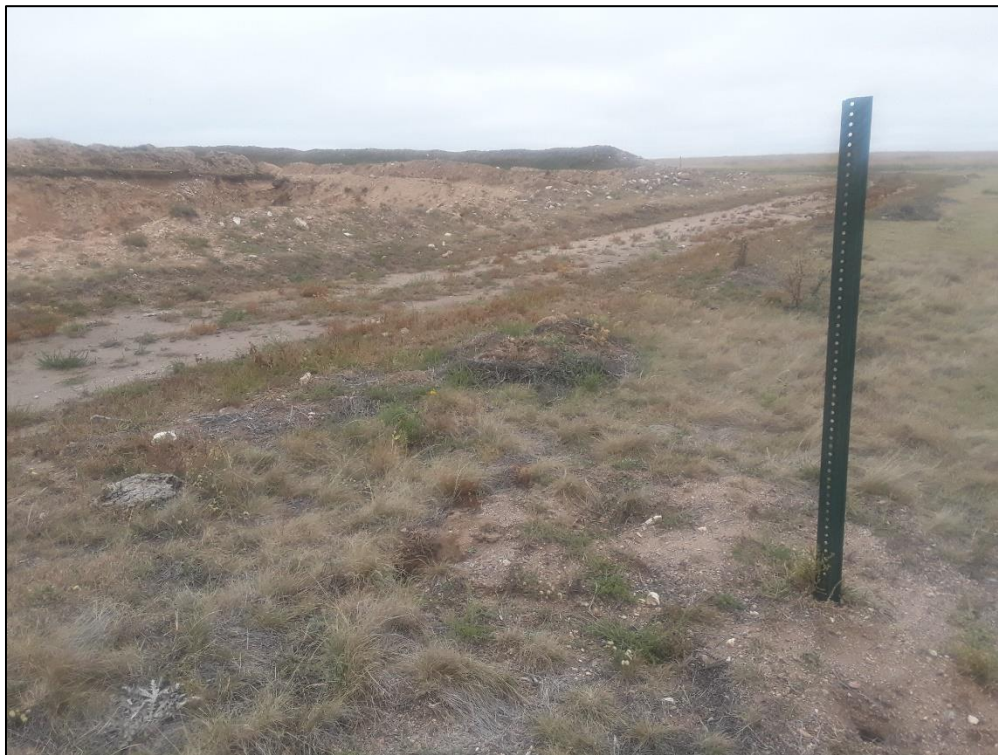
Photo 7. View looking south, showing T-post marking western edge of permit boundary.

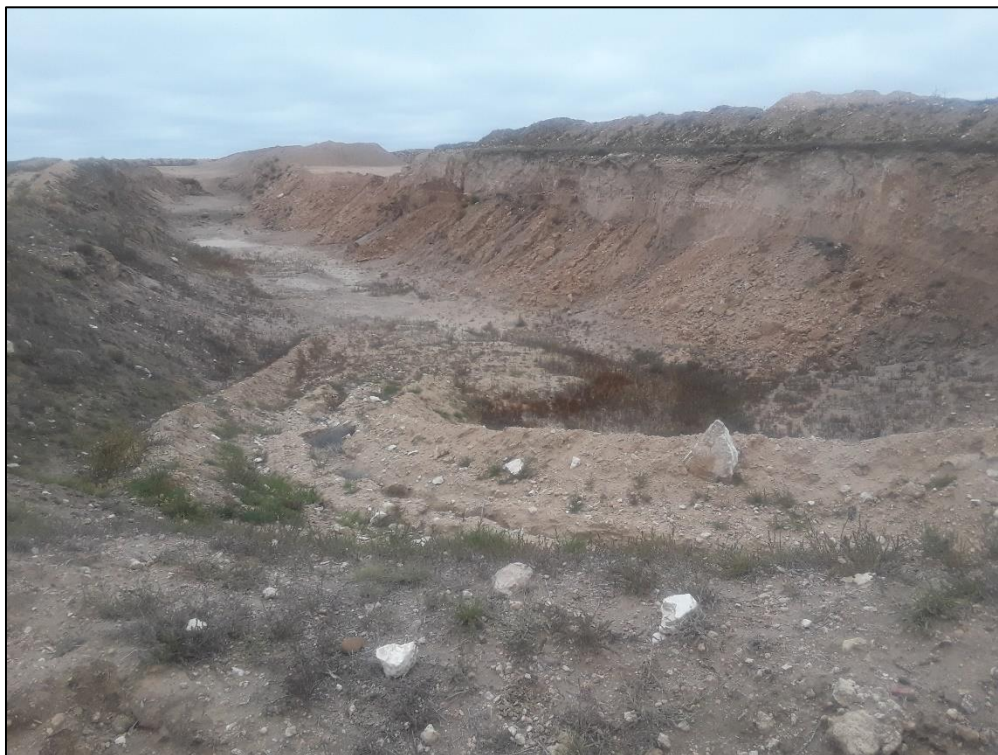
Photo 8. View looking north across pit, showing active highwall (at right) approximately 25 feet in height with near vertical slopes.

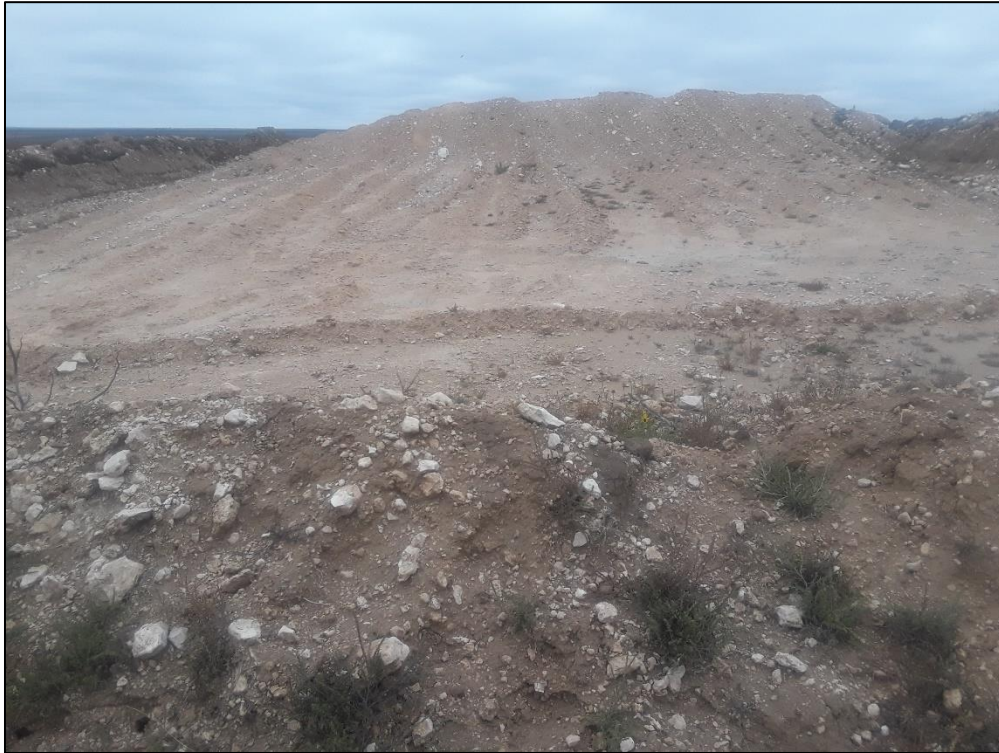
Photo 9. View looking north across area just east of pit which is being stripped in preparation for pit expansion.

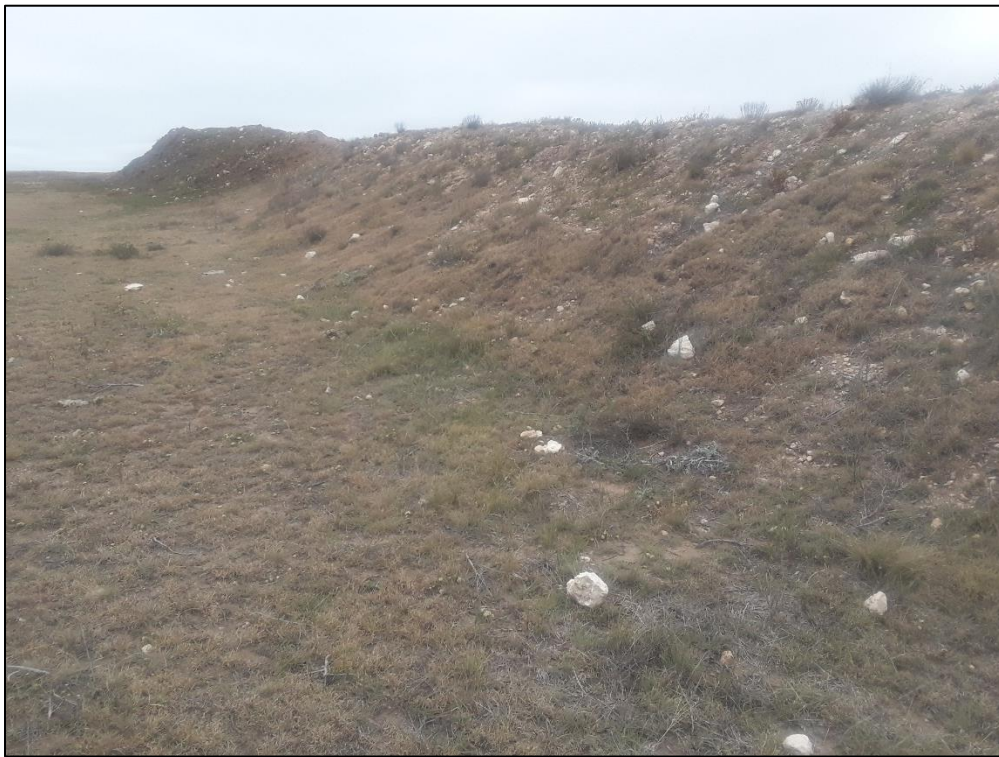
Photo 10. View looking east, showing topsoil stockpiled at north end of site. This stockpile is stable with good grass cover.
