MINERALS PROGRAM INSPECTION REPORT
PHONE: (303) 866-3567

MINE NAME: Schwartzwalder Mine	MINE/PROSPECTING ID#: M-1977-300	MINERAL: Uranium	COUNTY: Jefferson
INSPECTION TYPE: Monitoring	INSPECTOR(S): Michael A. Cunningham	INSP. DATE: November 19, 2018	INSP. TIME: 10:00
OPERATOR: Colorado Legacy Land, LLC	OPERATOR REPRESENTATIVE: Jim Harrington, Billy Ray	TYPE OF OPERATION: 112d-2 - Designated Mining Operation	
REASON FOR INSPECTION: Normal I&E Program	BOND CALCULATION TYPE: None	BOND AMOUNT: \$8,900,000.00	
DATE OF COMPLAINT: NA	POST INSP. CONTACTS: None	JOINT INSP. AGENCY: None	
WEATHER: Clear	INSPECTOR'S SIGNATURE:

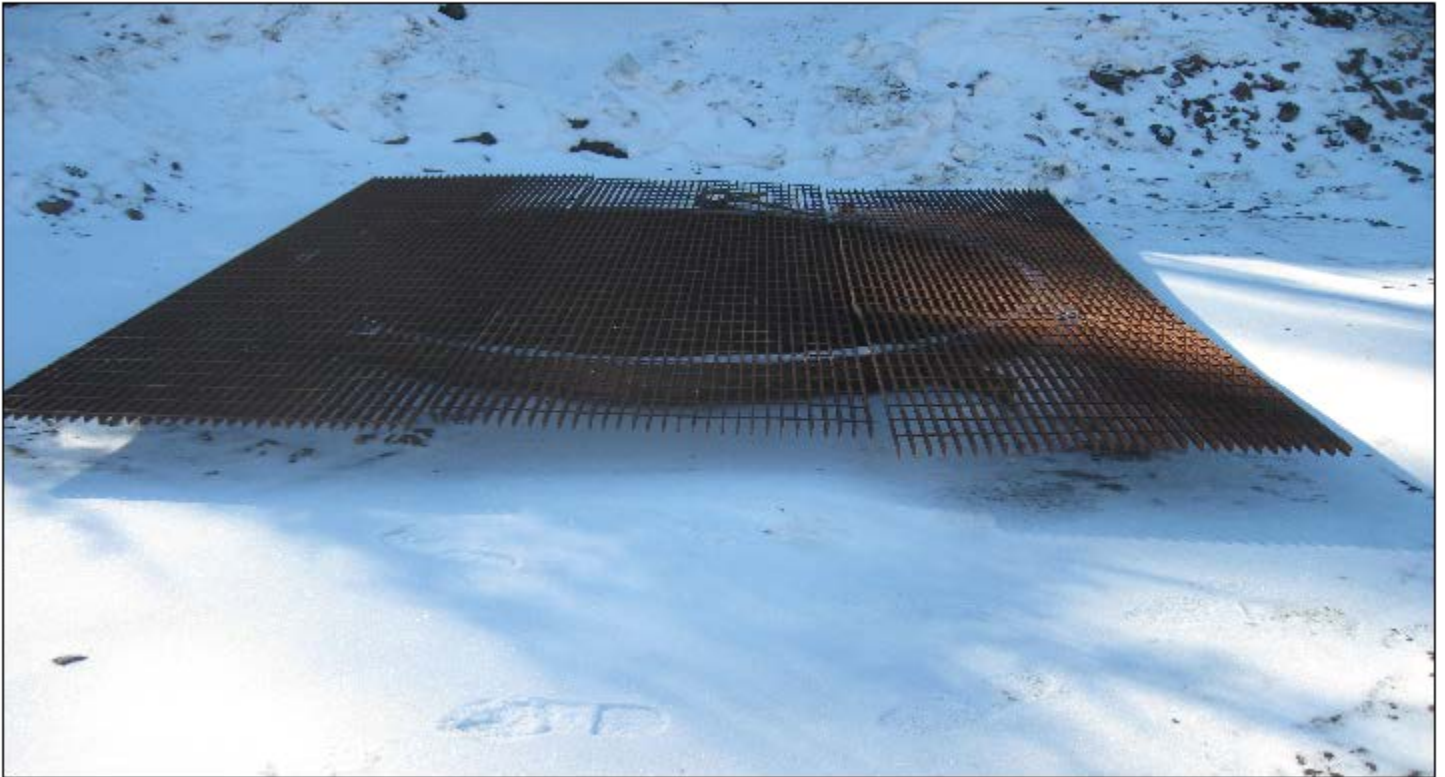
The Division is currently reviewing Technical Revision No. 27 (TR27) which addresses the relocation of the submersible pump from its current location within the Steve Adit. The relocation of the submersible pump to the Jeffrey Air Shaft will allow the pump to be placed at an approximate elevation of 410' below the Steve Adit and will allow for above ground maintenance and repair of the pump. In addition, TR27 addresses proposed changes to the groundwater sampling methods.

1. Jeffrey Air Shaft.

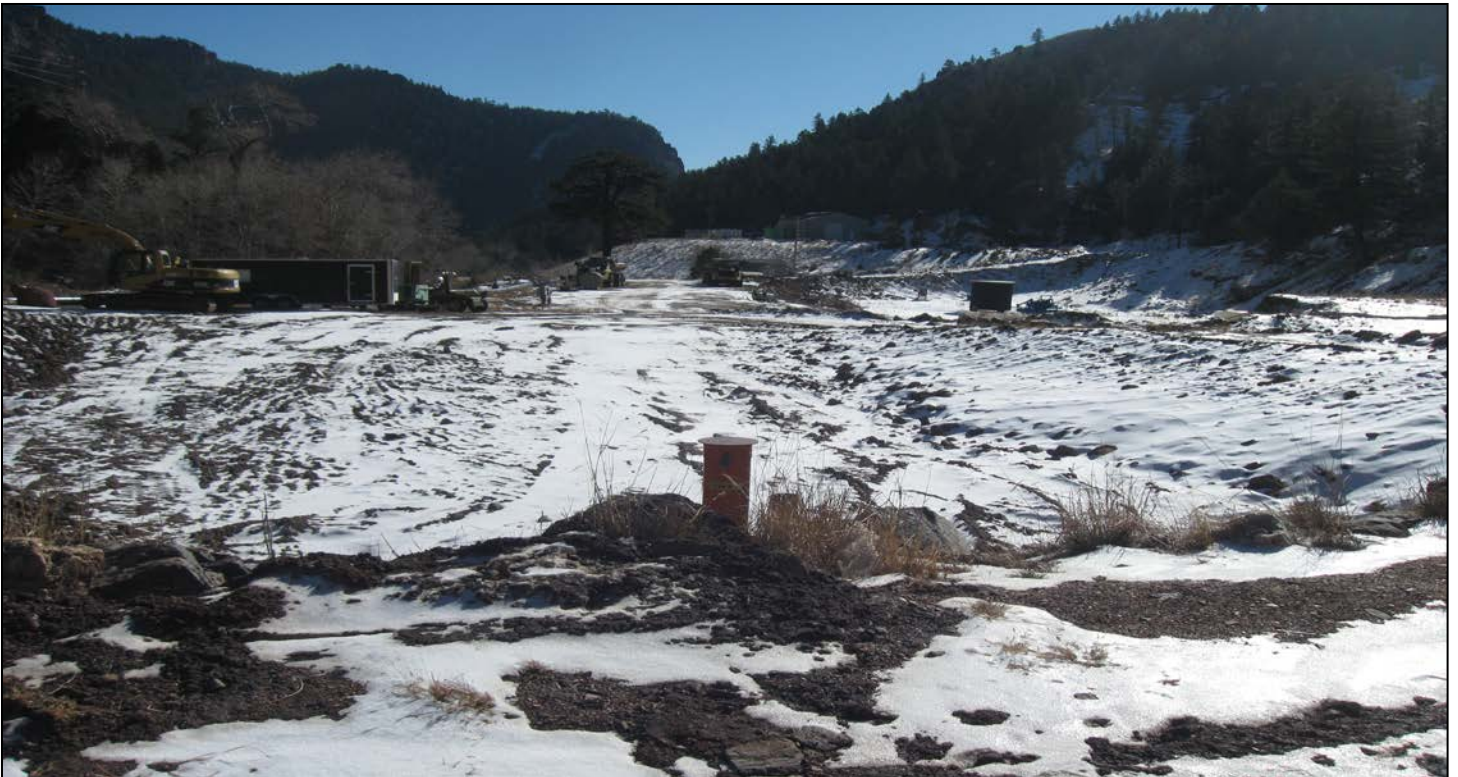
The Operator has continued to demolish and remove structures from the mine site. To date the Operator has removed the following structures from the site: former office trailer, concrete containment ponds, and steel tanks adjacent to the old water treatment plant (OWTP). The OWTP has been fully decommissioned and all equipment has been removed. During the inspection, the contractors were removing insulation from the building and they anticipated the structure would be demolished within several days following the inspection.

2. Location of former concrete containment ponds, photo taken facing east.

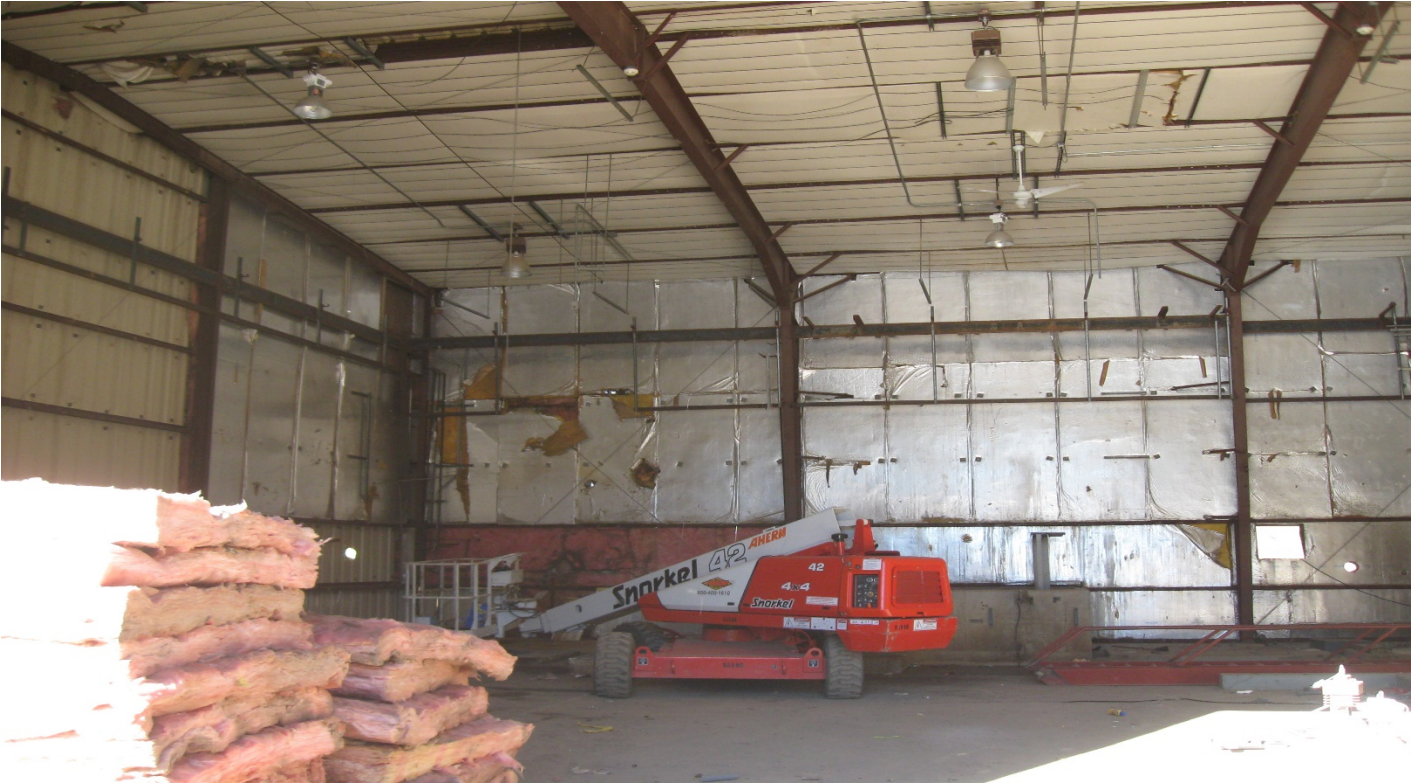
3. Inside view of Old Water Treatment Plant.

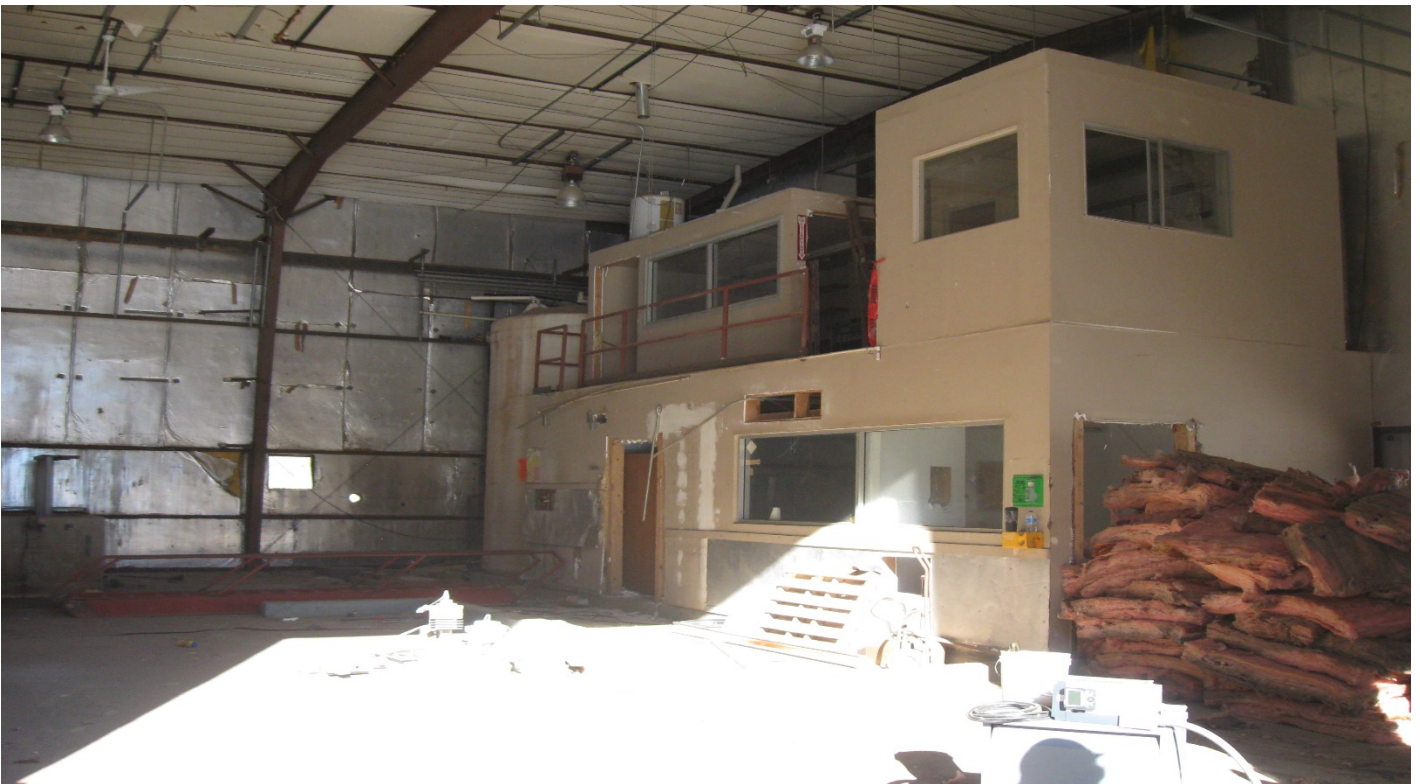
4. Inside view of Old Water Treatment Plant.

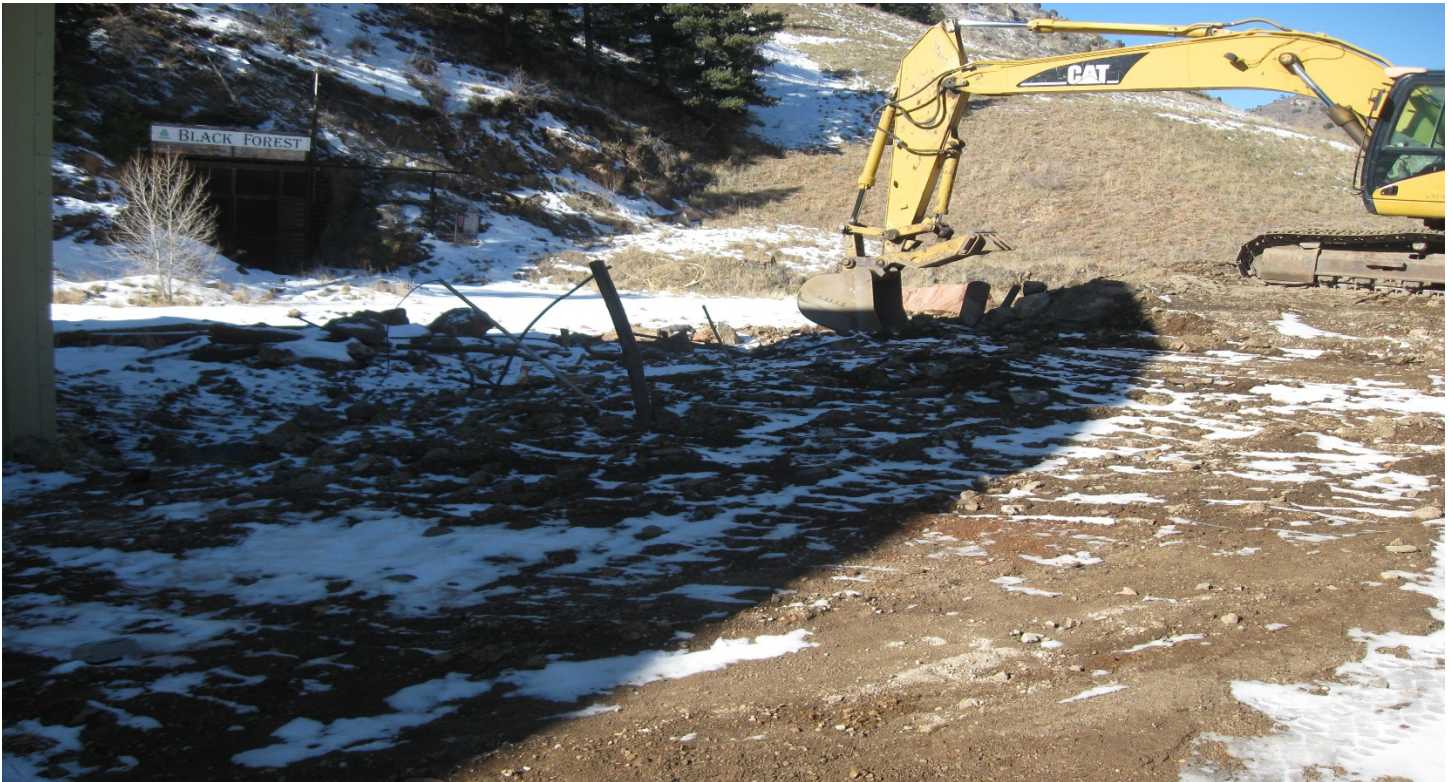
5. Location of former steel tanks, adjacent to Old Water Treatment Plant.

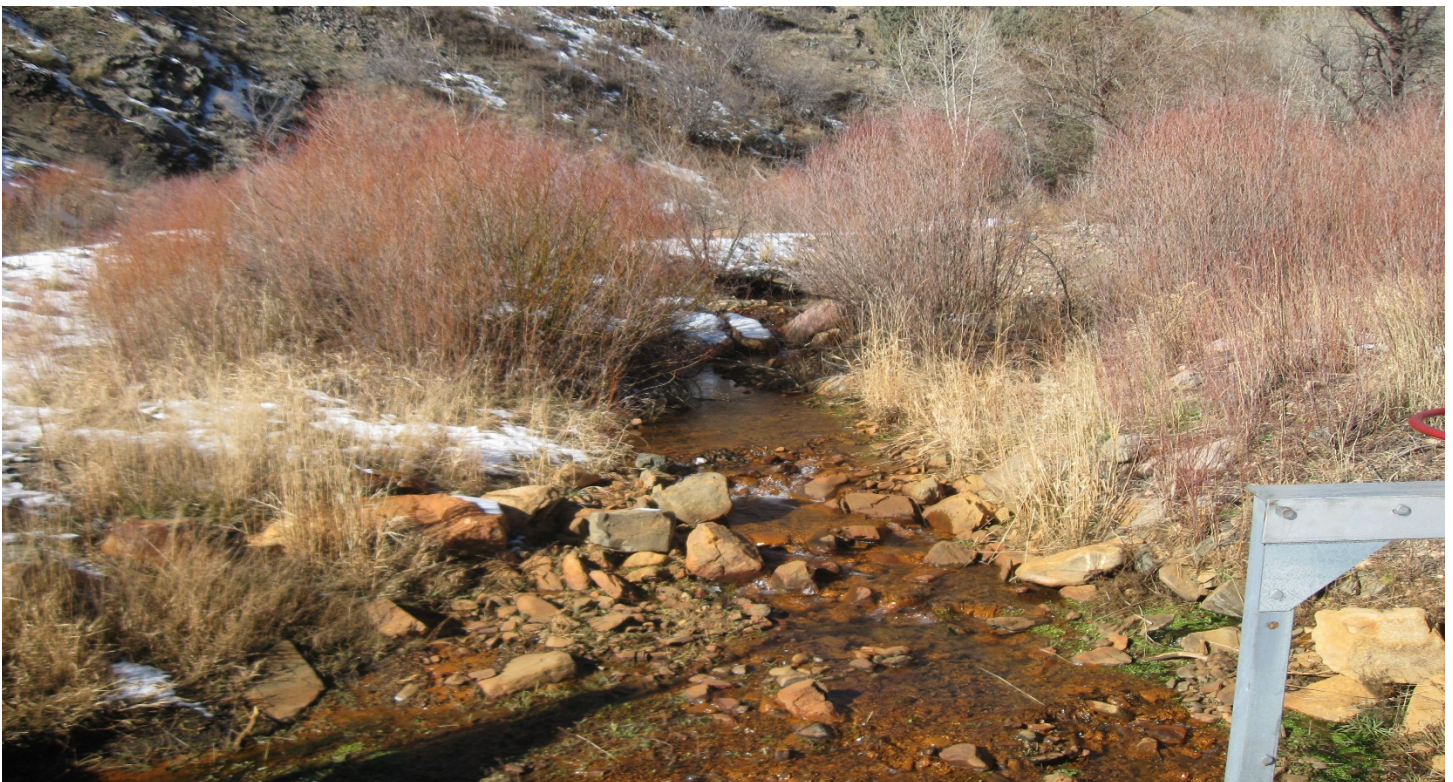
The Division inspected the cutoff wall and observed that all flows in Ralston Creek were being routed through the by-pass pipeline. The Division observed the by-pass pipeline had shifted onto the access road adjacent to the south waste rock pile. This is the second time the by-pass pipeline has shifted onto the access road, with the by-pass pipeline shifting in the same location each time. The Division did not observe any visible damage to the by-pass pipeline. Following the last time the by-pass pipeline moved, the Operator chained the pipe in place to prevent further movement. The Operator committed to moving the by-pass pipeline back to the north edge of the access road once temperatures were warm enough, so as to prevent damage to the pipeline. The Division recommends utilizing a different and more robust method to secure the pipeline.

6. Ralston Creek, upstream of cut-off wall.

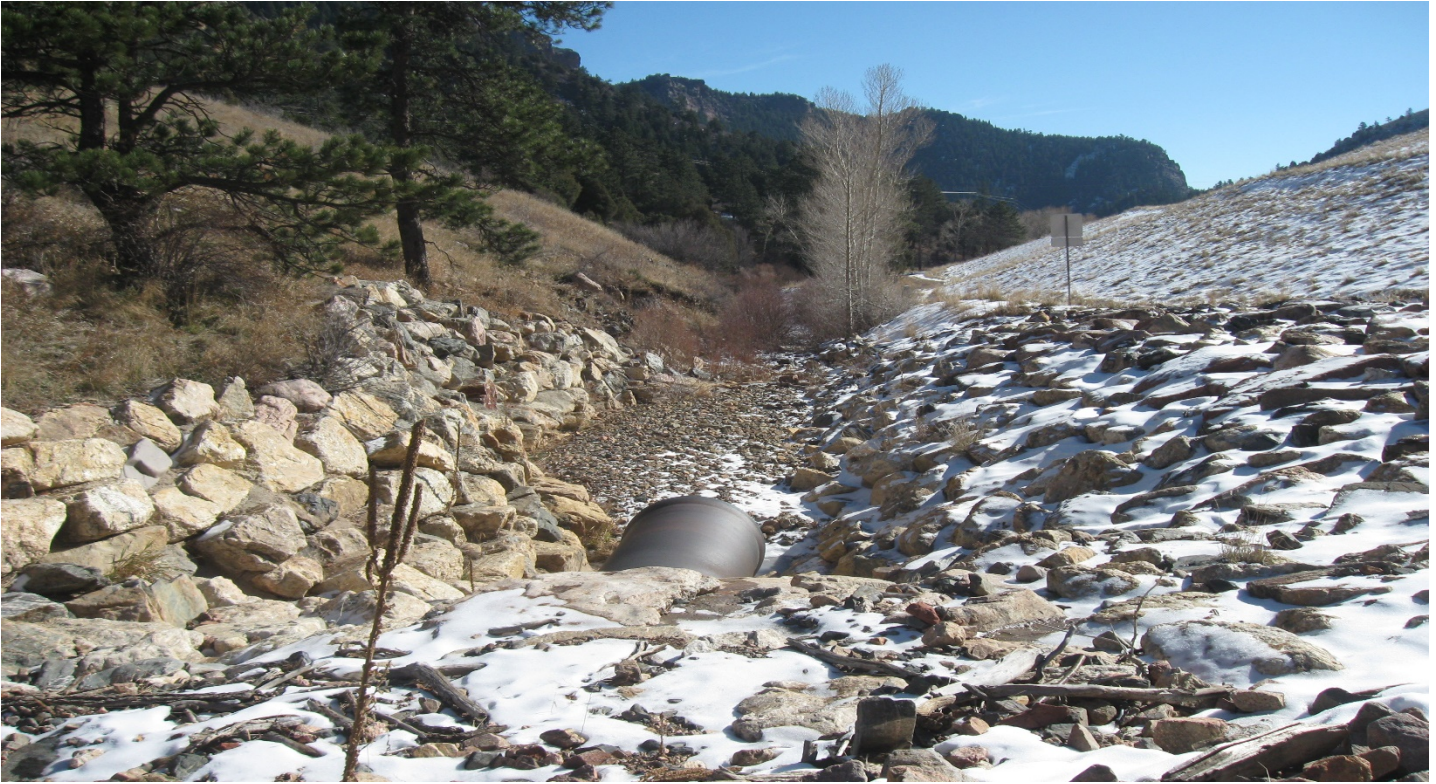
7. Ralston Creek, downstream of cut-off wall.
