MINERALS PROGRAM INSPECTION REPORT
PHONE: (303) 866-3567

MINE NAME: Fasse Pit	MINE/PROSPECTING ID#: M-1995-009	MINERAL: Sand, gravel, borrow	COUNTY: Kit Carson
INSPECTION TYPE: Surety-Related Inspection	INSPECTOR(S): Elliott R. Russell	INSP. DATE: November 2, 2018	INSP. TIME: 10:00
OPERATOR: Dorman Brothers LLC	OPERATOR REPRESENTATIVE: None	TYPE OF OPERATION: 112c - Construction Regular Operation	
REASON FOR INSPECTION: Surety Related	BOND CALCULATION TYPE: Complete Bond	BOND AMOUNT: \$159,850.00	
DATE OF COMPLAINT: NA	POST INSP. CONTACTS: None	JOINT INSP. AGENCY: None	
WEATHER: Clear	INSPECTOR'S SIGNATURE:

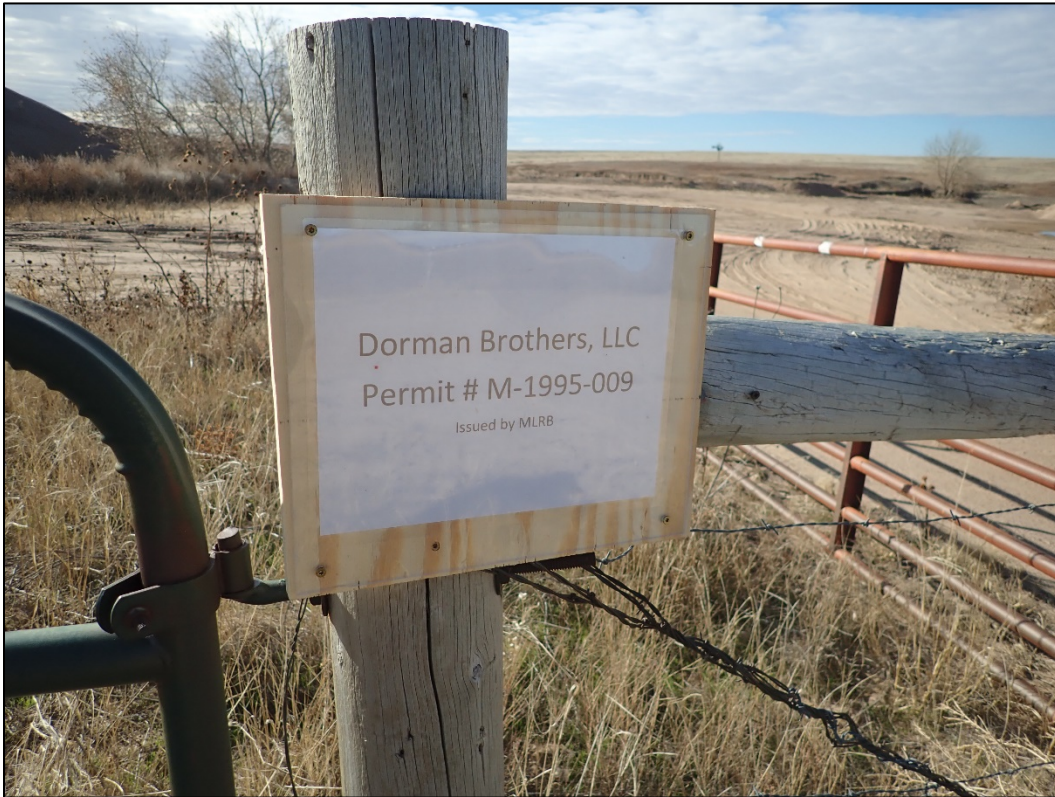
The permit identification sign was posted at the entrance to the mine and the permit was delineated by fence lines and t-posts. The site was not active at the time of the inspection, but the Division observed evidence of recent mining activity. Equipment on-site included one front-end loader.

Photo 1. Mine identification sign; looking south.

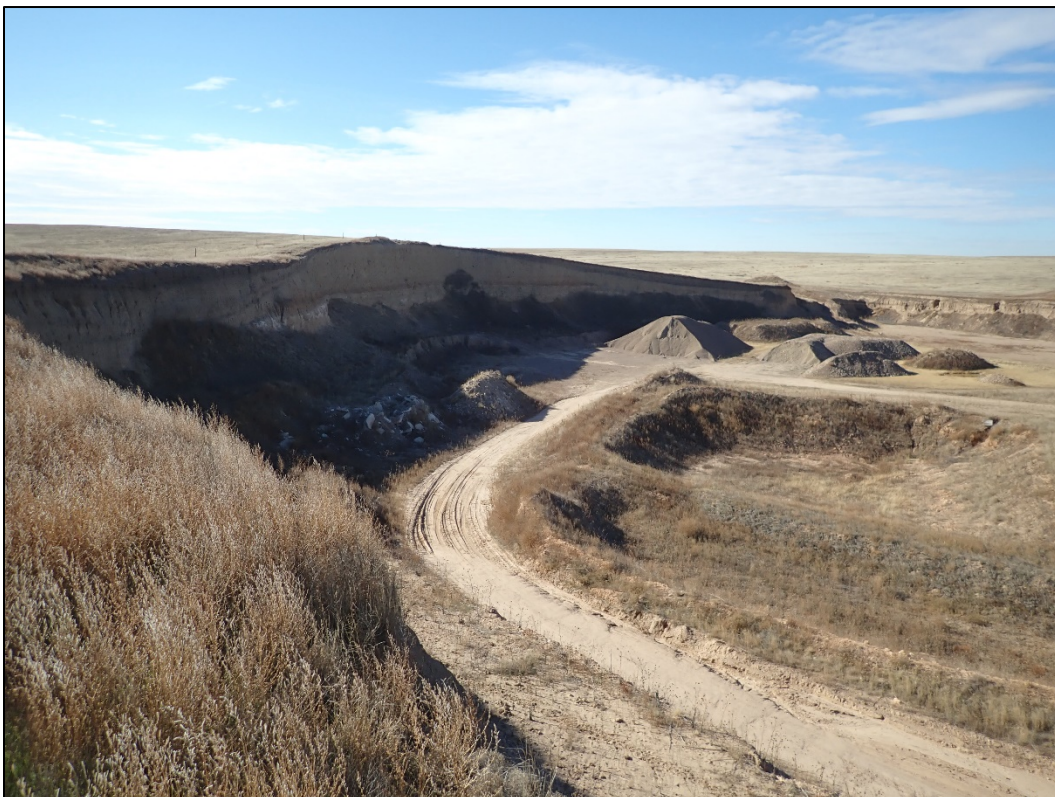
Photo 2. Overview of the site; looking southwest.

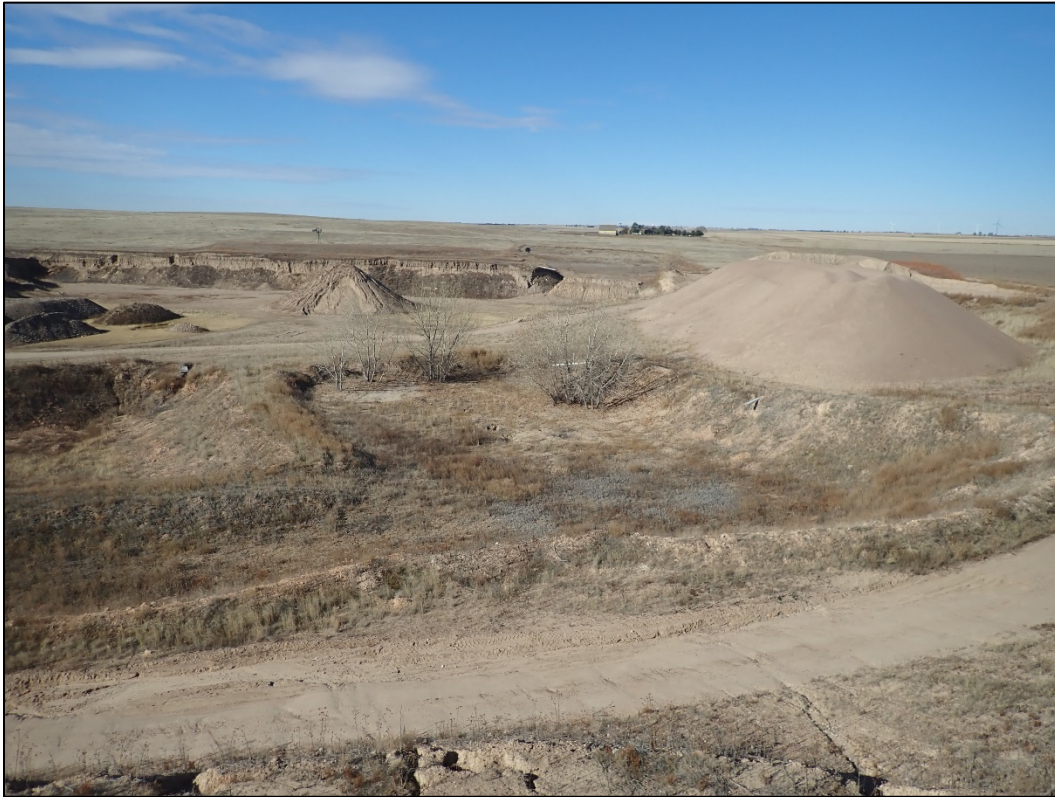
Photo 3. Overview of the site; looking west.

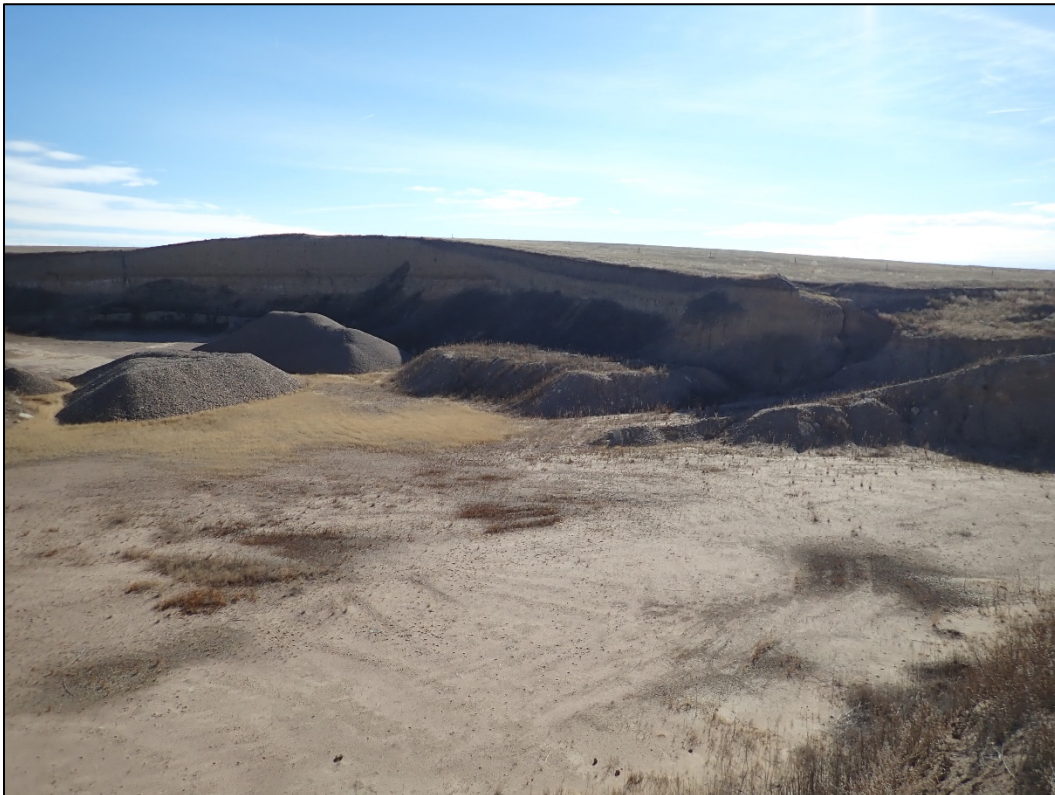
The site consisted of a single pit, several stockpiles of screened material, and a large highwall along the eastern and southern portion of the pit. This highwall, approximately 1,200 feet long and ranged from approximately 20 to 60 feet high, appeared to be stable and showed no signs of slope failure. If the site is mined deeper or advances to the southeast, the Division recommends the Operator ensure the depth of the pit does not exceed three times the distance to the permit boundary behind this highwall to achieve the approved reclaimed slope gradient of 3H:1V with a cut-fill approach. Failure to maintain an adequate buffer from the permit boundary in regards to the depth of the pit will result in a significant surety increase of the reclamation bond to complete the costly task of backfilling the highwall.

Photo 4. Overview of the site; looking east.

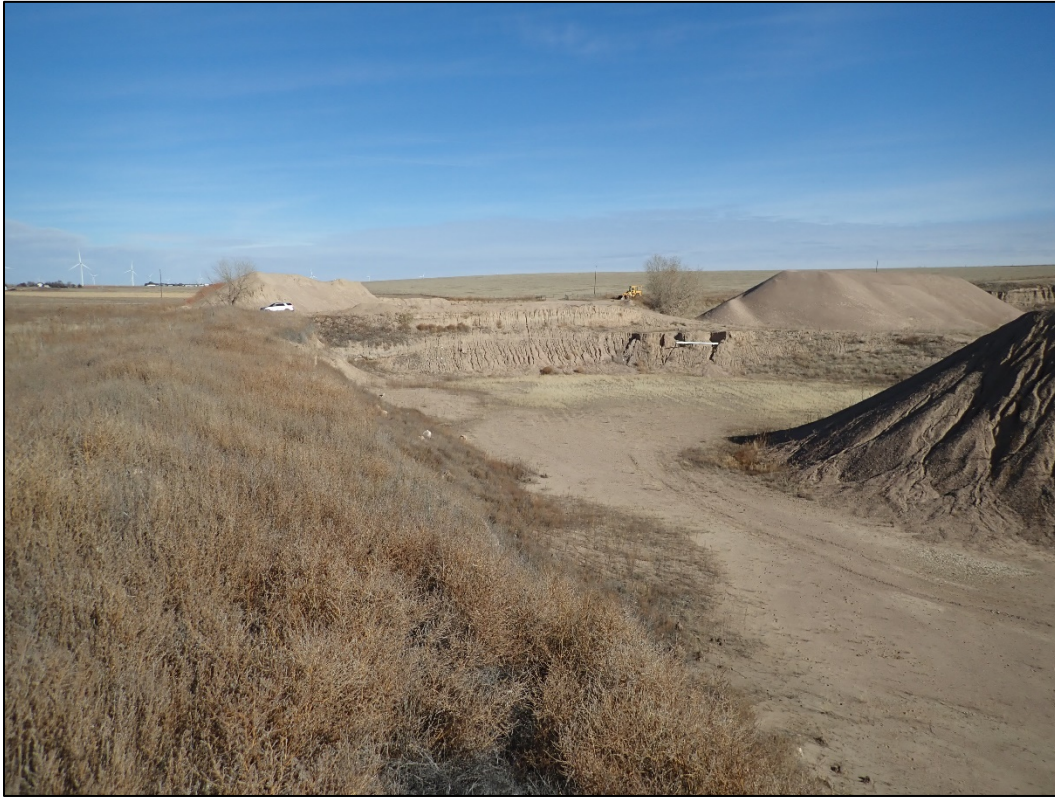
Photo 5. Overview of the site; looking north.
