MINERALS PROGRAM INSPECTION REPORT
PHONE: (303) 866-3567

MINE NAME: Keyah Grande Aggregate Mining Oper	MINE/PROSPECTING ID#: M-2011-026	MINERAL: SDG, AGGR	COUNTY: Archuleta
INSPECTION TYPE: Monitoring	INSPECTOR(S): Lucas J. West	INSP. DATE: October 25, 2018	INSP. TIME: 09:29
OPERATOR: Keyah Grande Lodge and Elk Ranch	OPERATOR REPRESENTATIVE: None	TYPE OF OPERATION: 112c - Construction materials	
REASON FOR INSPECTION: Normal I&E Program	BOND CALCULATION TYPE: Complete Bond	BOND AMOUNT: \$21,530.00	
DATE OF COMPLAINT: NA	POST INSP. CONTACTS: None	JOINT INSP. AGENCY: None	
WEATHER: Clear	INSPECTOR'S SIGNATURE:

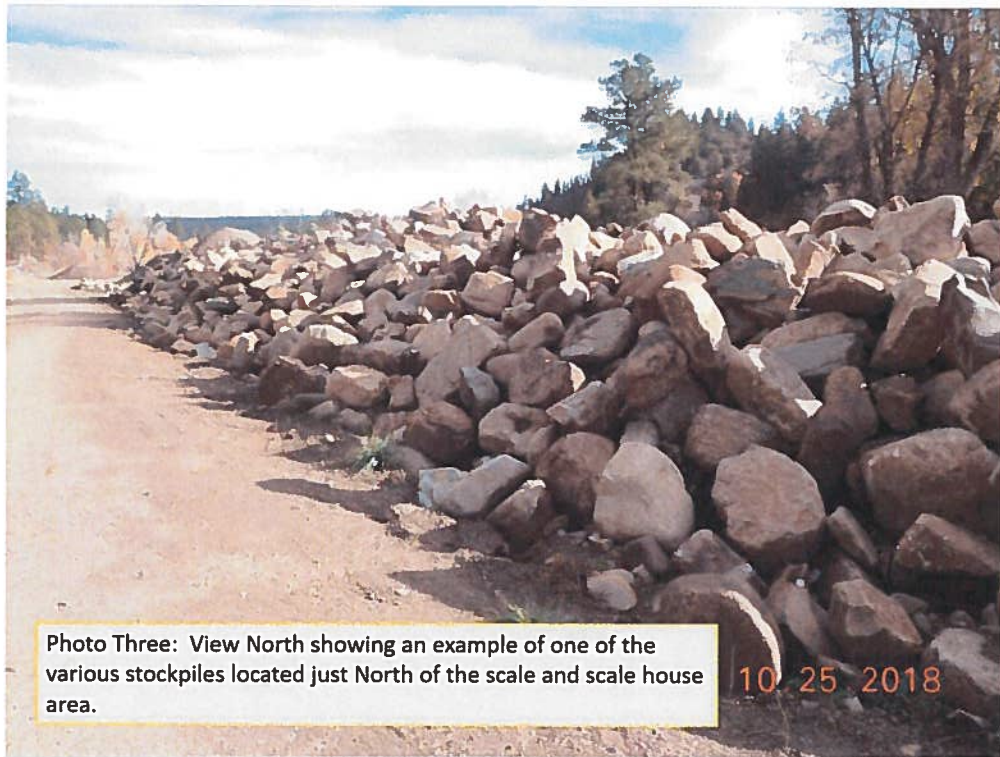
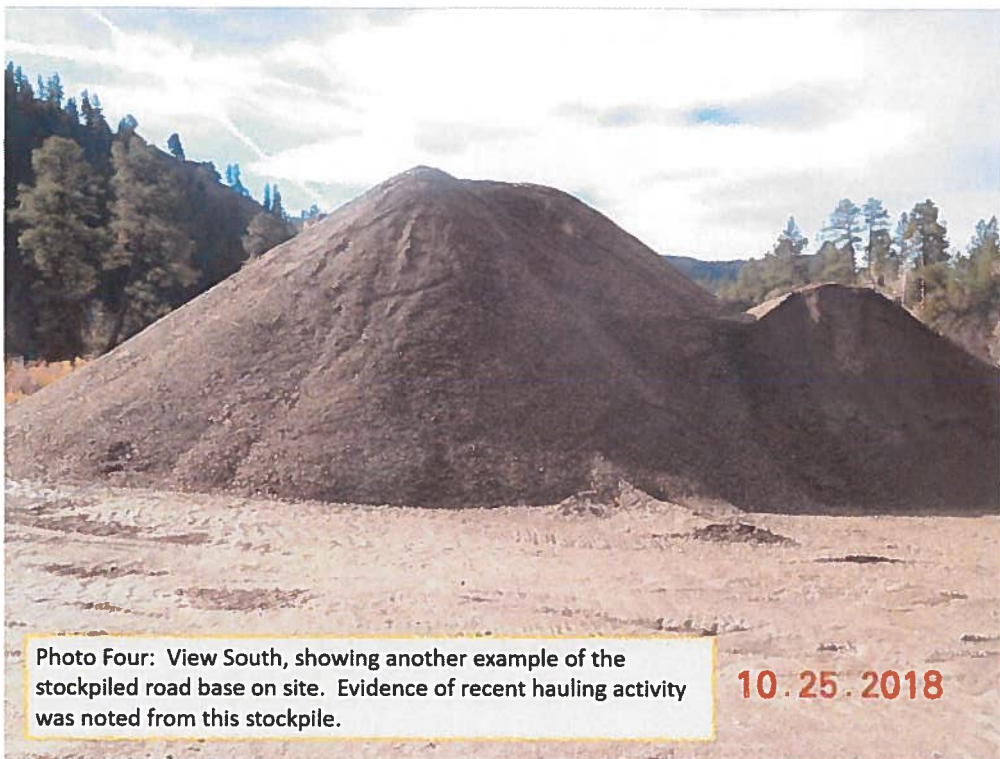
A large work and stockpile area is located just north of the scale and scale house. In that area are several stockpiles of various sized materials. All of the stockpiles appear to be in good condition and stable, and no significant signs of erosion or noxious weed were noted on the piles or the surrounding area. The condition of the stockpile area are further documented in Photos Three and Four.

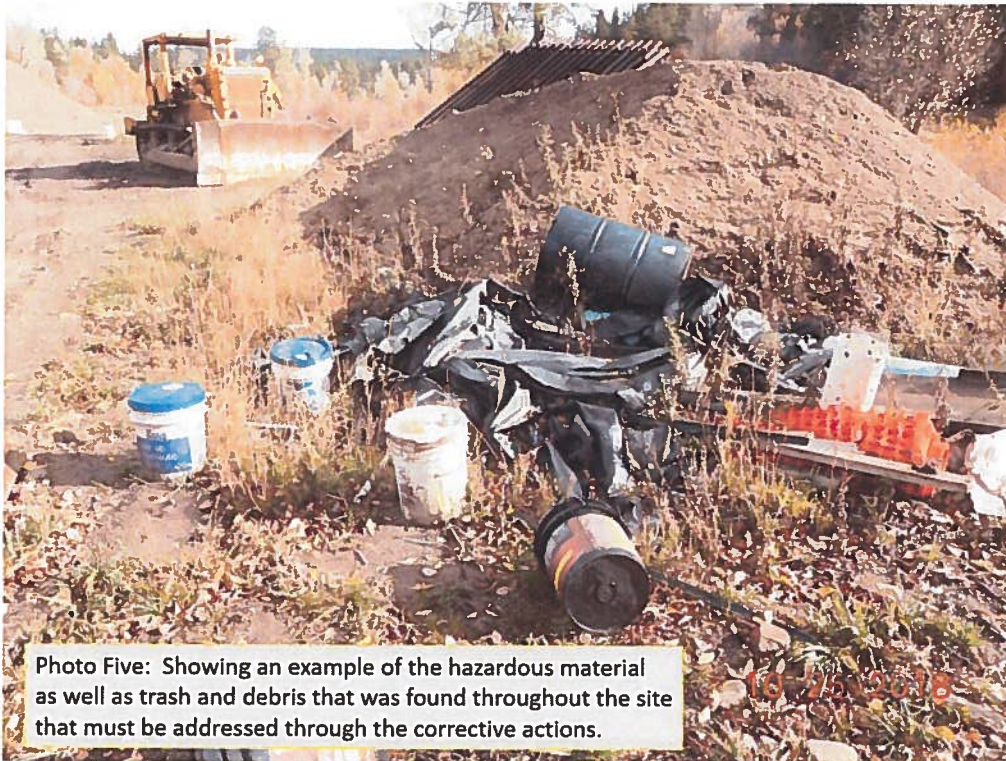
PROBLEM 2: Several containers, ranging from full to empty and ranging in capacity from 55 gallon drums to 5 gallon buckets, were present and assumed to contain hydraulic oil, motor oil and other potentially hazardous materials. The operation is located within an alluvial valley with groundwater elevations near surface. The containers were stored in a haphazard manner not protective of hydrologic resources.

As shown in Photos Five and Six, debris and hazardous materials, including motor oil and hydraulic fluids, were stored in a haphazard manner. Given the proximity of the operation to sensitive hydrologic resources, all petroleum products and hazardous materials stored on site shall have appropriate secondary containment. Please supply photo documentation that any fuel or hazardous materials containers are stored properly - including applicable secondary containment structures or that the items have been removed from the site completely. Please also include photo documentation that a general site cleanup has taken place to remove all trash and debris. Note that secondary containment structures shall consist of an impermeable containment which could contain all contents of the tanks and various containers (when full) plus 10% of the total capacity. Evidence of completion of these corrective actions should be received by the Division within **90 days** of the date of this report, no later than **Monday March 4, 2018**.

Photo Five: Showing an example of the hazardous material as well as trash and debris that was found throughout the site that must be addressed through the corrective actions.

CORRECTIVE ACTIONS: All fuel, oils, lubricants and other hazardous materials stored on site shall have appropriate secondary containment. Please supply photo documentation that any fuel or hazardous materials containers are stored properly - including applicable secondary containment structures by the corrective action date. Note that secondary containment structures shall consist of an impermeable containment which could contain all contents of the tanks and various containers (when full) plus 10% of the total capacity. The operator may also provide photo documentation that all containers have been removed from the site within 90 days of the date of this report.

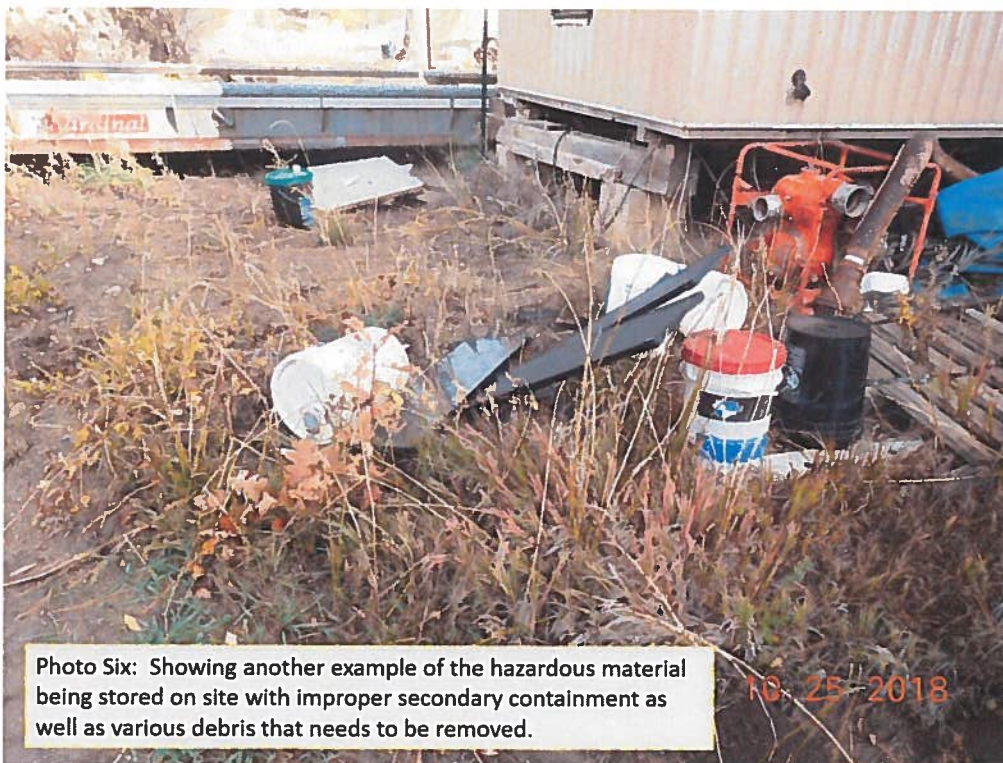
Photo Six: Showing another example of the hazardous material being stored on site with improper secondary containment as well as various debris that needs to be removed.
