MINERALS PROGRAM INSPECTION REPORT

MINE NAME: Cresson Project	MINE/PROSPECTING ID#: M-1980-244	MINERAL: Gold	COUNTY: Teller
INSPECTION TYPE: Monitoring	INSPECTOR(S): Timothy A. Cazier	INSP. DATE: July 31, 2018	INSP. TIME: 09:40
OPERATOR: Cripple Creek & Victor Gold Mining Company	OPERATOR REPRESENTATIVE: Justin Bills	TYPE OF OPERATION: 112d-3 - Designated Mining Operation	
REASON FOR INSPECTION: Normal I&E Program	BOND CALCULATION TYPE: None	BOND AMOUNT: \$208,491,188.00	
DATE OF COMPLAINT: NA	POST INSP. CONTACTS: None	JOINT INSP. AGENCY: None	
WEATHER: Clear	INSPECTOR'S SIGNATURE:

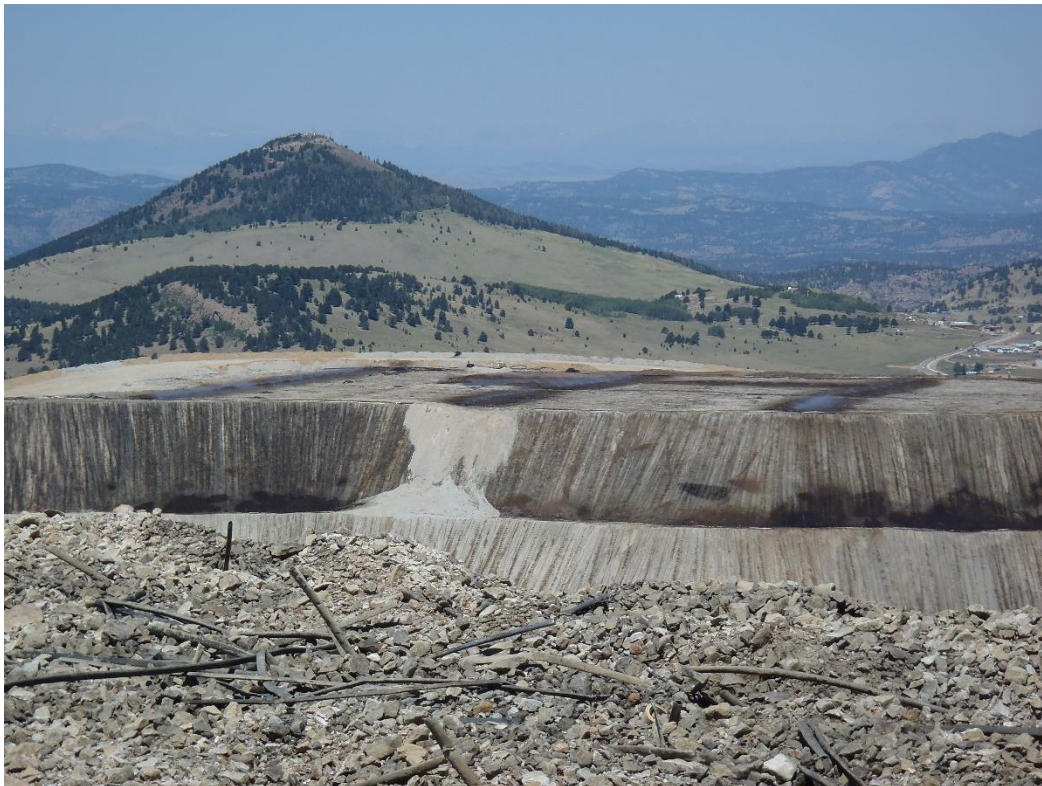
Arequa Gulch Valley Leach Facility (VLF1): Mr. Laurin Colby accompanied the DRMS and Mr. Bills on the VLF1 tour. Active leaching areas were observed, primarily elevation 10,200 and 10,400. **The copious amount of ponded solution observed on the surface was unprecedented** (see **Photos 1 -3**) **and cited as a Problem.** Mr. Colby indicated they were having troubles with the “wobblers” becoming plugged with solids, causing them to malfunction (“squirt” instead of spray). The DRMS reminded CC&V, pursuant to the approved Wildlife Protection Plan, there should be no areas of ponded solution greater in area than three feet by three feet. Site personnel were contacted by Mr. Colby during the inspection to begin remedying the situation. Due to the large areas exhibiting solution ponding, it took some time to correct this problem. It appeared to be resolved by the time the DRMS’s August inspection. The problem with solution ponding has been an issue on and off for several months. The DRMS acknowledges the change in personnel over the past several months has made the importance of this issue a challenge to convey to the appropriate responsible parties. Nonetheless, the **DRMS continues to emphasize the importance of adhering to the three foot by three foot limit for ponded solution as directed in the approved wildlife protection plan.** As of the writing of this inspection report, the ponded solution problem observed during the July inspection is considered abated.

Photo 1. Ponded solution on VLF 1 north end/phase IV, elevation 10,200.

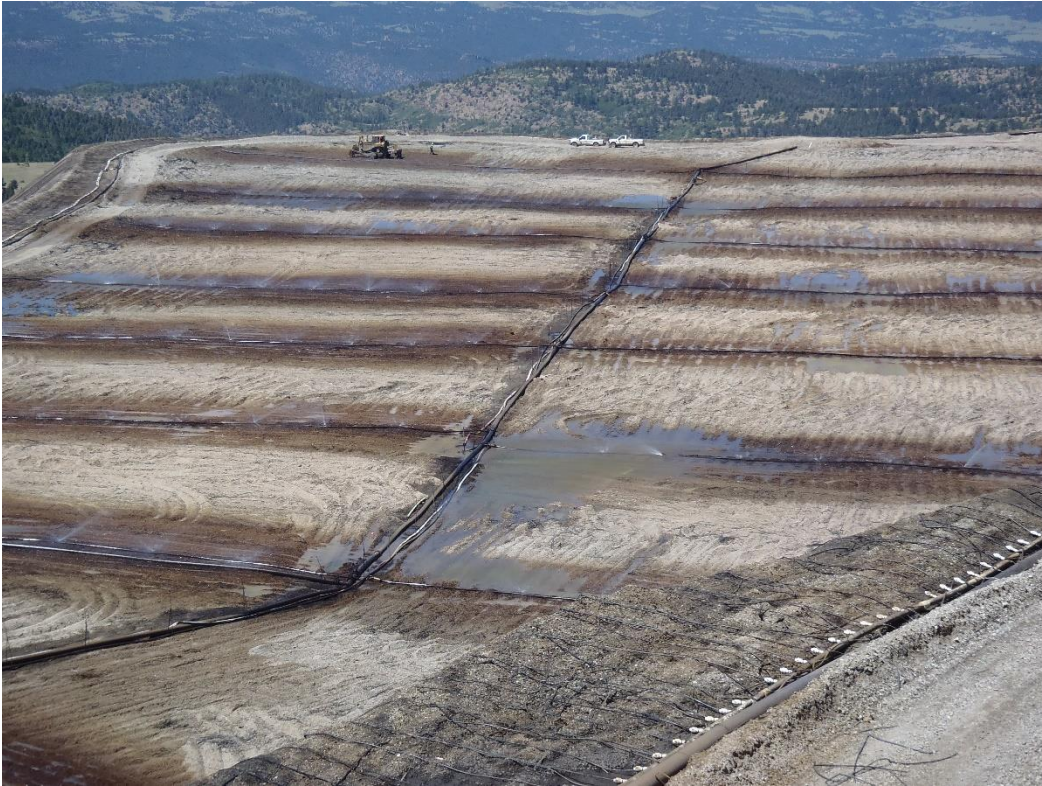
Photo 2. Poned solution on VLF 1 (elevation 10,200, phase I/II).

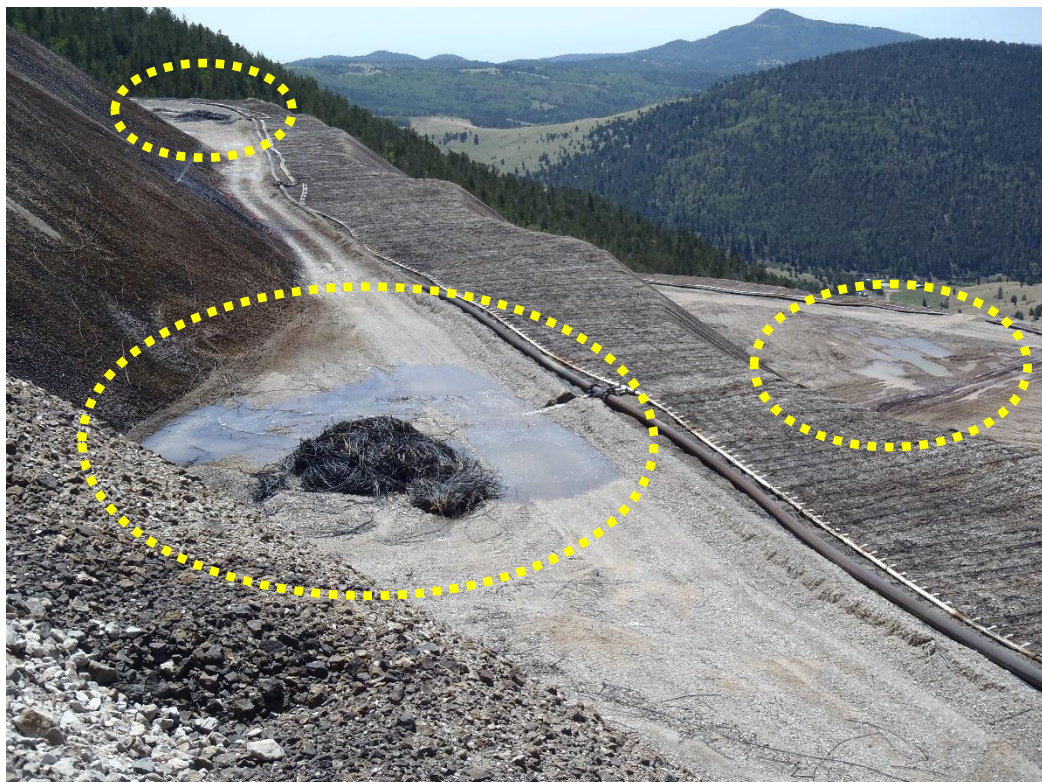
Photo 3. Poned solution on VLF 1 (south side phase I bordering phase V).

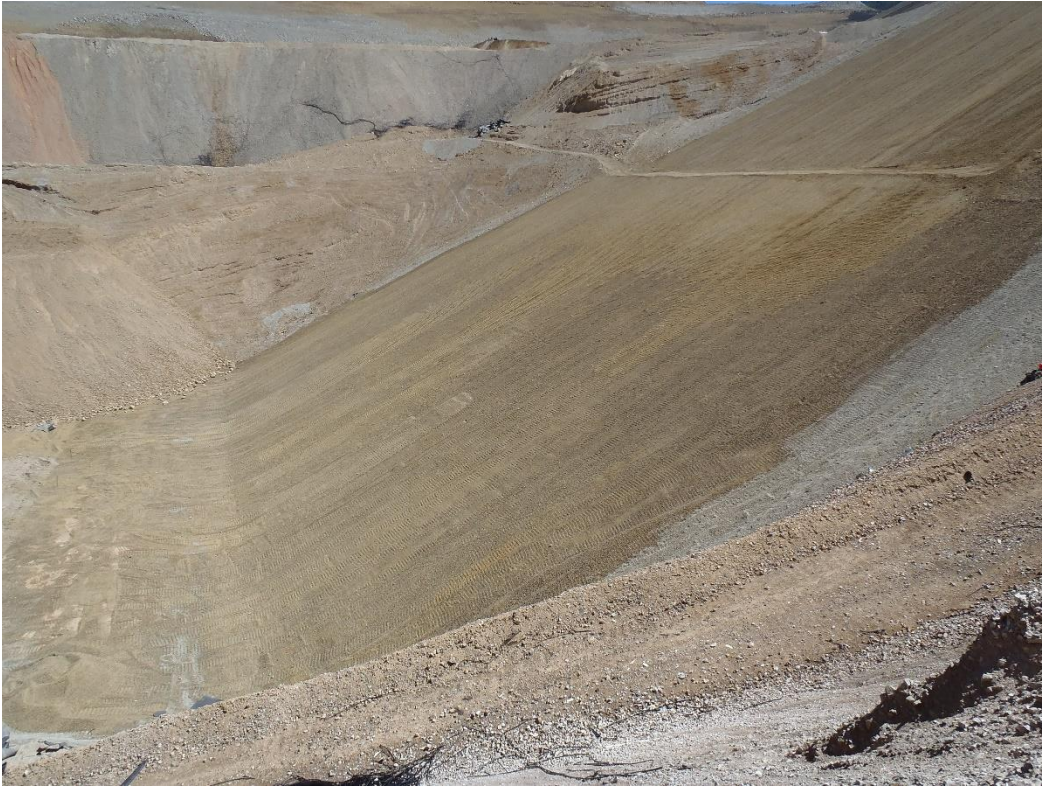
Squaw Gulch Valley Leach Facility (VLF 2) & Liner Repair Area: Messrs. Colby and Bills accompanied the Division to the VLF 2 slide area between the 9850 and 9650 benches. Ames construction had completed placement of the drain cover fill (DCF) over the repaired geomembrane liner between the 9650 and 9750 benches (see **Photo 4**) and were actively placing DCF between the 9750 and 9850 benches (see **Photo 5**) using a dozer with GPS to control the thickness of the DCF placement.

Photo 4. Completed placement of DCF between the VLF 2 9650 and 9750 benches.

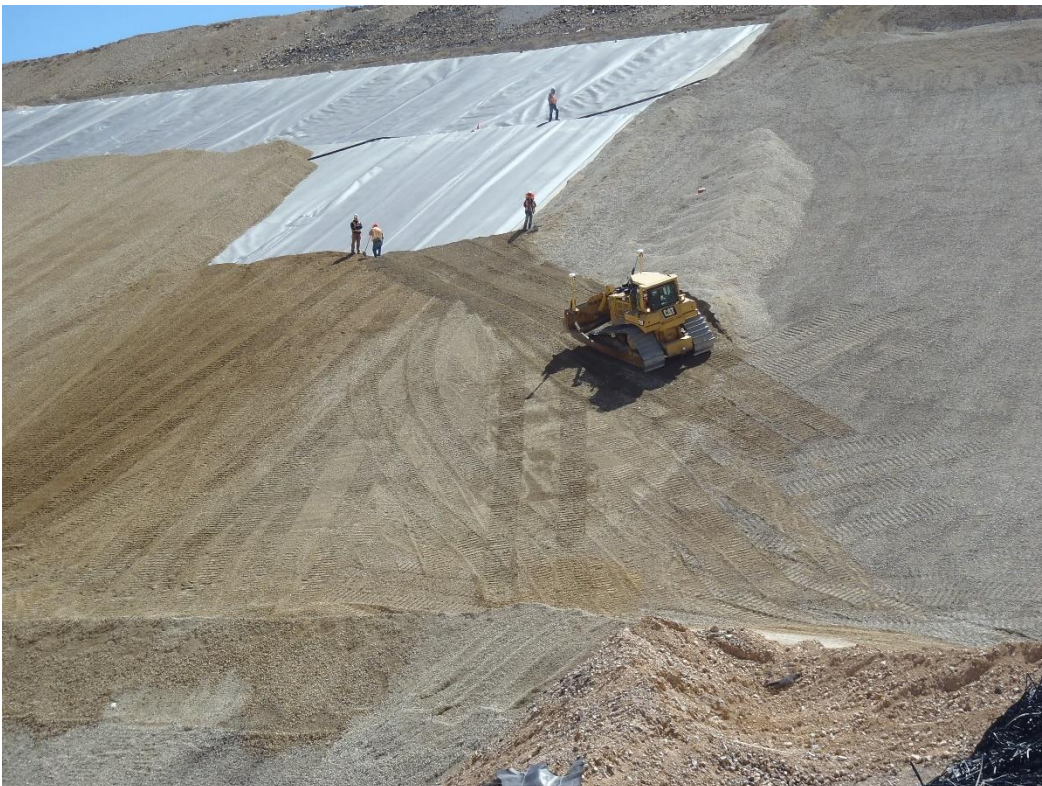
Photo 5. Actively placing DCF between the VLF 2 9750 and 9850 benches.

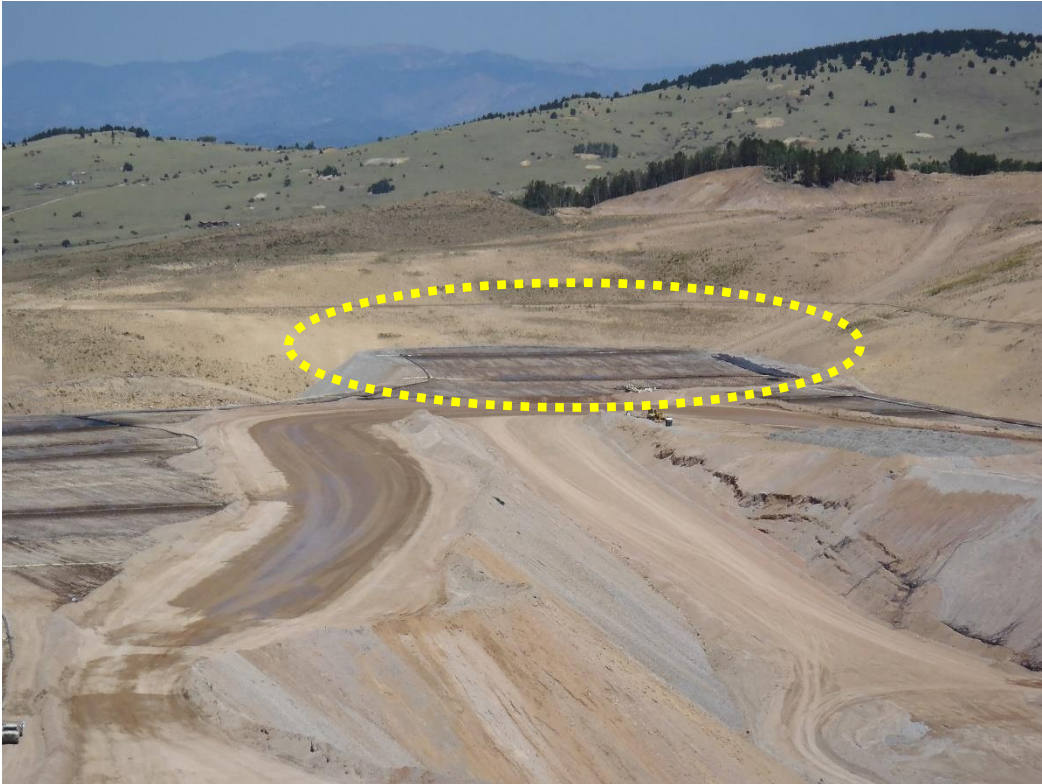
Active leaching areas were also observed on VLF 2. Some ponded solution was observed using binoculars on the northwest side of the pad (see **Photo 6**). However, the problem was not as extensive as that on VLF 1. Water levels in the VLF 2 pregnant solution storage area (PSSA) were checked to ensure they were below the 80 percent reporting level (94 feet for VLF 2 PSSA). The piezometer (which should provide the highest water level reading)

Photo 6. Ponded solution on northwest side of VLF 2.

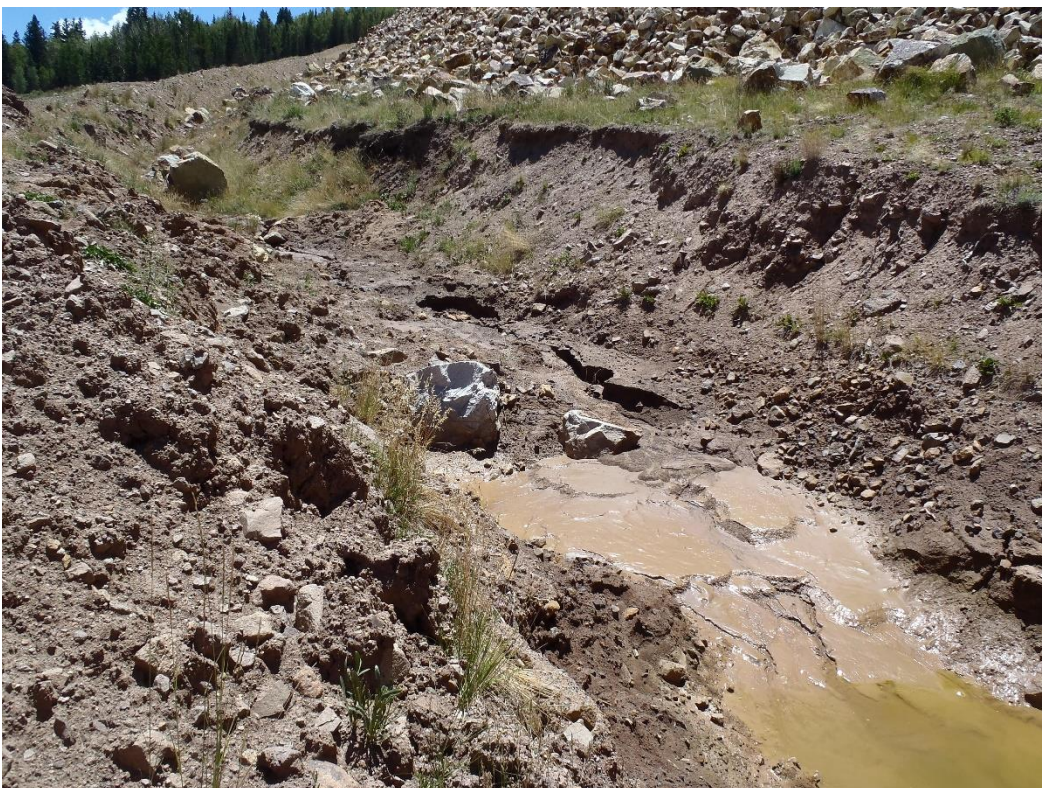
East Cresson Overburden Storage Area (ECOSA) Seep: Mr. Bills accompanied the DRMS to the ECOSA seep area. No inflow to the seepage ponding area (see **Photo 7**) was observed. Mr. Bills indicated seepage begins to be expressed 4 to 6 hours after a storm event. It was noted at the time of the inspection the new Grassy Valley monitoring well for monitoring potential seep impacts had not yet been installed.

Photo 7. ECOSA seepage collection pond (note lack of inflow).
