LKA Gold Incorporated

November 27, 2018

**RE: Responses - Golden Wonder Mine, Permit No. M-1978-091-UG, Minerals Program
Inspection Report Dated 10/24/18 – Corrective Actions**

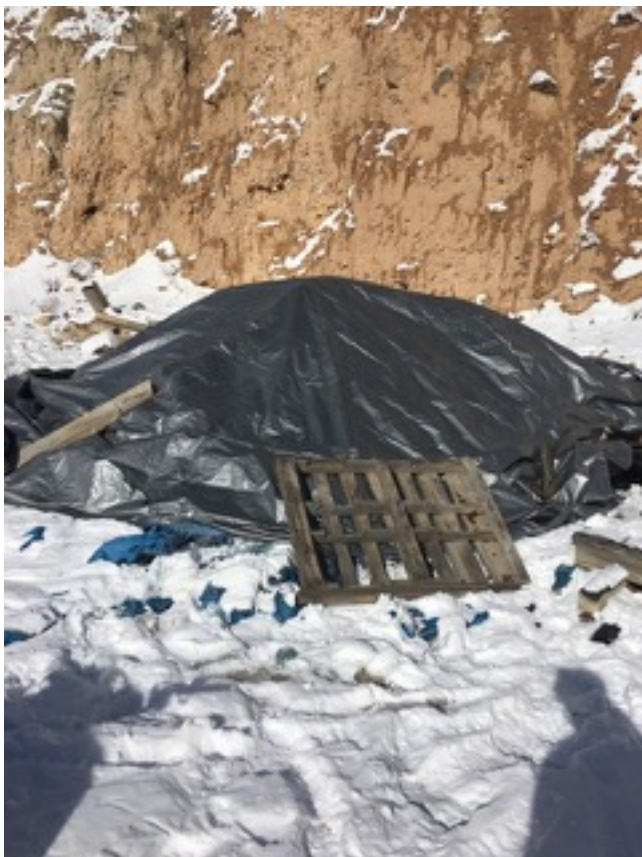
Re-tarped ore pile 6th Level Pad

- 1.) Re-tarping of ore piles (replace worn tarps) on both the 3rd and 6th levels of the mine has been completed. See attached photos.
- 2.) Freezing at the mine site, beginning in mid October, has prevented us from taking this corrective action. All mine water discharge was/is frozen including our passive treatment system. We anticipate that we will not be able to accomplish this testing until late April of 2019. At that time, based upon our previous experience, the treated water will be mixing with stormwater runoff from the 6 level pad and Deadman Gulch and can be sampled at the usual discharge sampling point (01A). As you know, this is the point where water from the Diversion Channel, the mine discharge treatment system, and the Gulch converge in a slag/limestone filled sump/weir and are sampled per LKA's discharge permit requirements.

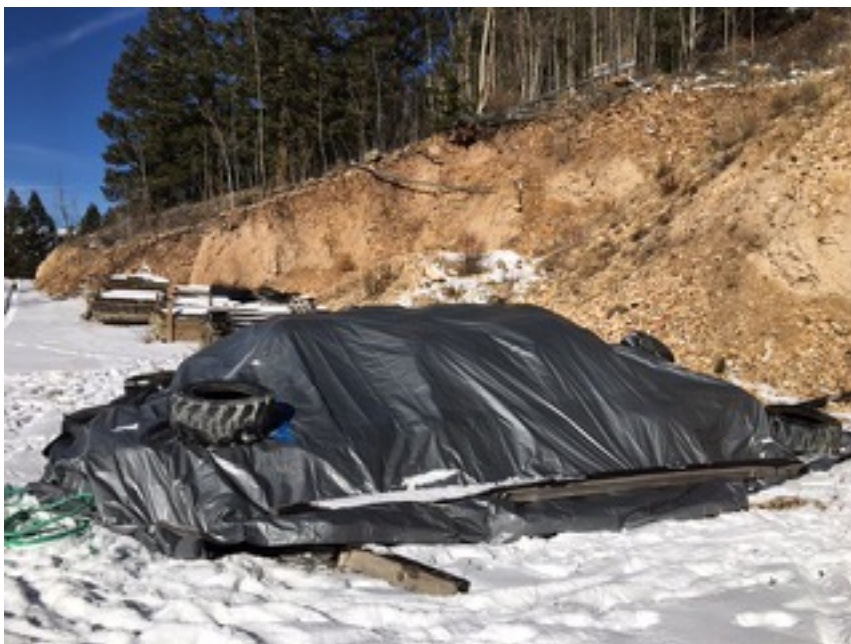
Re-tarped ore piles 3 Level Pad
