## MINERALS PROGRAM INSPECTION REPORT

<b>MINE NAME:</b> Wiley Pit	<b>MINE/PROSPECTING ID#:</b> M-1977-223	<b>MINERAL:</b> Sand and gravel	<b>COUNTY:</b> Prowers
<b>INSPECTION TYPE:</b> Surety Release Inspection	<b>INSPECTOR(S):</b> Amy Eschberger	<b>INSP. DATE:</b> November 29, 2018	<b>INSP. TIME:</b> 11:30
<b>OPERATOR:</b> Five Rivers Ranch Cattle Feeding LLC	<b>OPERATOR REPRESENTATIVE:</b> Thane Milenski	<b>TYPE OF OPERATION:</b> 112c - Construction Regular Operation	
<b>REASON FOR INSPECTION:</b> Surety Release Requested	<b>BOND CALCULATION TYPE:</b> Complete Bond	<b>BOND AMOUNT:</b> \$761,000.00	
<b>DATE OF COMPLAINT:</b> NA	<b>POST INSP. CONTACTS:</b> None	<b>JOINT INSP. AGENCY:</b> None	
<b>WEATHER:</b> Clear	<b>INSPECTOR'S SIGNATURE:</b>

This inspection of the Wiley Pit (Permit No. M-1977-223) was conducted by Amy Eschberger of the Division of Reclamation, Mining and Safety (Division) in response to a Surety Reduction request (Revision No. SR-1) filed for this site on November 7, 2018. No comments were received during the public comment period for SR-1, which closed on November 22, 2018. However, the Division did receive comments on SR-1 from the Division of Water Resource

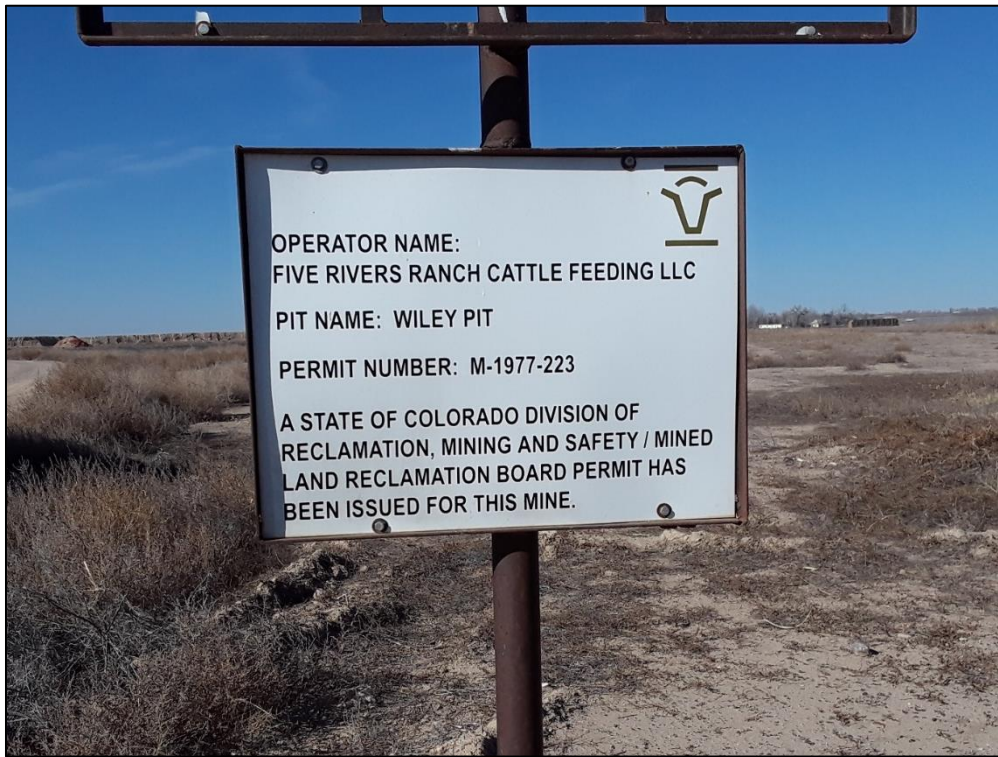
**Photo 1.** View of permit sign posted at main site entrance off Hwy 287.

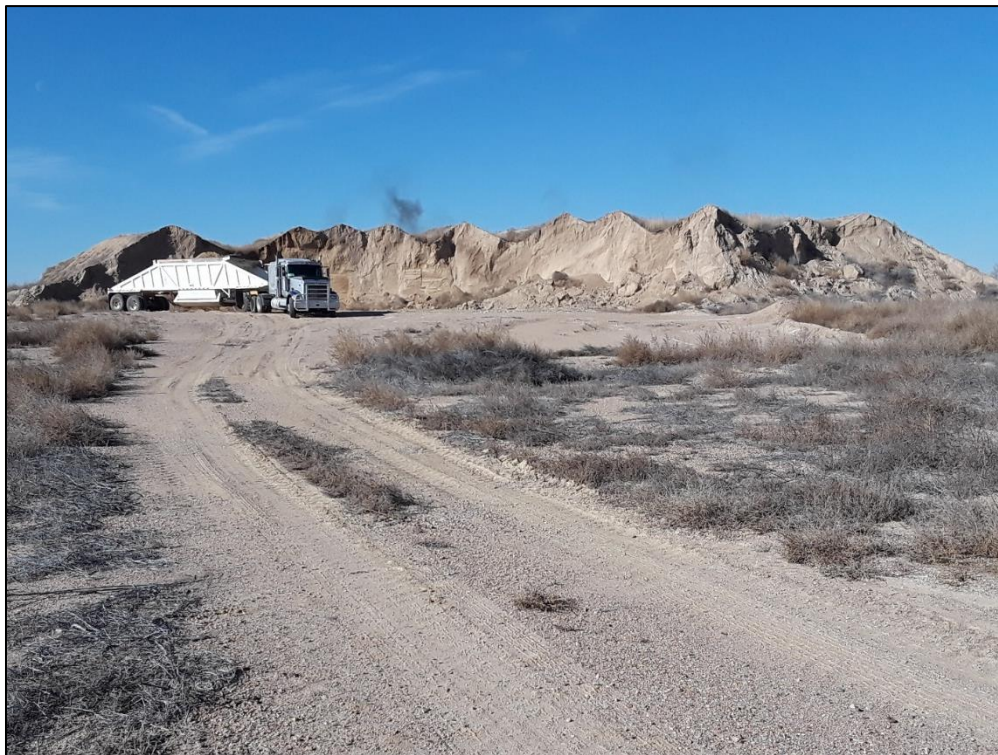
**Photo 2.** View looking west, showing product stockpiled northeast of reservoir. Note operation hauling off from stockpile during inspection.

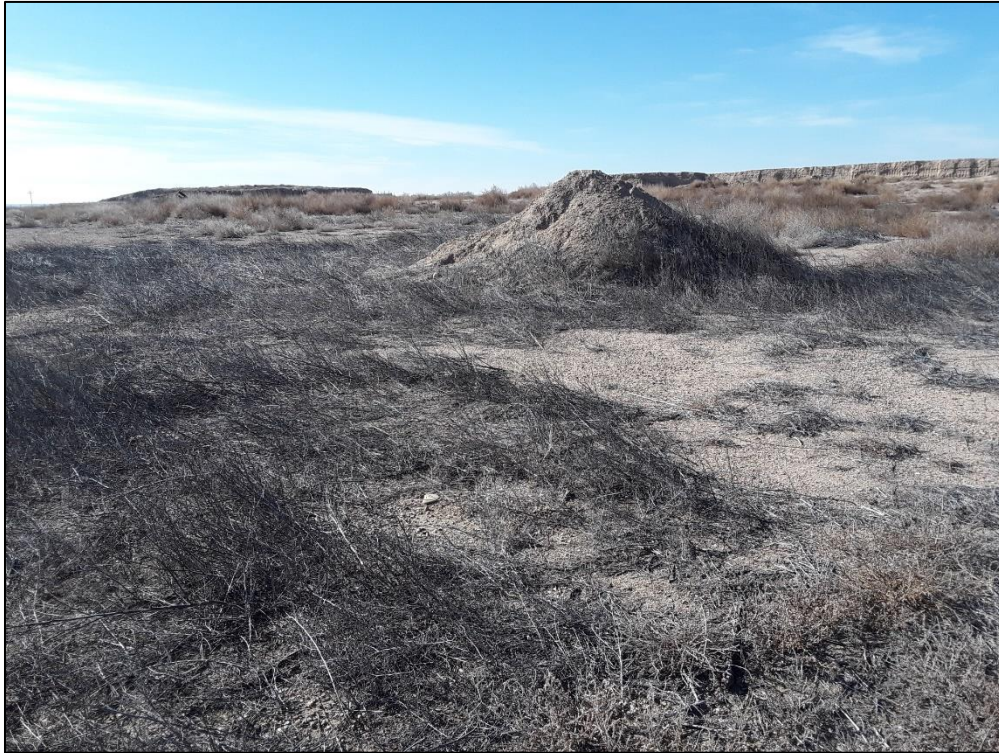
**Photo 3.** View looking southwest across northeastern portion of permit area, which has sparse vegetative cover consisting mainly of annual weeds.

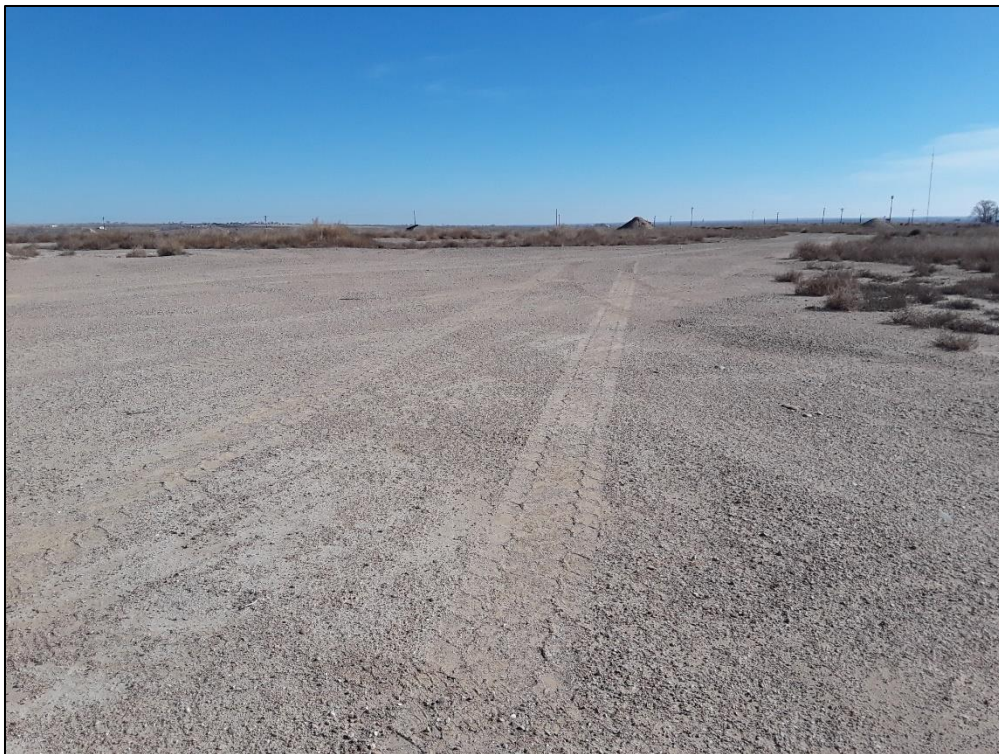
**Photo 4.** View looking east across northeastern portion of permit area utilized for stockpiling/processing, which has no vegetative cover.

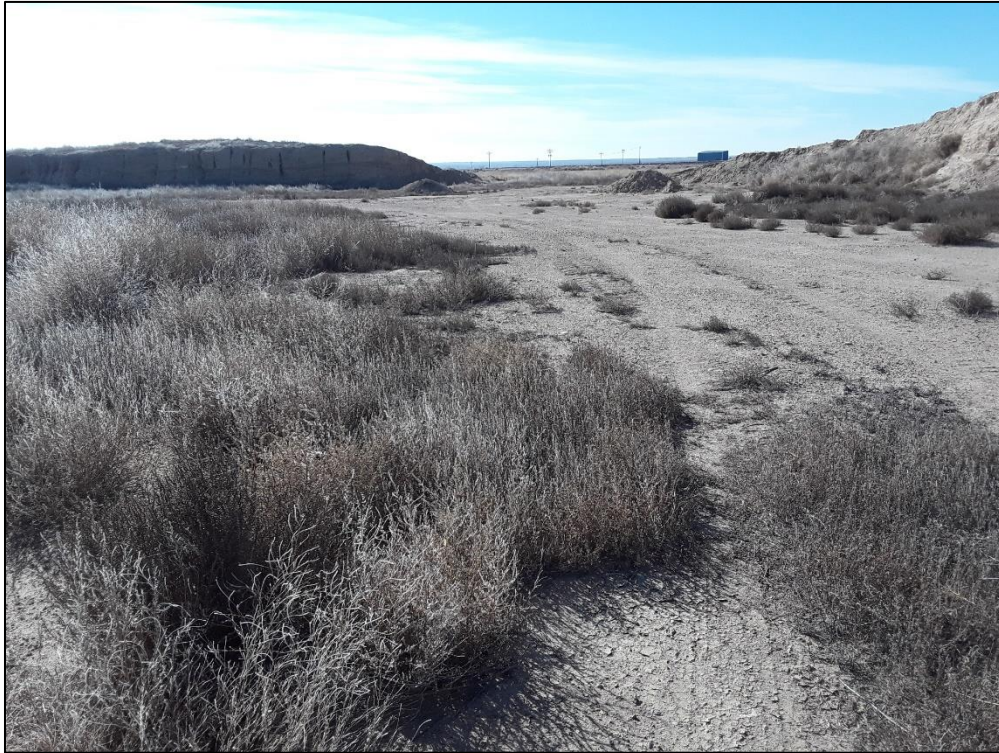
**Photo 5.** View looking southeast across northeastern portion of permit area utilized for stockpiling/processing, which has sparse vegetative cover consisting mainly of annual weeds.

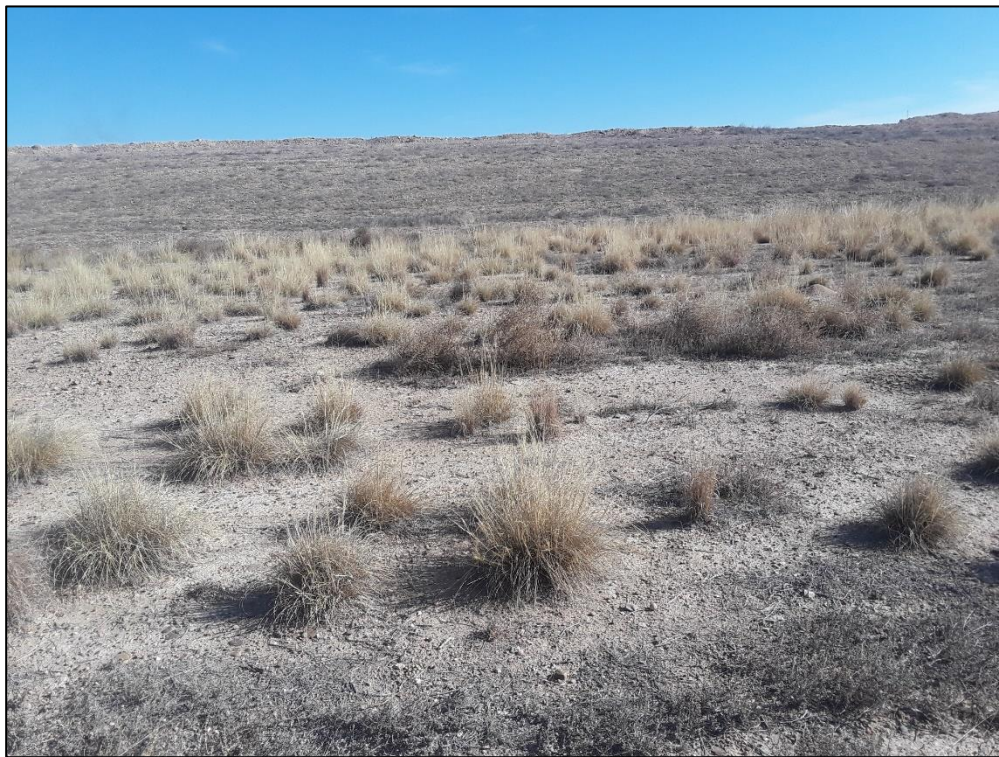
**Photo 6.** View looking east across land between overburden stockpile (visible in background) and reservoir, which operator has seeded. Note native grasses starting to establish in this area.

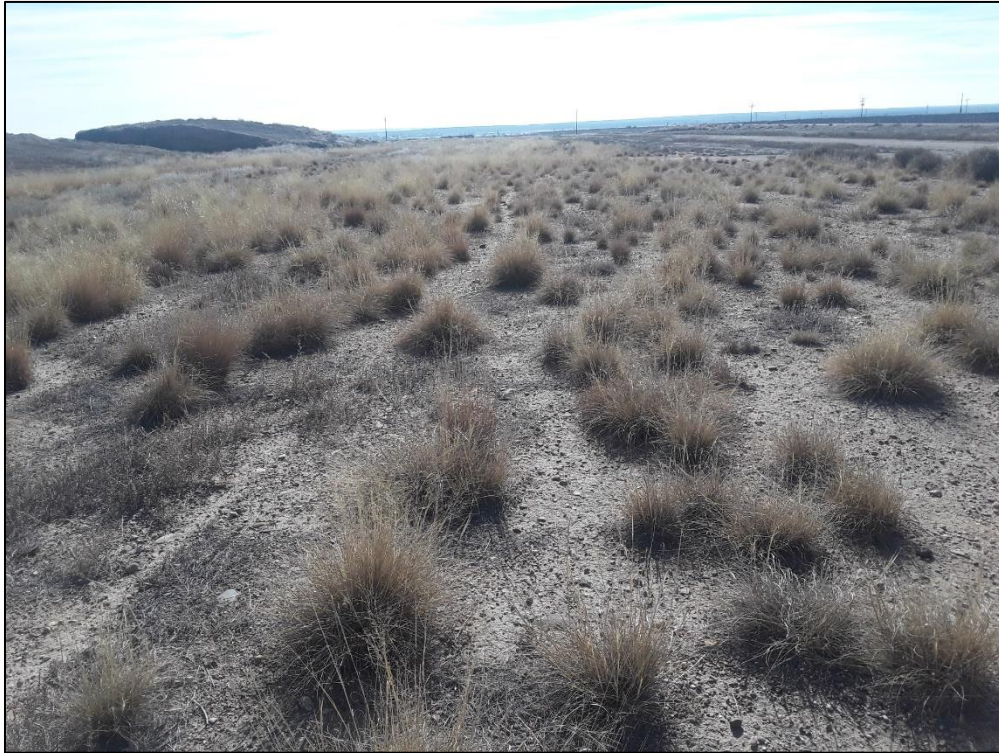
**Photo 7.** View looking south across land between overburden stockpiles and reservoir, which operator has seeded. Note native grasses starting to establish in this area.

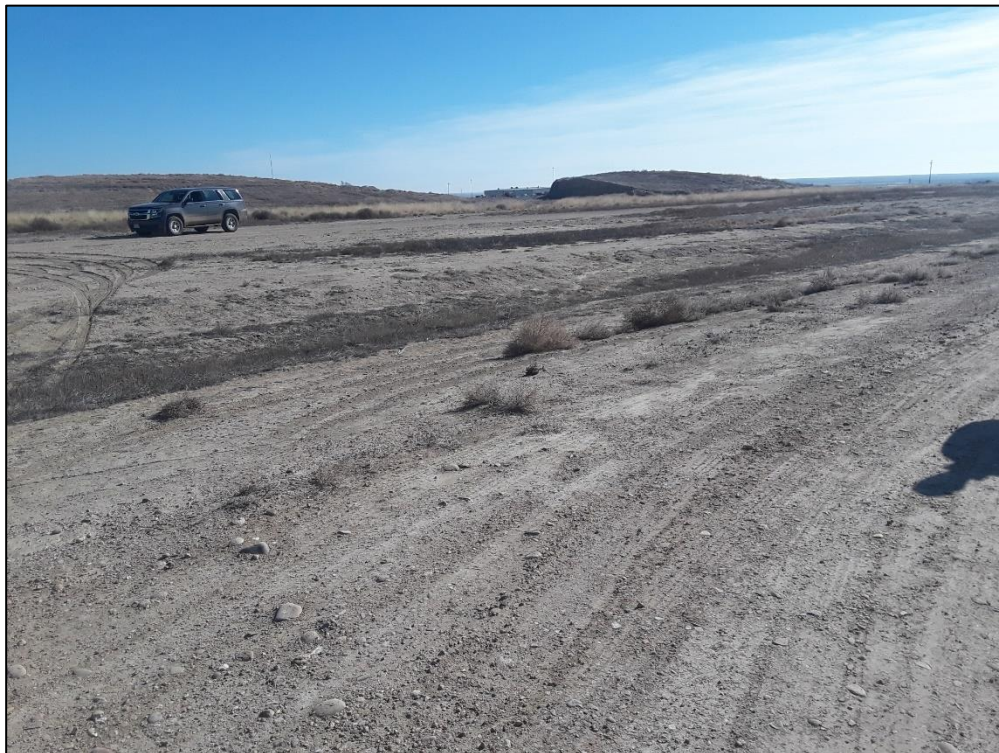
**Photo 8.** View looking southeast across land northeast of reservoir, which has very little to no vegetative cover.

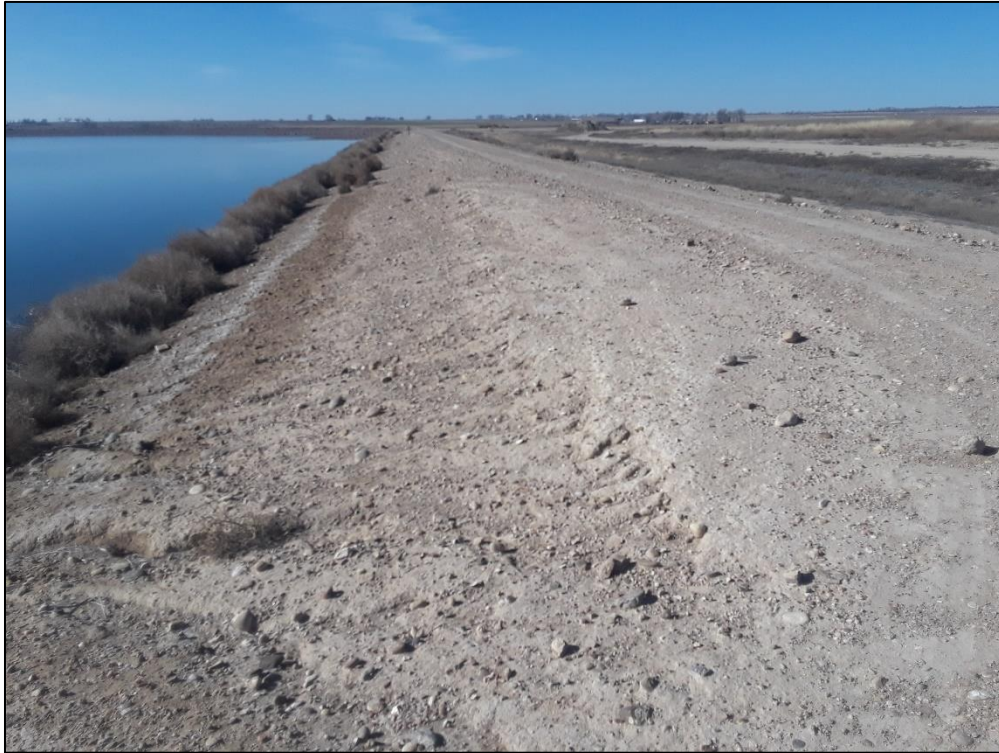
**Photo 9.** View looking west across northern shoreline of reservoir, which was graded to approved final configuration of 4H:1V, but lacks vegetative cover.

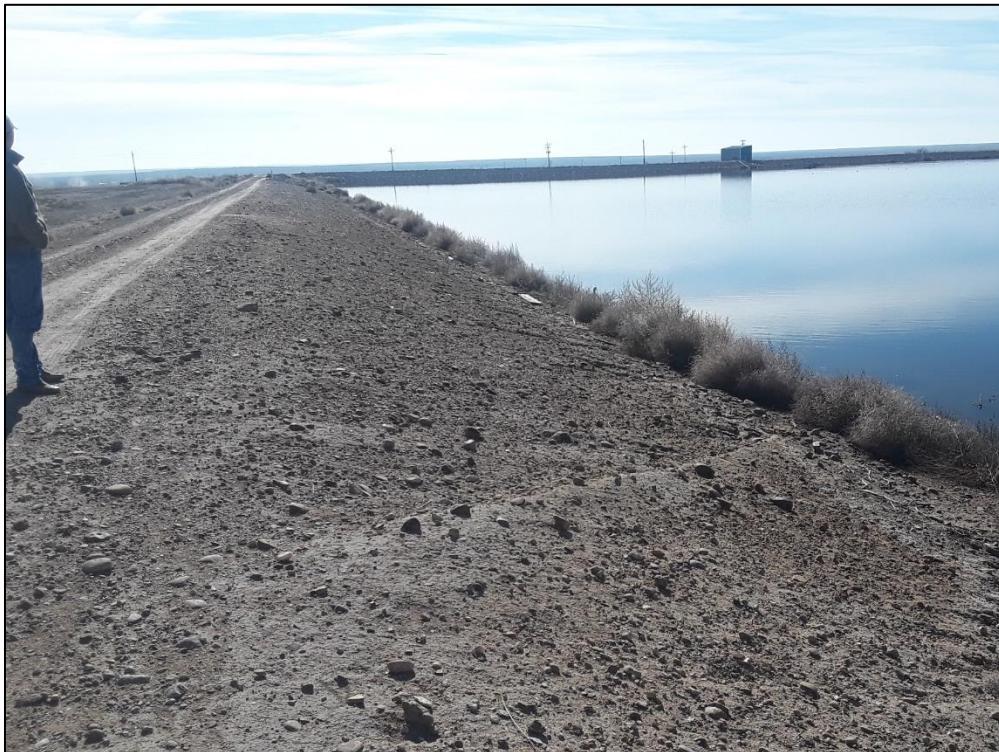
**Photo 10.** View looking south across eastern shoreline of reservoir, which was graded to approved final configuration of 4H:1V, but lacks vegetative cover.

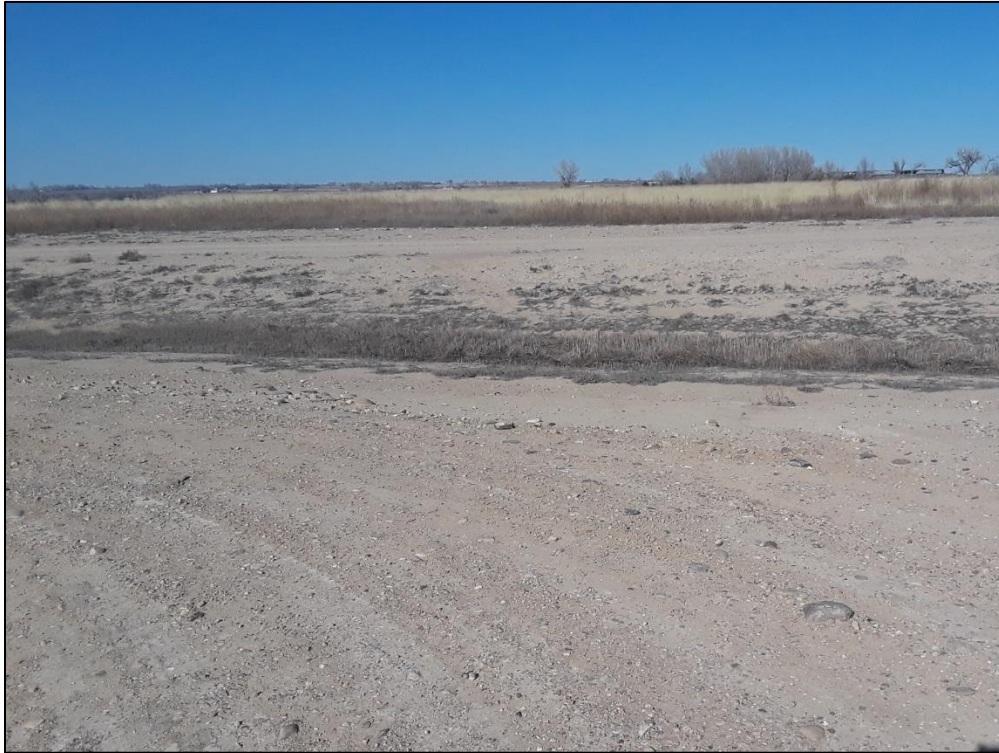
**Photo 11.** View looking north across land north of reservoir, which lacks vegetative cover.

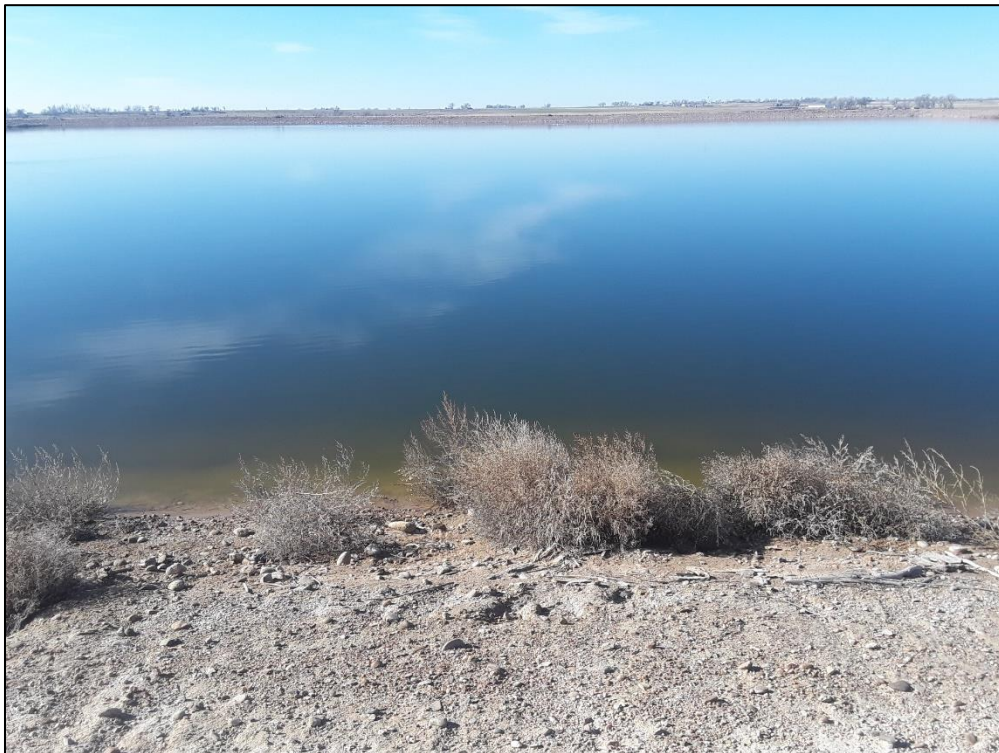
**Photo 12.** View looking west across reservoir from its eastern shoreline.

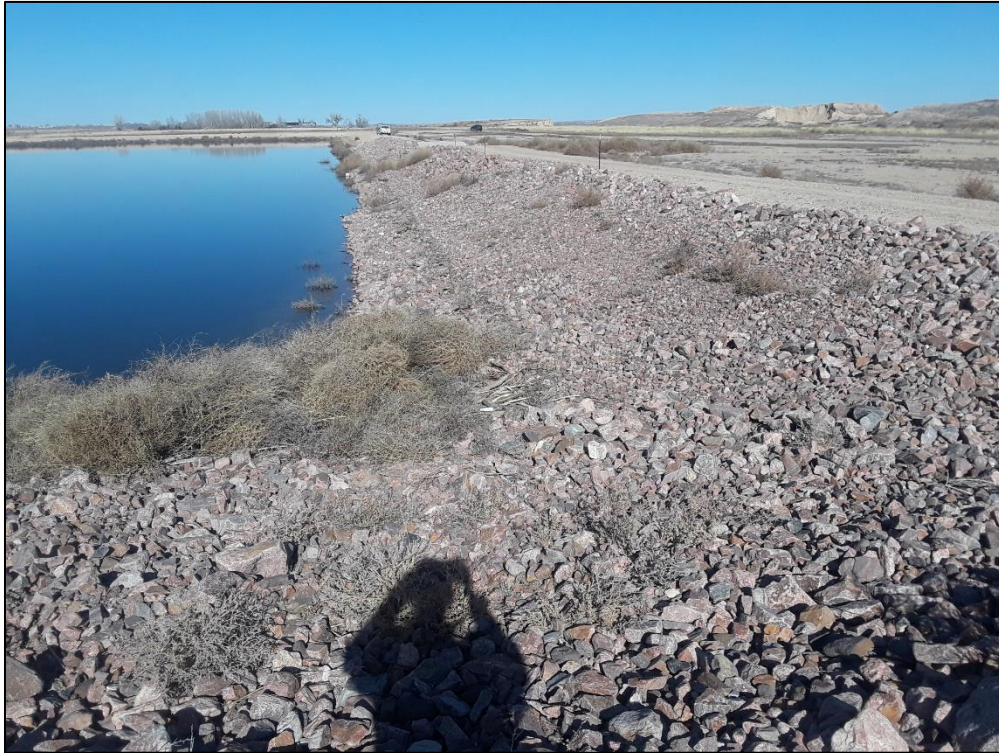
**Photo 13.** View looking north from southeastern corner of reservoir, showing riprap placed across eastern and southeastern slopes of reservoir.

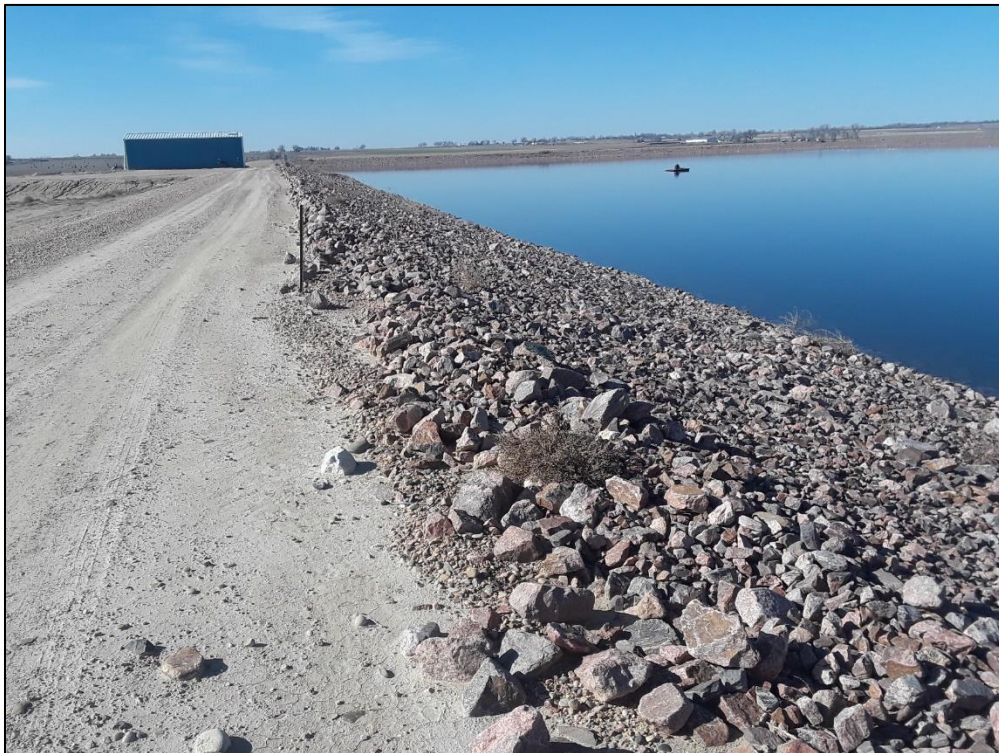
**Photo 14.** View looking west from southeastern corner of reservoir, showing riprap placed across southern slope of reservoir. Note pump house visible in background.

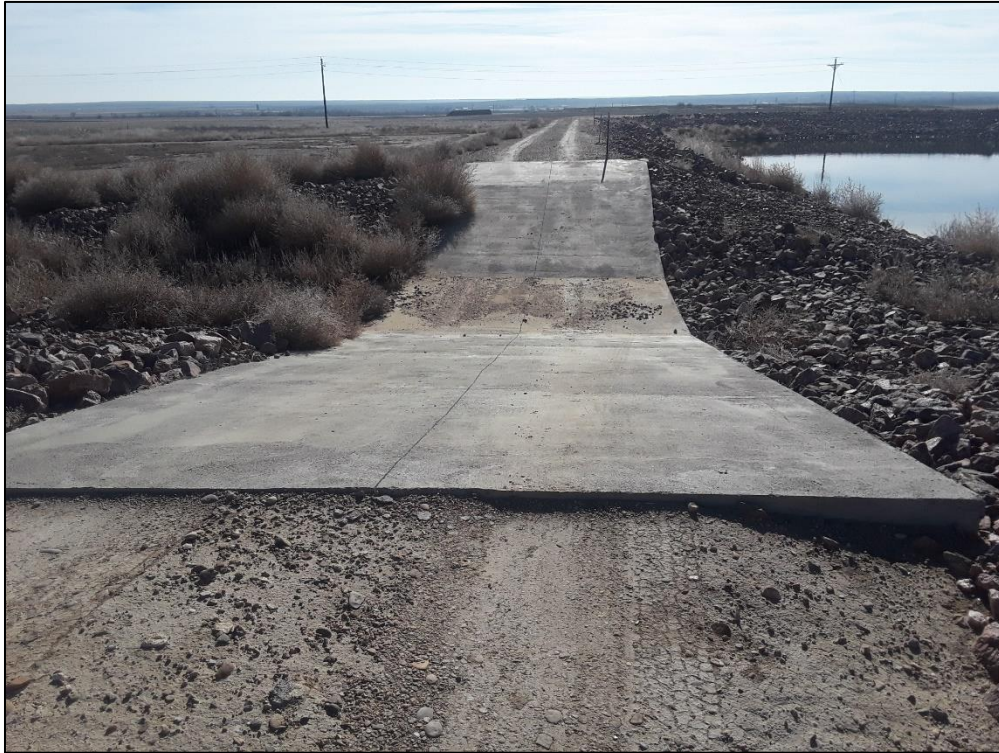
**Photo 15.** View looking south, showing concrete structure installed at southeastern edge of reservoir.

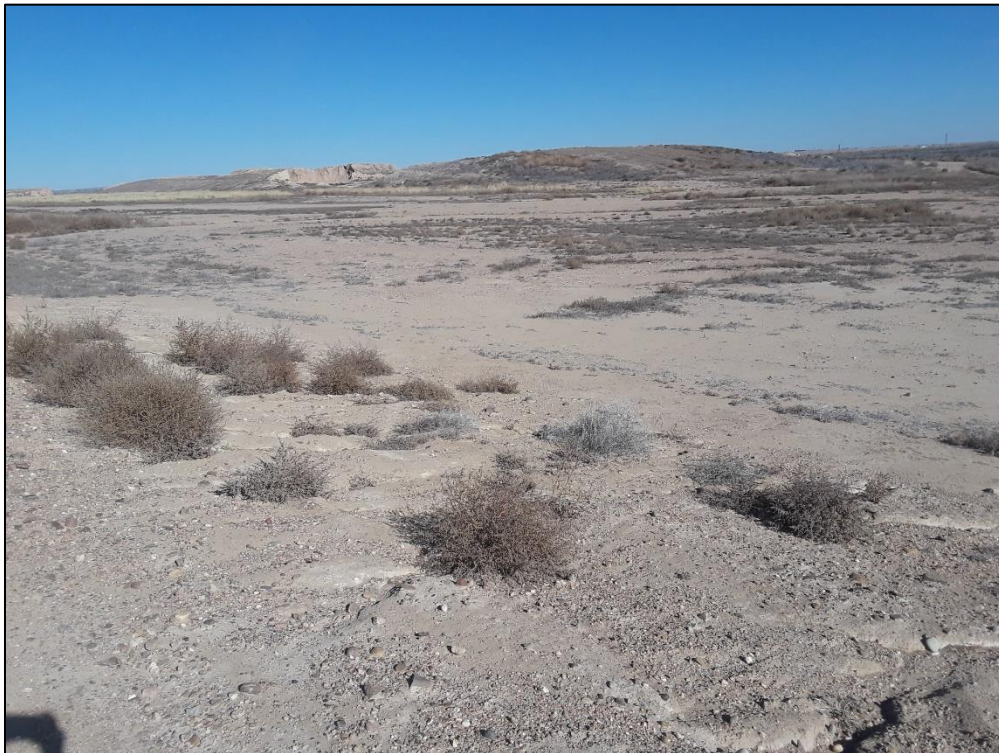
**Photo 16.** View looking northeast across land east of reservoir, which lacks vegetative cover.

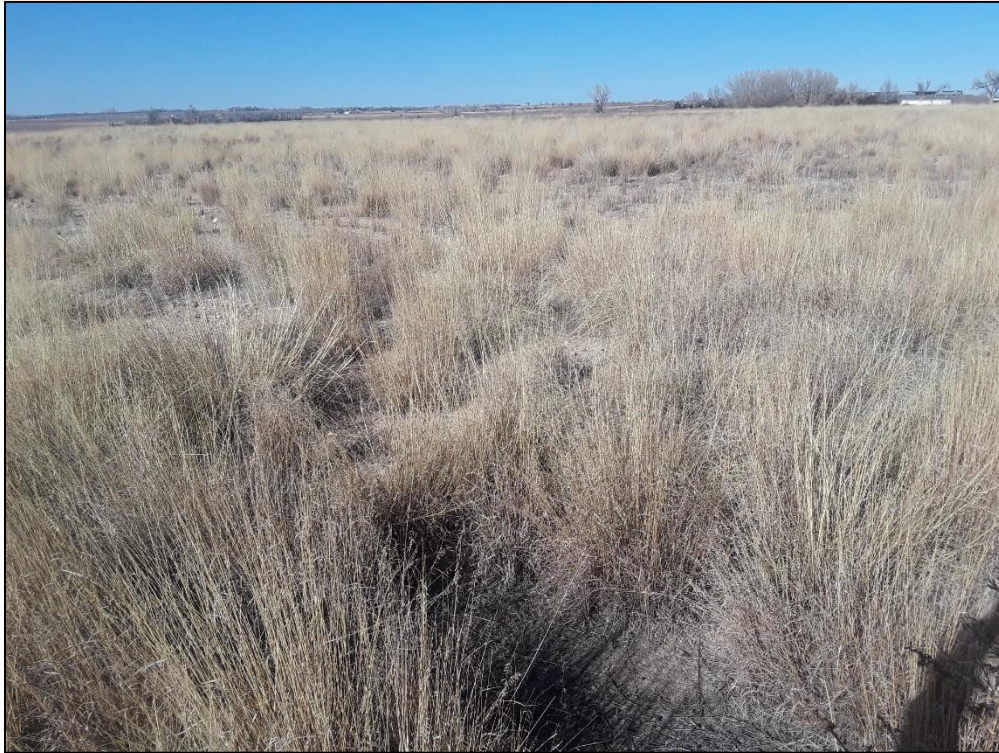
**Photo 17.** View looking north across area north of reservoir, which operator has seeded. Note native grasses establishing in this area.

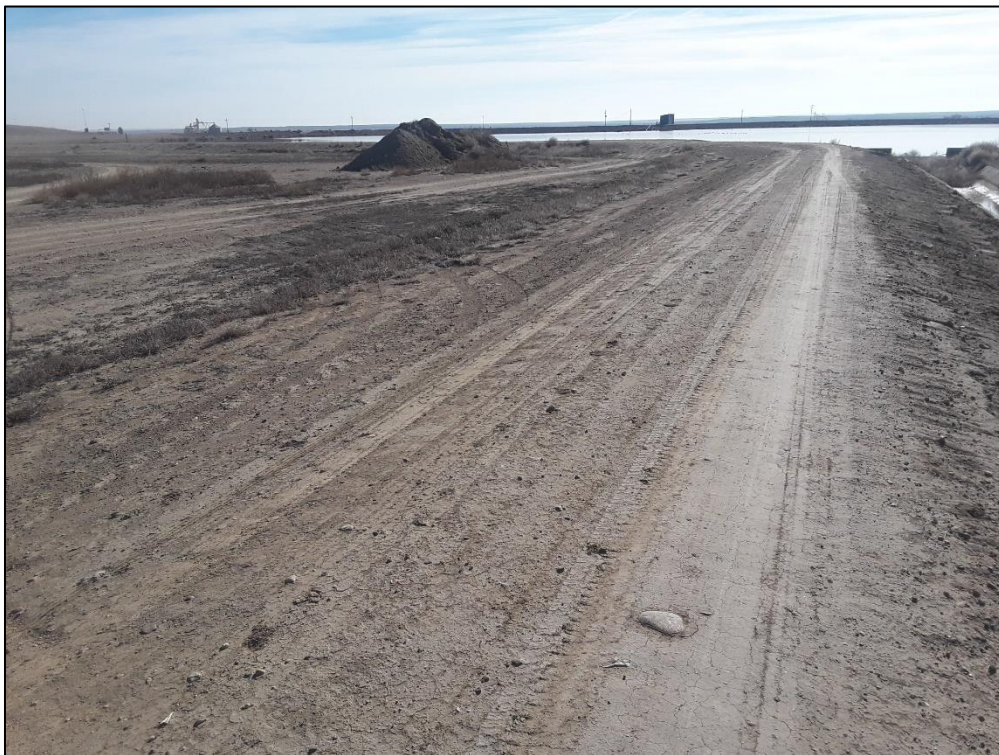
**Photo 18.** View looking south, showing access road that runs north to Co Rd LL which will remain after reclamation.

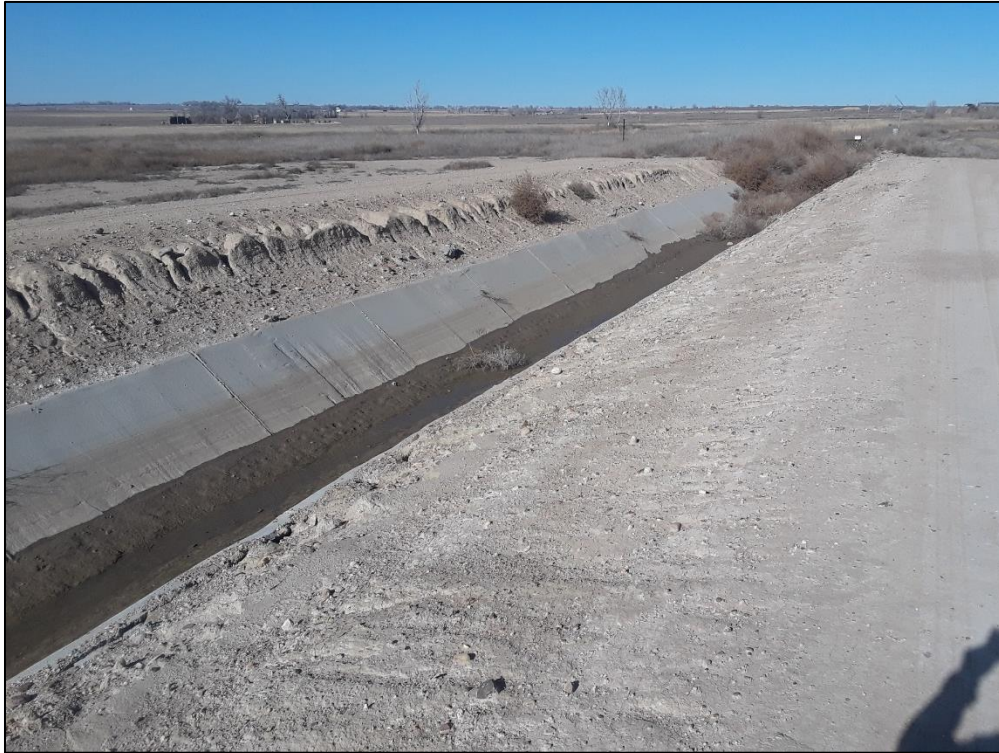
**Photo 19.** View looking northeast across concrete-lined inlet channel constructed north of reservoir.

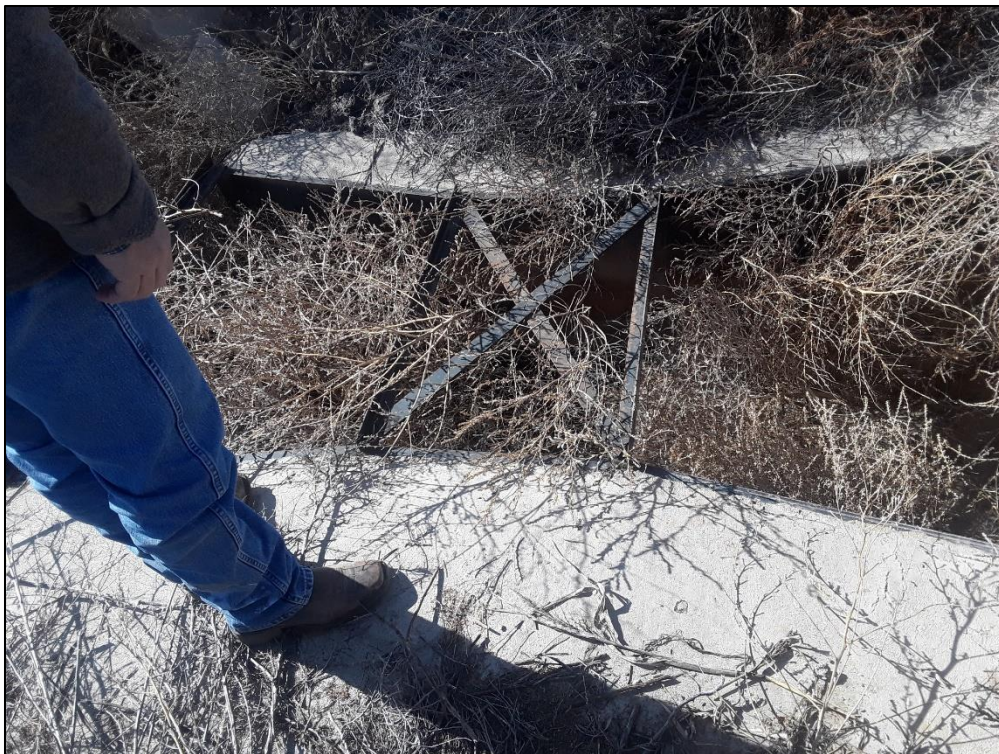
**Photo 20.** View of Parshall Flume installed in inlet channel north of reservoir. Note tumbleweeds filling flume due to recent high wind conditions. Operator should work to keep flume clear of vegetation and debris.

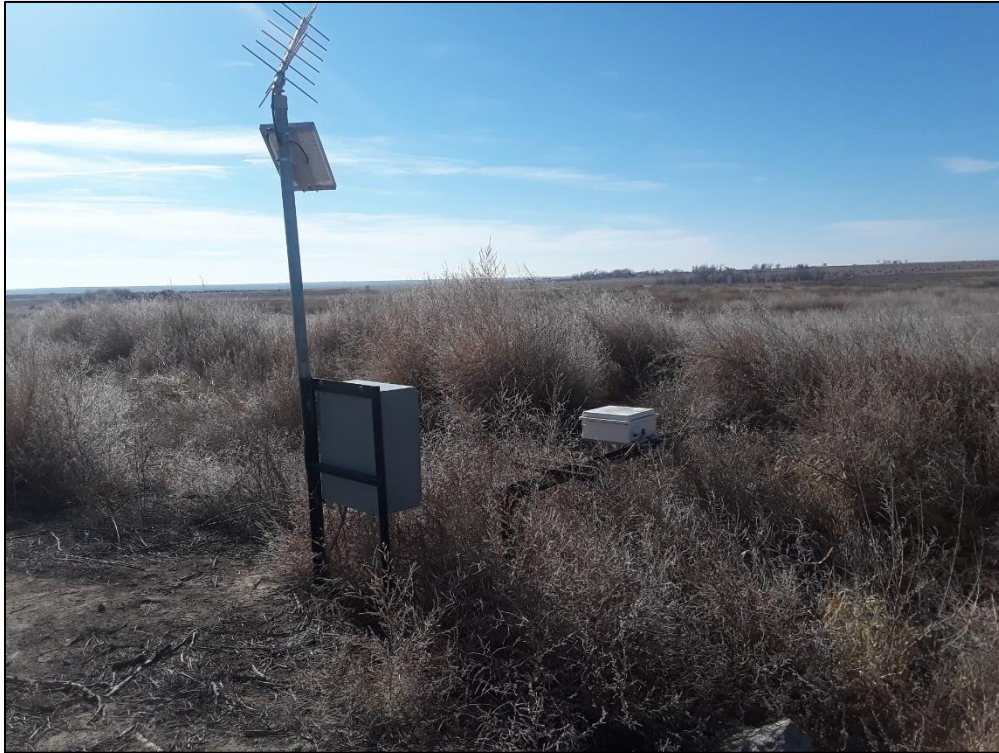
**Photo 21.** View of solar-powered monitoring station installed at reservoir inlet, which reports flow data via radio telemetry to DWR on a daily basis. Operator should work to keep inlet channel clear of vegetation and debris.

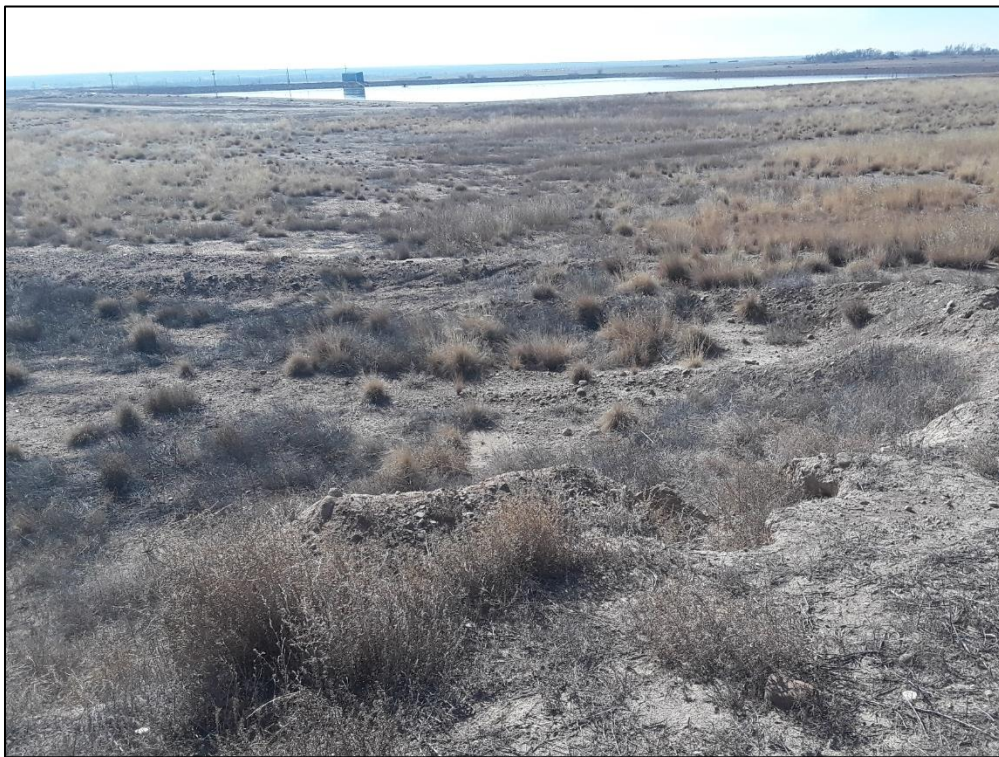
**Photo 22.** View looking southwest from top of overburden stockpile, showing current vegetative cover of land north of reservoir. Native grasses are establishing in some portions of this area, while other portions have sparse cover consisting mainly of annual weeds.

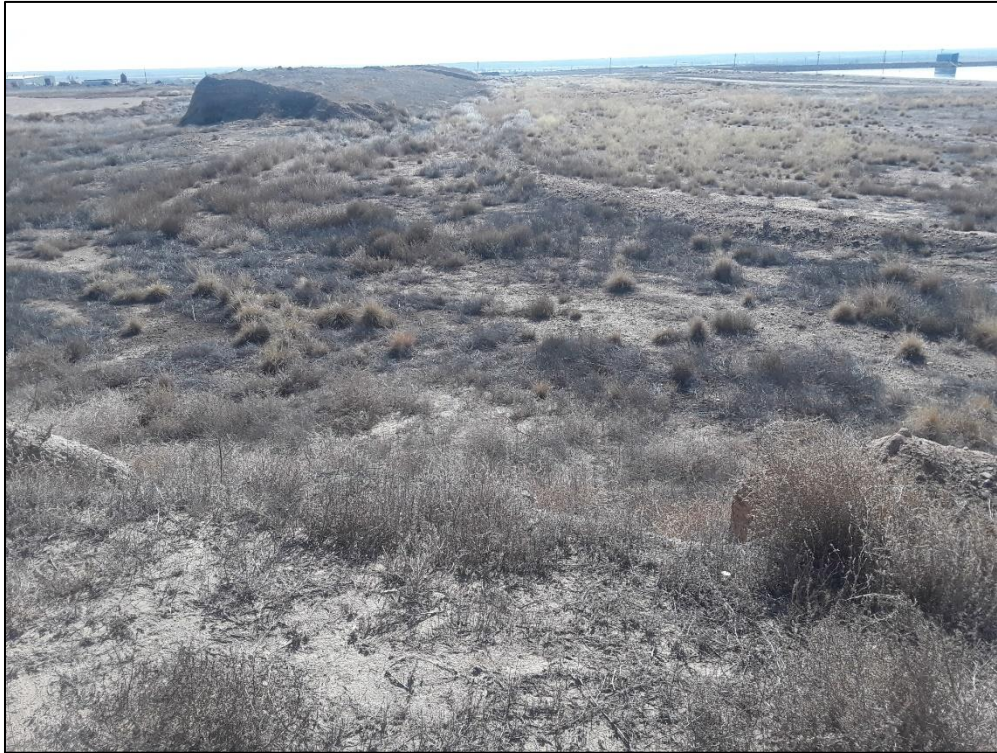
**Photo 23.** View looking south from top of overburden stockpile, showing current vegetative cover of land northeast of reservoir. Native grasses are establishing in some portions of this area, while other portions have sparse cover consisting mainly of annual weeds. Separate overburden stockpile visible in background.

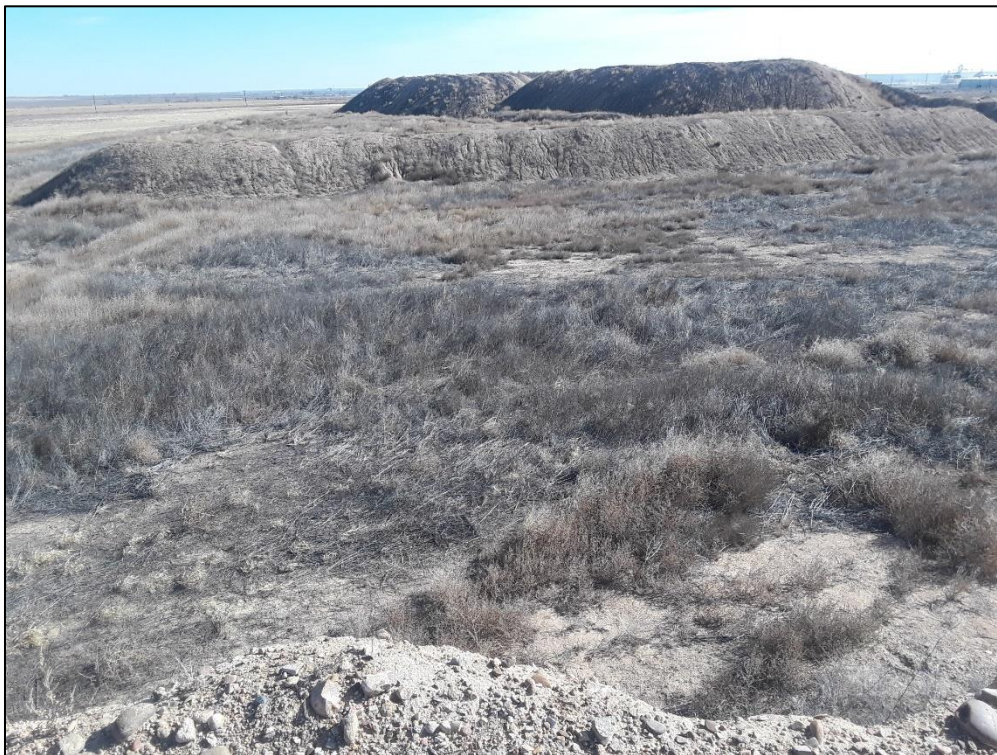
**Photo 24.** View looking east from top of overburden stockpile, showing current vegetative cover of land between overburden and product stockpiles. Vegetative cover in this area mainly consists of annual weeds. Product stockpile visible in background.

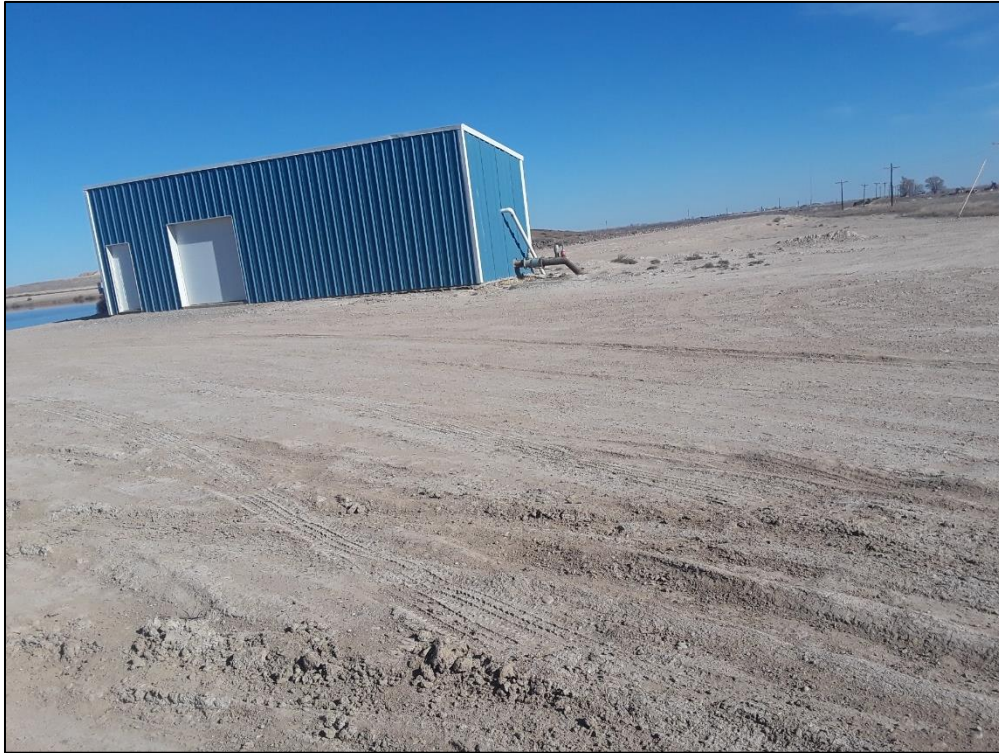
**Photo 25.** View looking east, showing pump house located south of reservoir. Note this area lacks any vegetative cover.

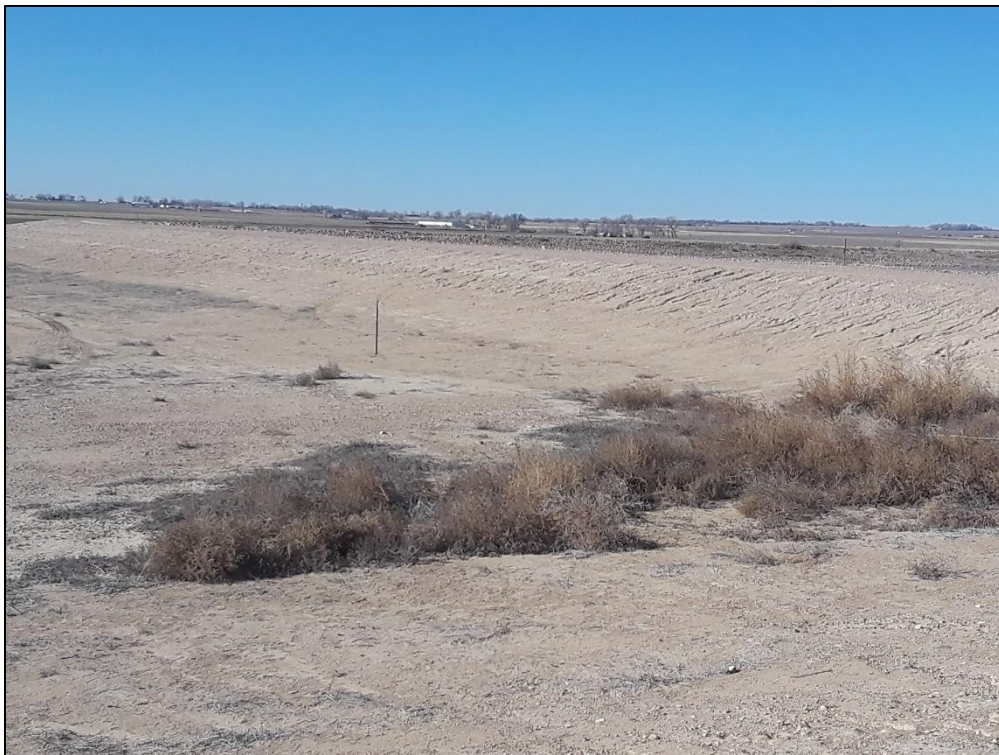
**Photo 26.** View looking northwest, showing southern embankment of reservoir. Note this area lacks any vegetative cover.

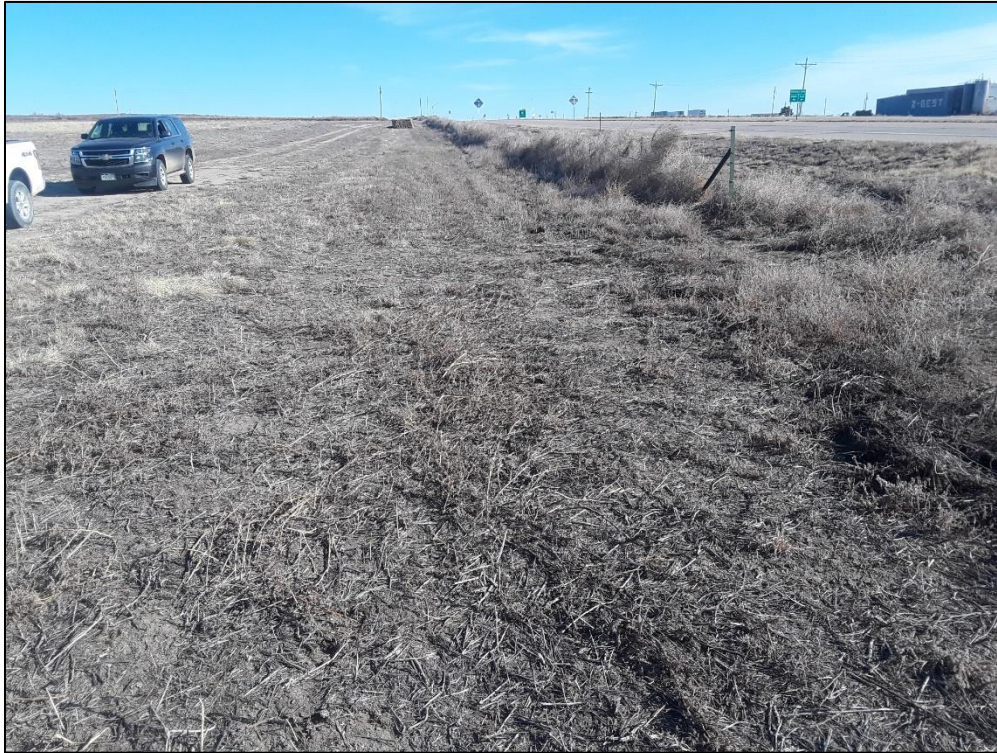
**Photo 27.** View looking east along portion of permit area north of and parallel to Hwy 50 which includes water pipeline from reservoir. Note area has been backfilled and reclaimed.

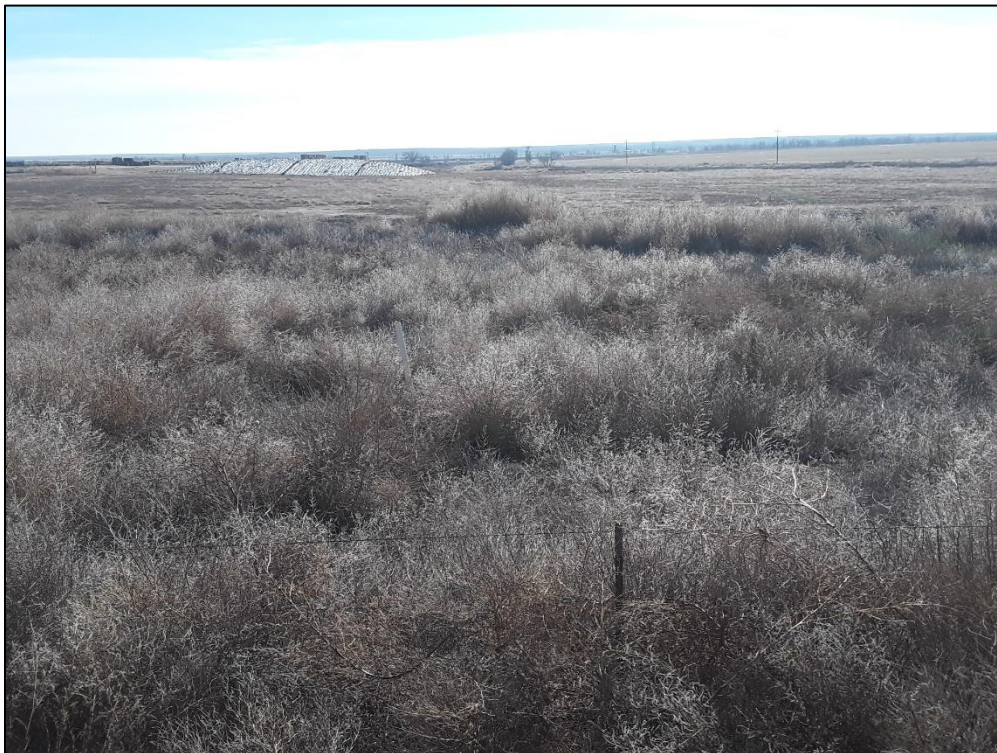
**Photo 28.** View looking south along portion of permit area south of and perpendicular to Hwy 50 which includes water pipeline from reservoir. Note area has been backfilled and reclaimed.
