## MINERALS PROGRAM INSPECTION REPORT

<b>MINE NAME:</b> Wiley Pit	<b>MINE/PROSPECTING ID#:</b> M-1977-223	<b>MINERAL:</b> Sand and gravel	<b>COUNTY:</b> Prowers
<b>INSPECTION TYPE:</b> Surety Release Inspection	<b>INSPECTOR(S):</b> Amy Eschberger	<b>INSP. DATE:</b> November 29, 2018	<b>INSP. TIME:</b> 11:30
<b>OPERATOR:</b> Five Rivers Ranch Cattle Feeding LLC	<b>OPERATOR REPRESENTATIVE:</b> Thane Milenski	<b>TYPE OF OPERATION:</b> 112c - Construction Regular Operation	
<b>REASON FOR INSPECTION:</b> Surety Release Requested	<b>BOND CALCULATION TYPE:</b> Complete Bond	<b>BOND AMOUNT:</b> \$761,000.00	
<b>DATE OF COMPLAINT:</b> NA	<b>POST INSP. CONTACTS:</b> None	<b>JOINT INSP. AGENCY:</b> None	
<b>WEATHER:</b> Clear	<b>INSPECTOR'S SIGNATURE:</b>

This inspection of the Wiley Pit (Permit No. M-1977-223) was conducted by Amy Eschberger of the Division of Reclamation, Mining and Safety (Division) in response to a Surety Reduction request (Revision No. SR-1) filed for this site on November 7, 2018. No comments were received during the public comment period for SR-1, which closed on November 22, 2018. However, the Division did receive comments on SR-1 from the Division of Water Resource

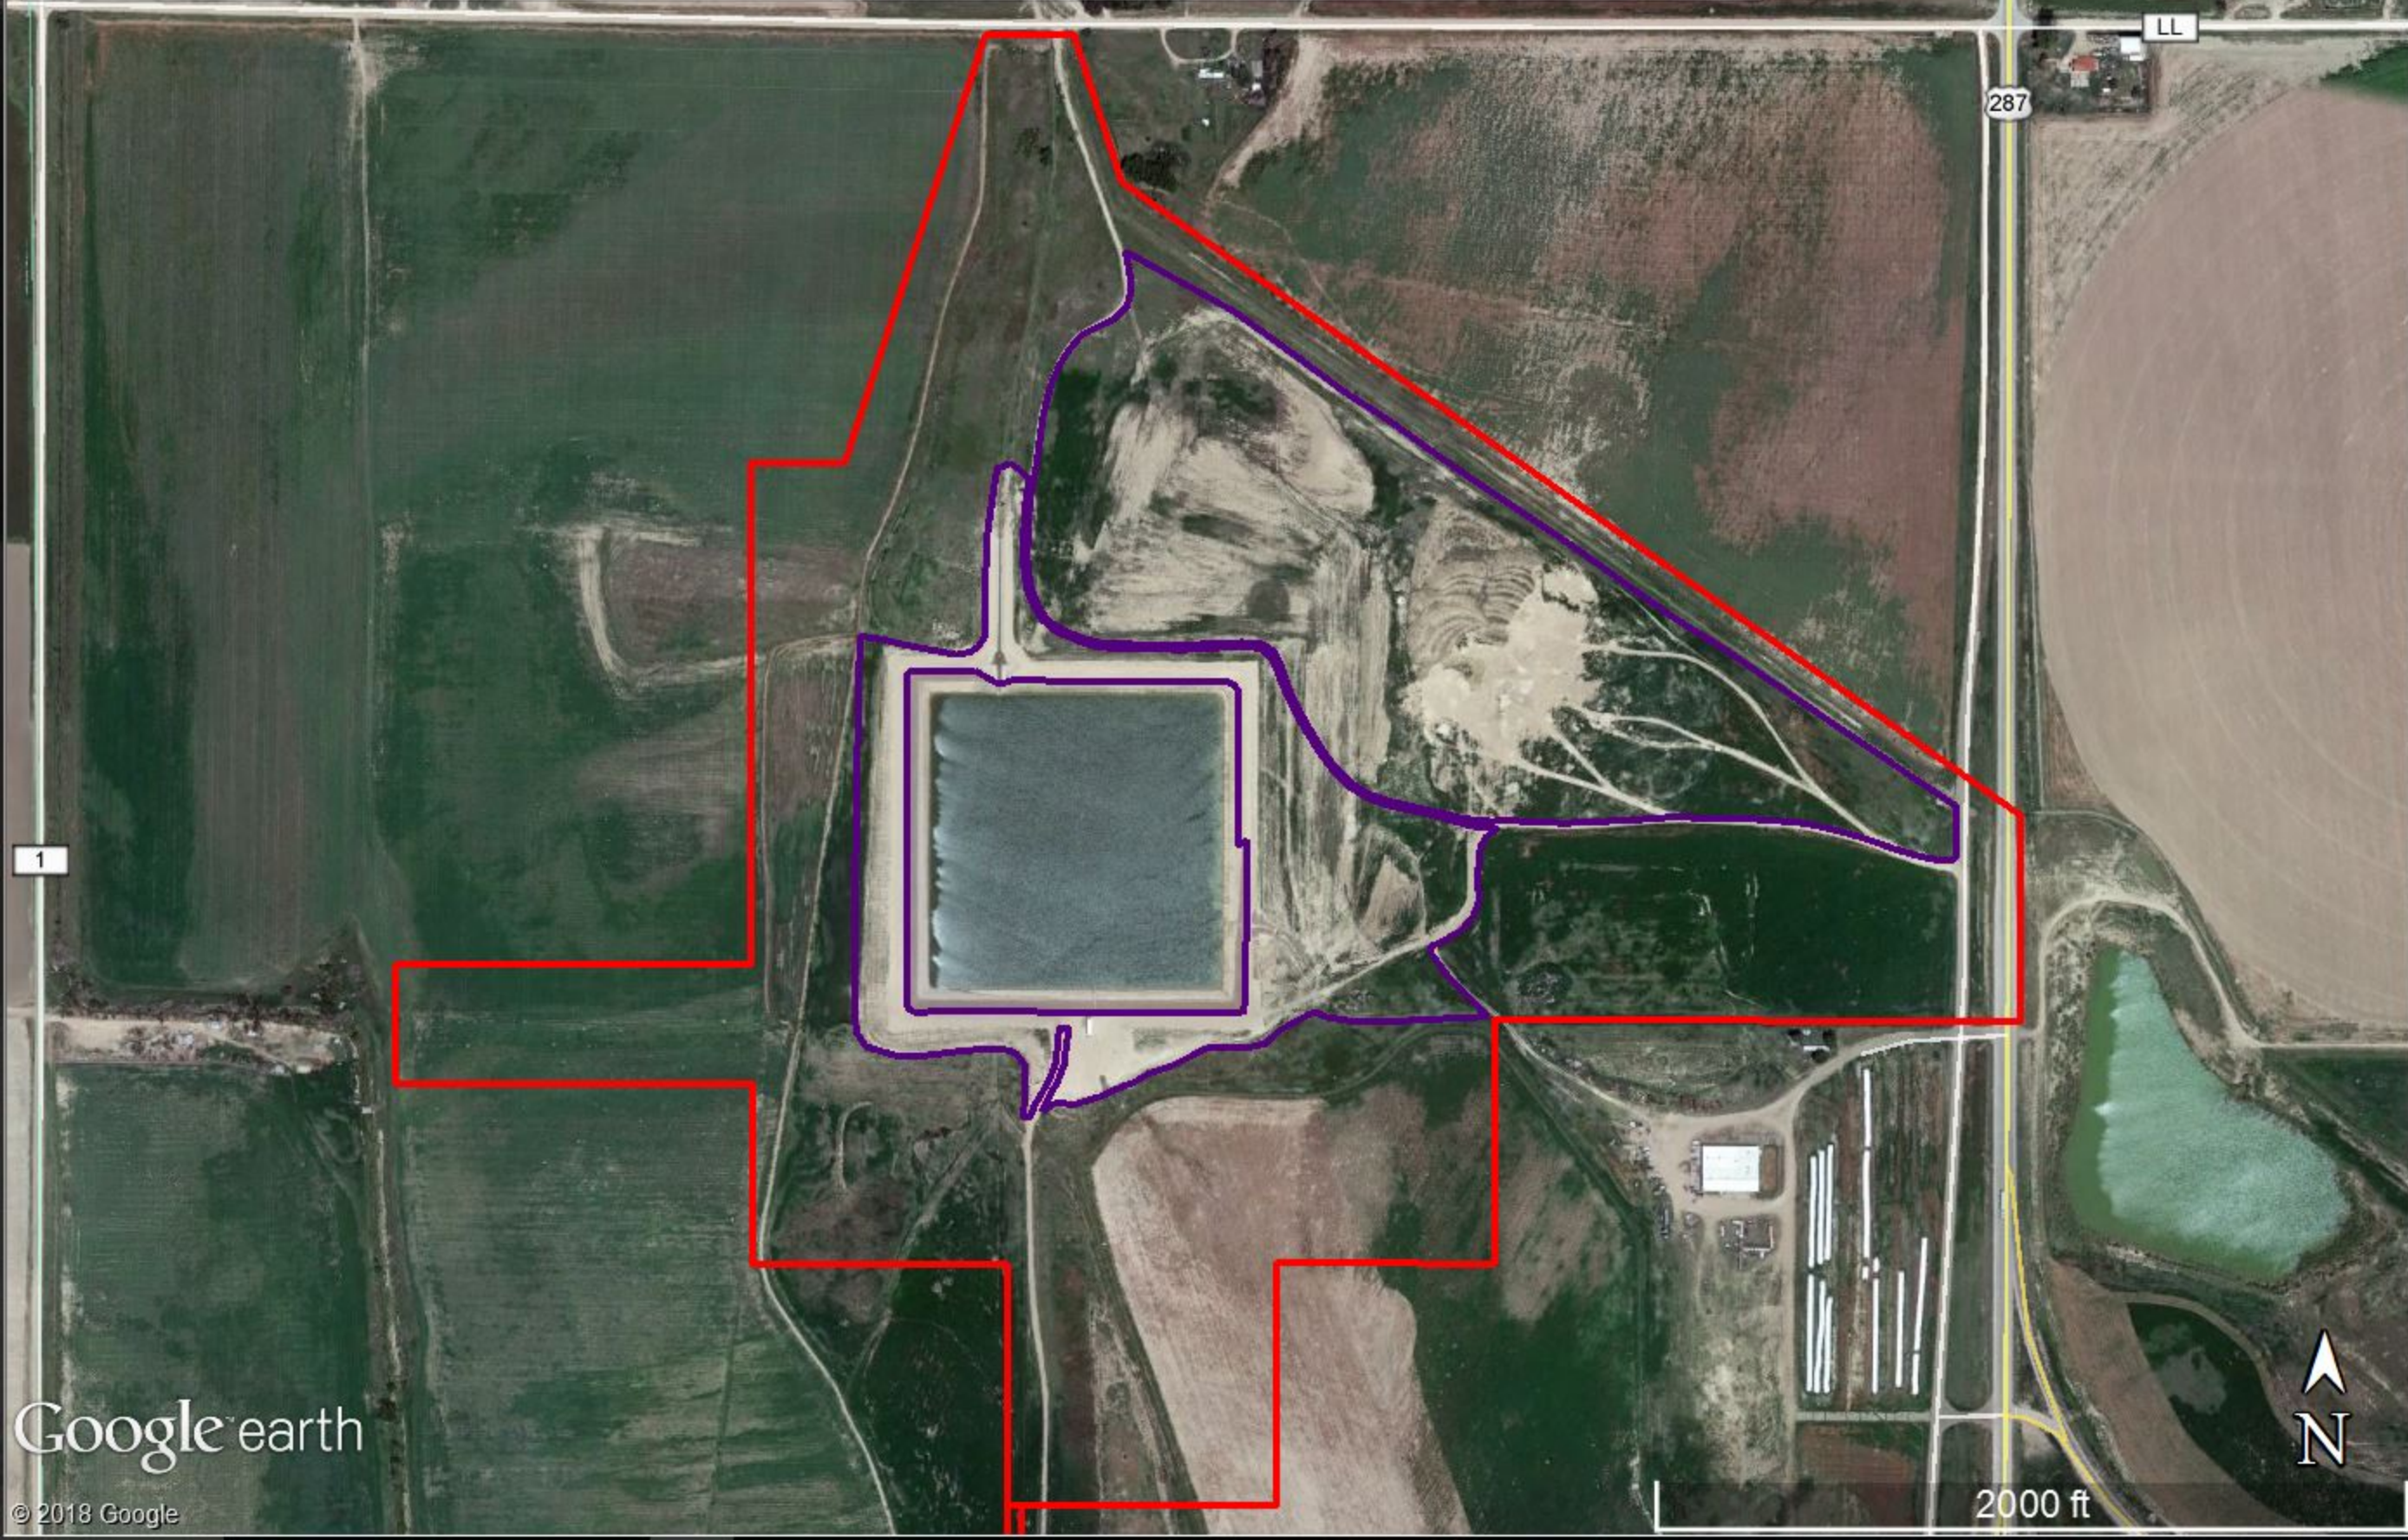
The Division estimates disturbance at the site to be 75.3 acres (not including the two roads to remain or reclaimed areas such as the water line; see enclosed Google Earth image of site showing disturbed area). Of this amount, approximately 18 acres of the reservoir area not requiring additional reclamation can be subtracted, leaving a total of 57.3 acres at this site that require reclamation. This amount includes portions of the reservoir slopes to be reclaimed, areas around the reservoir, and the stockpiling/processing area located northeast and east of the reservoir. Because the lined reservoir has been approved by the DWR as meeting the design standard (letter dated May 9, 2016, submitted with SR-1), the Division no longer requires the reclamation bond to include costs for backfilling the reservoir and demolishing its associated infrastructure. The Division estimates remaining reclamation at this site to include ripping approximately 45 acres, spreading growth medium from existing stockpiles across 57.3 acres (including reservoir slopes), and revegetating the 57.3 acres with the approved native grass mixture. The Division estimates the required financial warranty at this time to be in the amount of \$193,235.00. After discussing this calculated amount with Mr. Milenski, the Division approved the surety reduction (SR-1) in the amount of \$567,765.00 on December 4, 2018. The approval letter and associated bond estimate was mailed to the operator on the date of approval.

Red Outline = 174.6 acres = Approved Permit Area (~169 acres mine site + ~5.6 acres water line)  
Purple Outline = 57.3 acres = Disturbed Area To Be Reclaimed (75.3 acres total - 18 acres reservoir)  
The two access roads to remain after reclamation are not included in the disturbed area.  
(Image data from 6/12/2017)
