MINERALS PROGRAM INSPECTION REPORT
PHONE: (303) 866-3567

| MINE NAME: Bromley Lakes | MINE/PROSPECTING ID#: M-1987-049 | MINERAL: Sand and gravel | COUNTY: Adams |
| INSPECTION TYPE: Monitoring | INSPECTOR(S): Jared L. Ebert | INSP. DATE: 11/27/2018 | INSP. TIME: 09:00 |

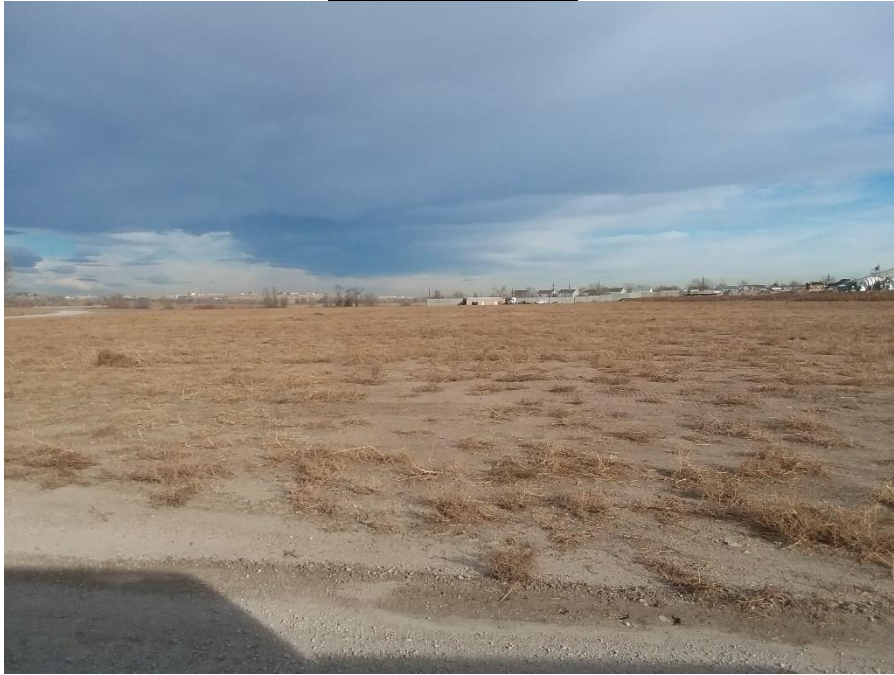
The Phase 18 area and the Cell No. 2 area has been backfilled and graded to a relatively level area. This area appears stable. According to Mr. Lamanna, RMCC intends to seed the site early next spring.

Little to no vegetation has established in the Phase 18 and Cell No. 2 area. However, RMCC plans on seeding these areas this spring.

Figure 1. From the south end of Phase 18 looking north.

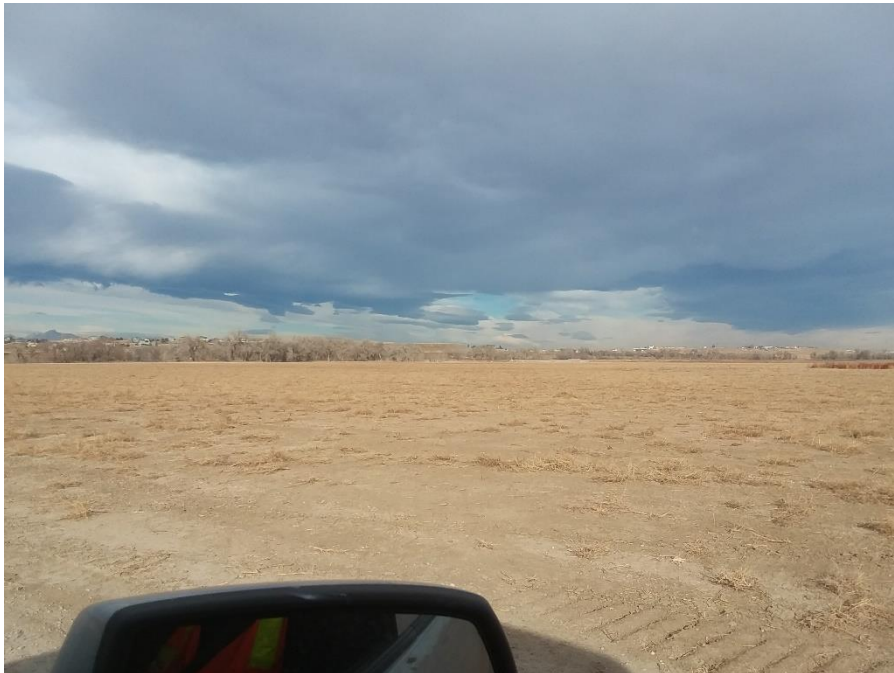
Figure 2. From the southern end of the Cell No. 2 area looking northwest.

Mr. Lamanna mentioned that the City of Brighton may desire to build a park and various recreational facilities in the Cell No. 2 area. Also, a scale, scale house, covered storage area and various stockpiles are located at the eastern end of the Phase 18 area. Mr. Lamanna indicated they may desire to leave this area for industrial use. It was discussed that RMCC would need to submit an amendment to the currently approved reclamation plan to change the post-mining land use and revise the reclamation plan to accommodate the changes for the Cell No. 2 and Phase 18 area.

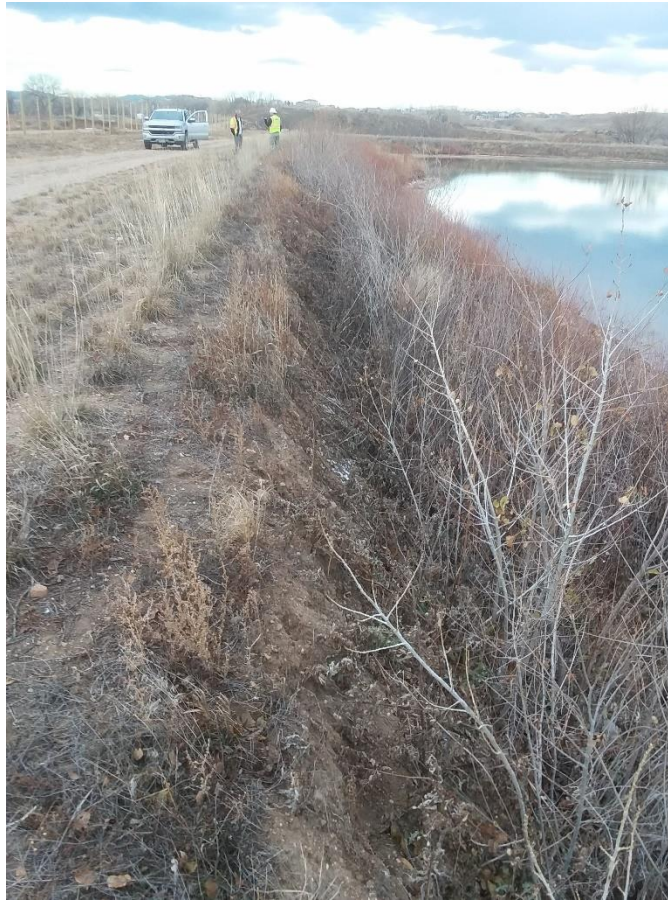
Cell No. 3 was observed. The northern pit slopes appears to be graded to a steeper than 3H:1V angle above the water line. This issue was discussed with the Operator. They indicated they would survey or otherwise measure the slope to insure it is graded to the required 3H:1V angle. Some small rills and gullies were observed along the northern pit slope that should be monitored and stabilized if necessary. The western pit slope of Cell No. 3 appeared to be graded at the required 3H:1V angle. This slope was stable and vegetated. A significant portion of the southern pit slope of Cell No. 3 has eroded or cut to a near vertical to 1H:1V slope. This slope will need to be repaired and regraded to the required 3H:1V angle five feet above to ten feet below the water line. The eastern pit slopes appeared to be graded to a 3H:1V slope and was stable.

Figure 3. Steep cut at the south slope of the Cell No. 3 reservoir.

Prior to bond release documentation will need to be submitted to the Division that the slurry wall around Cell No. 3 has passed the Office of the State Engineer leak test standards. Also, the Operator will need to insure the northern pit slopes are graded to the required 3H:1V ratio at least five feet above to ten feet below the water line. The southern pit slopes have eroded significantly and will need to be repaired and regraded.

Tamarisk trees were observed along the western and southern pit slopes of the Cell No. 3 area. This issue was discussed with the Operator. These trees will need to be treated with an appropriate weed control method. It is likely many of these trees will be disturbed by the slope repair along the southern boundary of the reservoir but the Operator is encouraged to monitor this area and to conduct follow-up weed control after the earthwork is completed.

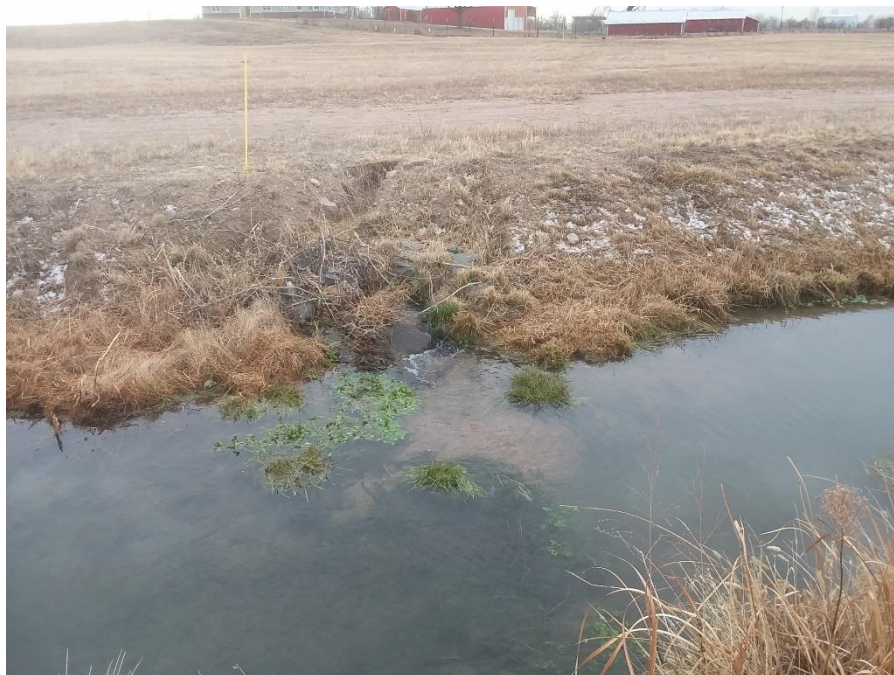
The French Drain installed adjacent to the Spier Property appears to be functioning. Water was discharging from the drain into the McCanne Ditch. The two cleanout areas were observed on the northwest side of the Spier property.

Figure 4. French Drain discharging at the McCanne Ditch.

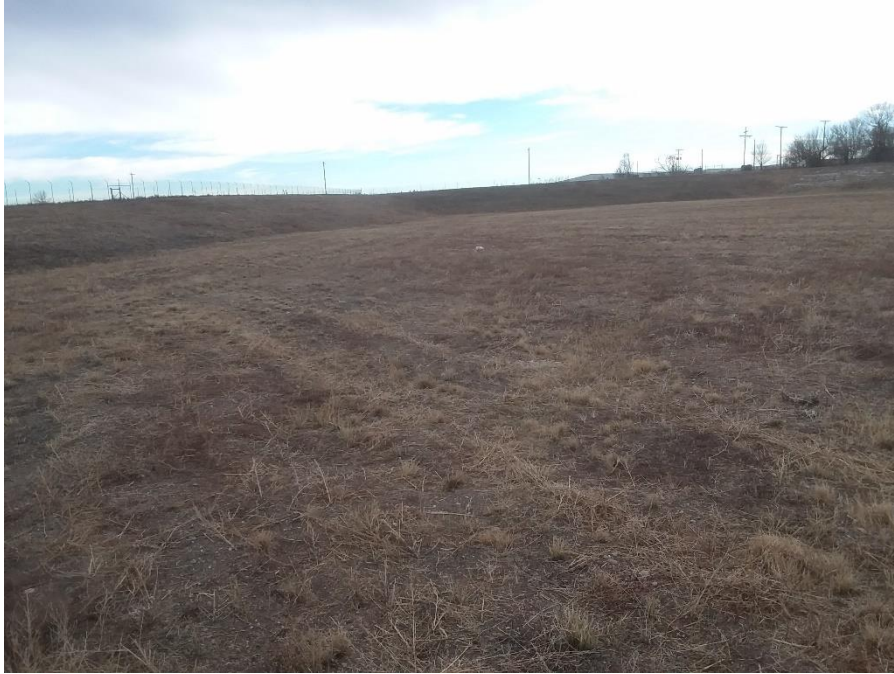
The ARA Addition area has been graded and seeded. The majority of the area has been graded relatively level with the back-slopes of the former pit area daylighting to the northwest. The back-sloped areas appear to be graded to a 3H:1V angle and were stable.

Vegetation has begun to establish within the ARA area. Several species of grasses were observed, however it was difficult to determine the type of species established as the area has been mowed. Fairly dense establishment of annual forbs were observed throughout this area as is typical in the early stages of reclamation. The operator should continue to monitor this site as the desirable vegetation begins to establish.

Figure 5. South end of the ARA Addition area looking southeast.
