## MINERALS PROGRAM INSPECTION REPORT

<b>MINE NAME:</b> United/Norwood Pit	<b>MINE/PROSPECTING ID#:</b> M-1988-037	<b>MINERAL:</b> Gravel	<b>COUNTY:</b> Montrose
<b>INSPECTION TYPE:</b> Monitoring	<b>INSPECTOR(S):</b> Lucas J. West	<b>INSP. DATE:</b> October 23, 2018	<b>INSP. TIME:</b> 12:30
<b>OPERATOR:</b> Oldcastle SW Group, Inc. dba United Company County	<b>OPERATOR REPRESENTATIVE:</b> None	<b>TYPE OF OPERATION:</b> 112c - Construction Regular Operation	
<b>REASON FOR INSPECTION:</b> Normal I&E Program	<b>BOND CALCULATION TYPE:</b> Complete Bond	<b>BOND AMOUNT:</b> \$245,000.00	
<b>DATE OF COMPLAINT:</b> NA	<b>POST INSP. CONTACTS:</b> None	<b>JOINT INSP. AGENCY:</b> None	
<b>WEATHER:</b> Raining	<b>INSPECTOR'S SIGNATURE:</b>

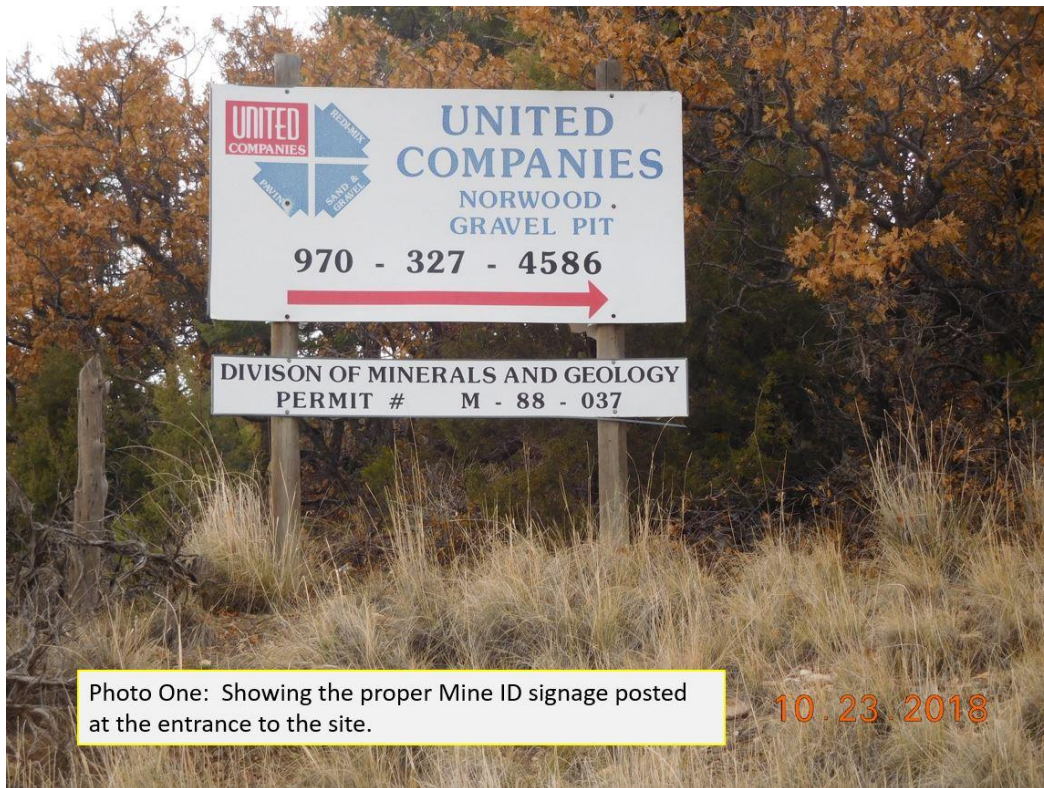
The proper mine identification signage was posted at the entrance to the site and the permit boundaries were clearly marked. The mine ID sign can be seen in Photo One. The site was not active during the day of the inspection due to the weather. The entrance to the site consists of the scale, scale house, fuel and equipment storage. All fuel and hazardous materials were stored with appropriate secondary containment, and all equipment, scrap and other items were stored in a neat and orderly fashion. Located all throughout the pit floor is the processing and stockpile area. Processing activities including the operation of the asphalt hot plant were not underway the day of the inspection. The hot plant and processing facilities can be seen in Photo Two. Several stockpiles of various sized materials were on the pit floor, all stockpiles that were observed appear to be stable and in good condition. The overburden and topsoil stockpiles were observed at different locations throughout the site for ease of transport during reclamation. Examples of the materials stockpiles can be seen in Photo Three. The pit floor exhibit positive drainage and no impounded storm water was observed. All areas that have been sloped and reclaimed appear to be stable and in good condition. In the area near the wash plant ponds, the sloping has been completed and the area appears to exhibit sufficient vegetative cover.

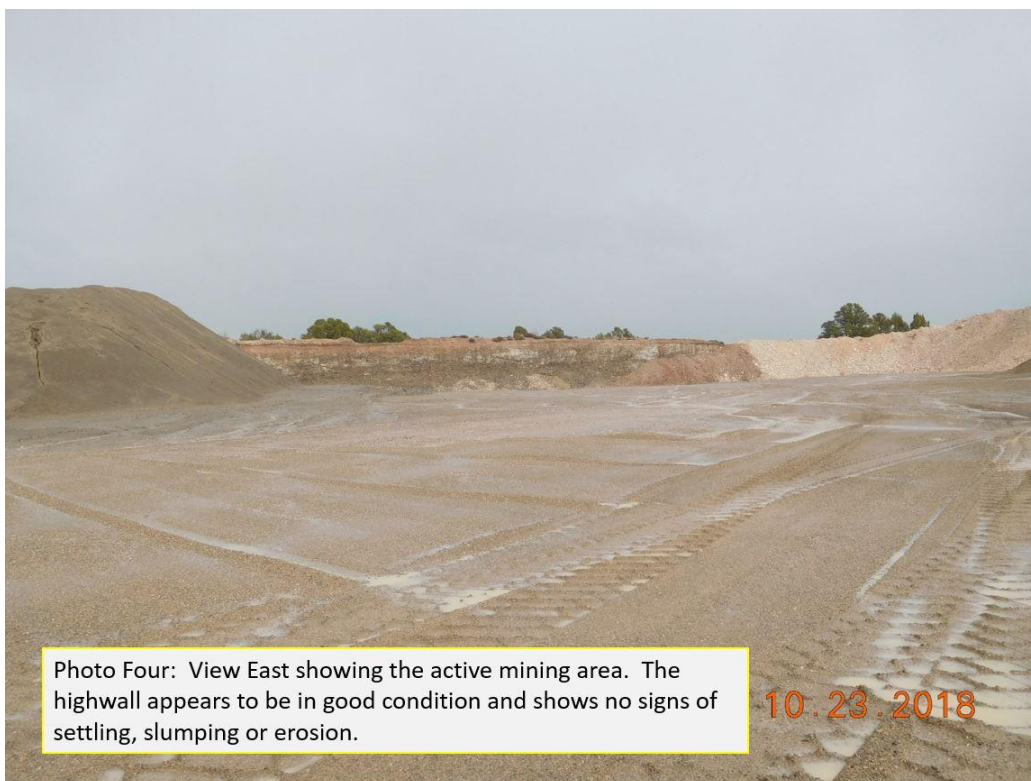
The active mining area consist of a highwall approximately 40 feet tall. A new mining area is currently being stripped in the area referred to as Phase 4. The active mining area can be seen in Photo Four. The highwall is in good condition and no evidence of settling, slumping, or erosion was observed. The overall footprint of the site is in good condition and free from excessive trash and debris. Evidence of chemical treatment of noxious weeds was observed and throughout the site no signs of significant erosion was observed.
