MINERALS PROGRAM INSPECTION REPORT

MINE NAME: Dawson Mine	MINE/PROSPECTING ID#: M-1977-392	MINERAL: Clay (general)	COUNTY: Elbert
INSPECTION TYPE: Monitoring	INSPECTOR(S): Patrick Lennberg	INSP. DATE: November 14, 2018	INSP. TIME: 10:45
OPERATOR: The Denver Brick Company	OPERATOR REPRESENTATIVE: Rob Tibbetts and Steve Helzer	TYPE OF OPERATION: 112c - Construction Regular Operation

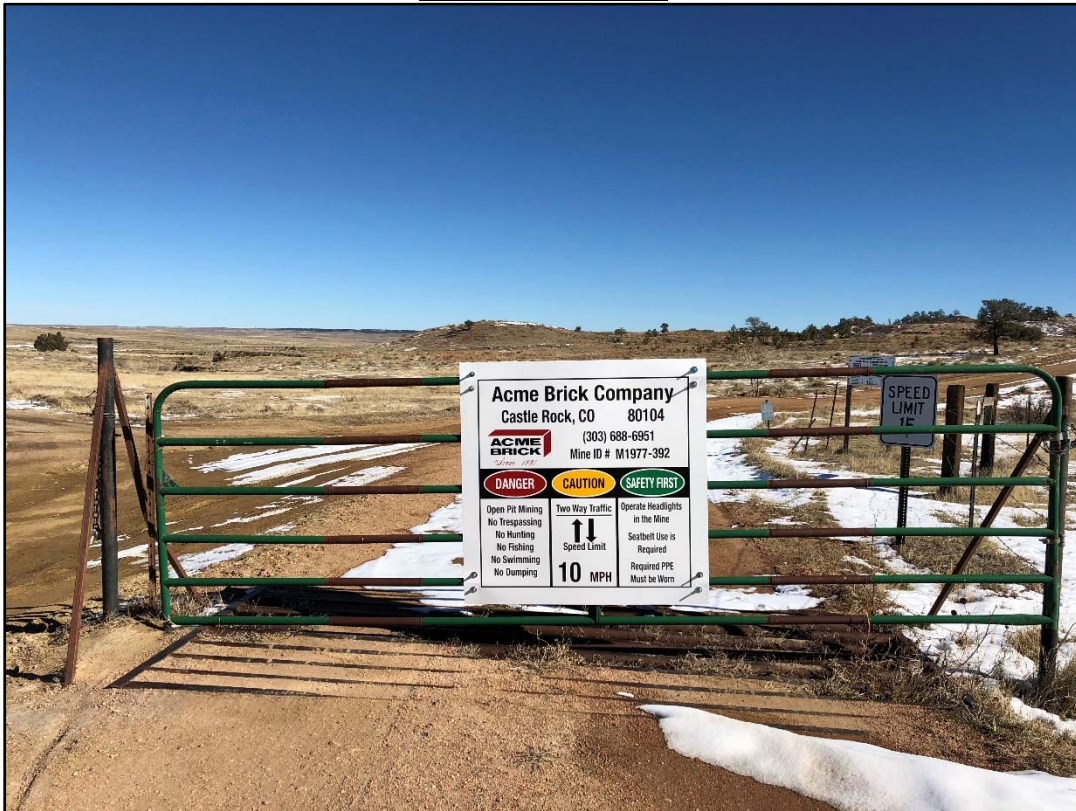
Photo 1: Mine permit sign

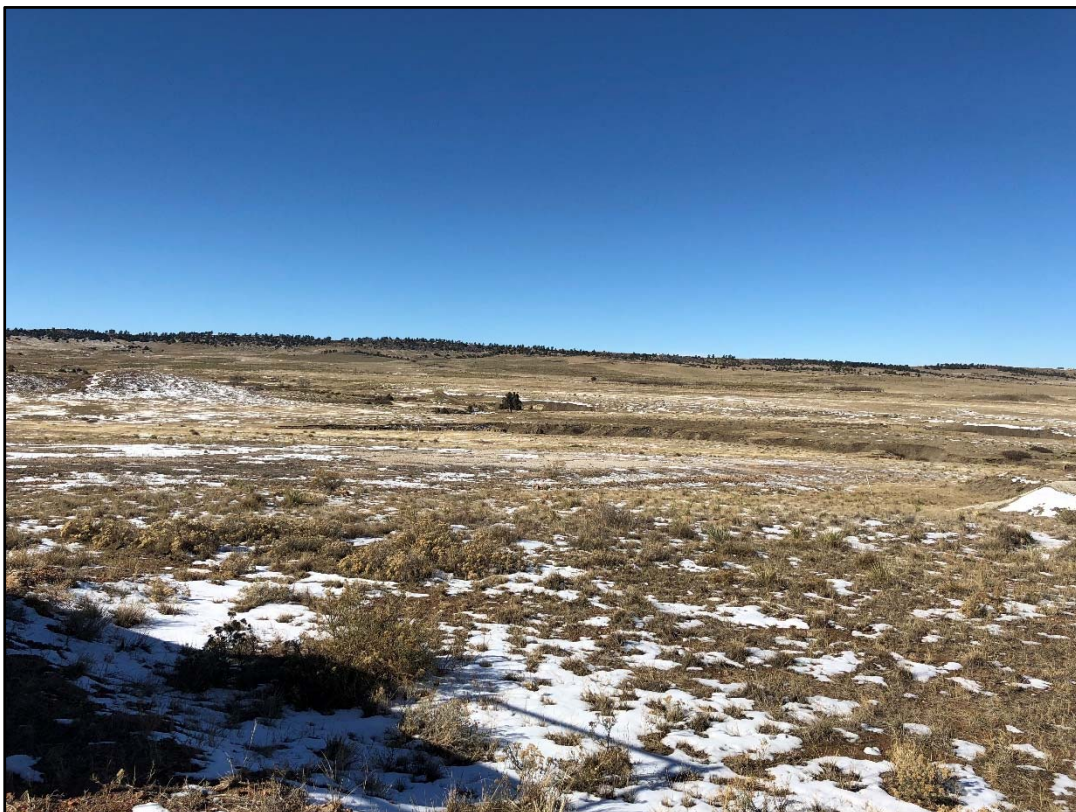
Area 4 consists of a relatively flat area most recently used as a stockpile area. The product and overburden stockpiles have been removed and the Operator stated the area was due to be reclaimed soon. The area was partially vegetated with volunteered native grasses.

Photo 2: Looking northwest from access road across Area 4

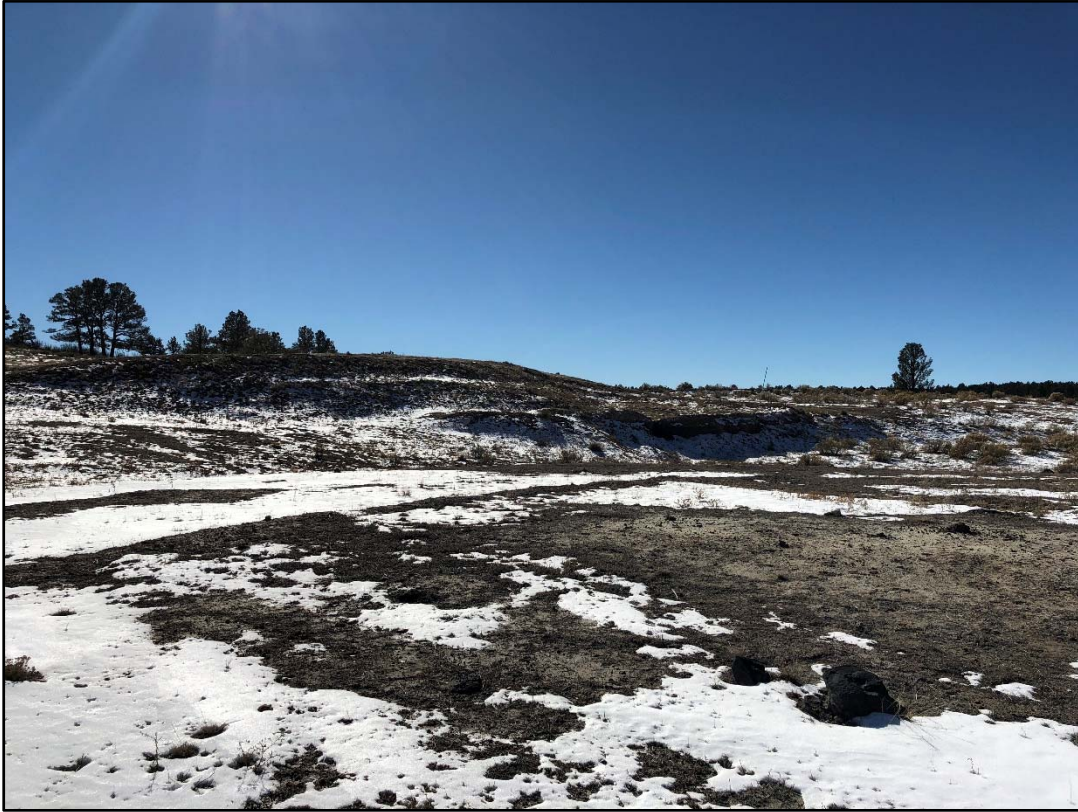
Area 3 contains a stockpile of calcine in the northwest corner of the area, a well vegetated topsoil stockpile in the southern portion of the area, a well vegetated overburden stockpile in the southwest corner of the area and a partially reclaimed mining area in the east portion of the area. The mining activity removed a portion of the western hill. The mined area was regraded to a 3H:1V slope on all sides creating a basin.

Photo 3: Topsoil stockpile located in Area 3

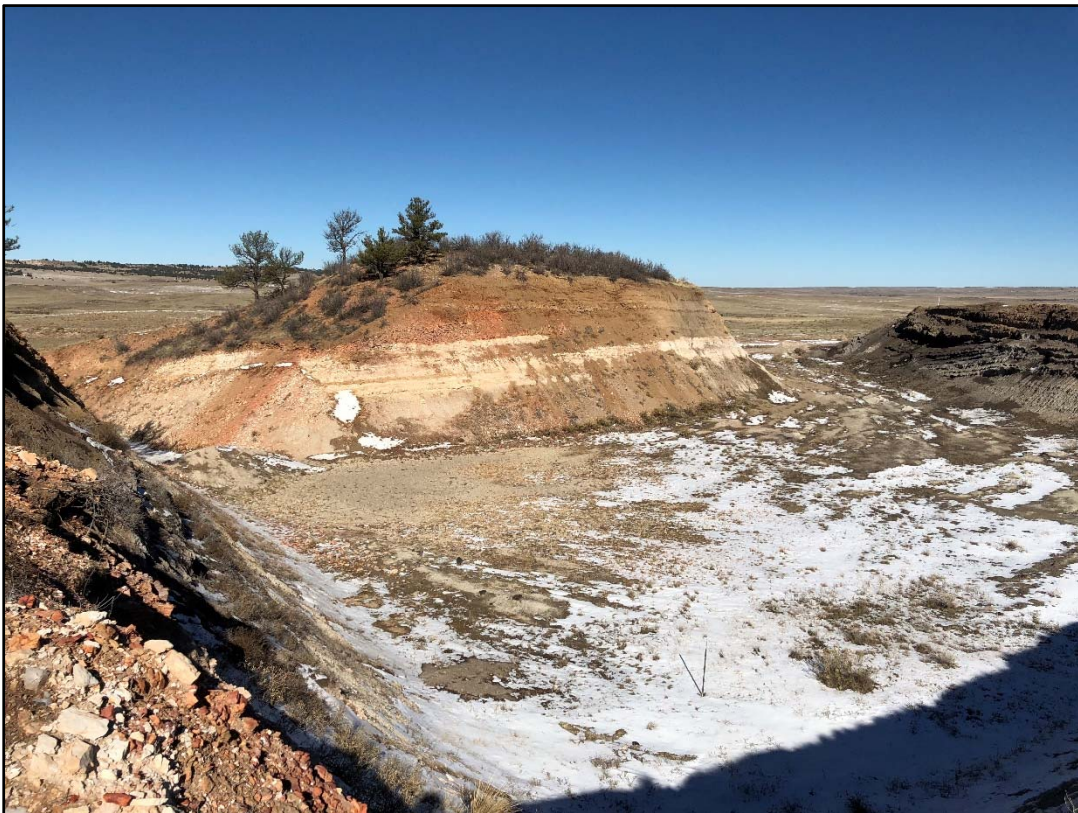
Area 2 contains the current mining disturbance with near vertical highwalls of 15 to 20 feet in height. Mining activities were planned to continue in this area and progress to the southwest and eventually mine through the three hills within the permit area.

Photo 4: Area 2, horseshoe pit, with isolated hill of material.

The Operator stated the tentative plan to reclaim the site was to backfill the Area 2 with the on-site overburden and calcine stockpiles, and push the isolated hill of material back into the pit to match the existing surrounding natural topography, replace the topsoil and vegetate the disturbed areas. Area 4 will require grading out of disturbances, placement of topsoil and seeding.

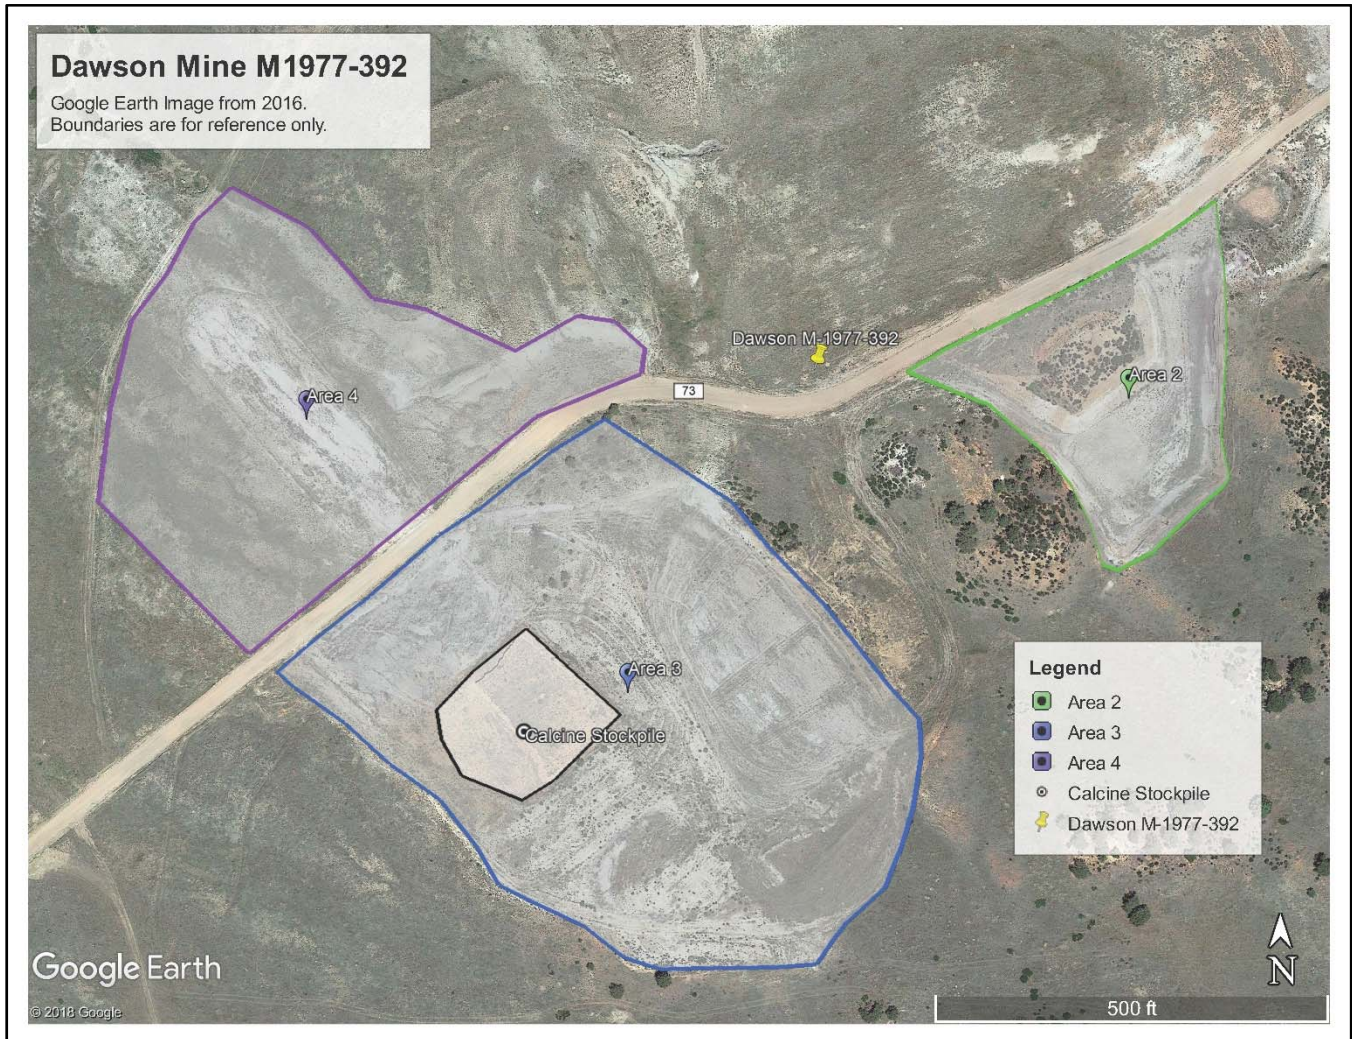
Picture 1: Aerial overview of site.
