MINERALS PROGRAM INSPECTION REPORT

MINE NAME: Bijou Clay Mine	MINE/PROSPECTING ID#: M-1997-007	MINERAL: Clay (general)	COUNTY: Elbert
INSPECTION TYPE: Monitoring	INSPECTOR(S): Patrick Lennberg	INSP. DATE: November 14, 2018	INSP. TIME: 11:45
OPERATOR: The Denver Brick Company	OPERATOR REPRESENTATIVE: Rob Tibbetts and Steve Helzer	TYPE OF OPERATION: 112c - Construction Regular Operation

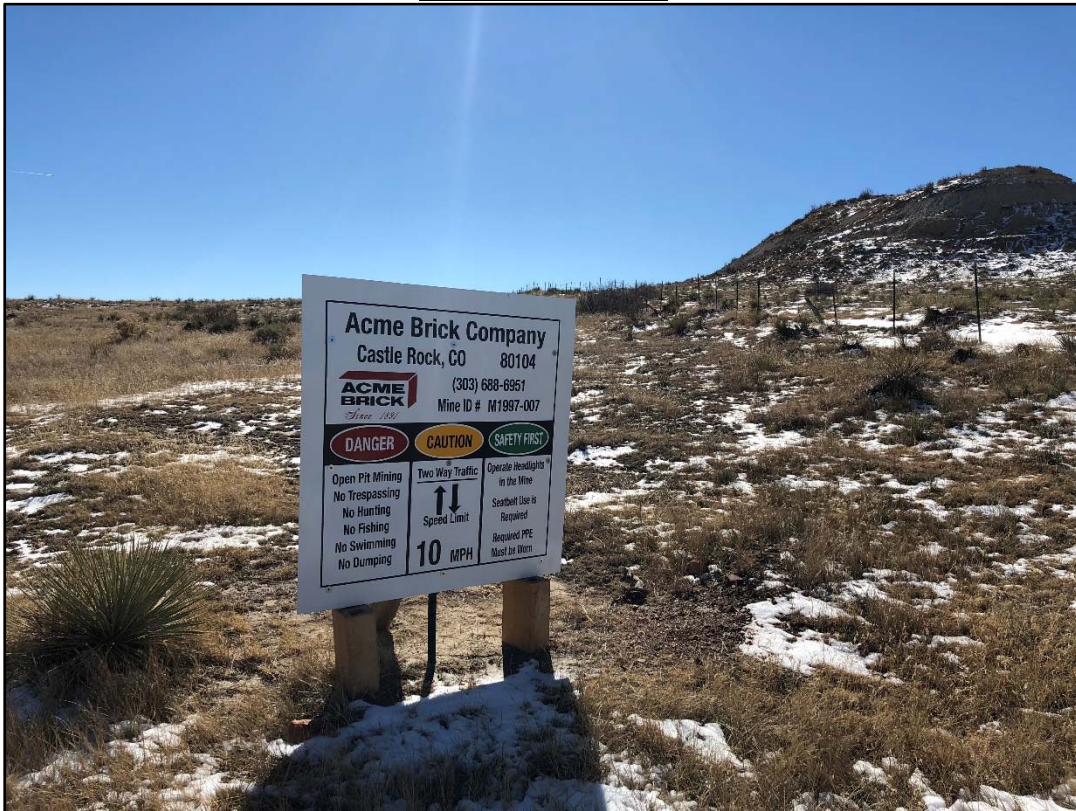
The site is an 112c Construction Materials permit for 33.75 acres for the mining of clay. The Division currently holds a financial warranty in the amount of \$196,124.37, which appeared adequate to reclaim the current site disturbance. A mine sign and boundary markers were observed as required by Rule 3.1.12.

Photo1: Mine permit sign

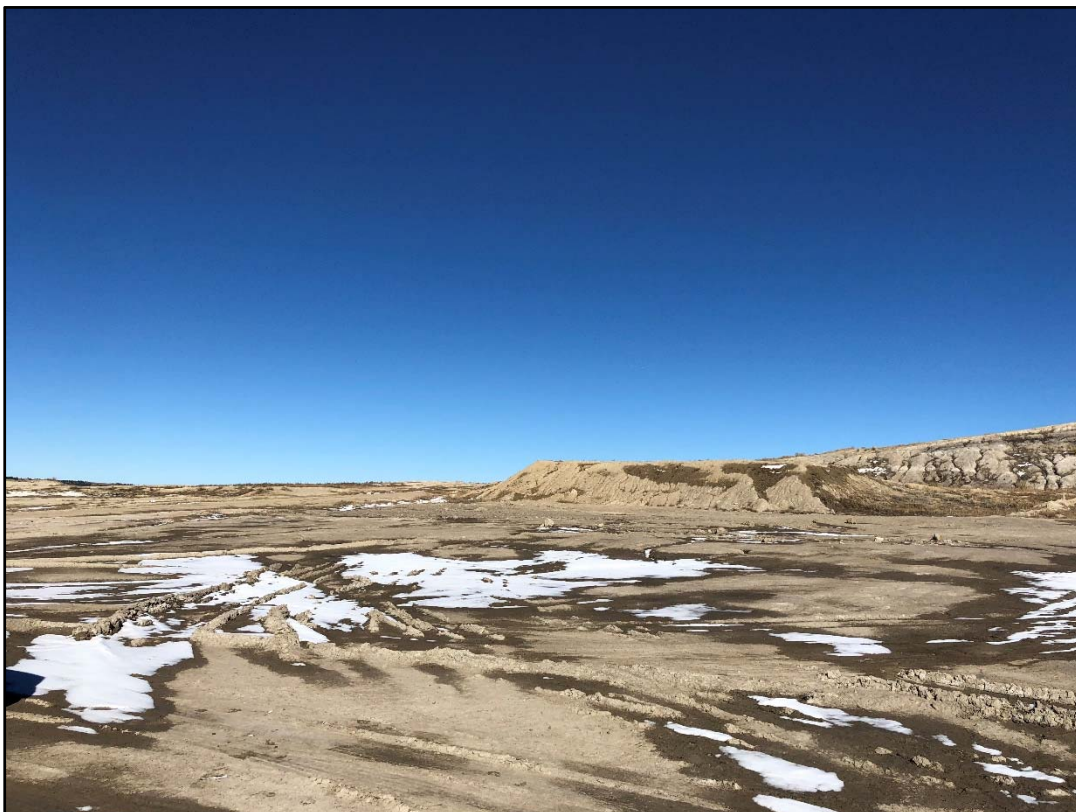
Photo 2: Topsoil stockpile located west side of stockpile area

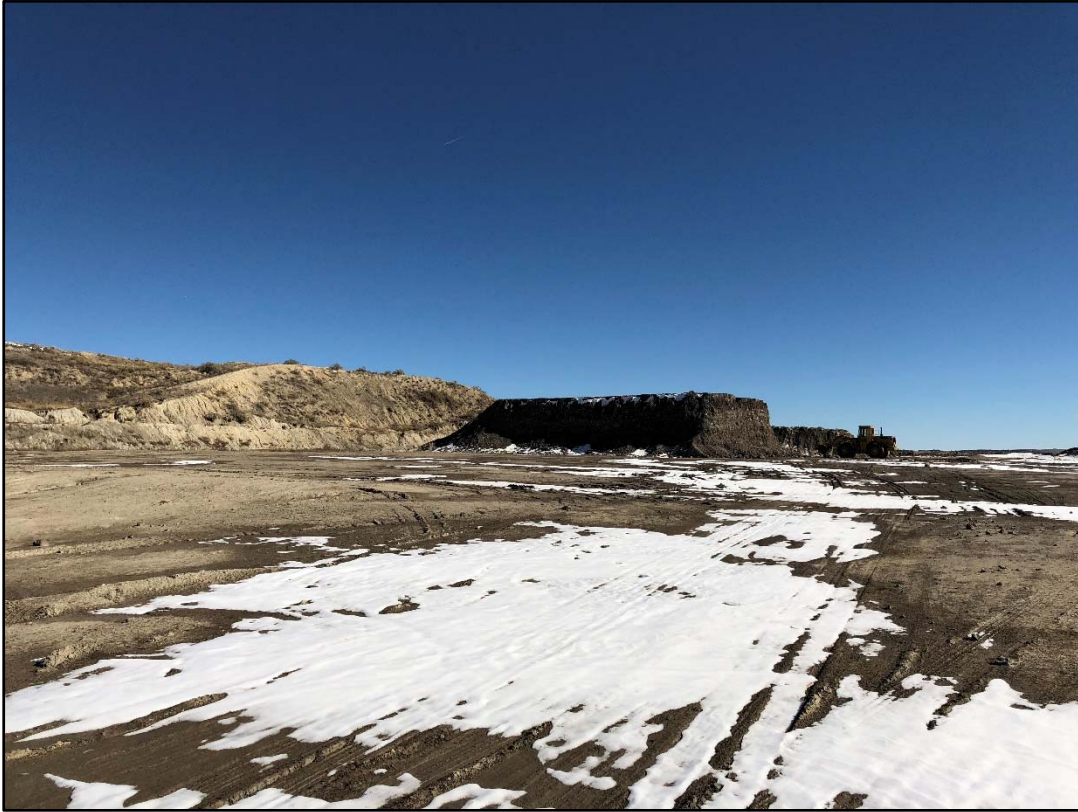
The site was inactive during the inspection. There was front-end loader in the stockpile area. Material from the site is transported off-site for processing and the production of bricks. The site is divided into three (3) areas; a stockpile area located in the center of the site, a partially reclaimed mining area north of the stockpile area and the current mining area south of the stockpile area.

Photo 3: Stockpiles and equipment

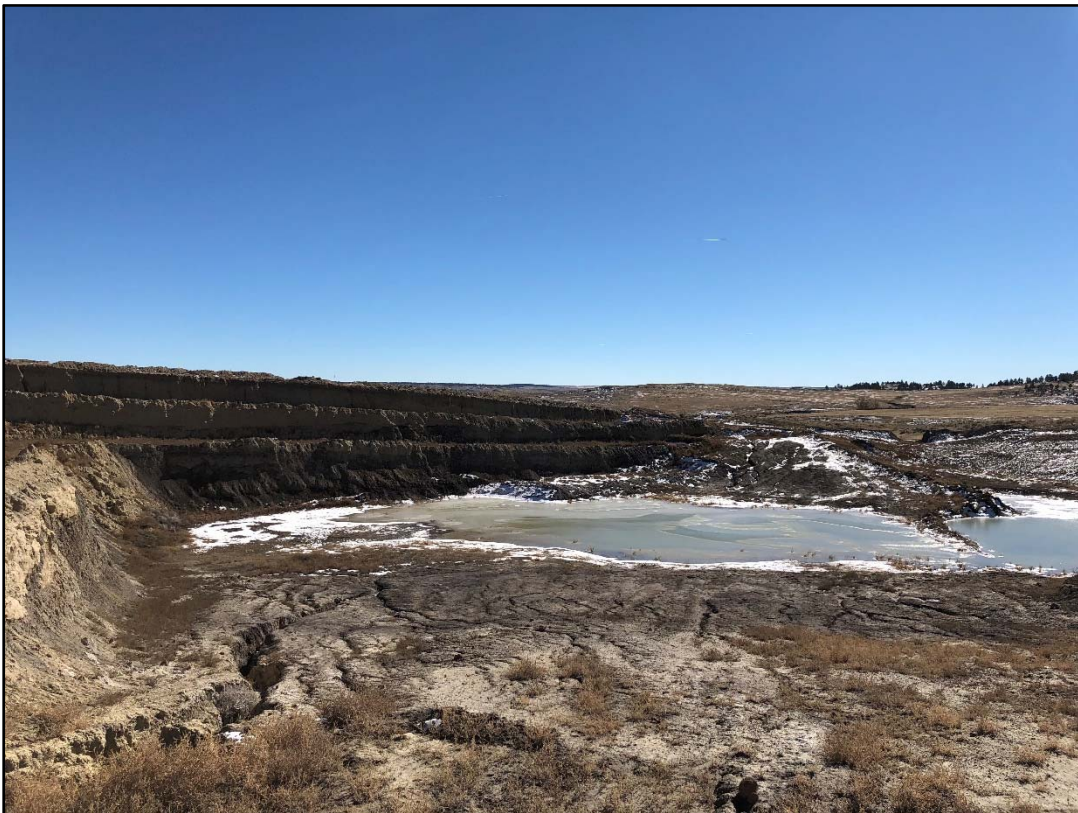
The south mining area was mined this year continuing in the southwest corner of the area. The west and south slopes of the mined area were graded at the approved 3H:1V slope, however topsoil has not been replaced on the slopes. The Operator stated additional grading and contouring will be done in the area prior to placement of topsoil. Additionally the Operator is in discussion with the landowner to determine the location of an approved post mine stock pond. Once the location is agreed upon a the Division will require the Operator to submit a technical revision, pursuant to Rule 1.9, with the \$216 fee to update the approved Reclamation Plan and Map to reflect the proposed final reclamation of the site.

Photo 4: South mining area

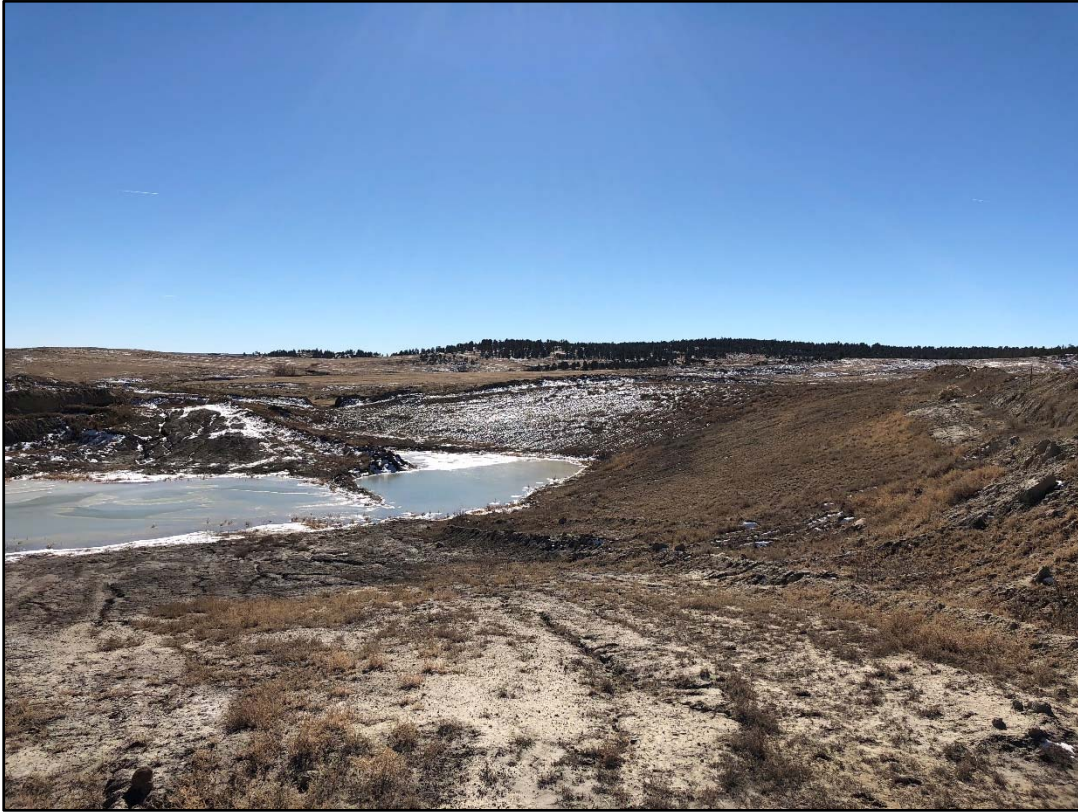
Photo 5: South mining area with reclaimed slopes to the right

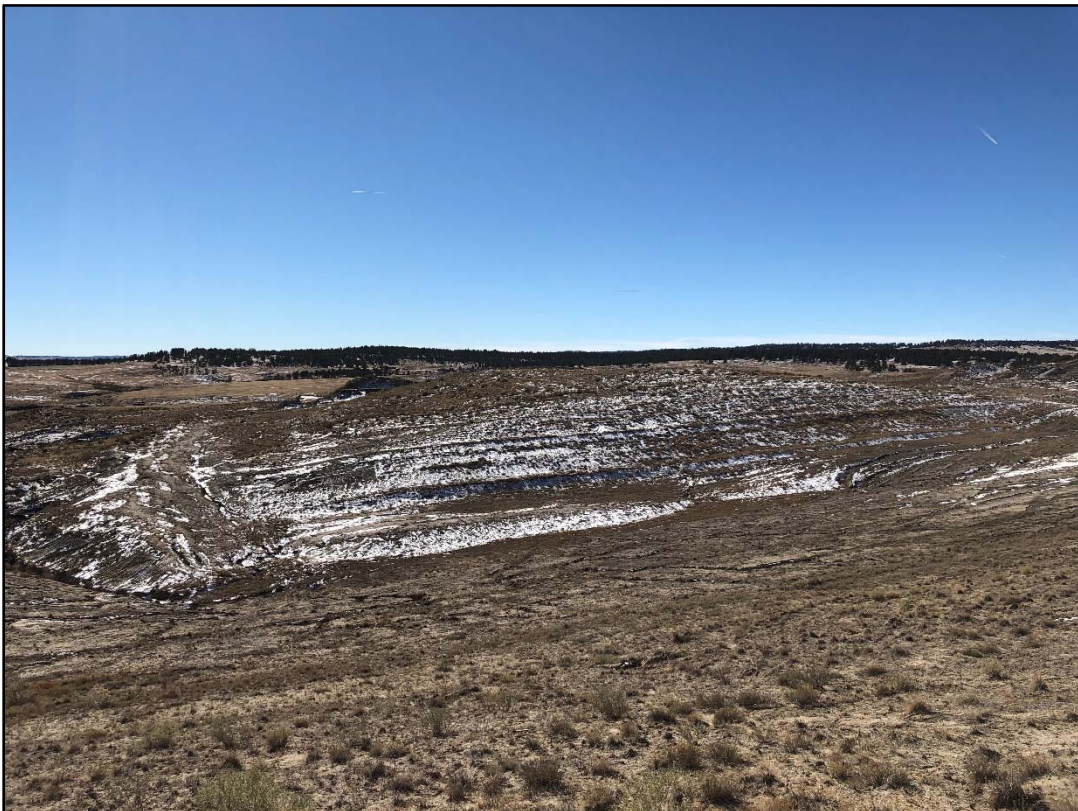
The north mining area appears unchanged since the last inspection. The area consists of a basin with 3H:1V graded slopes on the north, south and west sides. The slopes were partially vegetated and contained numerous erosion rills and gullies. The Operator should consider inter-seeding with the approved seed mixture to promote additional plant growth and aid in slope stability. The east side of the basin consists of a berm with a stormwater outfall at the low part of the berm. This area will need to be graded, have topsoil placed, and revegetated.

Photo 6: North mine reclaimed area
