## MINERALS PROGRAM INSPECTION REPORT

<b>MINE NAME:</b> Brownwood Pit	<b>MINE/PROSPECTING ID#:</b> M-1979-059	<b>MINERAL:</b> Sand and gravel	<b>COUNTY:</b> Larimer
<b>INSPECTION TYPE:</b> Monitoring	<b>INSPECTOR(S):</b> Jared L. Ebert	<b>INSP. DATE:</b> November 28, 2018	<b>INSP. TIME:</b> 09:00
<b>OPERATOR:</b> Coulson Excavating Company, Inc.	<b>OPERATOR REPRESENTATIVE:</b> Ken Coulson	<b>TYPE OF OPERATION:</b> 112c - Construction Regular Operation

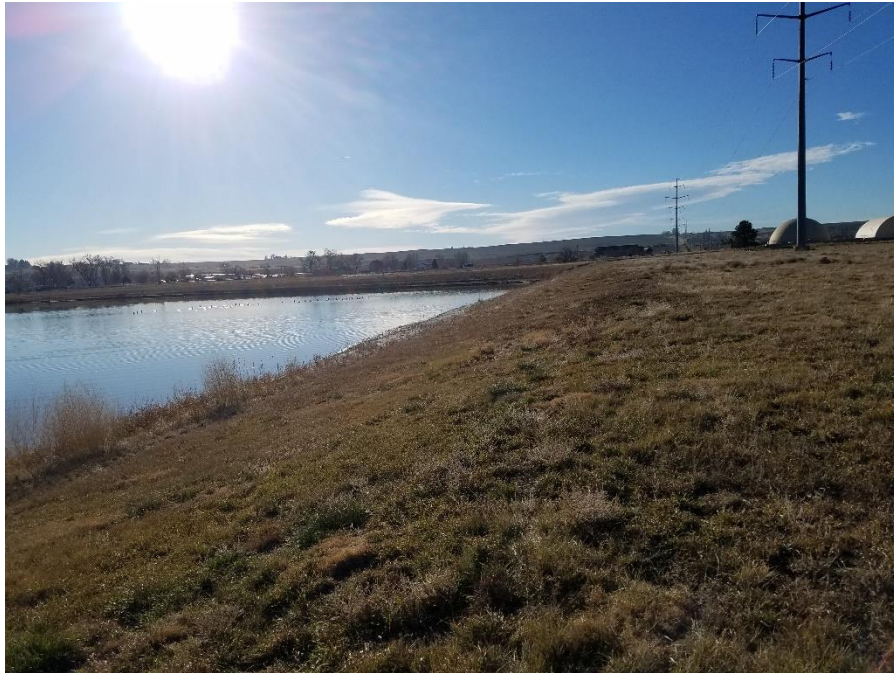
The reservoir constructed in the south east portion of the property known as the SE Reservoir was observed. The slopes of this reservoir have been graded to a 3H:1V ratio or less and appeared stable and vegetated.

**Figure 1. From the northwest corner of the SE Reservoir looking south.**

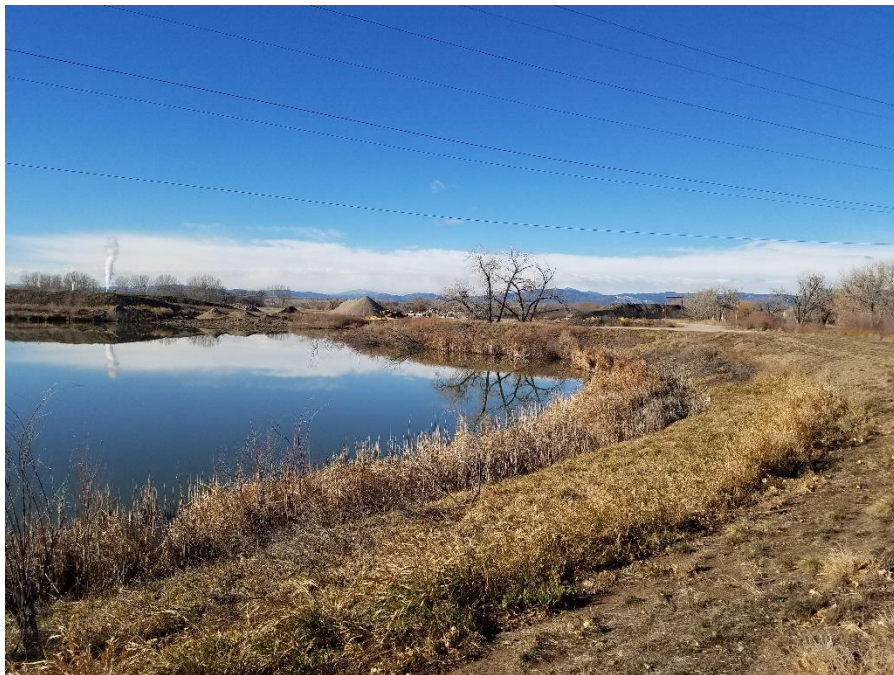
The industrial sand and gravel processing area is still currently in use. The hot mix asphalt plant was operational at the time of the inspection. The pond located north east of the processing area known at the Brownwood North East Reservoir ("BNER") was observed. The northern and eastern pit slopes of the BNER pond have been graded to a 3H:1V ratio or less and are well vegetated and stable. Land is still affected along the western pond slopes and several stockpiles of material was observed adjacent to the pond. It does appear material has been backfilled at the southern end of the pond in accordance with the approved reclamation plan.

The current reclamation plan calls for the BNER to be lined with clay. It does not appear that this has occurred and according to Mr. Coulson they are in the process of applying for a permanent augmentation plan for this pond as well as several other in the surrounding area. The reclamation plan will need to be revised with a Technical Revision to designate the BNER to be an open groundwater pond as opposed to a clay lined reservoir. The Division will need to see evidence Coulson is seeking a permanent plan for augmentation. This issue is cited as a problem at the beginning of this report.

**Figure 2. From the northeast corner of the BNER pond looking northwest.**

**CORRECTIVE ACTIONS:** The Operator shall submit evidence they have applied for a permanent plan for augmentation by the corrective action date.

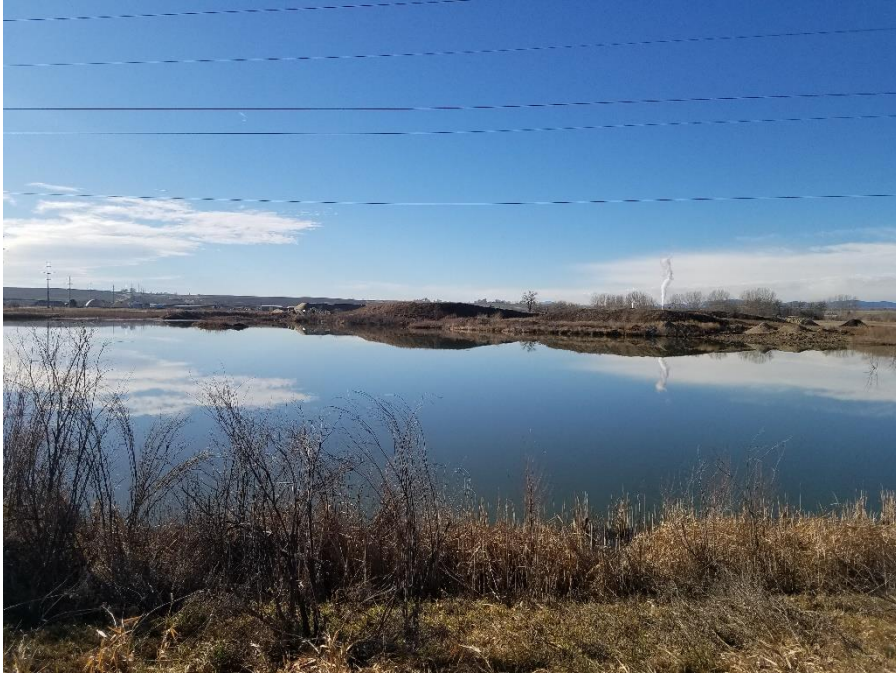
Figure 3. View of the west side of the BNER from the east side.

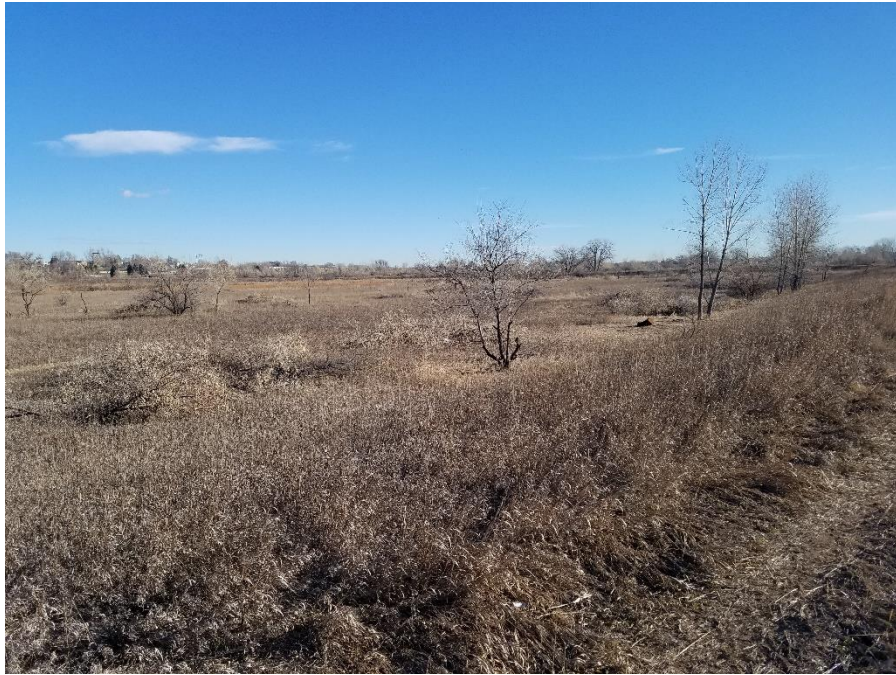
The Pfeiff Pond and adjacent land located in the northeast portion of the site was observed. The area appears to be graded in the configuration shown on the approved reclamation plan map. Dense vegetation has established around the pond and the area appears stable.

Figure 4. From the southwest side of the "Pfeiff Property" looking northeast.
