MINERALS PROGRAM INSPECTION REPORT

MINE NAME: Gardels Pit	MINE/PROSPECTING ID#: M-2005-033	MINERAL: Sand and gravel	COUNTY: Larimer
INSPECTION TYPE: Monitoring	INSPECTOR(S): Jared L. Ebert	INSP. DATE: November 28, 2018	INSP. TIME: 09:50
OPERATOR: Coulson Excavating Company, Inc.	OPERATOR REPRESENTATIVE: Ken Coulson	TYPE OF OPERATION: 112c - Construction Regular Operation

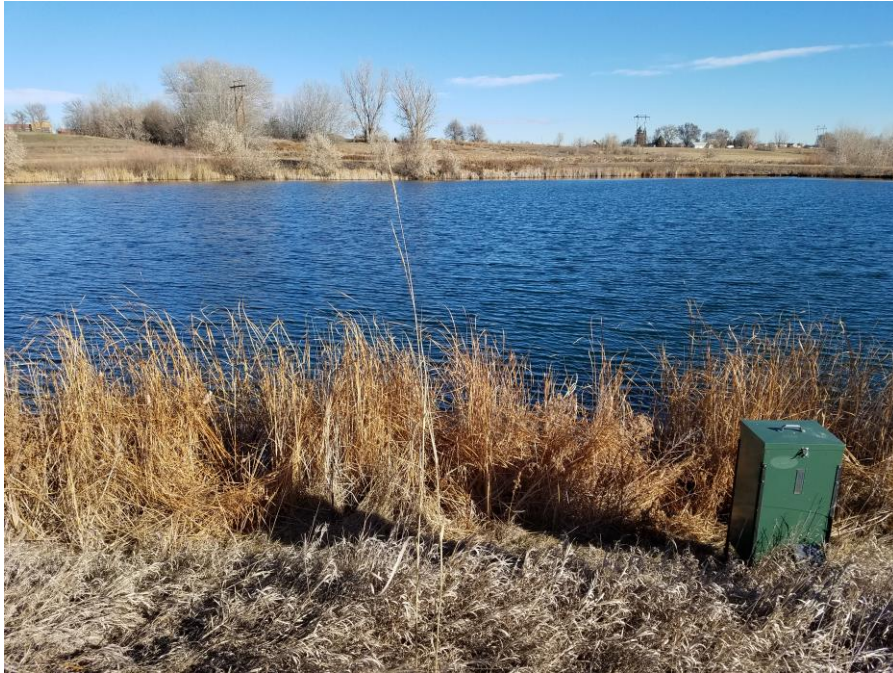
A permanent plan for augmentation has not been obtained for the Pond 1 area. This issue is cited as a problem at the beginning of this report. According to Mr. Coulson, they intend to submit an application for a permanent augmentation plan with the Office of the State Engineer for this site and several other areas in January of 2019. The Division will require the operator to submit documentation they have applied for a permanent augmentation plan by the corrective action date noted at the beginning of the report.

Overall, the site has been reclaimed in accordance with the approved reclamation plan. However, Pond 1 has not been lined and will need to have a permanent plan for augmentation approved and in place prior to the Division's approval of a bond release of this area.

Figure 1. From the south end of Pond 1 looking north.

CORRECTIVE ACTIONS: The Operator shall submit documentation to the Division that they have applied for a permanent plan for augmentation with the Office of the State Engineer by the corrective action due date.

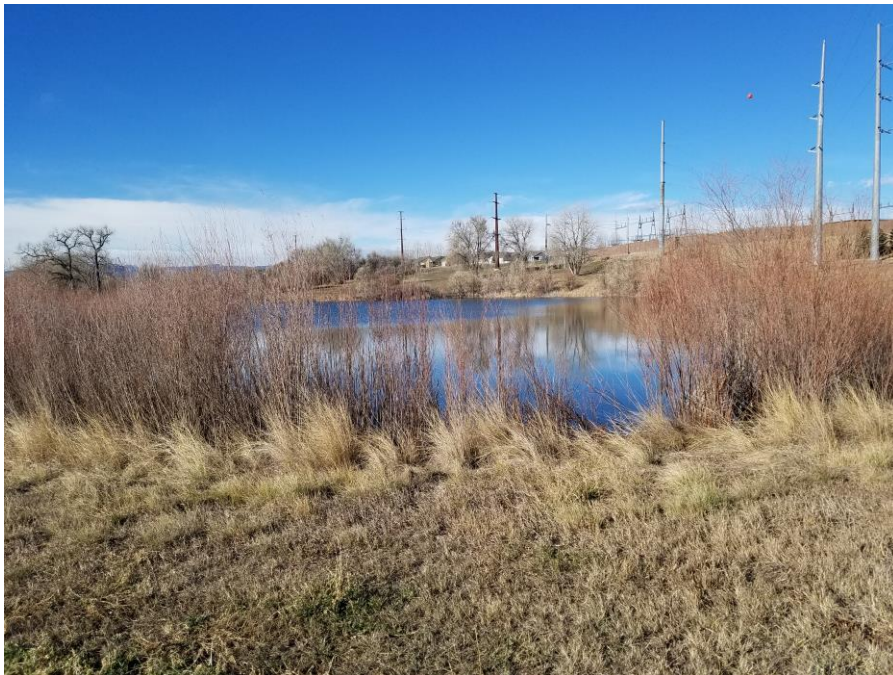
Figure 2. From the southeast corner of Pond 2, looking northwest.

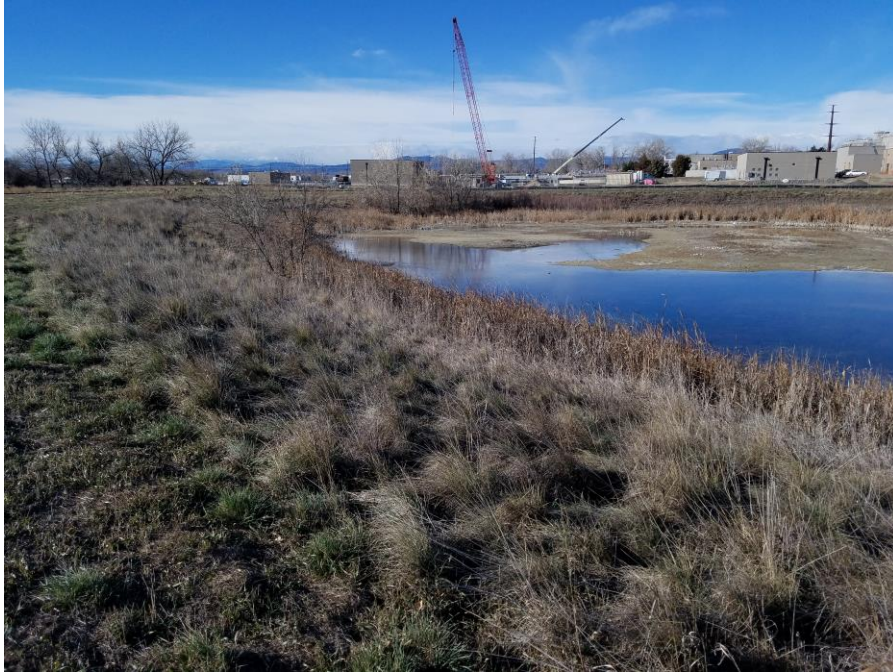
Figure 3. From the east side of Pond 3, looking southwest.

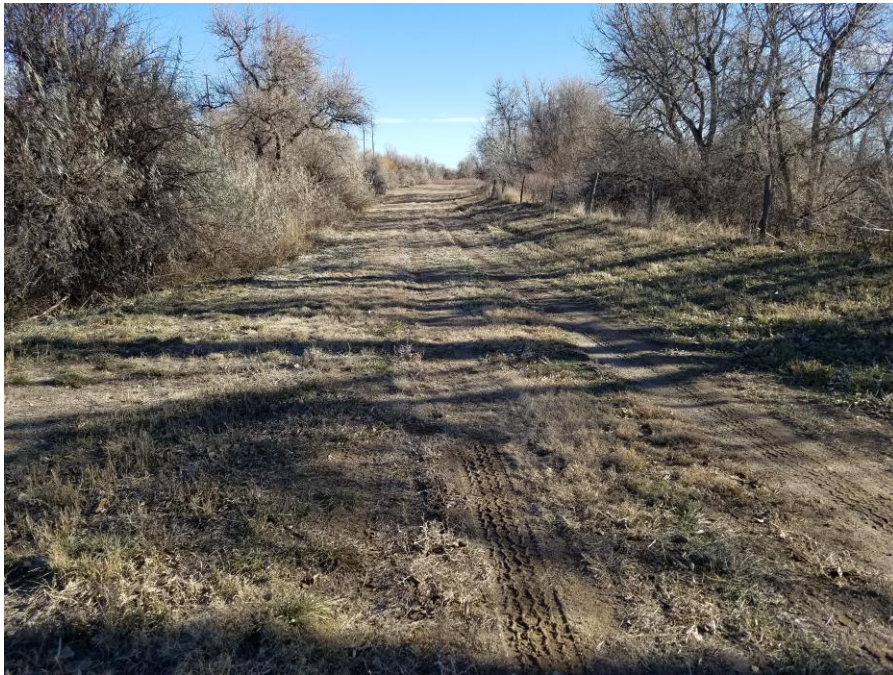
Figure 4. Access corridor between Pond 3 and Pond 2.
