**COLORADO**Division of Reclamation,
Mining and Safety

MINERALS PROGRAM INSPECTION REPORT**PHONE: (303) 866-3567**

MINE NAME: Fountain Pit	MINE/PROSPECTING ID#: M-1981-307	MINERAL: Sand and gravel	COUNTY: El Paso
INSPECTION TYPE: Surety-Related Inspection	INSPECTOR(S): Timothy A. Cazier	INSP. DATE: December 6, 2018	INSP. TIME: 11:00
OPERATOR: Martin Marietta Materials, Inc.	OPERATOR REPRESENTATIVE: Julie Mikulas	TYPE OF OPERATION: 112c - Construction Regular Operation

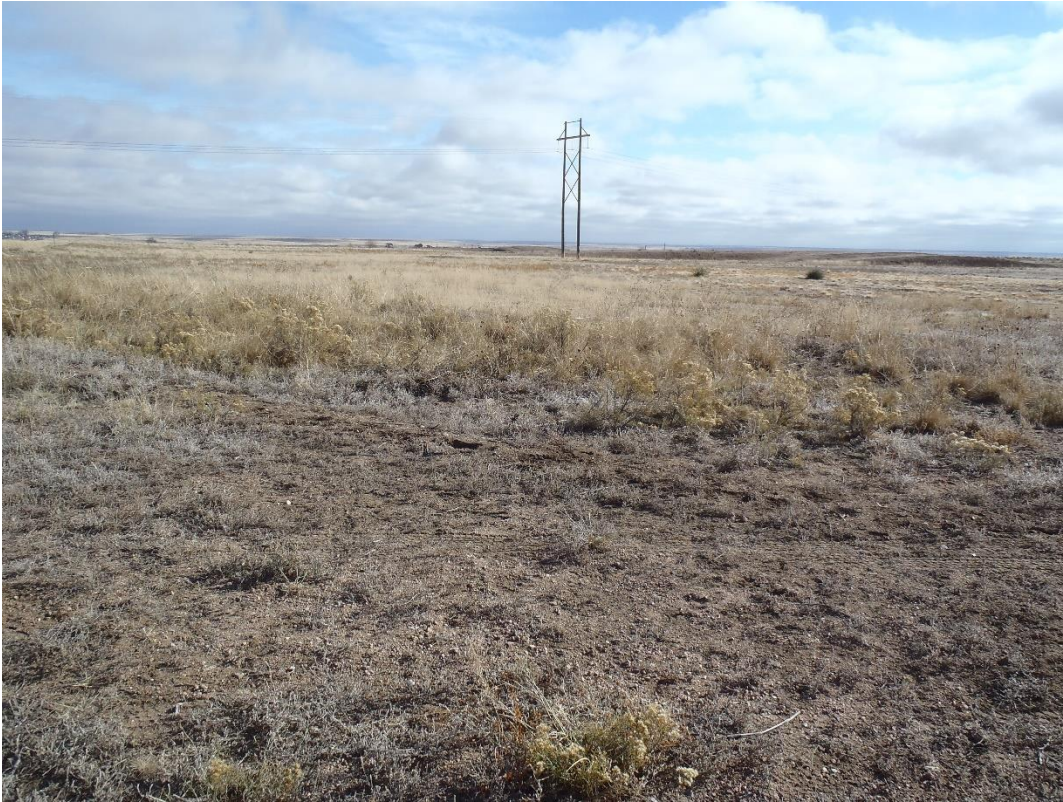
Revegetation: The vegetation appeared adequate (see **Photos 1 and 2**) for reclamation liability release.

Photo 1. Adequate revegetation (looking east from NW corner of release area).

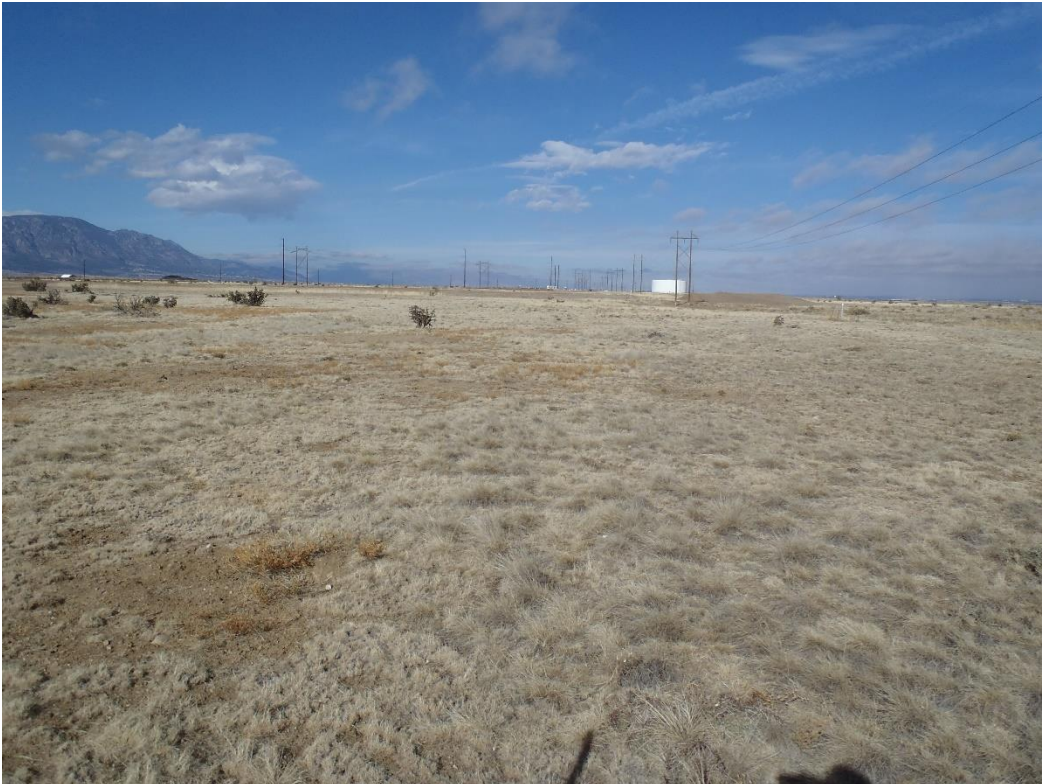
Photo 2. Adequate revegetation (looking NW from SE corner of release area)..

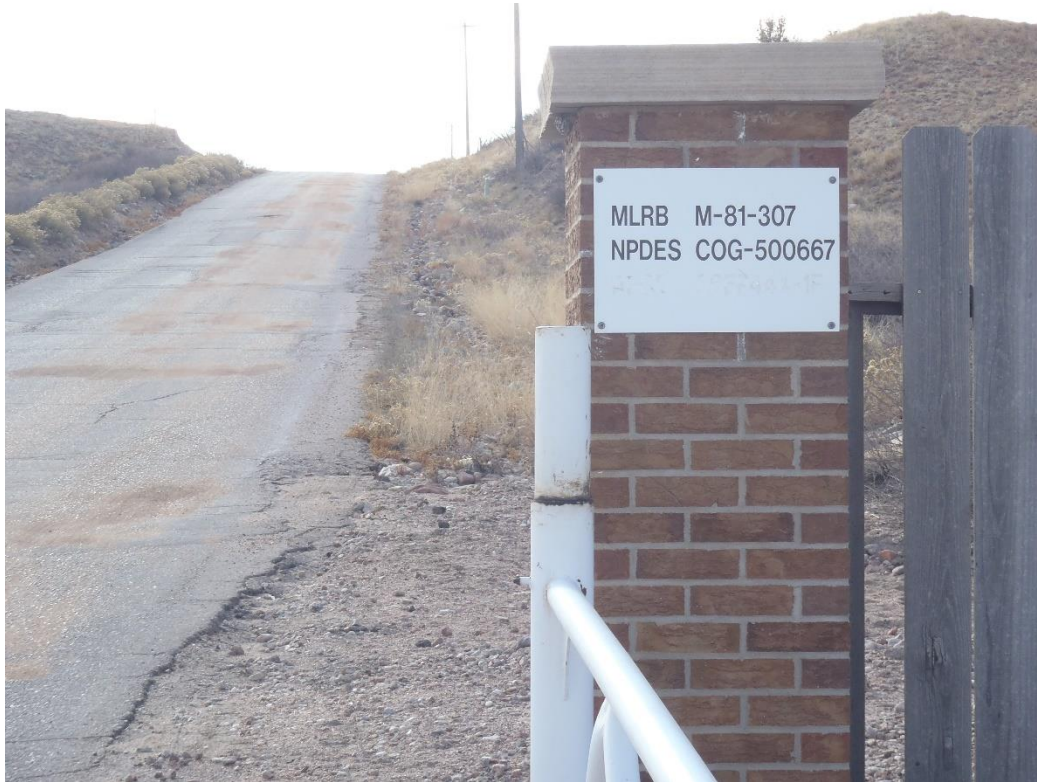
Photo 3. Permit sign (at entrance).

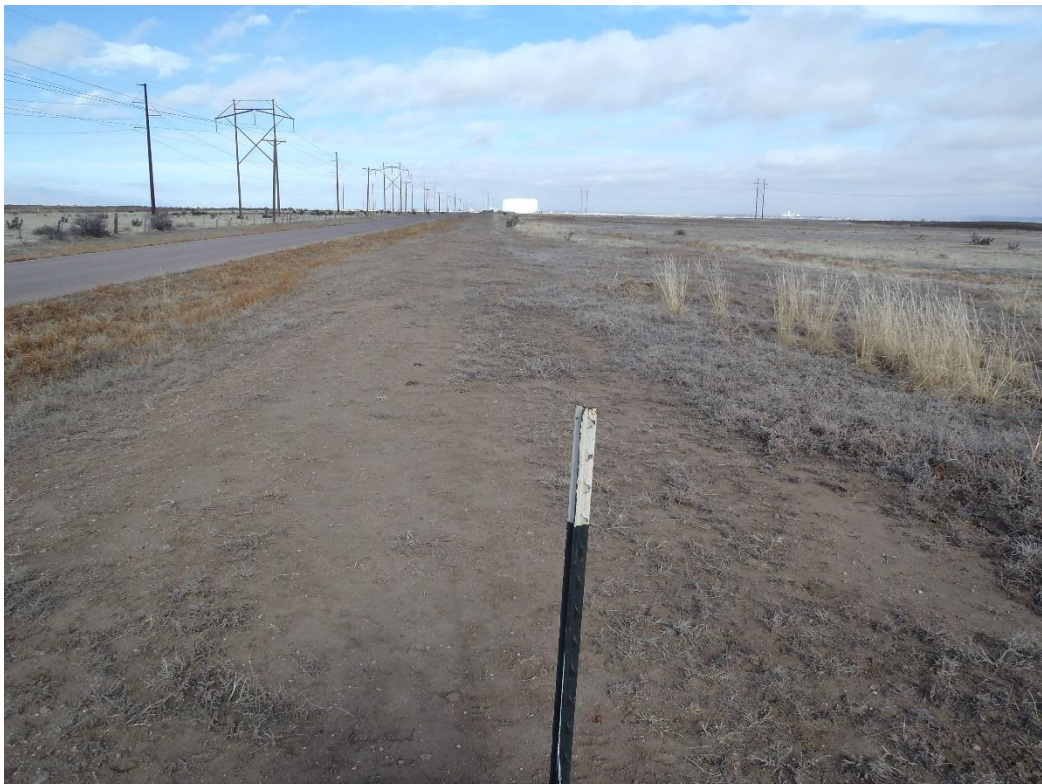
Photo 4. Typical T-post marking release parcel (SW corner, looking north).

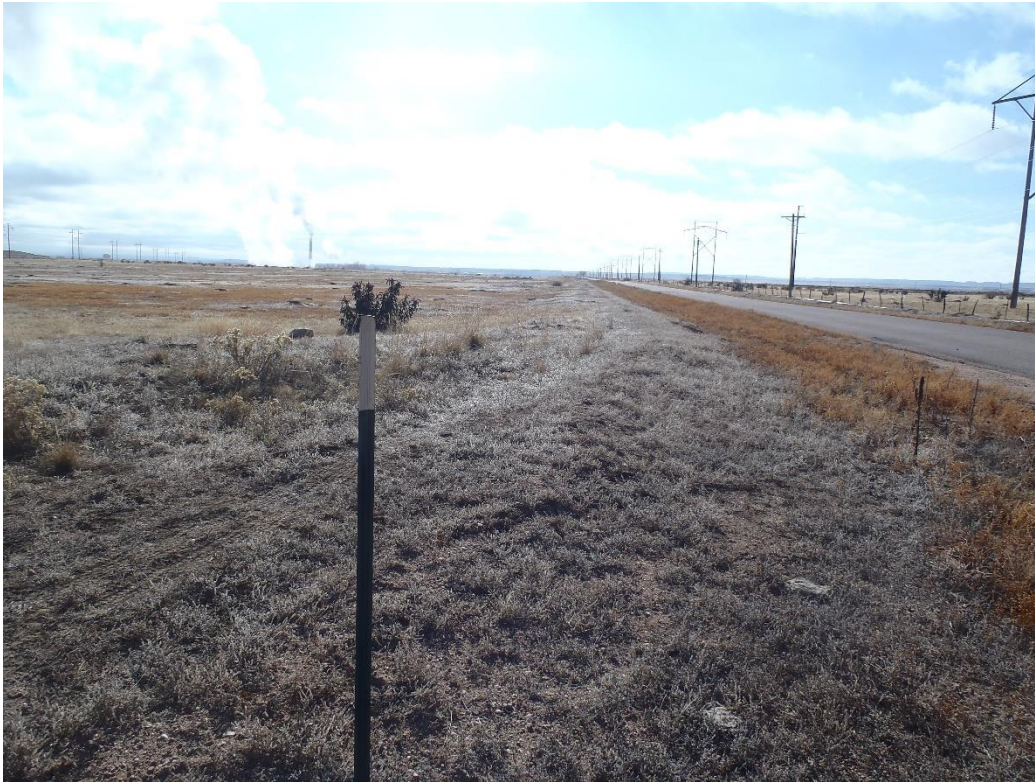
Photo 5. Adequate reclamation (from NW corner, looking south).

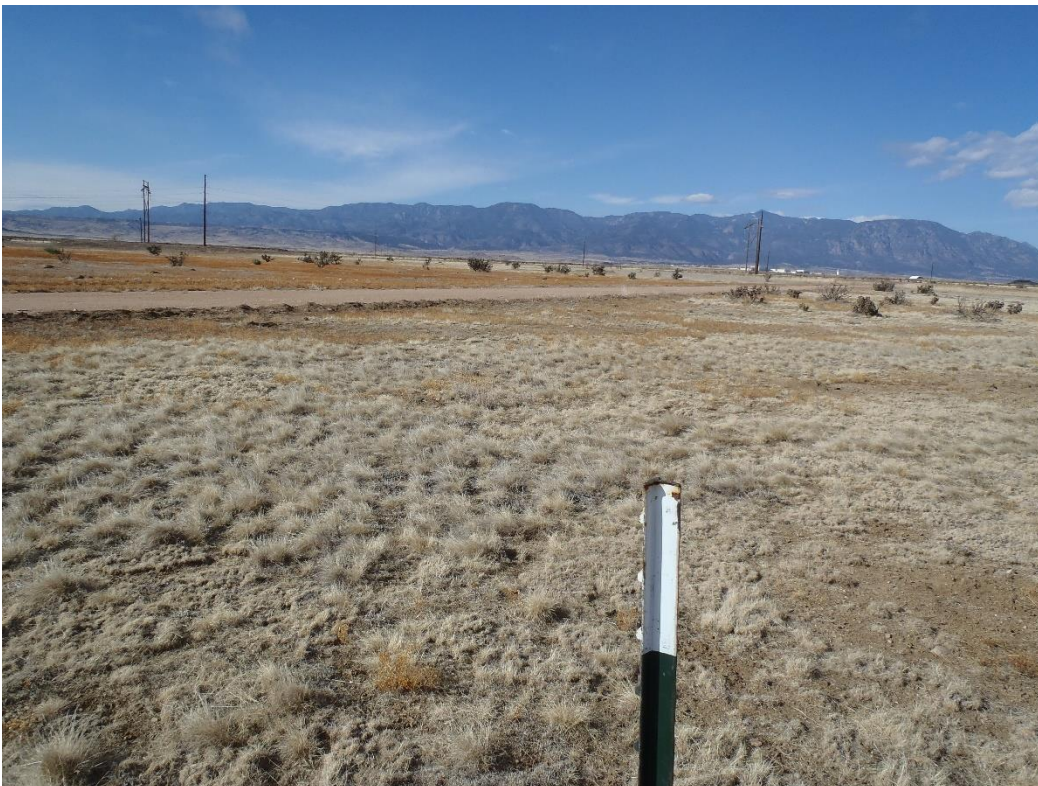
Photo 6. Adequate reclamation (from SE corner, looking west).
