**COLORADO**Division of Reclamation,
Mining and Safety

MINERALS PROGRAM INSPECTION REPORT**PHONE: (303) 866-3567**

MINE NAME: Kirtright Pit	MINE/PROSPECTING ID#: M-1986-123	MINERAL: Sand and gravel	COUNTY: Larimer
INSPECTION TYPE: Monitoring	INSPECTOR(S): Jared L. Ebert	INSP. DATE: November 28, 2018	INSP. TIME: 10:00
OPERATOR: Coulson Excavating Company, Inc.	OPERATOR REPRESENTATIVE: Ken Coulson	TYPE OF OPERATION: 112c - Construction Regular Operation

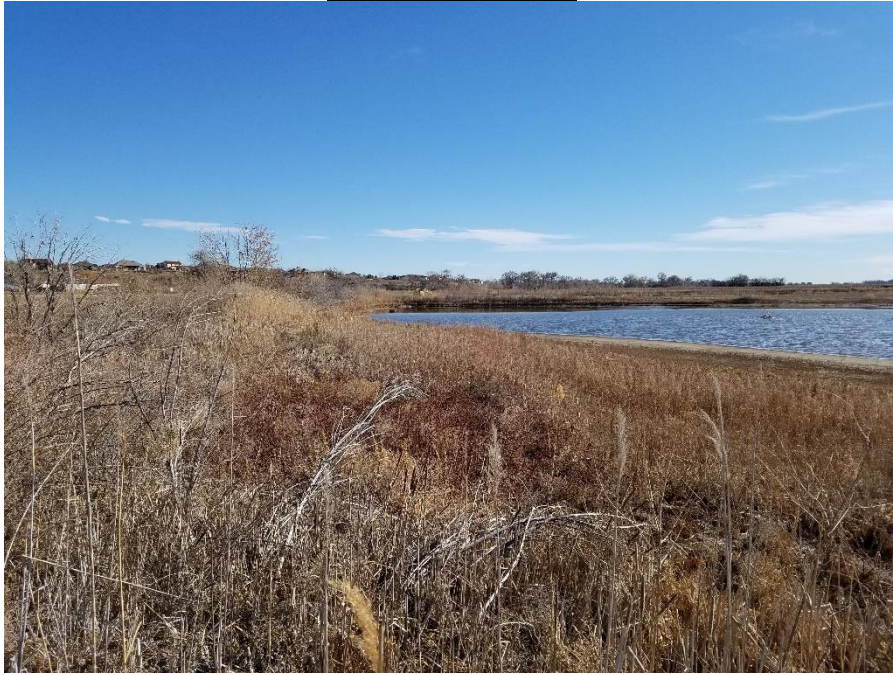
Figure 1. From the northwest corner of the 6.73 acre east pond looking east.

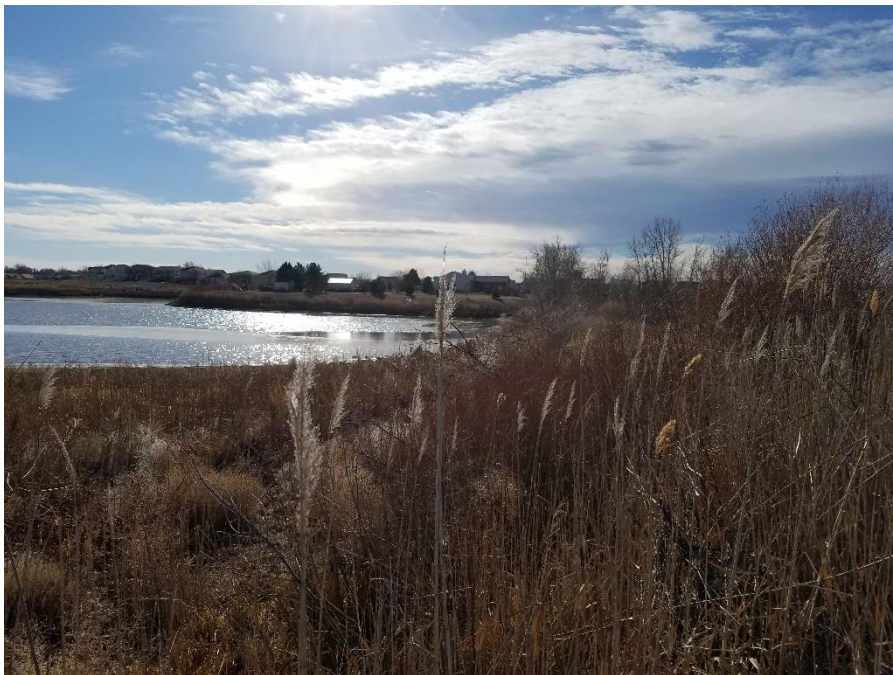
Figure 2. From the northwest corner of the 6.73 acre east pond looking south.

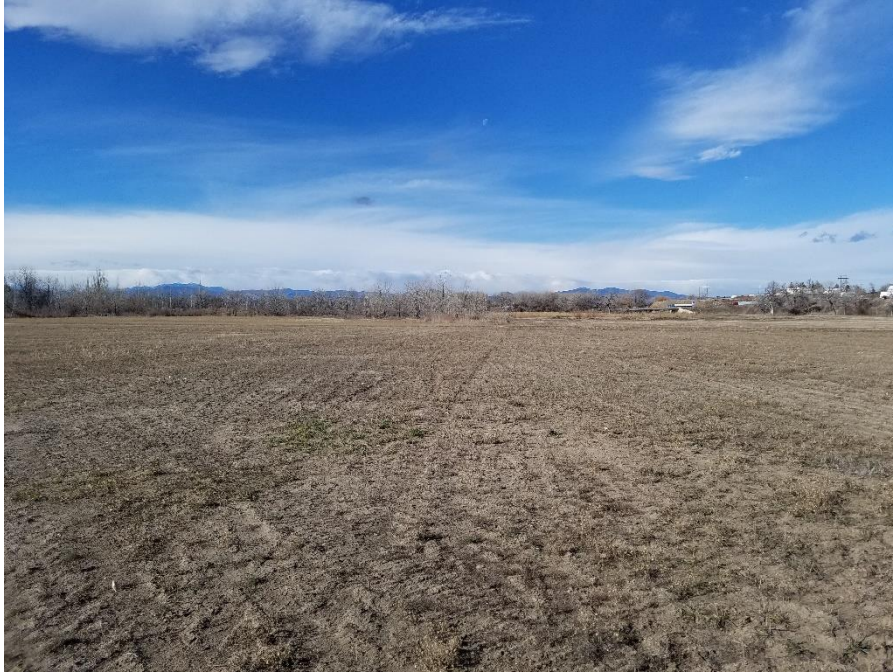
Figure 3. From the east side of the 6.73 acre east pond looking west at pasture area.

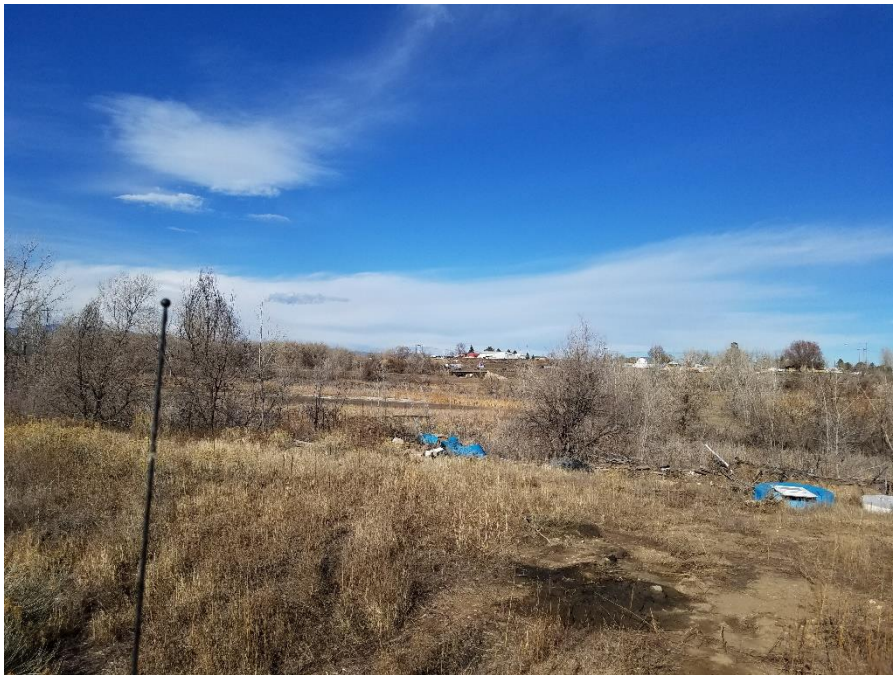
Figure 4. From the southeast end of the 3.37 acre west excavation area looking northwest.

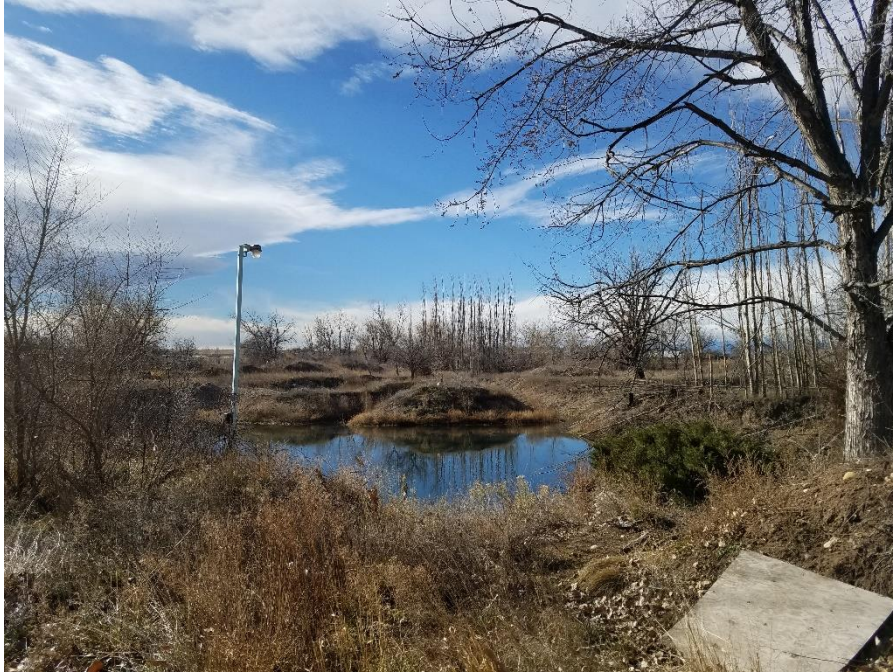
The slopes observed around the pit excavations appear to be graded at a 3H:1V ratio or less with the exception of the southwest pre-1980 pit excavation area. The pit slopes around the pre-1980 pit excavation were very steep in places likely near the angle of repose. Mr. Coulson indicated they intended to grade out these pit slopes and reclaim this area in the future.

Figure 5. From the northeast corner of the 1.48-acre pre-1980 pit looking southwest.

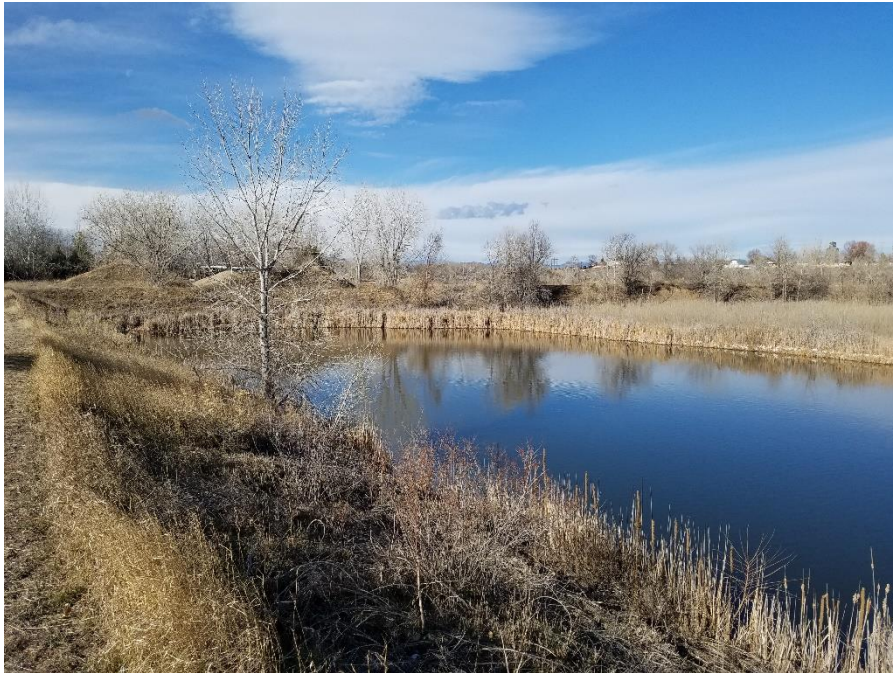
Figure 6. From the south side of the 1.51-acre central pond looking west.

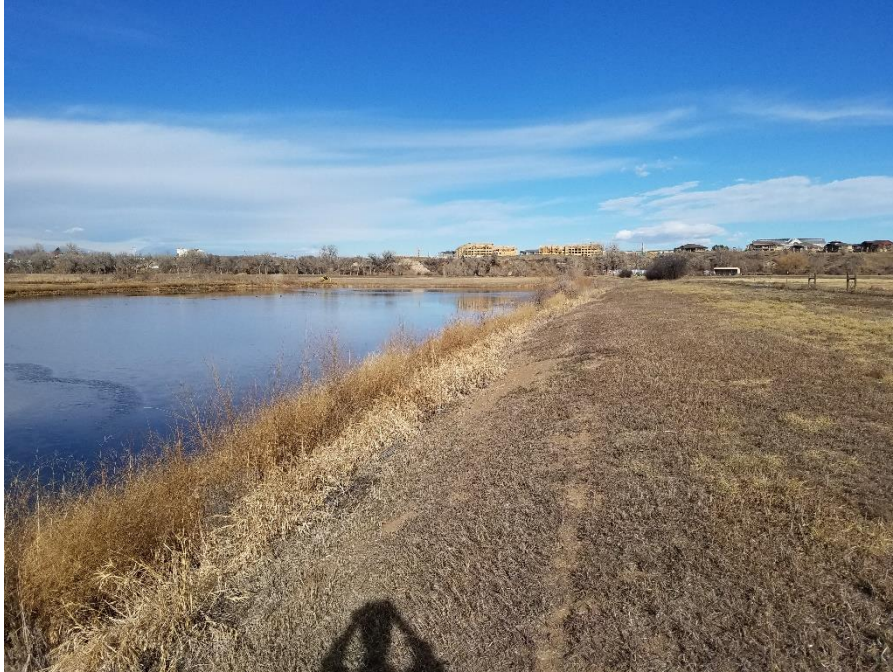
Figure 7. From the southeast corner of the 9.5 acre eastern most pit looking north.

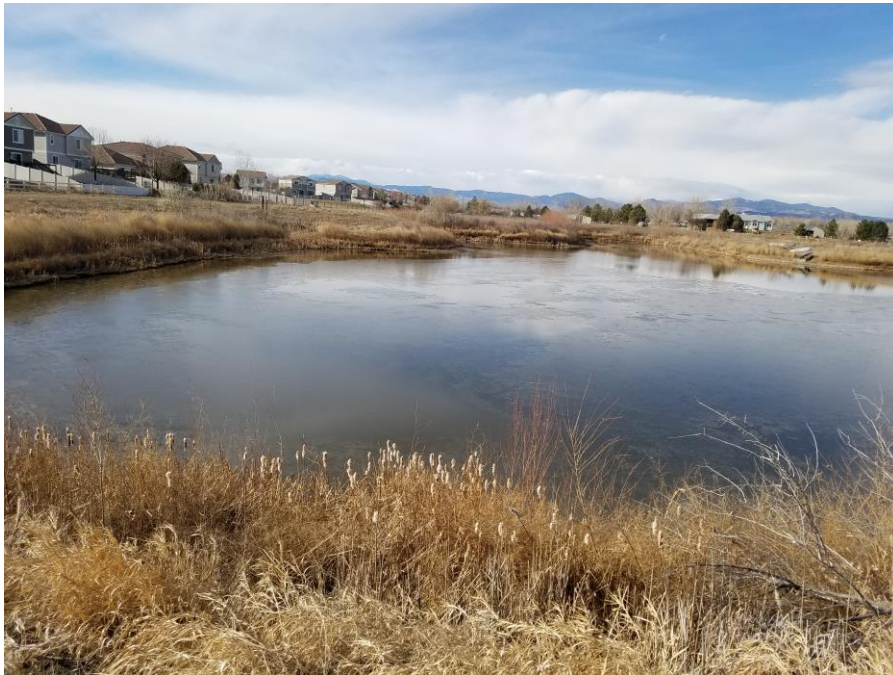
Figure 8. From the southeast corner of the 9.5 acre eastern most pit looking west.
